BYLAW NO. 19616

A bylaw to enter into a heritage revitalization agreement  
.....

**HERITAGE REVITALIZATION AGREEMENT**

# OLD ANNIE DALE SCHOOL

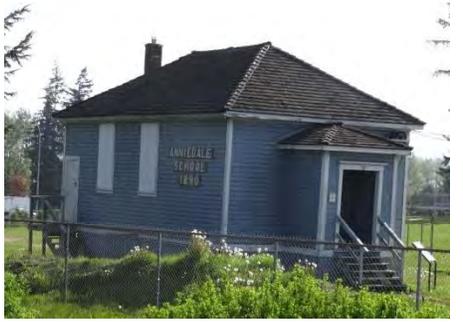
CONDITION ASSESSMENT TABLE			
REF.	ELEMENT	DESCRIPTION/CONDITION	IMAGE REFERENCE
3.1.1	Form, Scale & Massing	No significant alterations or additions have affected the building’s form scale and massing and these aspects of the building are essentially original.

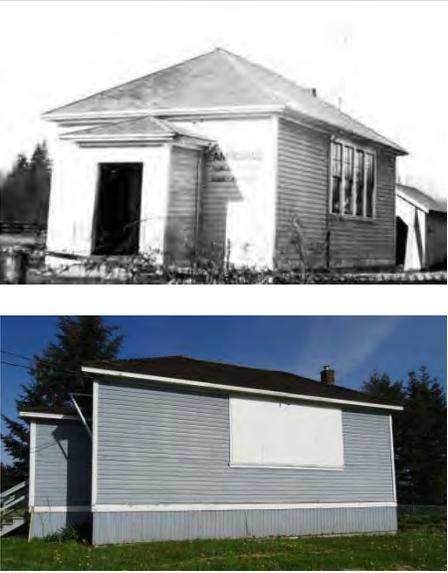
CONDITION ASSESSMENT TABLE			
REF.	ELEMENT	DESCRIPTION/CONDITION	IMAGE REFERENCE
3.1.2	Cladding, Fascia & Soffits	The original wood clapboard cladding is still largely intact, likely with select replacement of isolated boards over time as general maintenance required. The existing wood clapboard, fascia, and soffits are in good condition, with only the paint showing signs of peeling.

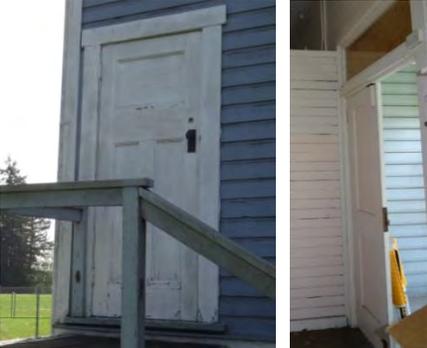
3.1.3	Doors	The original wood frame and panel doors are existing and in fair condition. The original vintage hardware is existing and should be retained.

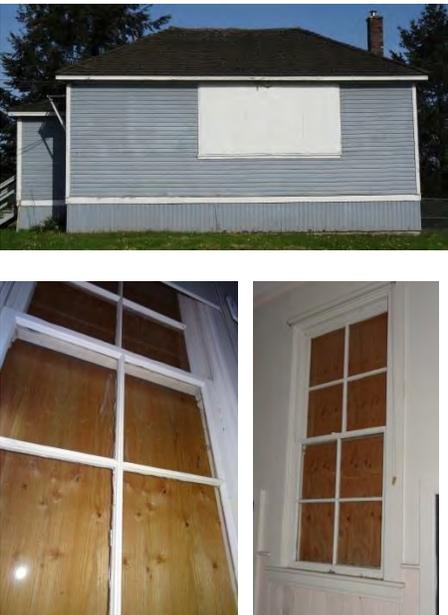
3.1.4	Windows	The original 4-over-4 windows have been boarded up from the outside, but are in good condition with the glass still intact. The interior window mouldings, trim and sills are still intact and in good condition.

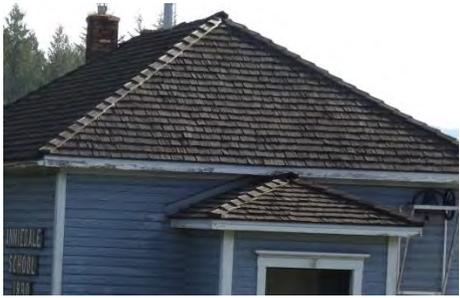
CONDITION ASSESSMENT TABLE			
REF.	ELEMENT	DESCRIPTION/CONDITION	IMAGE REFERENCE
3.1.5	Roof Surface	The cedar shingle roof surface is not original, but is in good condition, only showing minor signs of warping and biological growth.

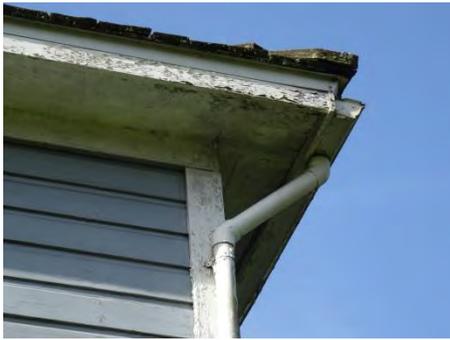
3.1.6	Rainwater Evacuation System	Currently there is only one gutter, on the one side elevation with the side door. It is attached to a rainwater leader. The remaining eaves (including those on the front porch) do not have gutters or leaders.

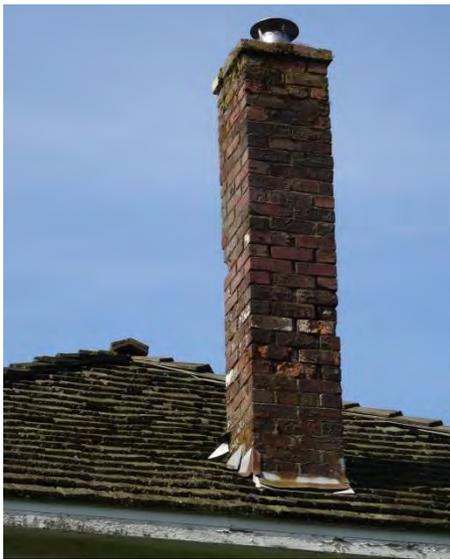
3.1.7	Chimney	The original brick chimney is in poor condition. Several bricks are severely spalled and the mortar joints have washed out. The sheet metal flashing at the roof is deformed and deteriorated. It appears that the chimney was reconstructed from the 6 <sup>th</sup> brick course up. This was perhaps done during the move in 1975. It is the reconstructed portion that is in poor condition. There is considerable evidence of water ingress from failed and corroded sheet-steel chimney step flashing at the interior ceiling.

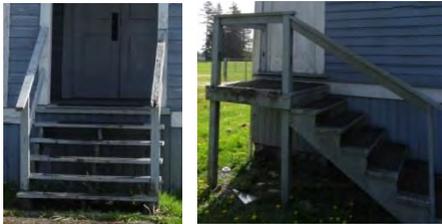
3.1.8	Entry Stairs	The entry stairs at the main entry and the side entry are in poor condition. The treads have deteriorated. The railings do not comply to the current building code.

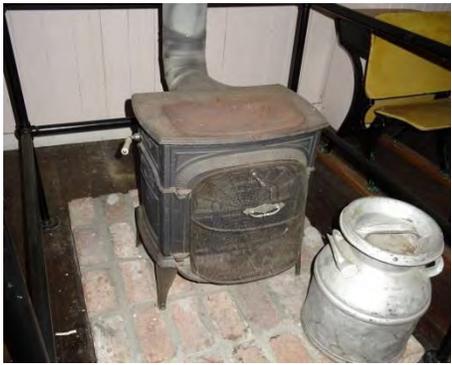
CONDITION ASSESSMENT TABLE			
REF.	ELEMENT	DESCRIPTION/CONDITION	IMAGE REFERENCE
3.1.12	Woodstove	The current wood stove is not original, but contributes to the heritage character of the space.

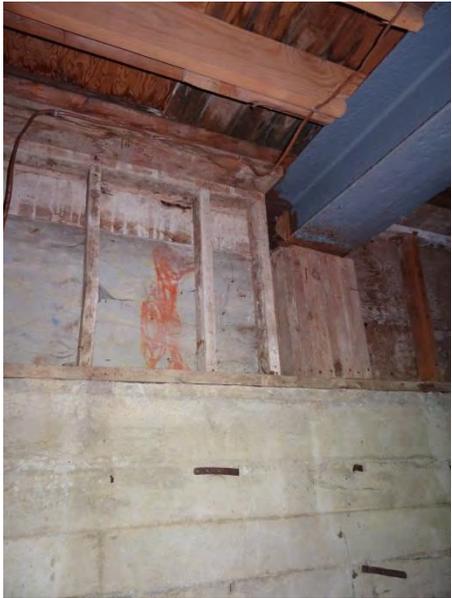
3.1.13	Structure: Basement	<p>The 6'-4" concrete foundation wall is in very good condition.</p> <p>The steel needle beams that were used in the move have remained in place. They are in good condition and are more than adequate for the load.</p> <p>Some of the wood joists have been doubled and new joists have been added over time. The 4" seats are adequate.</p>

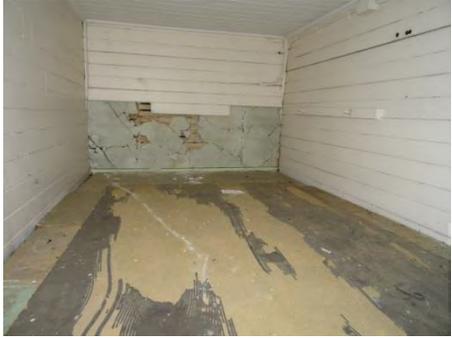
3.1.14	Structure: Main Floor	The walls are framed with rough cut 2 x4's at 16" o.c. The ceiling joists are rough cut 2x6's, also 16" o.c.

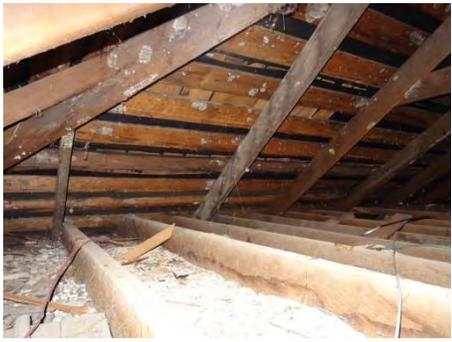
CONDITION ASSESSMENT TABLE			
REF.	ELEMENT	DESCRIPTION/CONDITION	IMAGE REFERENCE
3.1.15	Structure: Roof	The rafters are rough cut 2x6's at 3'-0" o.c. and is in good condition, however, they are likely 'birdmouthed' and possibly toenailed to the top plate, which does not comply with current building code.

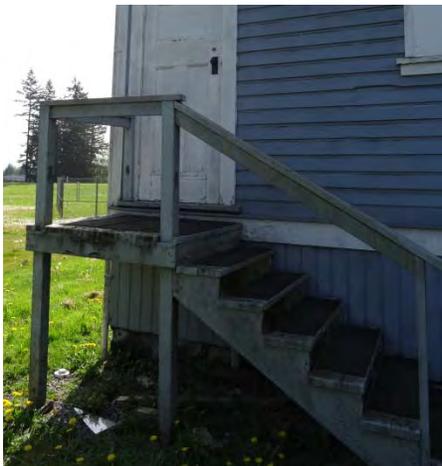
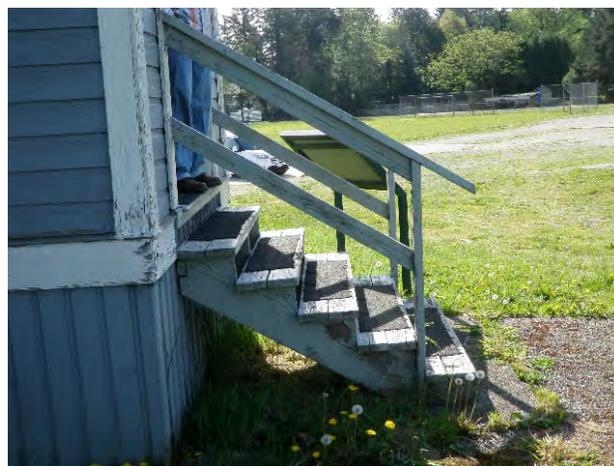
The access stairs to the school building were adequately constructed; however the treads and stringers are well aged and should be replaced. The railings do not comply with the current building code.

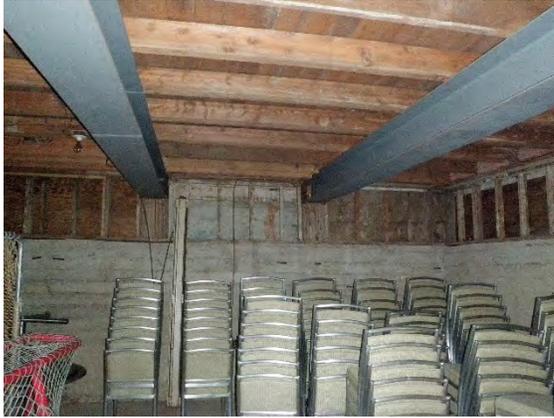
The basement of the school has only exterior entry. The 6'-4" high concrete wall is in very good condition. It is topped by 2'-6" high pony wall (see below). The pony wall was constructed after the building was moved to the present location; the steel needle beams used for the move have remained in place and are supported by 1-1/2' high solid wood stack of 1'x3-1/2" in area that transfers the load to the concrete wall. Though the two steel beams have been welded from shorter segments and have minor cut outs the size of WF 12"x64 (approximate beam size for 12" wide flange) for the span of 28' is more than adequate as it can carry double the current load for assembly type use.

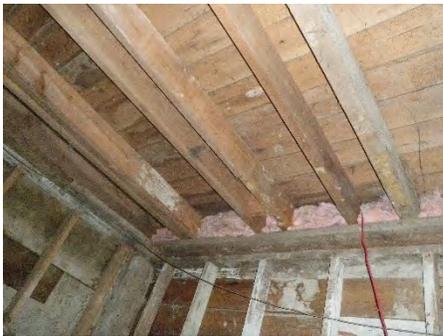
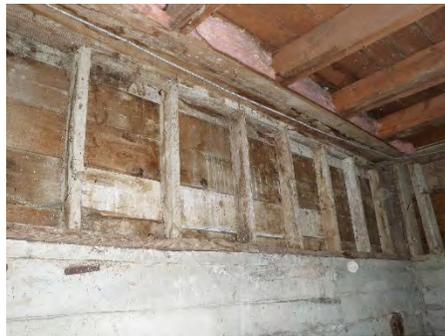
The original floor joists were rough cut 2x6 at 24" o.c. The joists extend to the exterior sheathing with more than adequate seats on the 4" deep top plate of the pony wall (see next photo). It appears that during the last renovations some joist may have been damaged and were doubled and also some new joists were added.

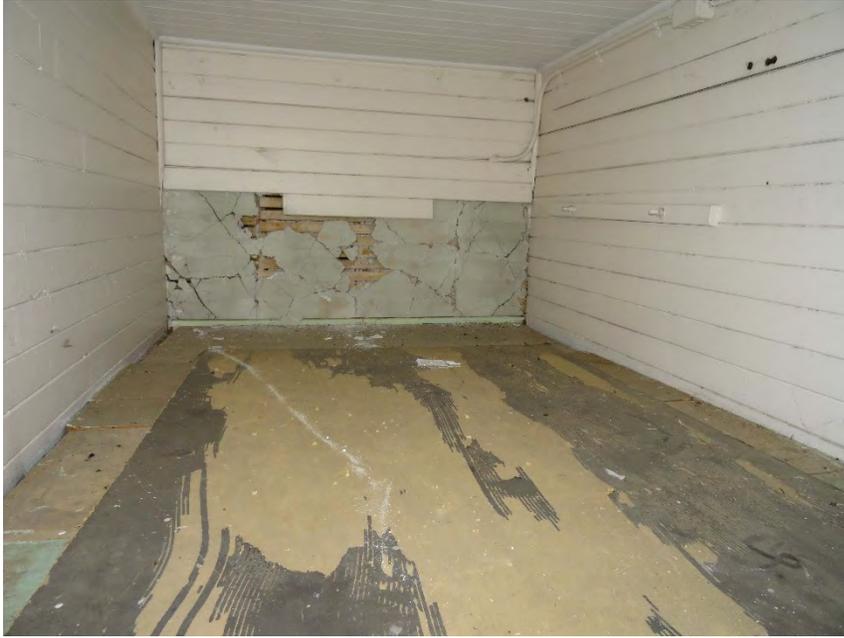
This damaged wall at the entry foyer allowed us determine the wall structure. The walls are framed using 2x4 most likely rough cut lumber at 16" o.c. which is also the spacing of the ceiling jooists.

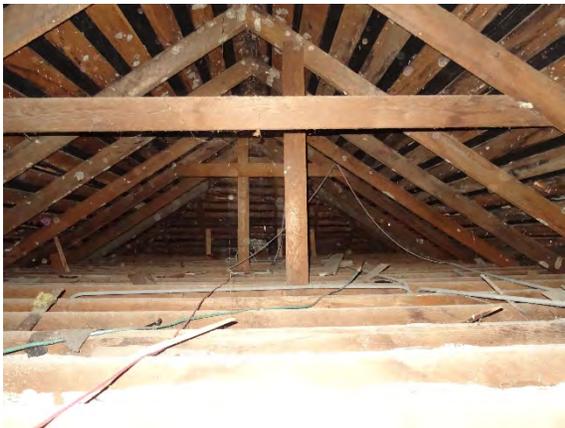
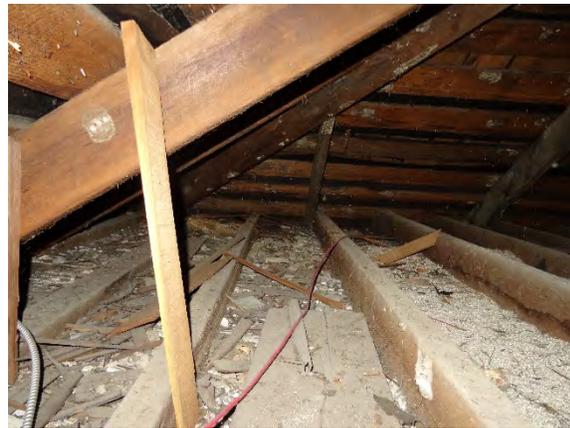
The hip roof structure has 2x6 rough cut rafters at approximately 3'-0" o.c. The rafters extend about a foot past the wall top plate to form the outer roof perimeter including fascia, soffit and gutters. The rafters must be "birdmouthed" and possibly toe nailed to the top plate as they do not match the ceiling joists which are 16" o.c. The common rafter sets have collar ties every 4<sup>th</sup> set and wind braces at one of the common rafter sets inbetween the colalr tie sets. It is generally very well constructed roof though somewhat evading current roof standards. The roof structure complies with current load standards though in order to comply with the 2012 Building Code the rafters would have to be connected to wall plate by ties. As the rafters butt-end at the hip line, installing a steel strap connector would stiffen the roof structure.

One possible connector type that could be installed to tie the roof to the walls.

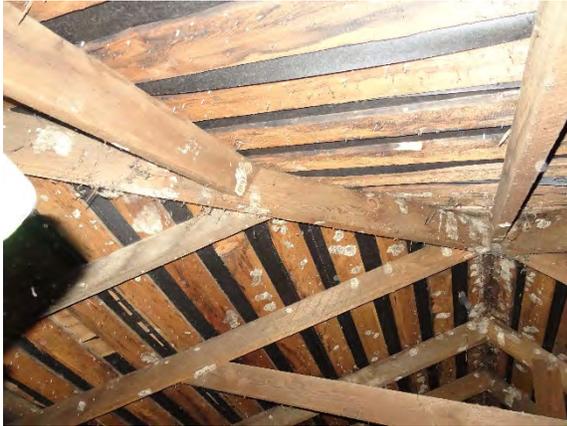
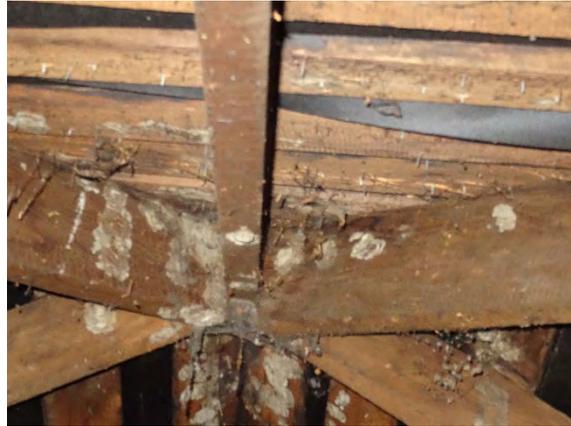
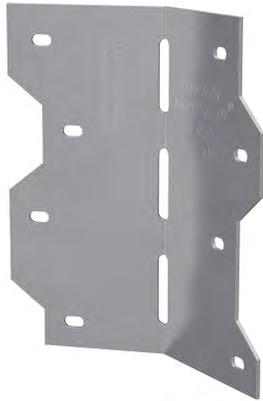
The two hip joints of the common rafters and hip rafters are a masterpiece of carpentry with no evidence of nails, strictly relying on compression. However, as winds and seismic events apply to the structure horizontally and uplift forces, it would be desirable to use steel connectors for the hip ridge joint and for the jacks attached to hip rafters.

SST – LS 18 field adjustable angle connector.
