Corporate Report

TO: Mayor & Council DATE: December 7, 2007
FROM: Laurie Cavan, General Manager FILE: 6140 – 20/KW
Parks, Recreation & Culture Department
SUBJECT: Former Camp Kwomais Site – Buildings and Planning Process

Camp Kwomais

Building Assessment Follow-up

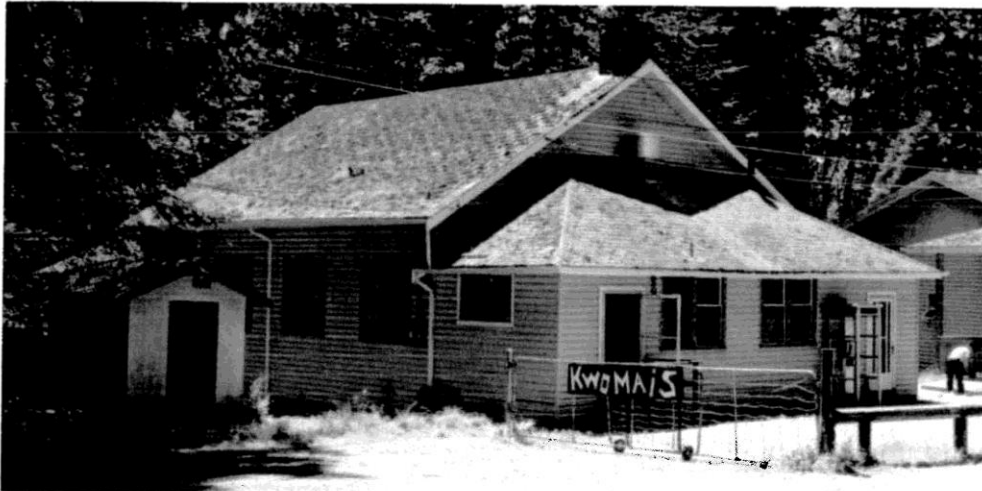
* facing south-west

- * roofing needs cleaning
- * strong smell of mustiness from wood exposed continually to moisture, probably from crawl space
- * original wood T&G floor boards wearing through
- * original wood-burning fireplace no longer "emissions acceptable"
- * original wood frame, single-glazed windows no longer up to energy requirements
- * insulation levels & moisture protection not up to Code

In my opinion, this building is not worth retaining any longer. It is past its age of usefulness. Perhaps, however, some of the larger timbers could be re-cycled and re-used.

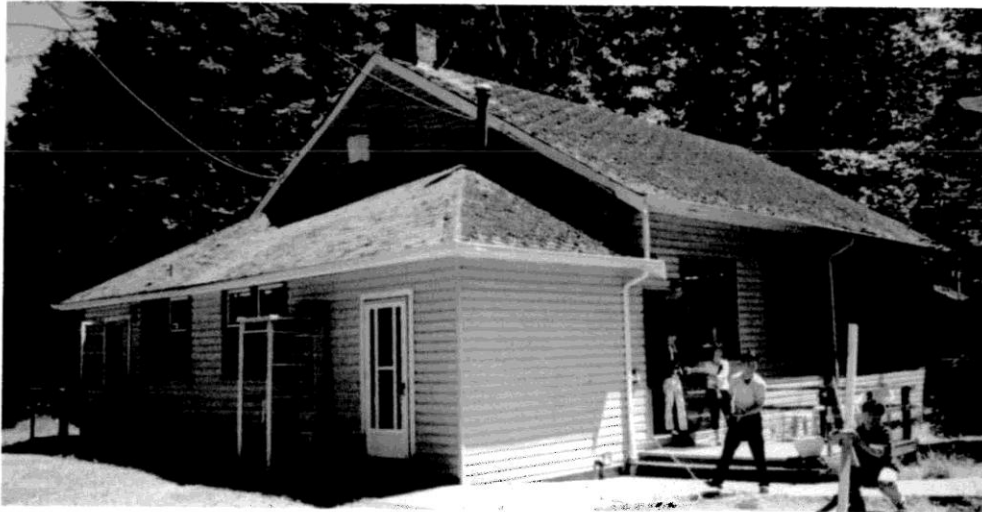
Exterior * facing south-east

Most of the roof has a heavy layer of moss growth, and the quality of the shingles beneath is unknown at present. However, many of the shingles where the edge condition can be ascertained are curling and clearly stressed. The ceiling inside has many areas of water staining, obviously from roof leaks, so I will assume that a re-roofing is in order. I think that asphalt shingles are of acceptable quality. I would also expect to encounter some areas of rotten sheathing, which would need repairing. I would not expect to encounter any serious damage to the rafters or trusses. Include new flashing and fascias.

I suggest a budget of \$35,000.

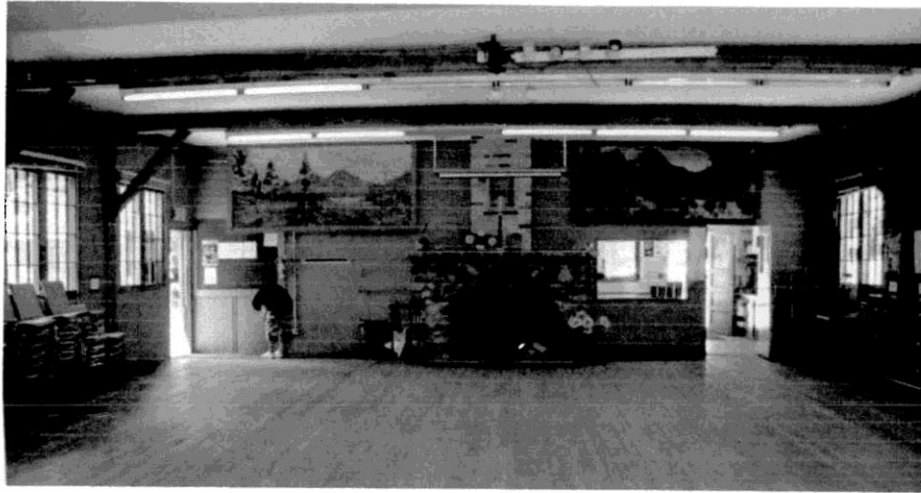
Interior: * facing north, from washroom area towards kitchen

The existing ceiling has been damaged by exposure to water penetrating from the roof, and should be removed, then replaced. The attic space will benefit from added insulation, vapour barrier, perimeter (soffit) and ridge or gable venting.

I suggest a budget of \$30,000.

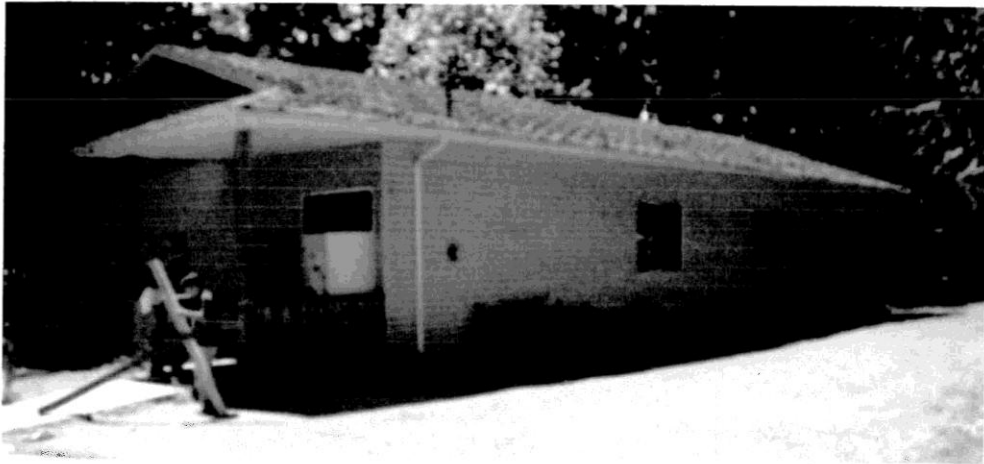
* facing south-west

- * roofing needs cleaning
- * basement storage is dry
- * hall is usable

Most of the roof has a heavy layer of moss growth, and the quality of the shingles beneath is not entirely clear at this time. However, only a few of the shingles appear distressed. So the roofing should be cleaned, and if fewer than 10% of the shingles are damaged, they should be replaced. If damage is more extensive, a further review is necessary.

Budget \$4,000.

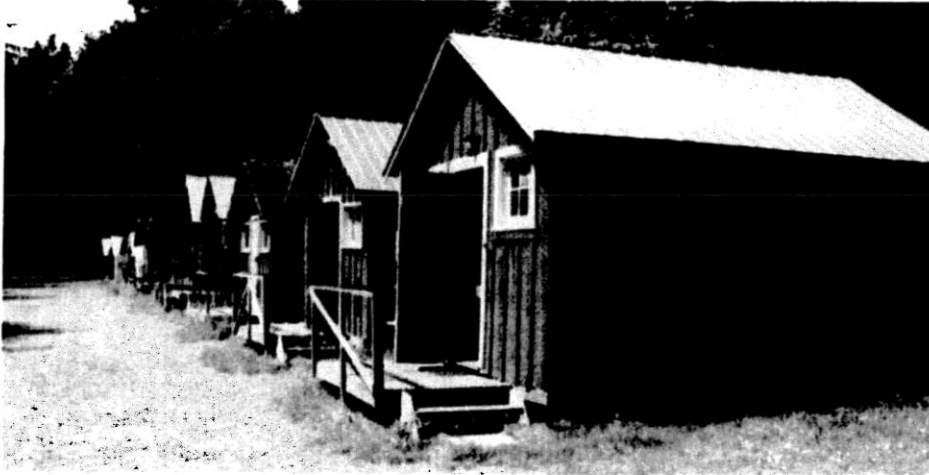
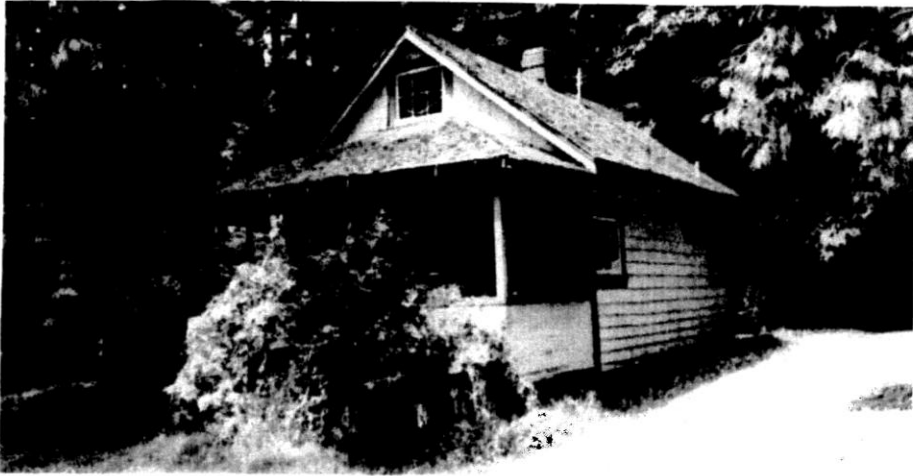
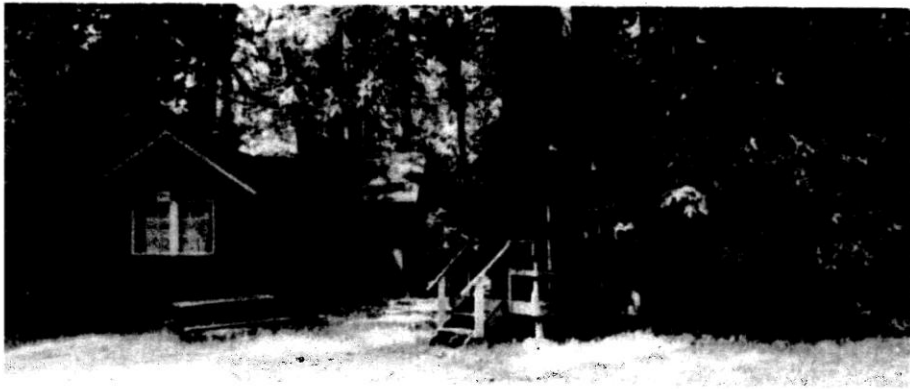
The activity building called the "Bunn-galow" had been upgraded in 1986 with the installation of a handicapped-accessible washroom, but does not appear to be used very often. The air is stale and excessively musty; poor air quality. The smell caused by rotting lumber in the floor and walls is very heavy and disagreeable.

- * some floors and walls structurally unstable
- * remaining asphalt roofs need to be re-roofed; some rot noted at fascias and soffits
- * strong smell of mustiness from wood exposed continually to moisture, probably from floor joists
- * original and newer single-glazed windows no longer up to energy requirements
- * insulation levels & moisture protection not up to Code

The cabins cannot be left as is. Upgrading is needlessly expensive. The buildings are not compatible with intended use. Removal is the only viable option.

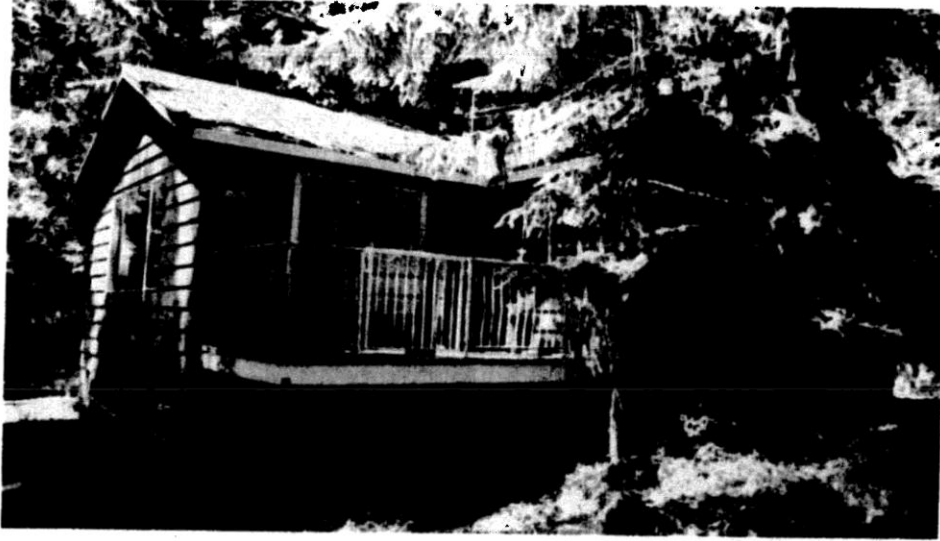
The Manager's residence is located near the main entrance to the site. It has been adequately repaired and maintained over the years, and is currently quite liveable.

- * roofing needs cleaning
- * balcony membranes still in good shape
- * single-glazed windows could use upgrading to double-glazed

A Manager's Residence is very useful in establishing a security presence on this property. This building can continue to function in this capacity for the foreseeable future.
