SUBJECT: **Heritage Revitalization Agreement Application No. 7918-0037-00 for
1881 Town Hall and Old Anniedale School located at 17710 – 56A Avenue**

conservation plan

3 CONDITION ASSESSMENT

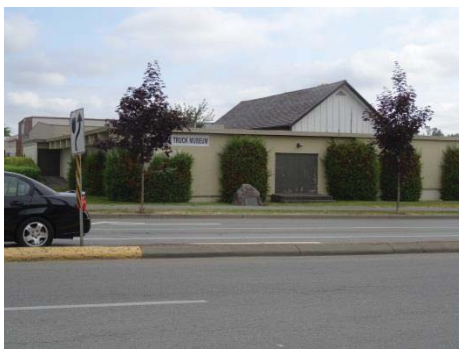
CONDITION ASSESSMENT TABLE			
REF.	ELEMENT	DESCRIPTION/CONDITION	IMAGE REFERENCE
3.1.1	Form, Scale & Massing	The building has been added to over time, to the point that it has been enveloped on all sides by the existing building. The only discernable massing from the exterior is the gabled roof, and gable ends. This encasement is not desirable from a heritage standpoint as it altered the historic place beyond recognition.

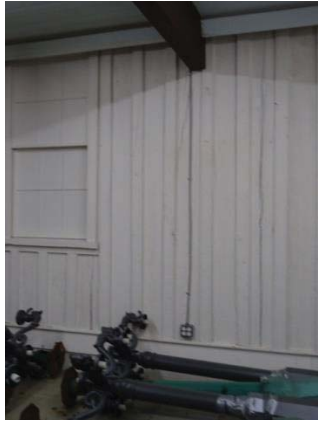
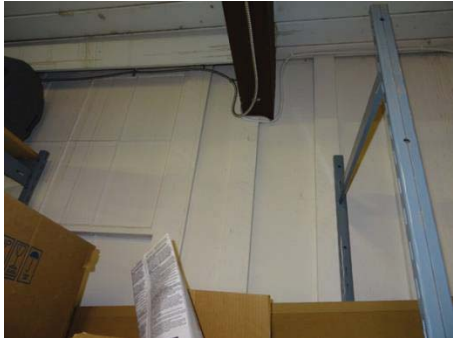
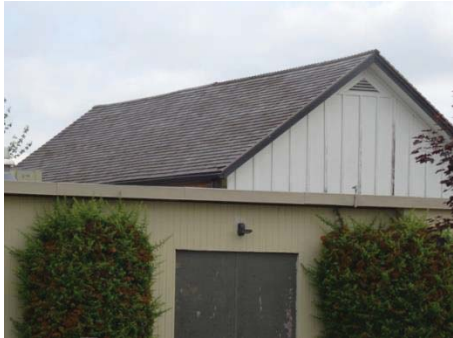
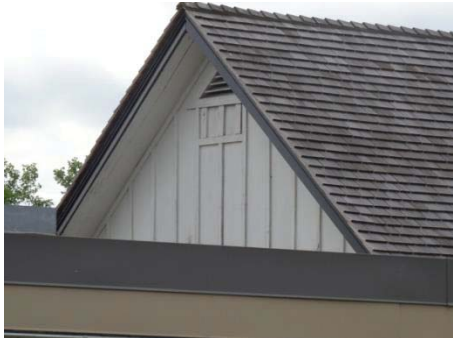
CONDITION ASSESSMENT TABLE			
REF.	ELEMENT	DESCRIPTION/CONDITION	IMAGE REFERENCE
3.1.2	Cladding, Fascia & Soffits	<p>The historic hall has its original cedar board and batten cladding intact and in good condition. The cladding has been replaced at the vertical sections aligning with the east elevation beam penetrations, as the support for the beams on this elevation was integrated into the heritage hall exterior wall to take advantage of the concrete foundation was built to receive the relocated building.</p> <p>Comparisons to historic photography indicate that the roof had quite a small eave extension, but may have been further clipped back during subsequent roof renovations since the relocation.</p> <p>The exterior board and batten cedar cladding is also in excellent condition.</p>

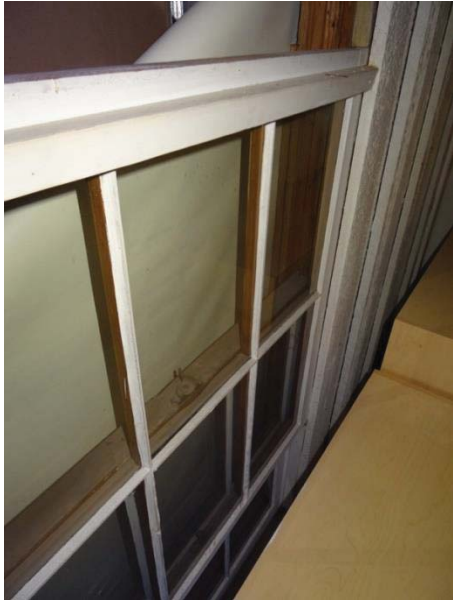
CONDITION ASSESSMENT TABLE			
REF.	ELEMENT	DESCRIPTION/CONDITION	IMAGE REFERENCE
3.1.3	Doors	The original doors have been removed, as has the original front stoop.	
3.1.4	Windows	The original 6-over-6 wood muntined double hung windows have survived in good condition. The glazing has been painted on some elevations, but this is easy to strip off of glass.

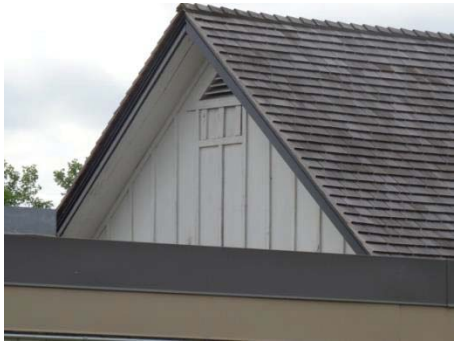
3.1.5	Roof Surface	A new sawn cedar shingle roof on a plywood sheathing was installed as part of a structural and roof rehabilitation within the last three years and is in excellent condition.

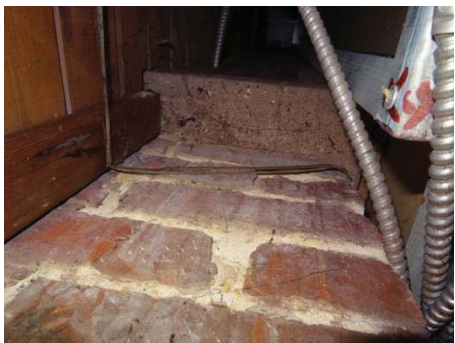
3.1.7	Chimney	The original brick chimney set into the northeast wall is currently supported on wood framing and terminates just below the roof.

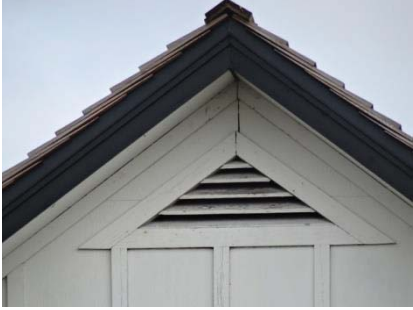
CONDITION ASSESSMENT TABLE			
REF.	ELEMENT	DESCRIPTION/CONDITION	IMAGE REFERENCE
3.1.9	Gable Vents	The original gable vent is in place and excellent condition.

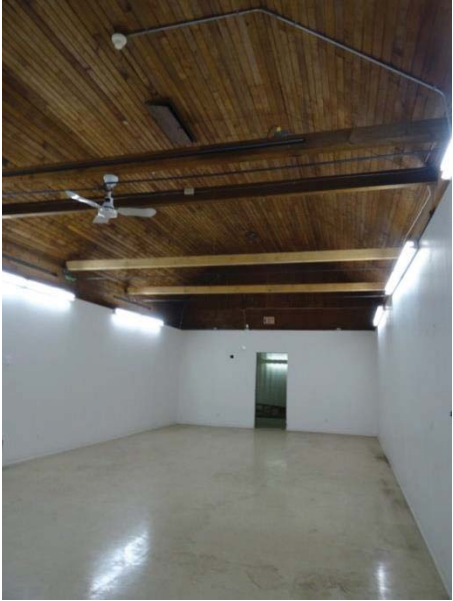
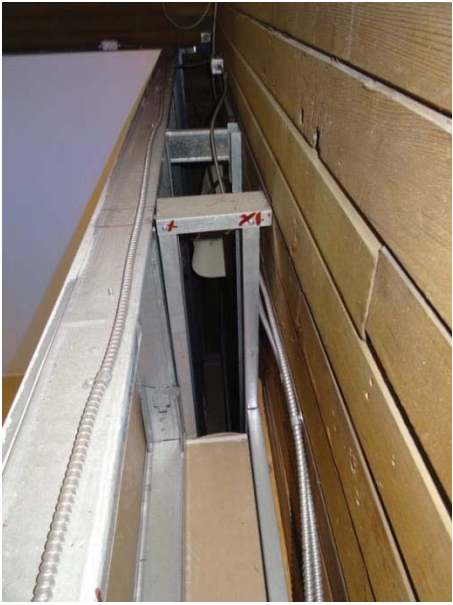
3.1.10	Interior Features	The tongue-and-groove V-groove ceiling paneling is still intact and in good condition. The same paneling, installed in a horizontal configuration, is intact and in fair condition behind a steel stud and gypsum board interior wall. The steel studs have been screwed to the interior paneling in places, so some fastener holes and patching/finishing is to be expected.

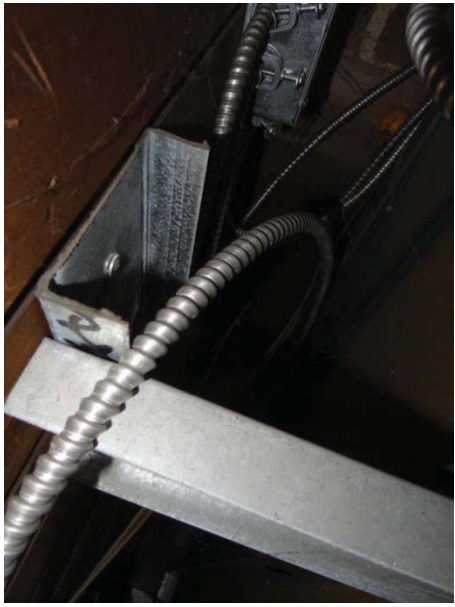
CONDITION ASSESSMENT TABLE			
REF.	ELEMENT	DESCRIPTION/CONDITION	IMAGE REFERENCE
3.1.11	Electrical Distribution	BX electrical cable is run within the interior liner wall and is fed from a panel outside the heritage hall in the museum area.

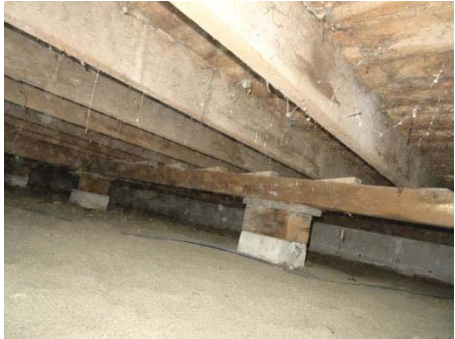
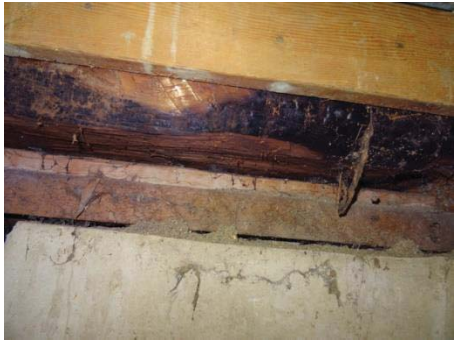
3.1.12	Structure: Floor	<p>The original 2"X10" joists are intact and supported at the ends on a new reinforced concrete foundation wall constructed at this new relocation site. A 6"X6" longitudinal beam supported on blocking runs the full length of the foundation at the center line. Wood wedge blocks have been set to level the floor.</p> <p>The original hewn log end joist, which carries the gable end wall loads, still exists in good condition, and is set on a heavy wood sill, which bears on the new concrete foundation wall. This hewn log end joist would need to be supported by the moving needle beams.</p>

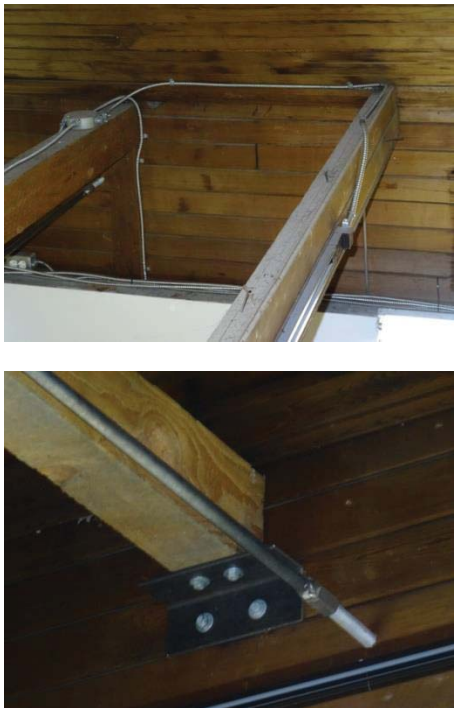
CONDITION ASSESSMENT TABLE			
REF.	ELEMENT	DESCRIPTION/CONDITION	IMAGE REFERENCE
3.1.13	Structure: Walls	To limit splaying of the walls and improve the rafter support, new tie beams and tie rods have been installed, which connect through the top of the wall to an exterior heavy wood ledger. The wall structure is assumed to be 2"X4", but access to confirm this was not available.

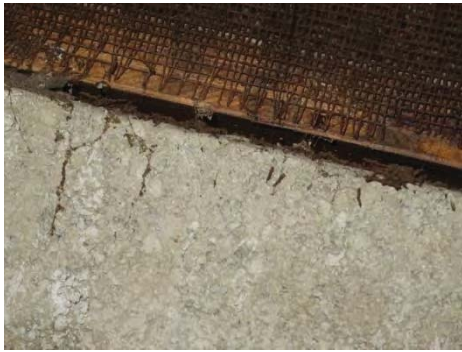
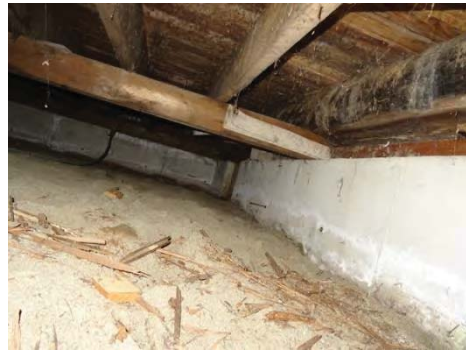
The Townhall structure walls were placed on a concrete perimeter foundation that created a crawl space about 3' high. The walls are resting on the perimeter cedar beam as this was one of the common foundations for buildings in the 19th century in Lower Mainland. The beam is placed on top of the concrete foundation.

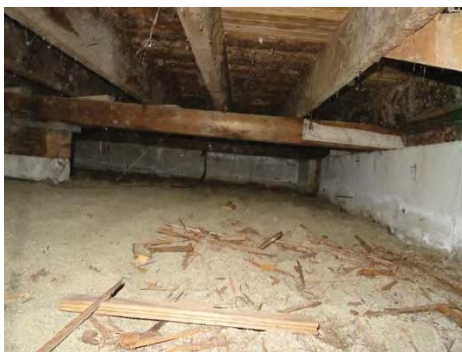
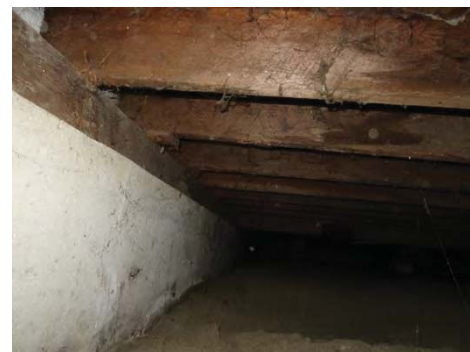
The floor joists are rough cut 2x8 spaced 18" running parallel to the shorter walls, about 20 feet in length. The floor joist are seated on the perimeter foundation beam and on the centrally located 6x6 rough cut beam so that the active load bearing length of the joists is 10 feet. The beam is supported by piers consisting of a combination of concrete blocks, 6x6 timber and 2x8 RC lumber. The joists are shimmed by lumber wedges where required. The floor boards appear to be 2x8 RC lumber.

The floor structure is capable of meeting the assembly loads in compliance with the current building code.

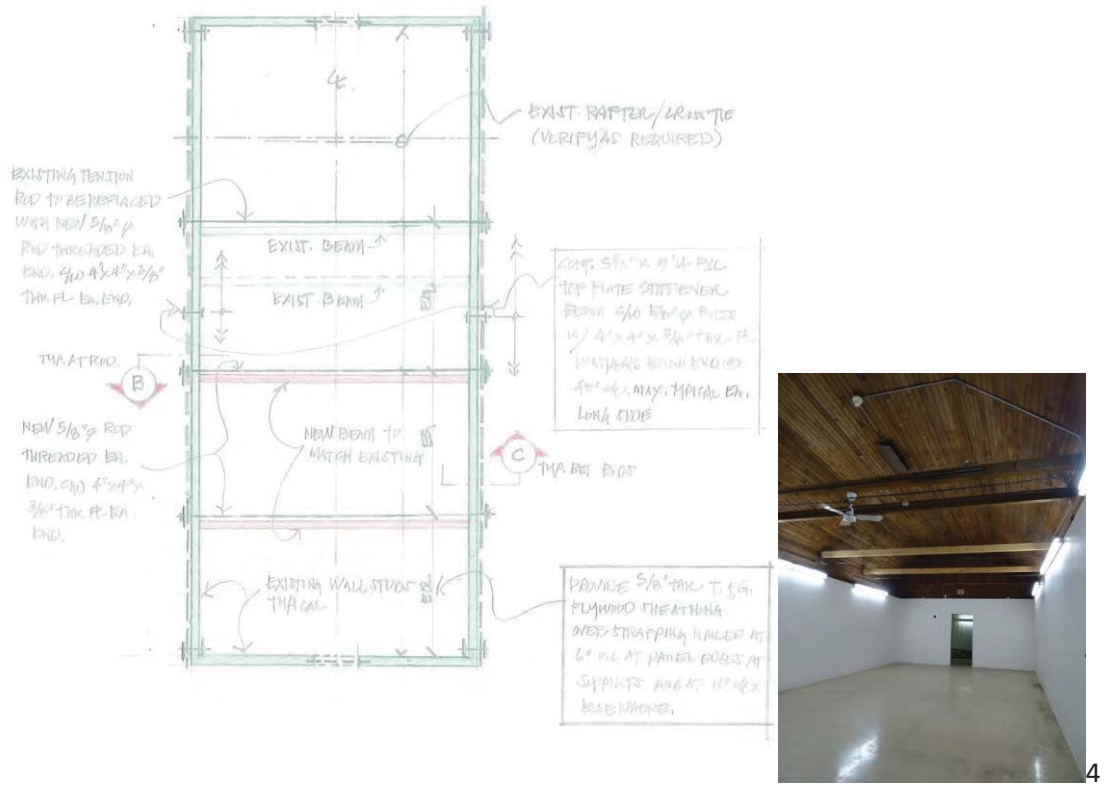
The superstructure was subject to repairs to correct the sagging roof in the summer of 2014. The then existing one tension rod and two compression beams were augmented by installation of two new similar elements.

This 2014 installation will be very helpful for preparing the structure for the planned relocation.

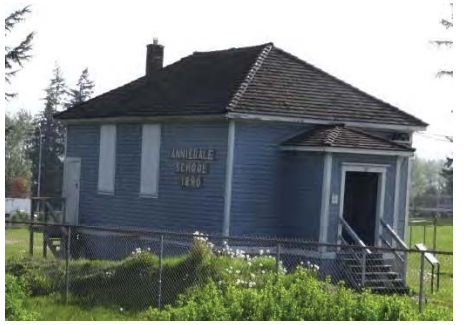
CONDITION ASSESSMENT TABLE			
REF.	ELEMENT	DESCRIPTION/CONDITION	IMAGE REFERENCE
3.1.1	Form, Scale & Massing	No significant alterations or additions have affected the building’s form scale and massing and these aspects of the building are essentially original.

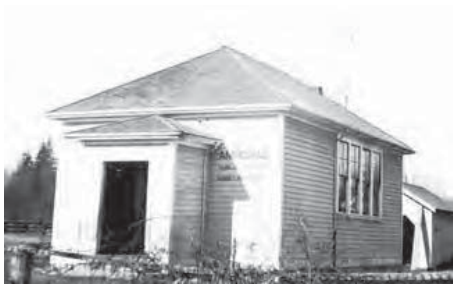
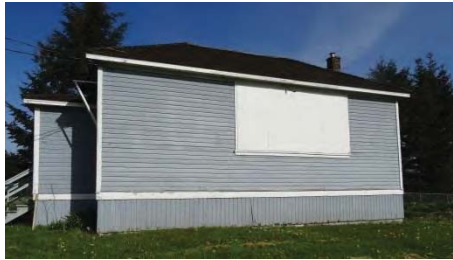
CONDITION ASSESSMENT TABLE			
REF.	ELEMENT	DESCRIPTION/CONDITION	IMAGE REFERENCE
3.1.2	Cladding, Fascia & Soffits	The original wood clapboard cladding is still largely intact, likely with select replacement of isolated boards over time as general maintenance required. The existing wood clapboard, fascia, and soffits are in good condition, with only the paint showing signs of peeling.

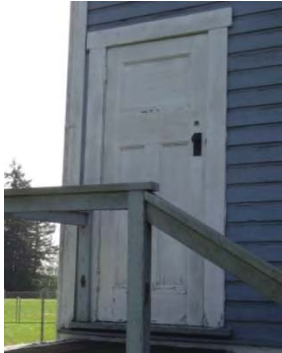
3.1.3	Doors	The original wood frame and panel doors are existing and in fair condition. The original vintage hardware is existing and should be retained.

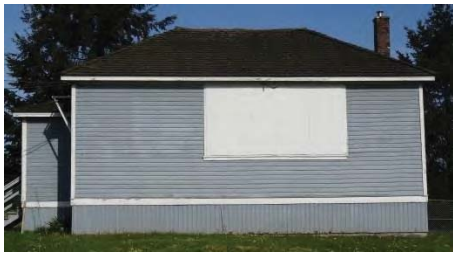
3.1.4	Windows	The original 4-over-4 windows have been boarded up from the outside, but are in good condition with the glass still intact. The interior window mouldings, trim and sills are still intact and in good condition.

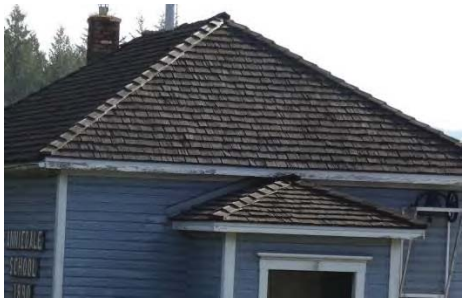
CONDITION ASSESSMENT TABLE			
REF.	ELEMENT	DESCRIPTION/CONDITION	IMAGE REFERENCE
3.1.5	Roof Surface	The cedar shingle roof surface is not original, but is in good condition, only showing minor signs of warping and biological growth.

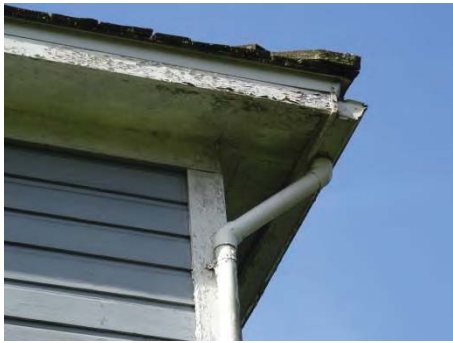
3.1.6	Rainwater Evacuation System	Currently there is only one gutter, on the one side elevation with the side door. It is attached to a rainwater leader. The remaining eaves (including those on the front porch) do not have gutters or leaders.

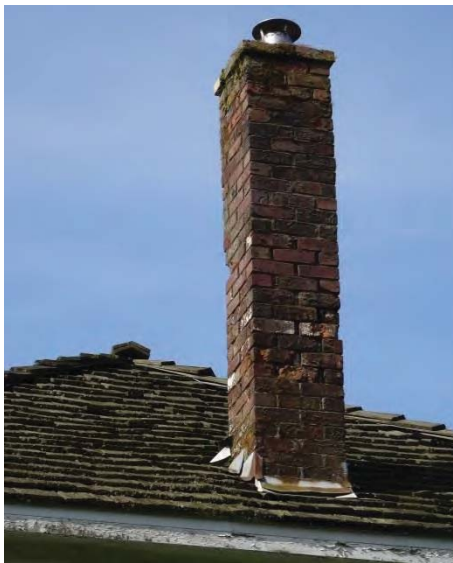
3.1.7	Chimney	The original brick chimney is in poor condition. Several bricks are severely spalled and the mortar joints have washed out. The sheet metal flashing at the roof is deformed and deteriorated. It appears that the chimney was reconstructed from the 6 th brick course up. This was perhaps done during the move in 1975. It is the reconstructed portion that is in poor condition. There is considerable evidence of water ingress from failed and corroded sheet-steel chimney step flashing at the interior ceiling.

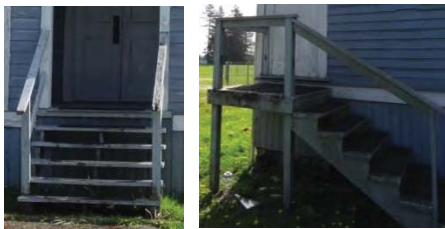
3.1.8	Entry Stairs	The entry stairs at the main entry and the side entry are in poor condition. The treads have deteriorated. The railings do not comply to the current building code.

The access stairs to the school building were adequately constructed; however the treads and stringers are well aged and should be replaced. The railings do not comply with the current building code.

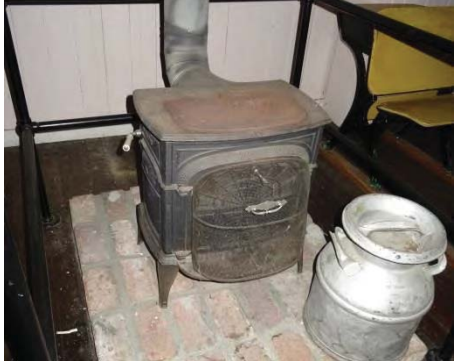
CONDITION ASSESSMENT TABLE			
REF.	ELEMENT	DESCRIPTION/CONDITION	IMAGE REFERENCE
3.1.12	Woodstove	The current wood stove is not original, but contributes to the heritage character of the space.

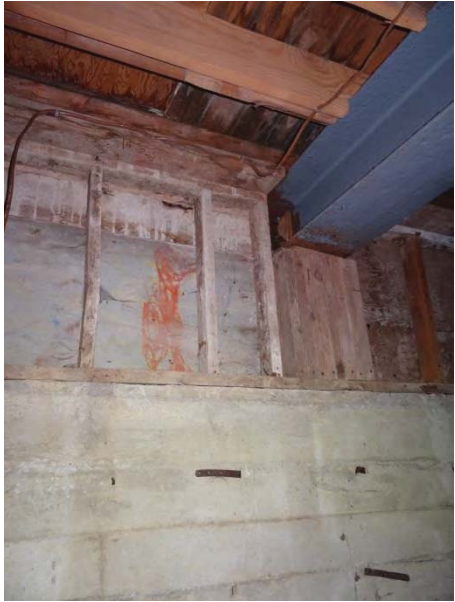
3.1.13	Structure: Basement	<p>The 6'-4" concrete foundation wall is in very good condition.</p> <p>The steel needle beams that were used in the move have remained in place. They are in good condition and are more than adequate for the load.</p> <p>Some of the wood joists have been doubled and new joists have been added over time. The 4" seats are adequate.</p>

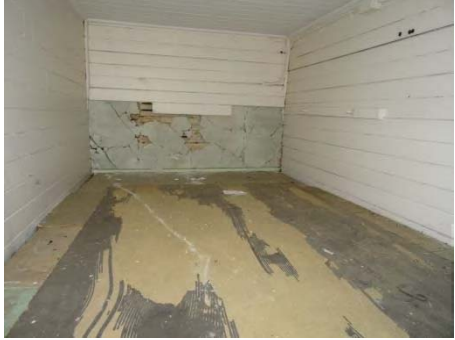
3.1.14	Structure: Main Floor	The walls are framed with rough cut 2 x4's at 16" o.c. The ceiling joists are rough cut 2x6's, also 16" o.c.

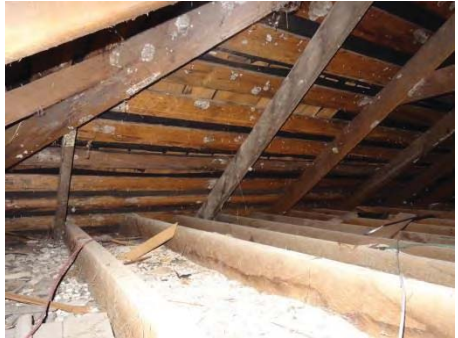
CONDITION ASSESSMENT TABLE			
REF.	ELEMENT	DESCRIPTION/CONDITION	IMAGE REFERENCE
3.1.15	Structure: Roof	The rafters are rough cut 2x6's at 3'-0" o.c. and is in good condition, however, they are likely 'birdmouthed' and possibly toenailed to the top plate, which does not comply with current building code.

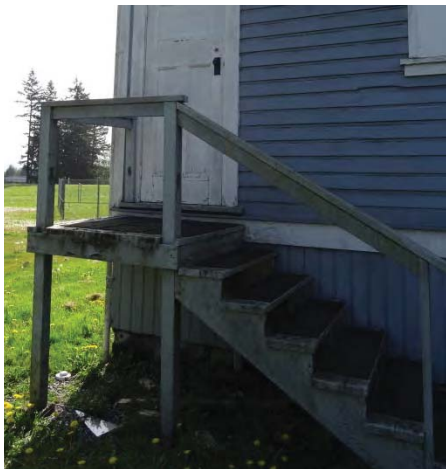
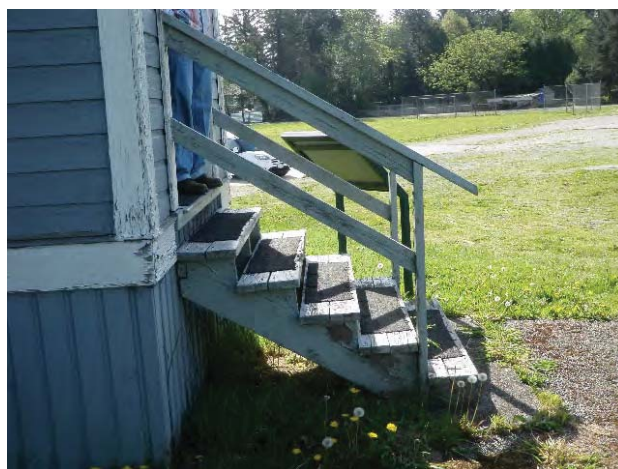
Old Anniedale School is in good condition overall. It was moved to the present location some 40 years ago. Some structural components of the building were improved at the time.

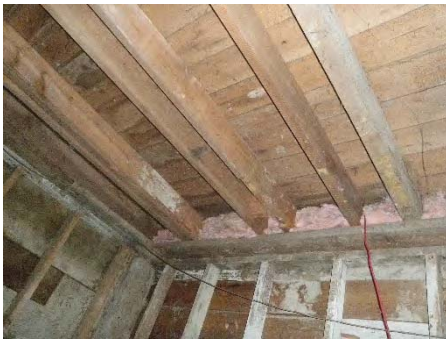
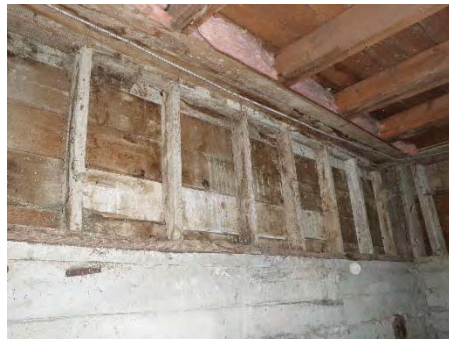
The basement of the school has only exterior entry. The 6'-4" high concrete wall is in very good condition. It is topped by 2'-6" high pony wall (see below). The pony wall was constructed after the building was moved to the present location; the steel needle beams used for the move have remained in place and are supported by 1-1/2' high solid wood stack of 1'x3-1/2" in area that transfers the load to the concrete wall. Though the two steel beams have been welded from shorter segments and have minor cut outs the size of WF 12"x64 (approximate beam size for 12" wide flange) for the span of 28' is more than adequate as it can carry double the current load for assembly type use.

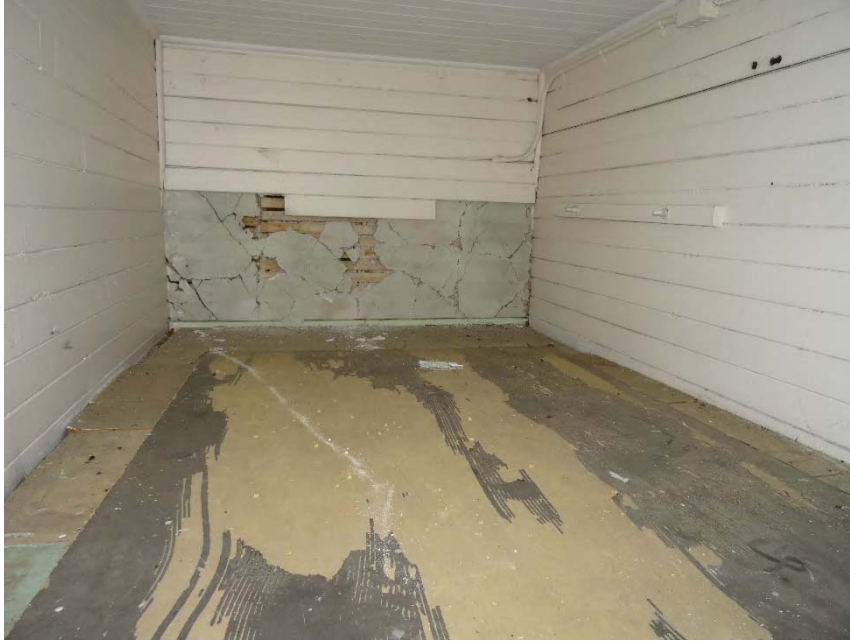
This damaged wall at the entry foyer allowed us determine the wall structure. The walls are framed using 2x4 most likely rough cut lumber at 16" o.c. which is also the spacing of the ceiling jooists.
