City of Surrey

Erickson Creek Integrated Stormwater Management Plan

September 2010

**Re: ERICKSON CREEK INTEGRATED STORMWATER MANAGEMENT PLAN
FINAL REPORT**

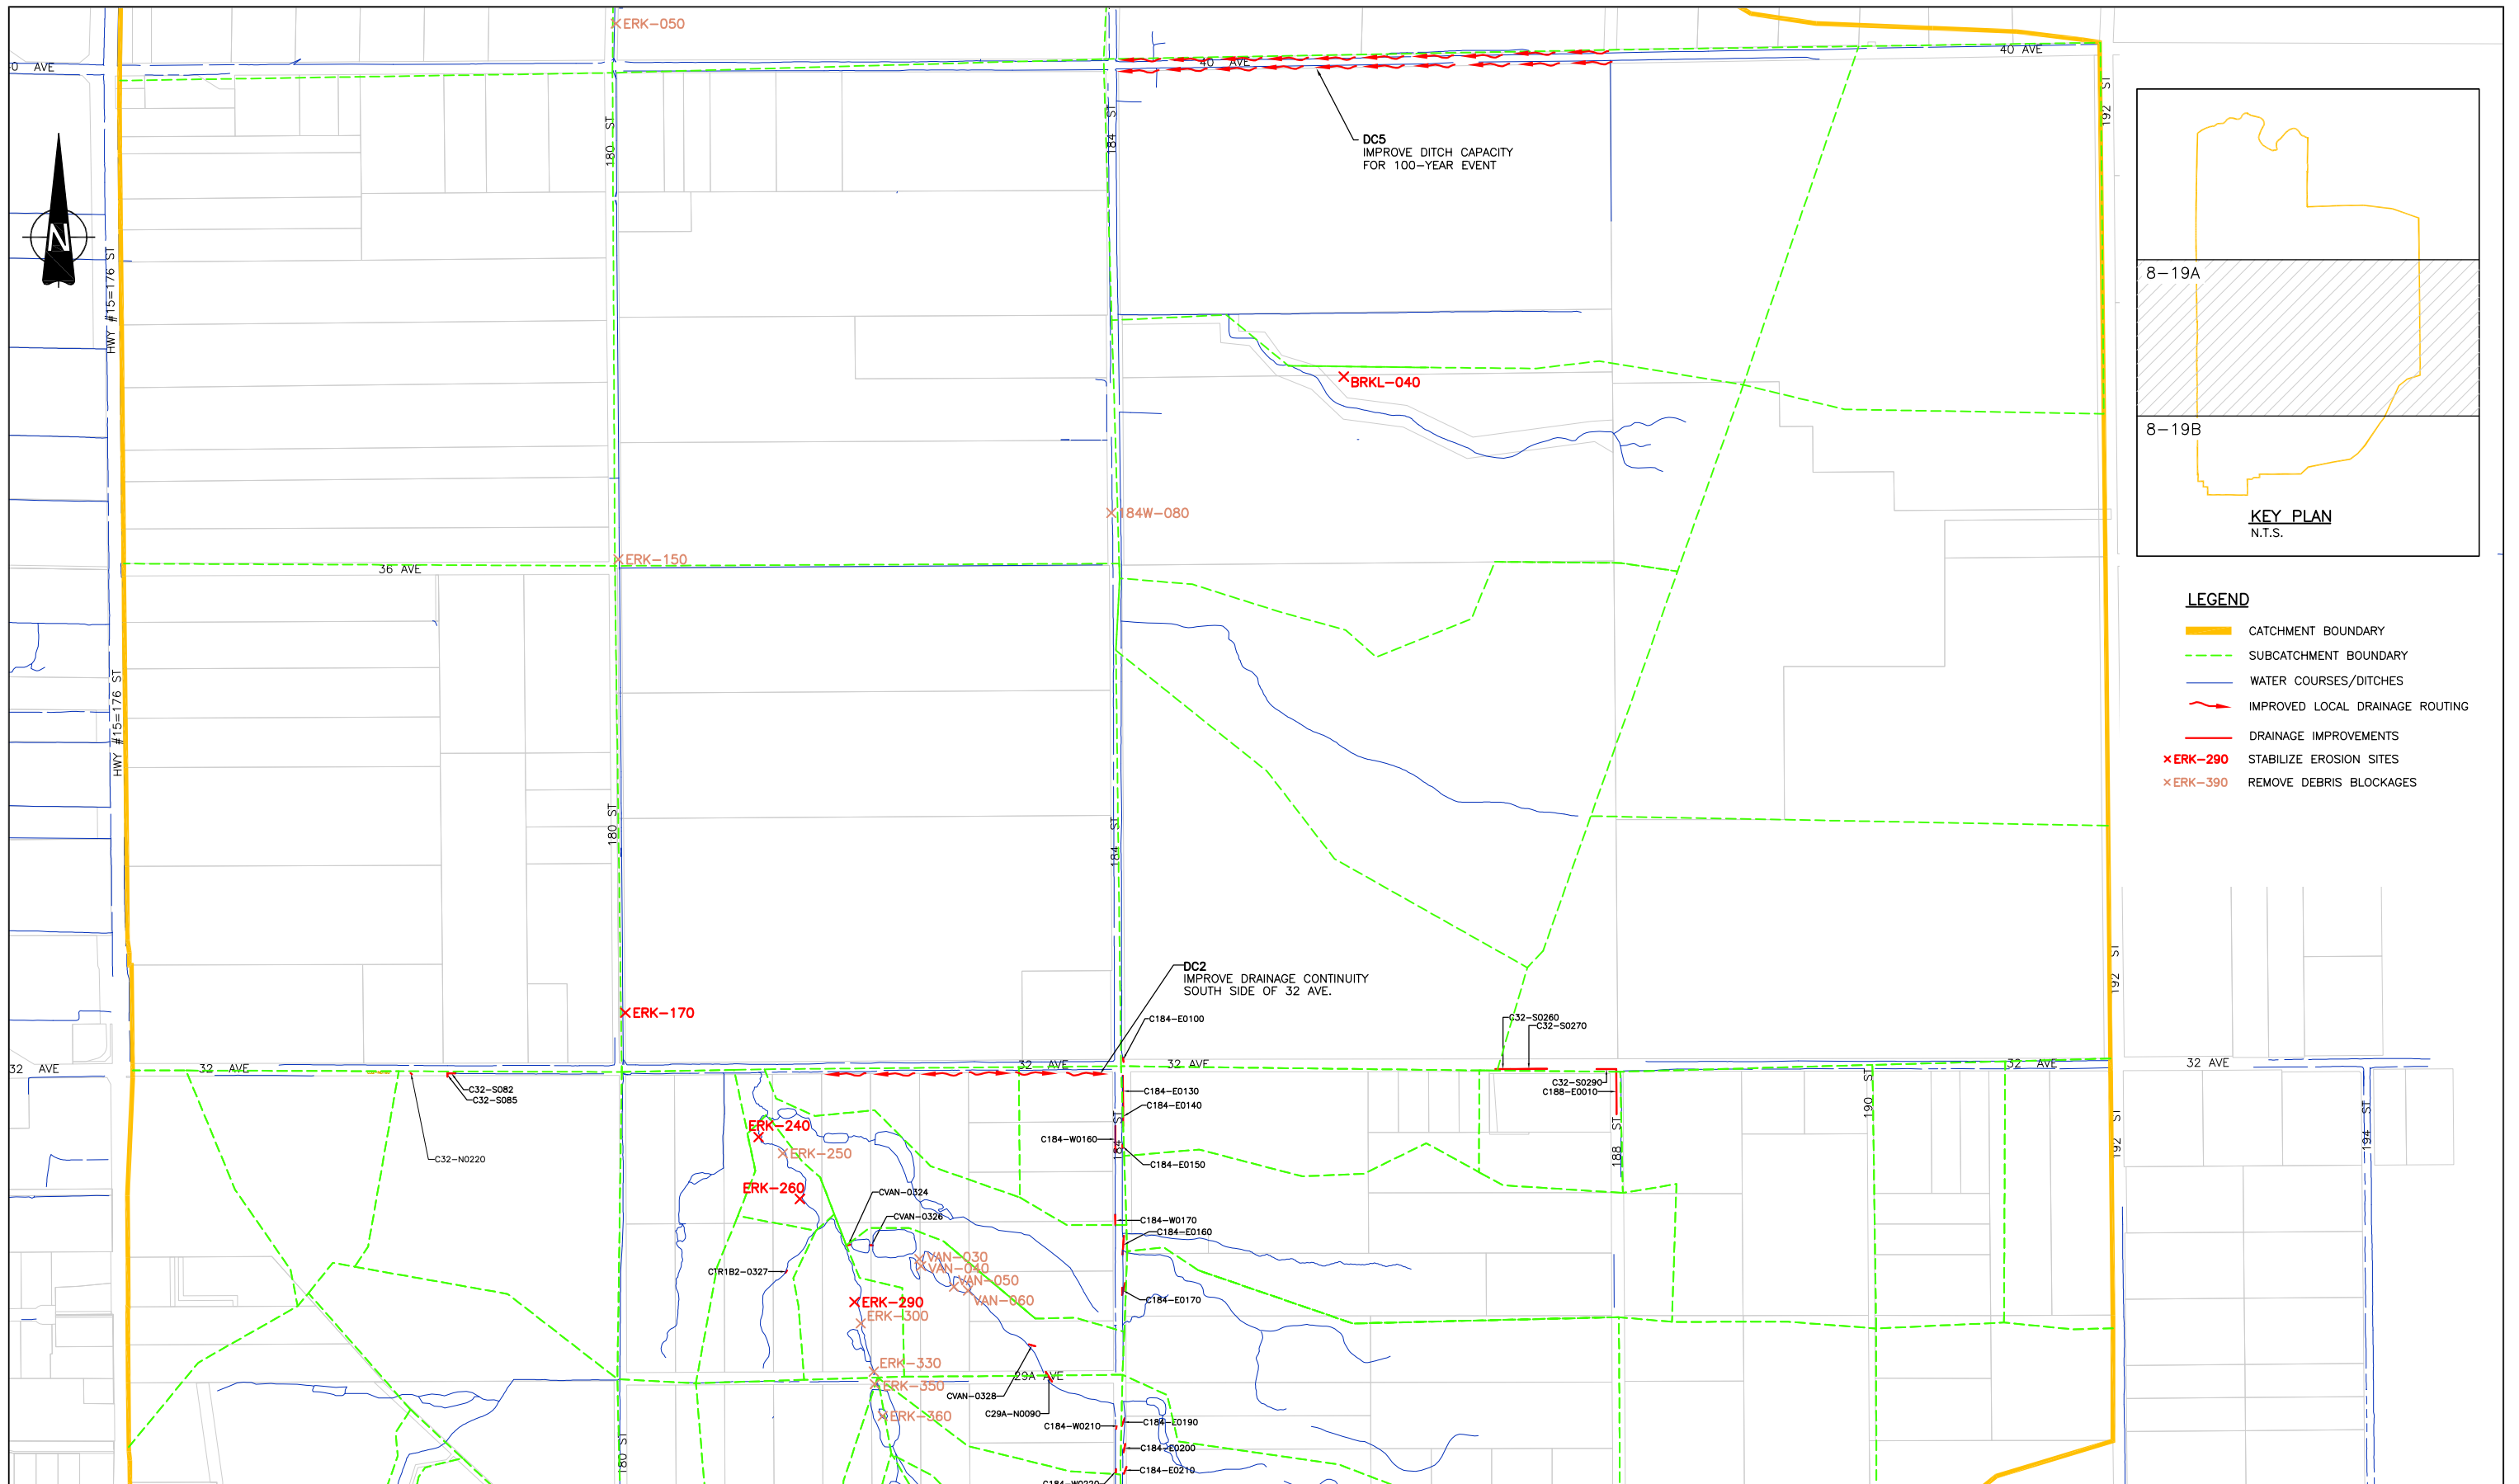
Some drainage components, primarily culverts, of the upland drainage system will require upgrading to ensure safe conveyance of the 100-year design flow. These deficient components are highlighted on Figure 8-24A and 8-24B. Lowland drainage upgrades were identified in the previous lowland drainage strategy.

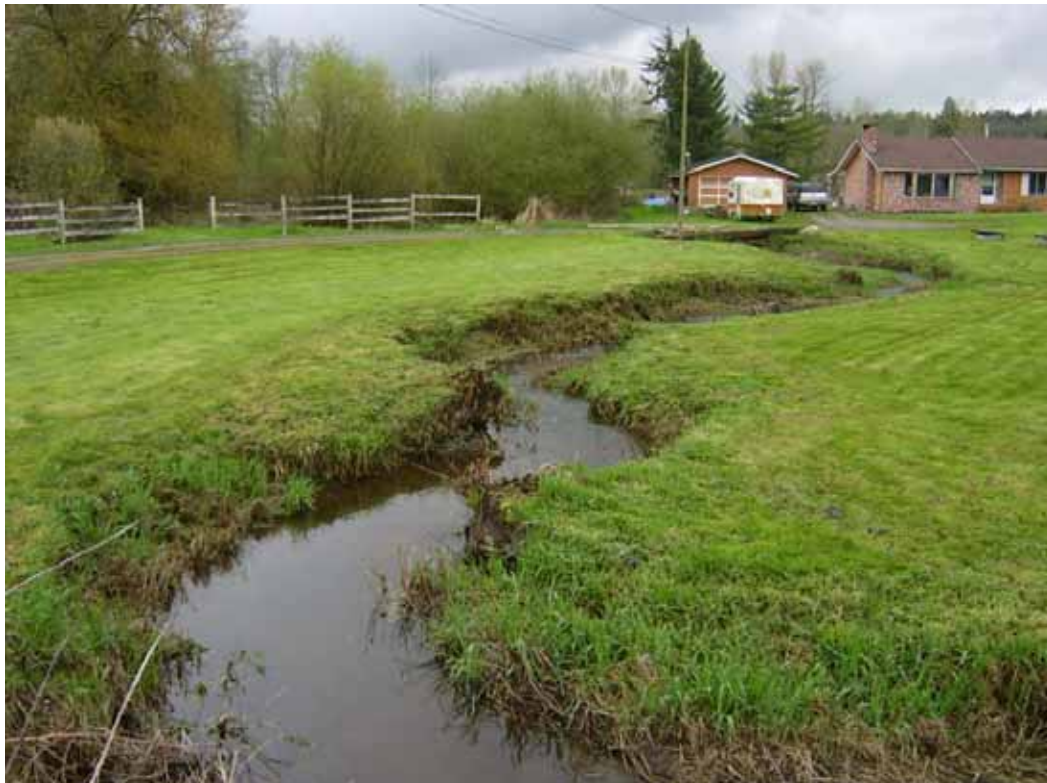
Photo 3: EC-1 – although all riparian cover has been replaced by lawn at this location, EC-1 has good rearing habitat overall, with undercut banks and over stream vegetation providing cover upstream.

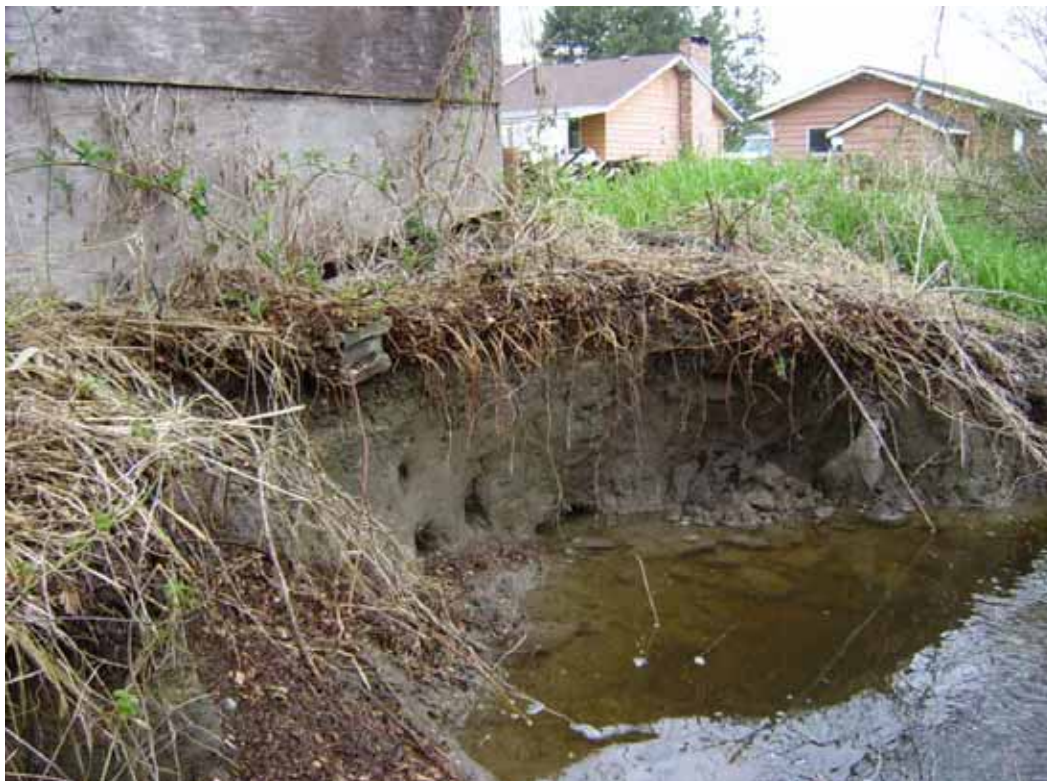
Photo 4: Some bank erosion at EC-1.

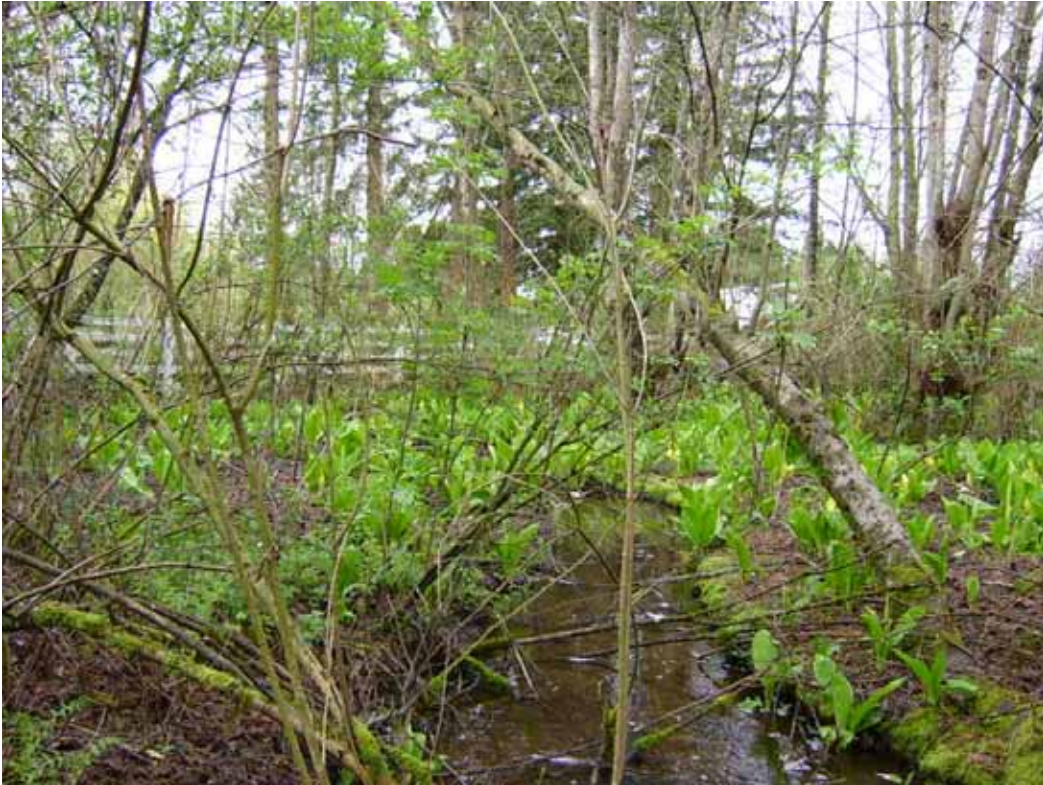
Photo 29: Creek flows through a forested marshy area in VB-2. Cows have access to creek, causing bank erosion and potential water quality degradation.

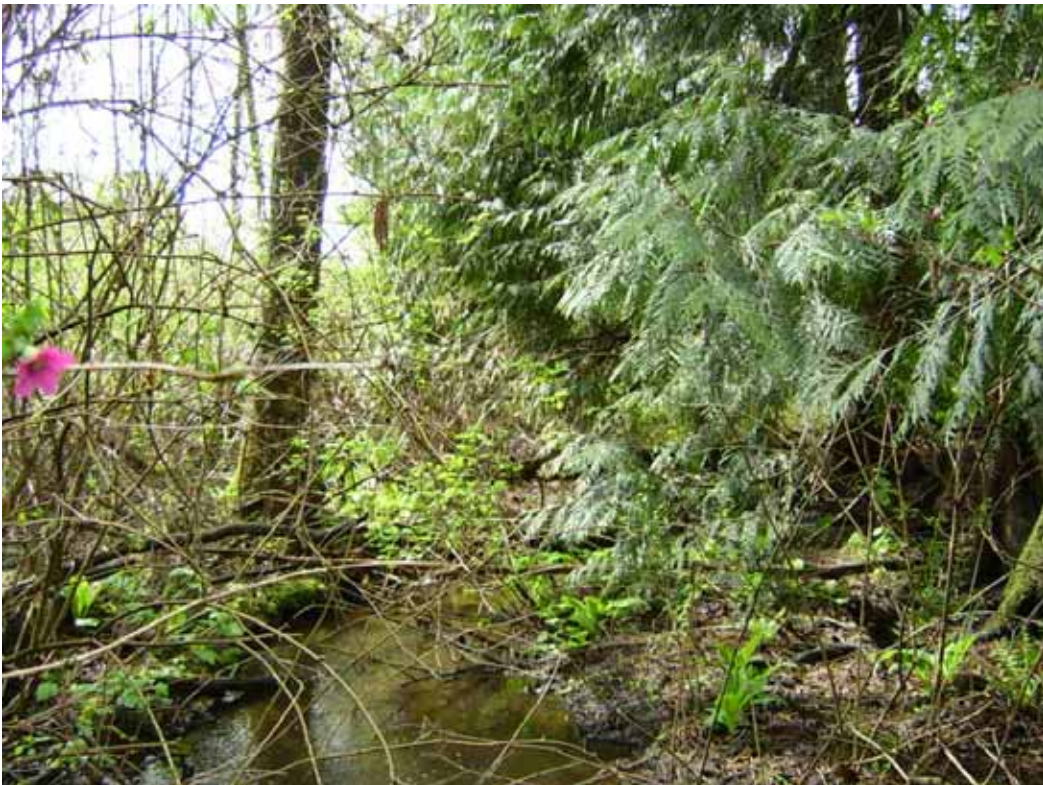
Photo 30: Riffle-pool morphology in VB-3 provides excellent rearing habitat. Localized gravels provide some potential for spawning.

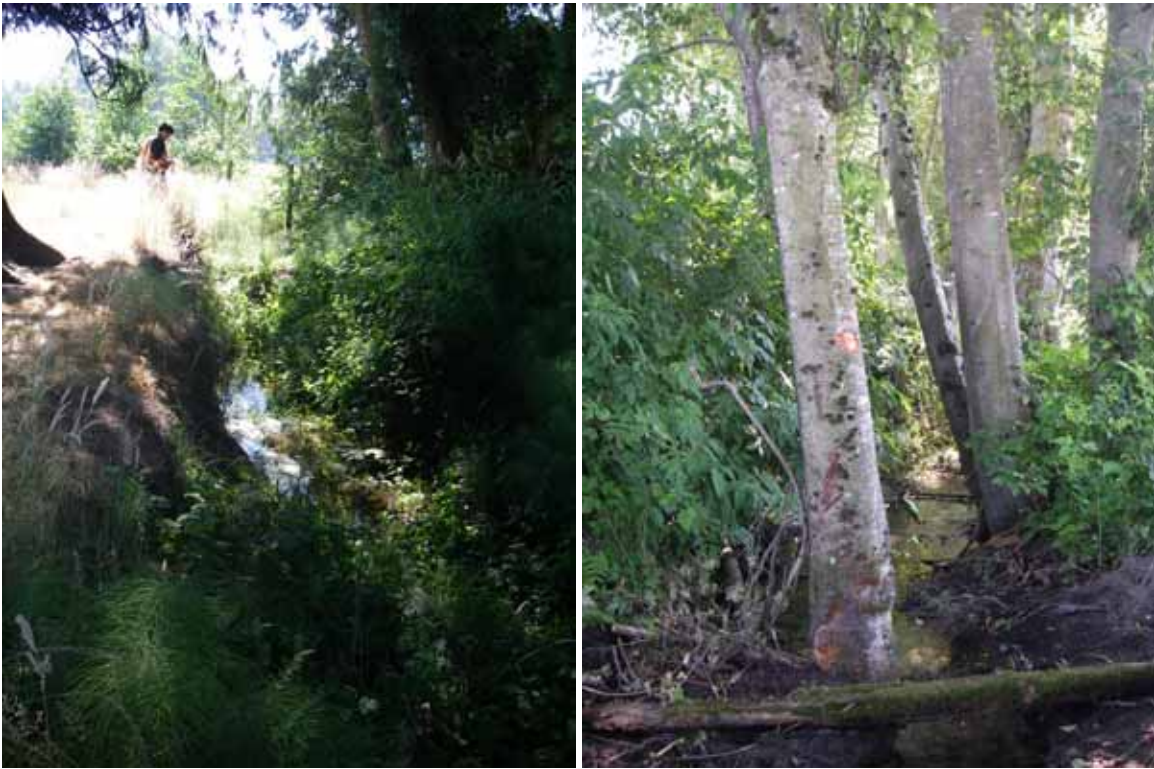
Photo 40 Brooklane Creek BC-1. Sparse riparian vegetation near 184 St. but increases
and 41: upstream. Fish observed rear the residence, where cows have access to the creek.

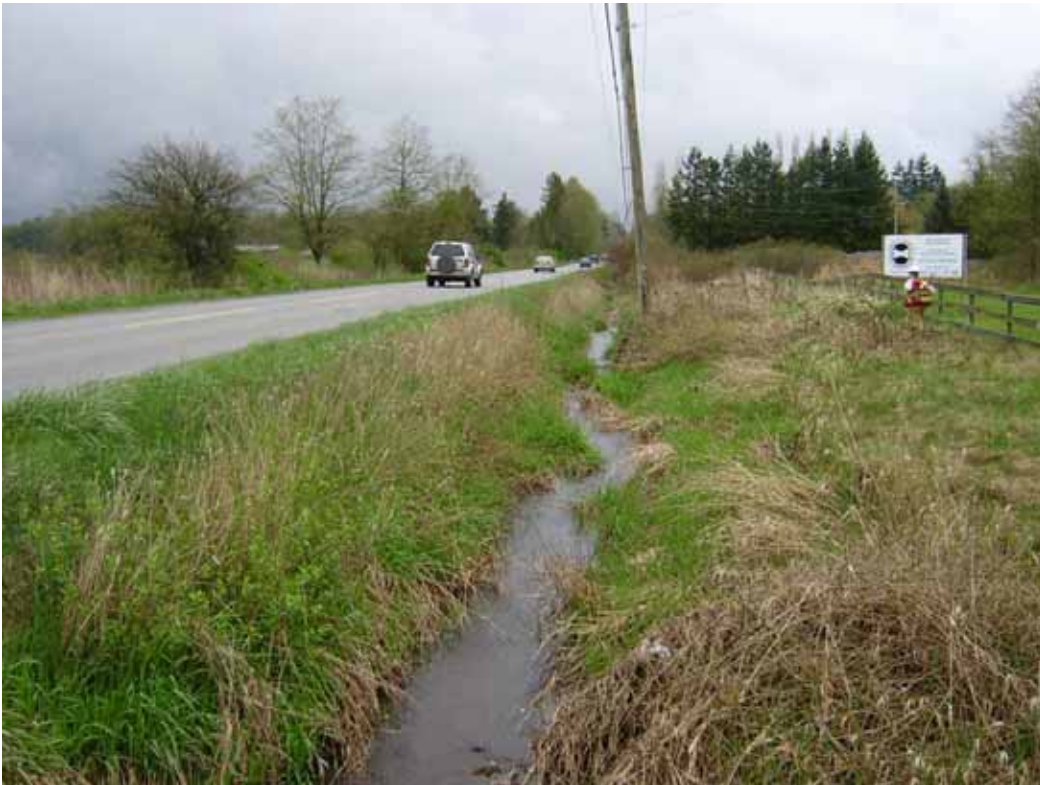
Photo 42: Habitat complexity in the 32nd Avenue ditch is low. Cover and gravels are limited.
