ADDENDUM No. 1

REQUEST FOR QUOTATIONS No.: 1220-040-2022-020

TITLE: Coverdale Fairgrounds Shannon Hall Boiler Replacement

Pre-Renovation Hazardous Materials Inspection Report

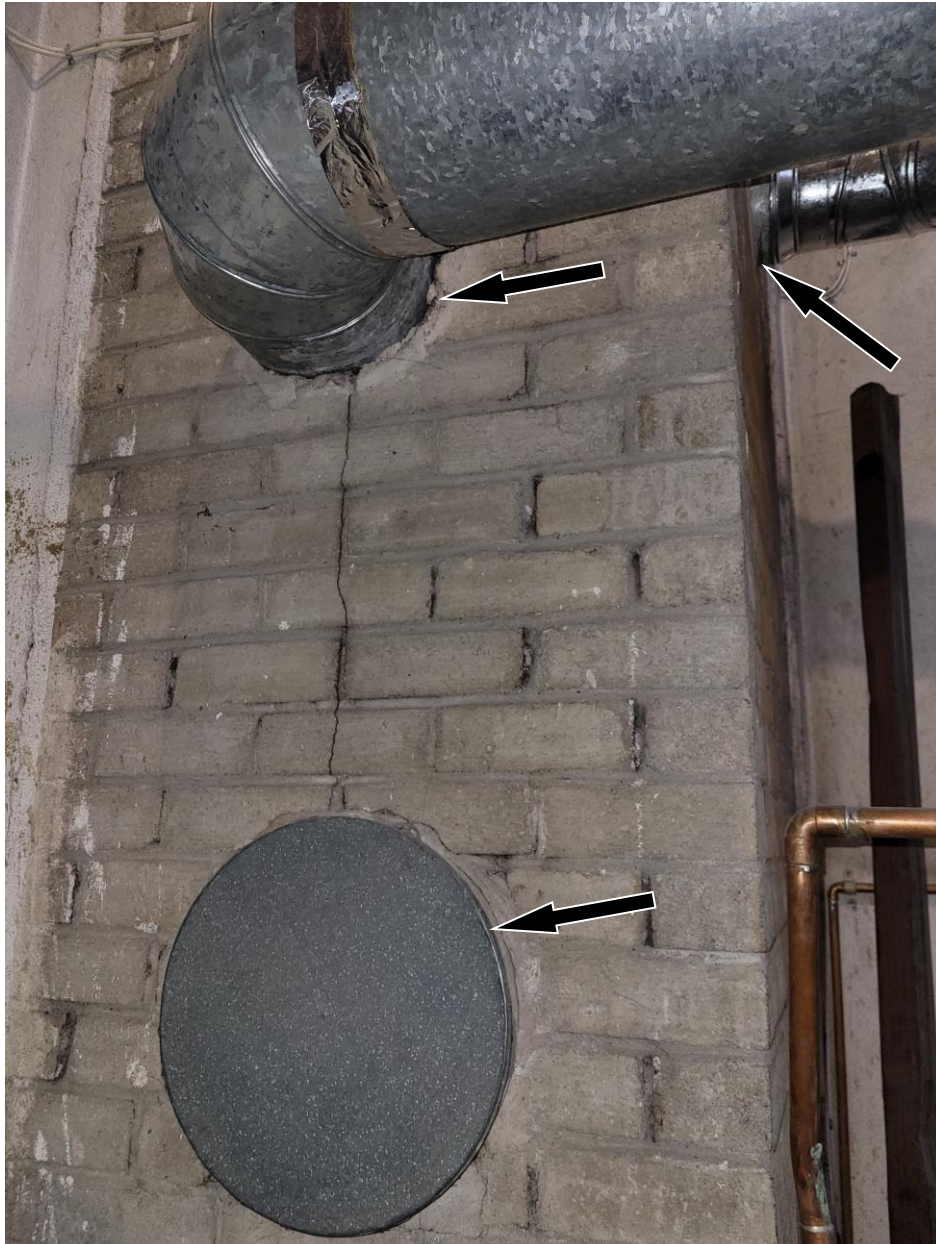
| Table #1: Analysis of Suspect ACMs Shannon Hall, Surrey, BC | | | | | | | |
|--|---|---|---|---|---|---|---|
| 4 | Boiler Room, Chimney – Upper Penetration | Fire Stop | Chrysotile 5-10% | Yes | Good | Low | Low |

Photo # 1 – Asbestos-containing fire stop compound

All asbestos-containing materials must be removed prior to demolition activities by a qualified hazardous materials contractor using appropriate work procedures as defined by WorkSafe BC.

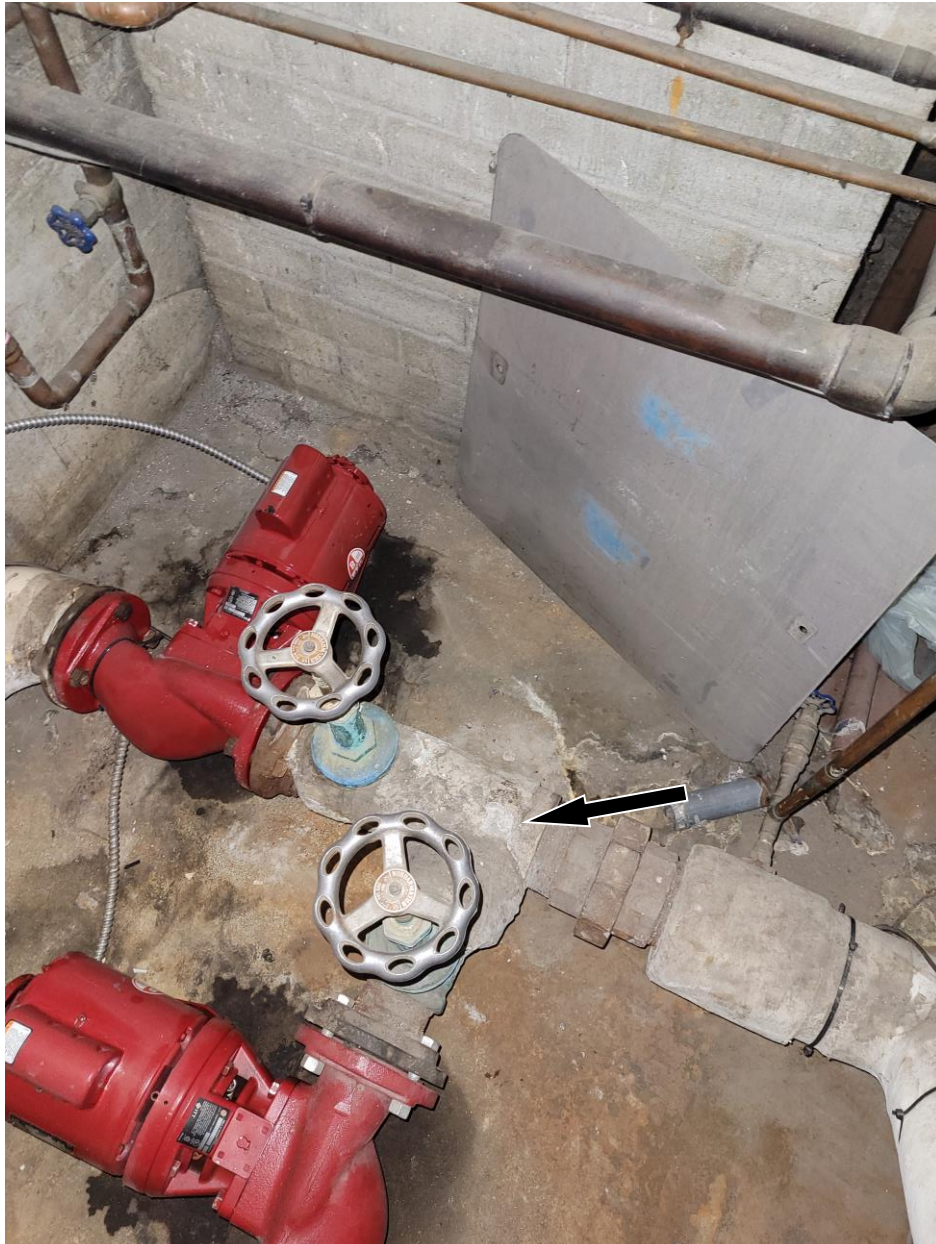
| 9 | Boiler Room – South Water Pipe Joint | Parging Cement | Chrysotile 20-25% | Yes | Good | Low | Low Hazard removed |

Parging cement present on rigid pipe fittings was determined to be asbestos-containing. Parging cement was observed to have been removed from a majority of the pipe fittings within the Boiler Room.

Photo # 2 – Asbestos-containing parging cement

This hazard has been removed.

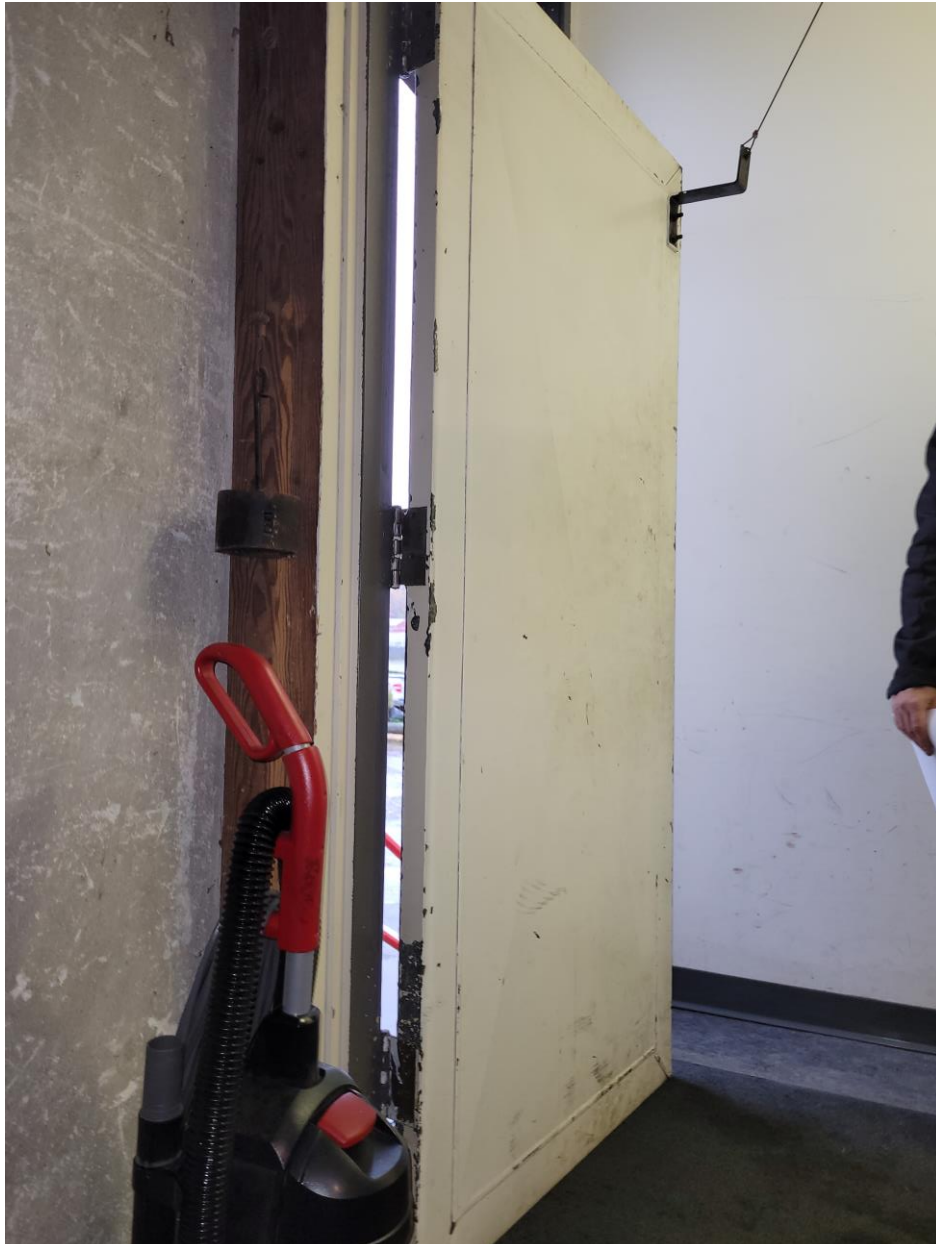
~~Photo # 3 – Fire door with presumed asbestos-containing lining & lead-based paint coatings. Lead-based paint on plaster is pictured on the Hallway wall~~

This hazard (Door and jam) has been removed

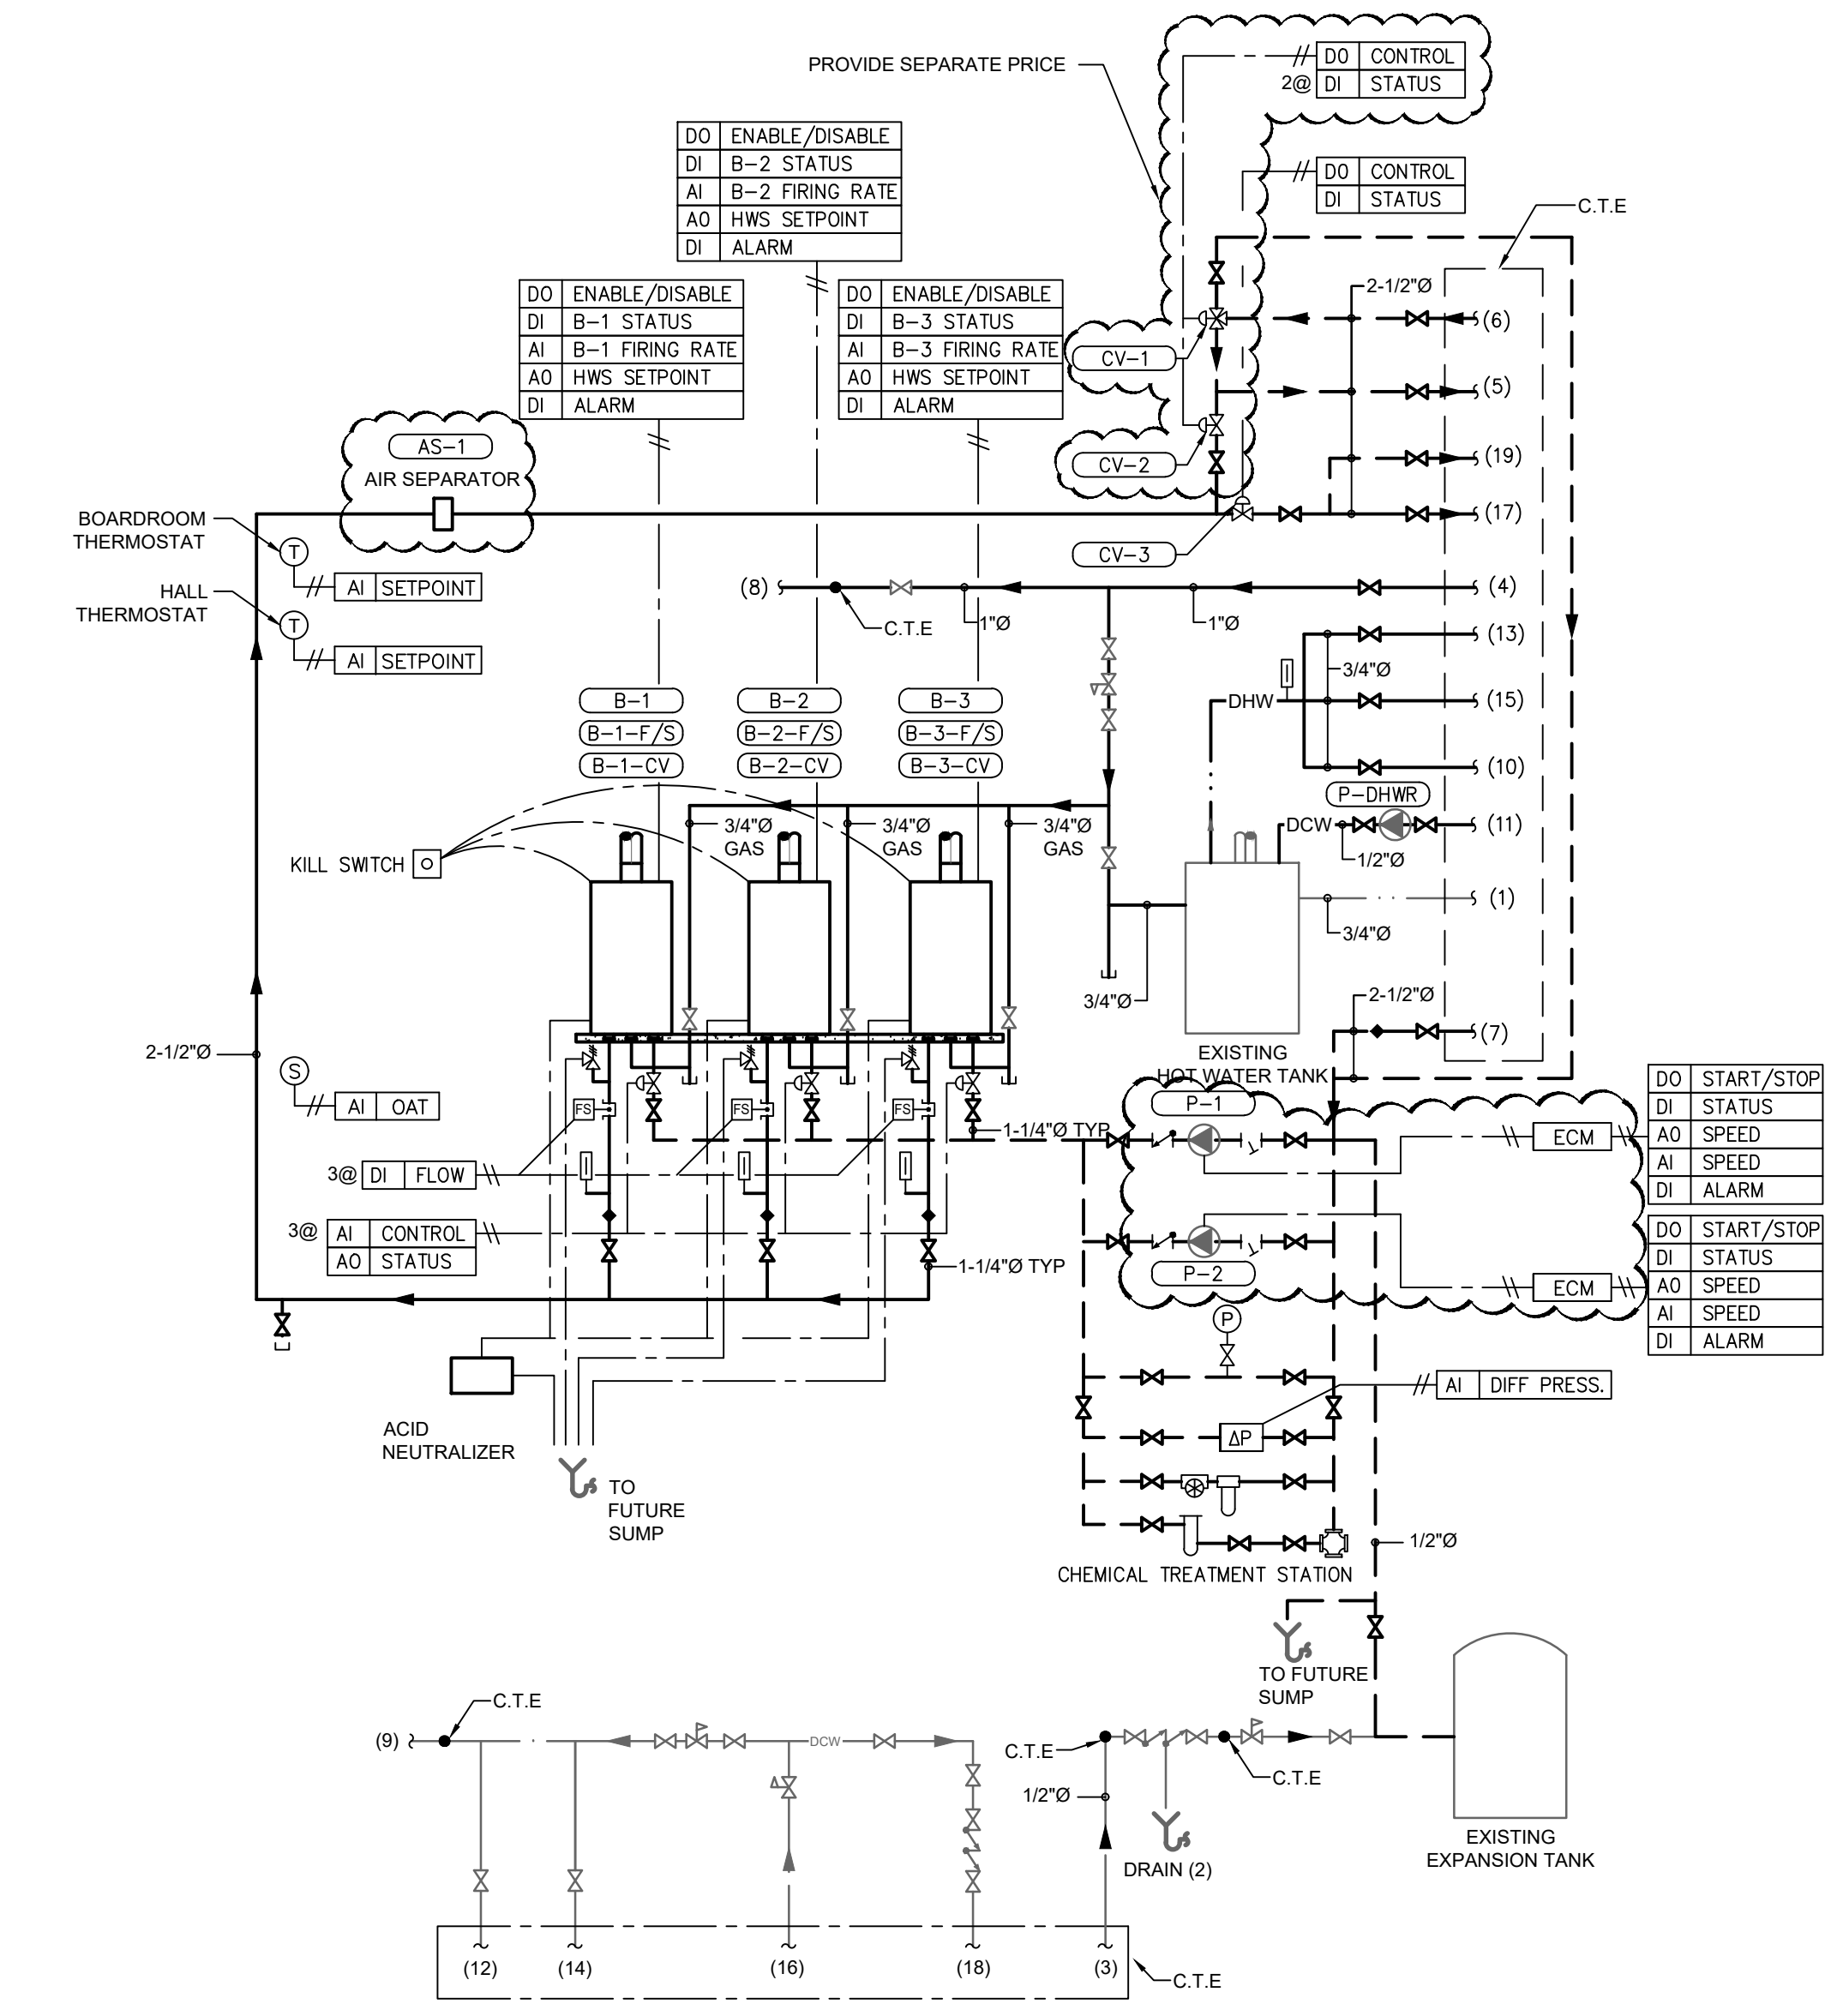
2 MECHANICAL RENOVATION SCHEMATIC
SCALE: NTS

A4. The components included in the clouded area in detail #2 of drawing M1.01 [Mechanical Renovation Schematic] represents the scope for cascading operations.

- .1 Add:
 - .1 Tag AS-1 for Air Separator added to 2/M1.01
- .2 Delete:
 - .1 Note: “Existing Pumps” on P-1,2 deleted from 1/M1.03 and 2/M1.03.
 - .2 Tags V-1,2 on VSD deleted from 1/M1.03 and 2/M1.03
- .3 Revise:
 - .1 “VSD” on circulation pumps P-1,2 changed to “ECM”
