BYLAW NO. 20262

HERITAGE REVITALIZATION AGREEMENT

# Conservation Plan

ROBERT DOUGAL MACKENZIE HOUSE

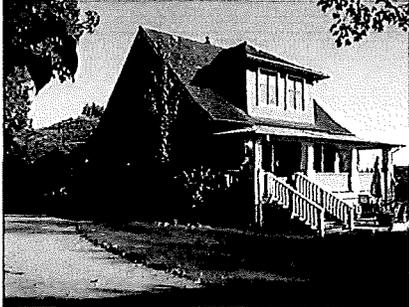
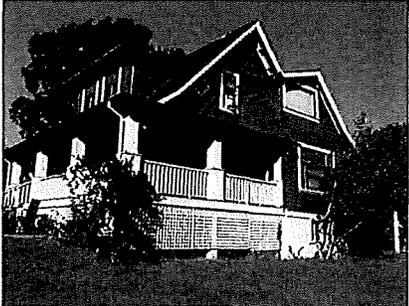
CONDITION ASSESSMENT TABLE			
REF.	ELEMENT	DESCRIPTION/CONDITION	IMAGE REFERENCE
3.1.1	Form, Scale & Massing	<p>Viewed from the drive from 184<sup>th</sup> Street side, no significant alterations to the original form and massing are visible. The dominant bell cast cross gable main roof with a large half-hip roofed central 2<sup>nd</sup> floor dormer on the front, and a hip-roofed wrap around porch are the dominant massing elements and have survived in good condition. The house is situated on a board-formed concrete basement foundation and is not showing any significant cracking or differential settlement. The main house level is approximately 4' above grade on the front and north and 7' above grade on the south, which contributes to the house's site presence and provides fine views out from the porch.</p> <p>An original gable-roof over the dining room projection on the south elevation has been altered to extend this mass up for a second floor room addition. It is an awkward and unattractive massing element that detracts from the original symmetry of this end wall. Originally the fixed-over-casement window and diamond fixed window configuration visible on the west side of the south gable wall would</p>

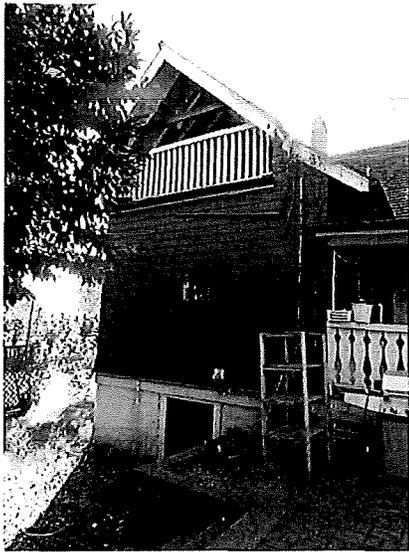
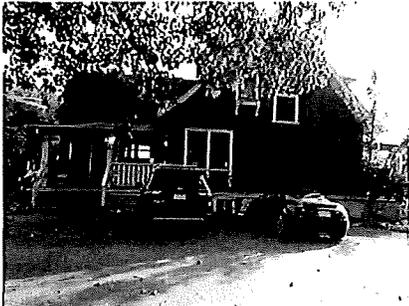
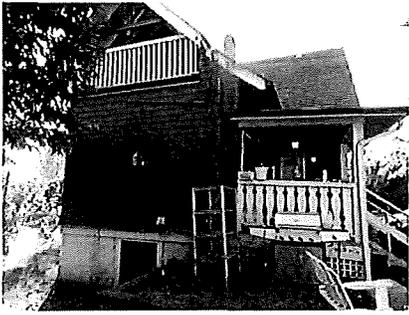
CONDITION ASSESSMENT TABLE			
REF.	ELEMENT	DESCRIPTION/CONDITION	IMAGE REFERENCE
		<p>have repeated on the east side.</p> <p>The porch columns and balustrade appear largely original.</p> <p>The rear gable-roofed kitchen mass is original or quite early; the foundation is board-formed concrete. An open sleeping porch incorporating a truss element, wood balustrade and gable roof extension are fairly recent alterations and do not detract from the character of the house.</p> <p>The rear porch post supports have been repaired through jacking the roof beam level from the porch floor, and reinstating them with longer posts/cladding, without taking some of the settlement slope out of the porch floor, resulting in excessive slope to the porch floor.</p>

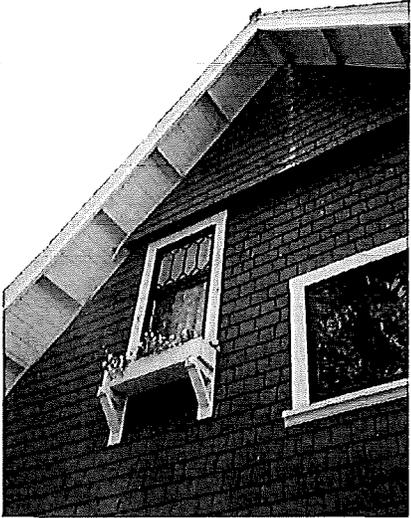
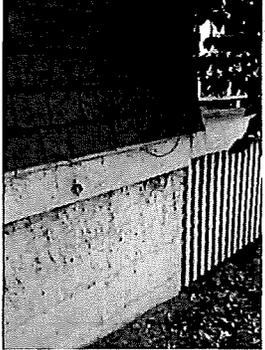
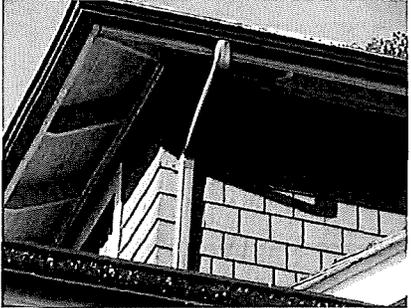
CONDITION ASSESSMENT TABLE			
REF.	ELEMENT	DESCRIPTION/CONDITION	IMAGE REFERENCE
3.1.2	Cladding, Fascia & Soffits	<p>The original sawn shingle wall cladding is in good condition, including the current paint coating.</p> <p>The corbelled gable detail and the swelled base at the water table are distinctive cladding features and in good condition.</p> <p>The swelled base with the water table molding and board are in good condition.</p> <p>The open eaves with clipped rafter tails, exposed 1"X4" T&amp;G soffit boarding and 2"X8" fascia are in excellent condition.</p> <p>The gutter and rainwater leader system are in place, acceptable replacements of the originals and working well.</p>

The existing cladding/trim is in generally good condition and will be preserved through preparation and painting of all windows, doors and the porch. The paint condition on the existing body (brown shingle) and most of the trim, including fascia, barge board, and open eaves is in good condition. The trim paint on windows/casings, doors/casing and many of the porch elements has deteriorated and will be prepared and re-painted to match the existing appropriate colour scheme.

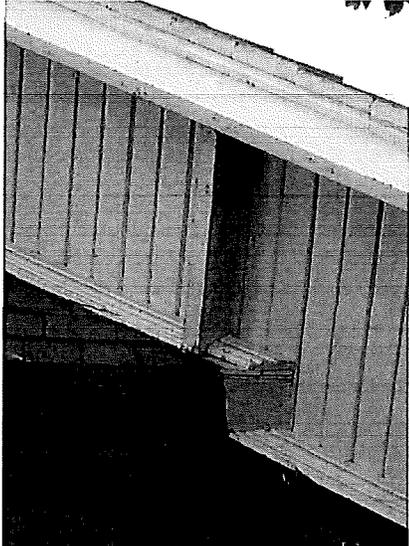
CONDITION ASSESSMENT TABLE			
REF.	ELEMENT	DESCRIPTION/CONDITION	IMAGE REFERENCE
		View of the gable eaves with corbelled upper wall cladding, gable beam, soffit moldings, V-groove T&G exposed soffit boards, simple shingle molding and edge of shingles.

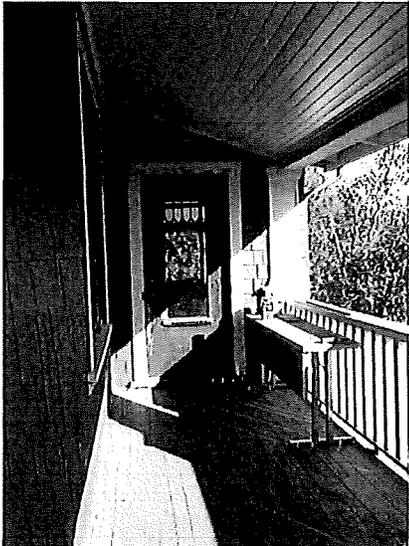
3.1.3	Doors	The two original porch ¾ light wood frame and panel doors have been altered with exterior overlays of painted plywood. The lights would have been set with a muntined or leaded light pattern reflecting the elongated hexagon motifs seen in nearly all of the fixed sash over the casement sash in the exterior walls.

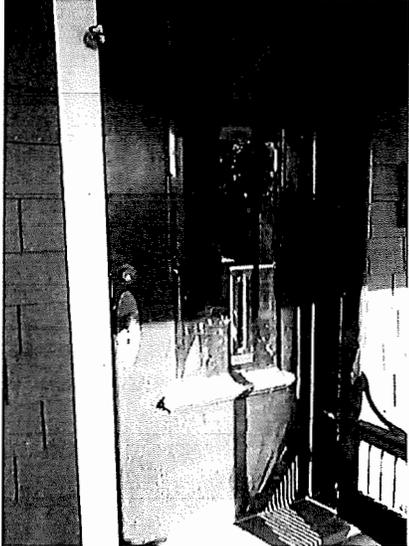
CONDITION ASSESSMENT TABLE			
REF.	ELEMENT	DESCRIPTION/CONDITION	IMAGE REFERENCE
		An early ornamental fretted screen door is installed on the main porch door.

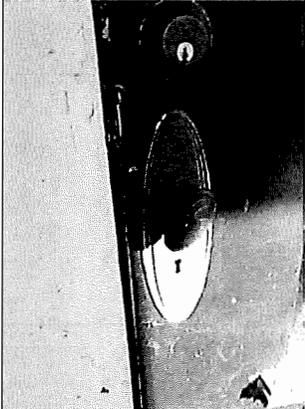
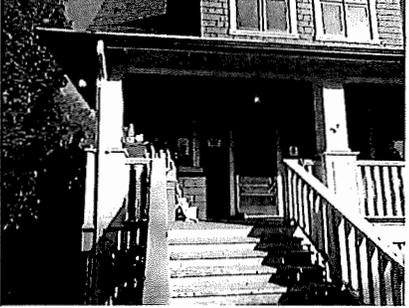
The original front door mortise latch set, including the oval escutcheon plate and knob have survived, as well as a later deadbolt.

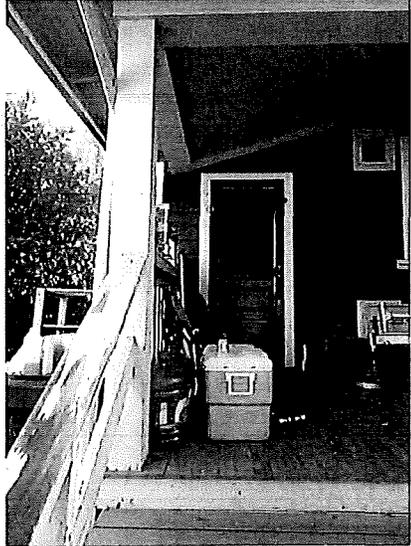
CONDITION ASSESSMENT TABLE			
REF.	ELEMENT	DESCRIPTION/CONDITION	IMAGE REFERENCE
		<p>The original or early rear kitchen 3 panel, half-light frame and panel survives; the 1/2 light has an early textured glass inset. A simple screen door is set on the exterior.</p>

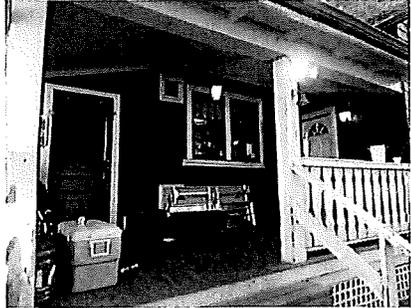
<p>The rear entry door, visible at right in white with the lunette upper lights is contemporary and out of keeping with the building's heritage character.</p>

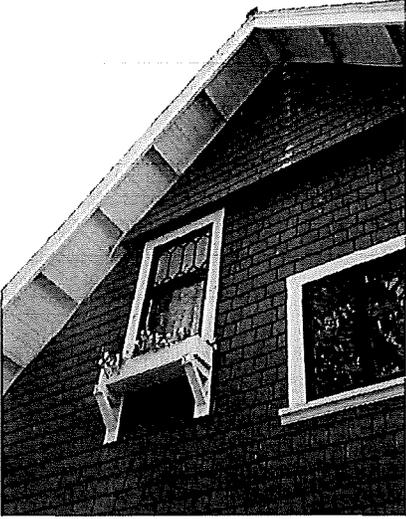
CONDITION ASSESSMENT TABLE			
REF.	ELEMENT	DESCRIPTION/CONDITION	IMAGE REFERENCE
		<p>The north elevation lower fixed-over-casement windows are in good condition and the flower box brackets have survived here as well.</p>

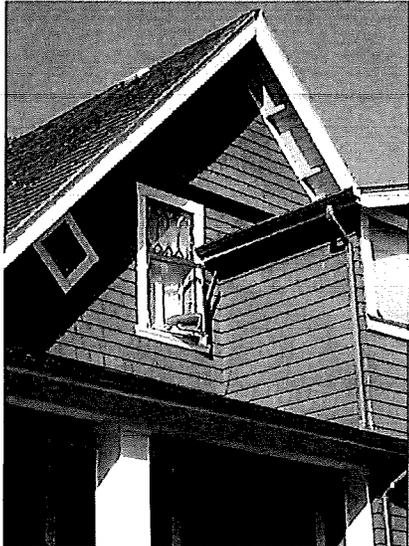
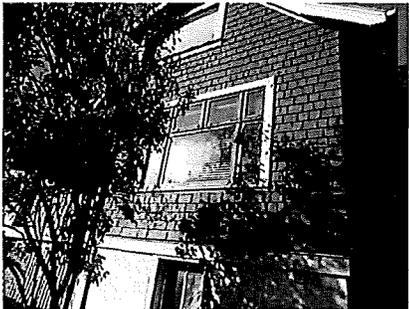
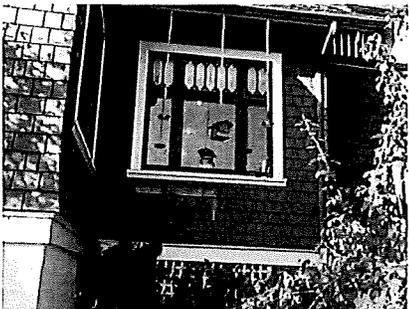
CONDITION ASSESSMENT TABLE			
REF.	ELEMENT	DESCRIPTION/CONDITION	IMAGE REFERENCE
		<p>The west window bank on the south elevation has suffered some loss of original upper fixed sash – all of the original lozenge muntined sash have been replaced. The casement windows flanking the center fixed window is in place. As in other south-facing windows, sun exposure has promoted weathering and these windows also need to be prepared and painted.</p> <p>The east window on the south elevation has entirely survived and is less weather damaged.</p>

<p>The south window on east elevation, fixed lozenge-muntined twin sash over a fixed lower sash, is in good condition.</p>

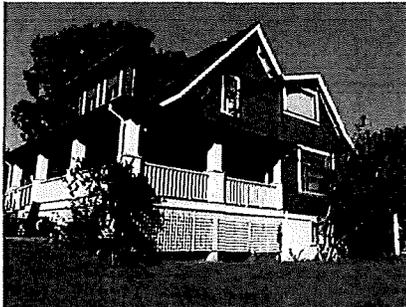
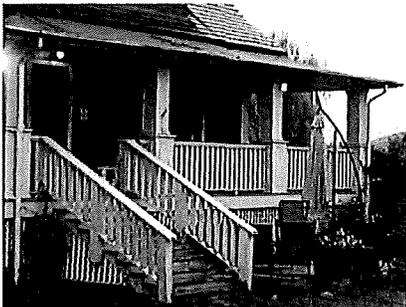
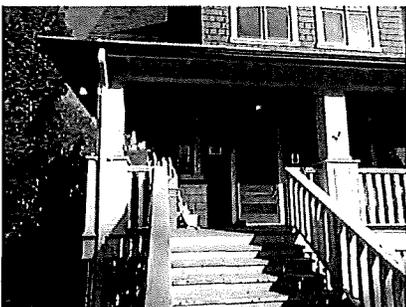
3.1.6	Front Porch	The front wrap-around porch is strong character-defining element of the house and in generally good condition.

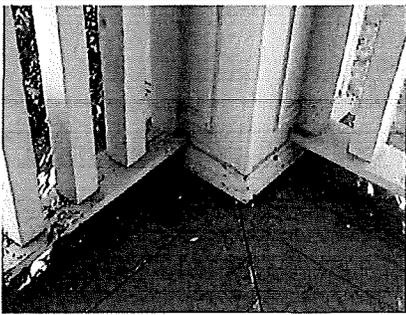
CONDITION ASSESSMENT TABLE			
REF.	ELEMENT	DESCRIPTION/CONDITION	IMAGE REFERENCE
		<p>There is general weathering and paint loss on surface that collect water. The lower rails of the balustrade are showing cracking and deterioration and will require selective replacement. The porch deck is showing open cracks at the joints and needs to be prepared with filler, removal of loose scale paint and recoated. The front stair treads, though not original, also need preparation and painting to avoid deterioration.</p>

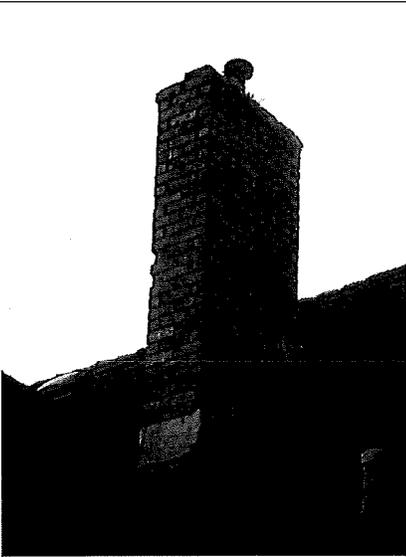
3.1.7	Chimney	<p>The existing brick chimney is in poor condition; there is significant mortar joint loss and moss/fern growth at upper mortar joints. Some brick spalling has occurred at corners. Galvanized sheet steel step flashing is still in place, but it is heavily weathered and the reglets are likely cracked and open. The chimney requires raking and repointing and new step flashing.</p>

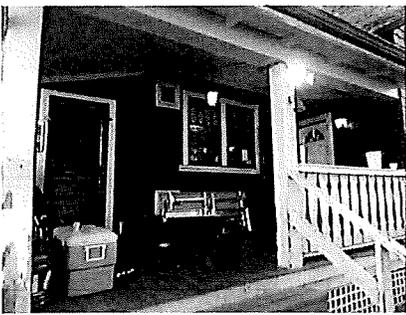
3.1.8	Rear Porch	<p>The rear porch is largely original, but as mentioned earlier, has been subject to some repairs that have resulted in a sloped deck. The existing guard is not original and likely more crude than the original.</p>

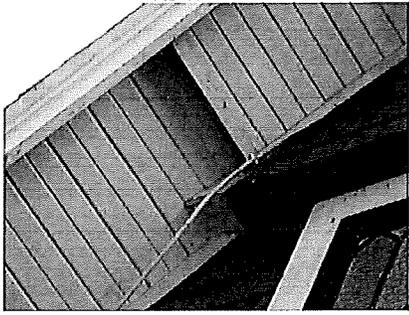
CONDITION ASSESSMENT TABLE			
REF.	ELEMENT	DESCRIPTION/CONDITION	IMAGE REFERENCE
3.1.9	Paint Condition	The existing body paint (shingle) and most of the trim paint is in good to excellent condition. The Colour scheme is appropriate from a heritage perspective and has not changed appreciably from the original scheme, based on paint sliver analysis and review of early of the tonal differences in early black and white images.

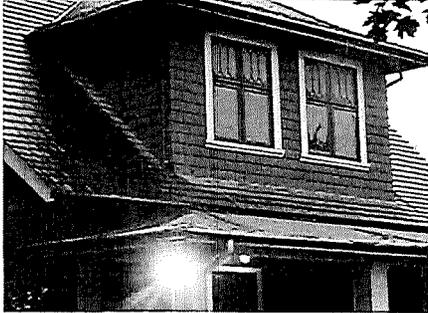
West Elevation				
Tag	Description	Condition	Remediation	Image
W1	Original twinned windows with wood lower casement sash and fixed lozenge-muntined upper sash featuring patterned etched glass	Fair Condition, isolated loss of original linseed oil glazing compound and paint loss/deterioration on sash, sill, frame and casing	Remove any loose dry glazing compound with your finger only and not a metal scraper and install new linseed oil glazing compound where missing. Scrape loose, aligating and curled paint on the sash, sill and frame with a plastic scraper following WorkSafeBC procedures for work in and around lead, prepare and paint.

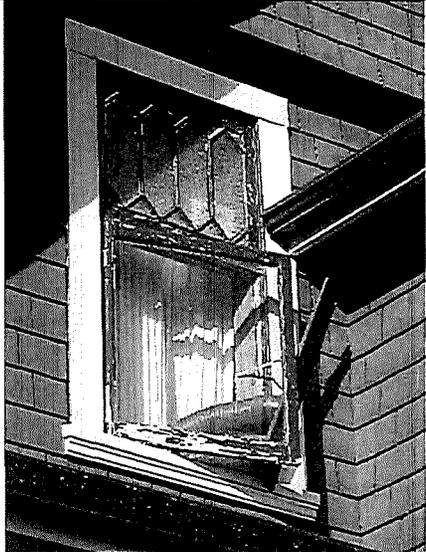
lozenge-muntined upper sash featuring patterned etched glass			
<b>South Elevation</b>				
<b>Tag</b>	<b>Description</b>	<b>Condition</b>	<b>Remediation</b>	
S1	Original single wood window with lower casement sash and fixed lozenge-muntined upper sash featuring patterned etched glass	Good, paint surface deteriorated.	Prepare and paint

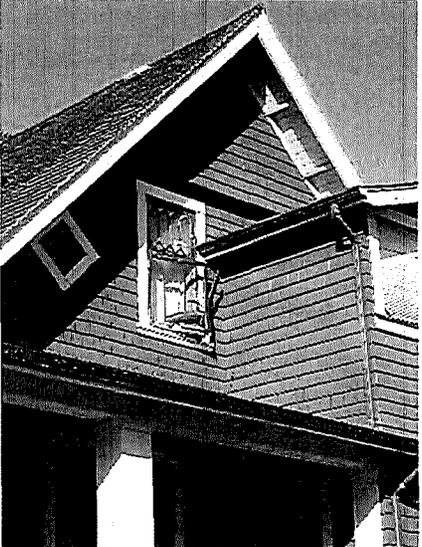
patterned etched glass matching S1			
S2	Original fixed wood diamond window	Good, paint surface deteriorated.	Prepare and paint

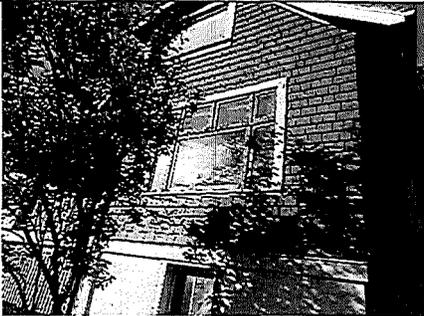
<p>S4</p>	<p>Original 7 sash feature front room window bank consisting of a central large fixed lower window with flanking casements, smaller upper casements over the lower casements, and two smaller fixed sash over the large lower central sash.</p>	<p>Original sash in fair to poor condition showing significant paint loss. Lower casement and fixed sash are in fair condition. The upper sash bottom rails are all split and open at the joints and require replacement. The upper sash would have original been muntined in the elongated lozenge shape as the other upper sash in original windows in the house.</p>	<p>Replace the upper sash (4) in new wood upper sash, casements on the outside and fixed on the inside, and all sash are to have the elongated lozenge muntined profile.</p>

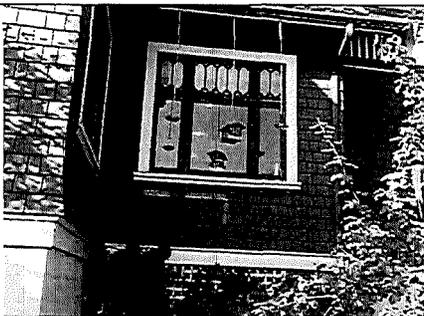
<p>S5</p>	<p>Original 6 sash feature dining room window bank consisting of a central large fixed lower window with flanking casements, smaller upper casements over the lower casements, and two smaller fixed sash over the large lower central sash.</p>	<p>Good, paint surface deteriorated.</p>	<p>Prepare and paint</p>

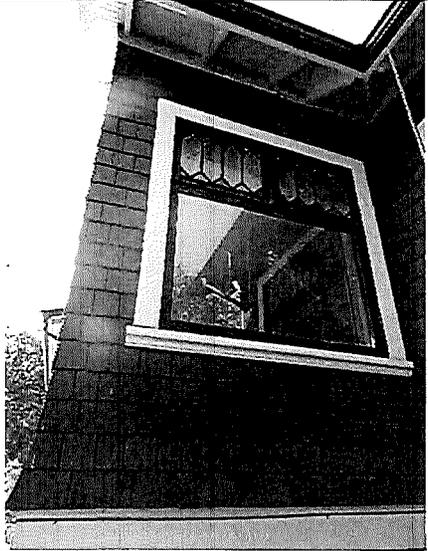
S6	Original/early wood muntined basement window	Good, paint surface deteriorated.	Prepare and paint	
<b>East Elevation</b>				
<b>Tag</b>	<b>Description</b>	<b>Condition</b>	<b>Remediation</b>	
E1	Original 3 sash feature dining room window bank consisting of a central large fixed lower window with, smaller upper fixed sash with fixed lozenge-muntined upper sash featuring patterned etched glass	Good, paint surface deteriorated.	Prepare and paint

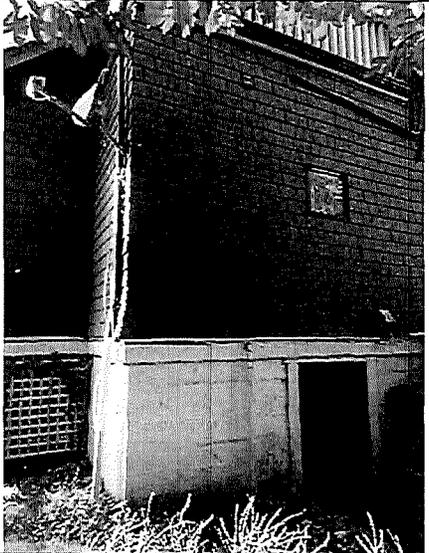
E2	Bathroom wood window	Fair condition – not original	Prepare and paint

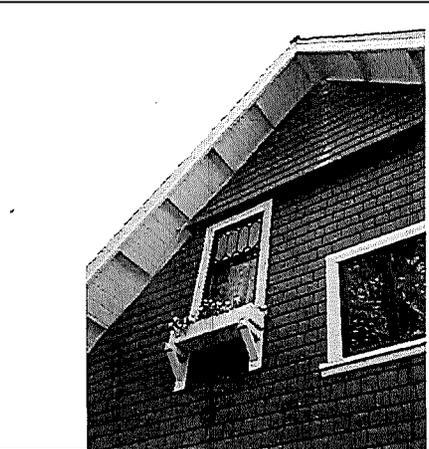
<b>North Elevation</b>				
<b>Tag</b>	<b>Description</b>	<b>Condition</b>	<b>Remediation</b>	
N1	Original single wood window with lower casement sash and fixed lozenge-muntined upper sash featuring patterned etched glass	good	Prepare and paint

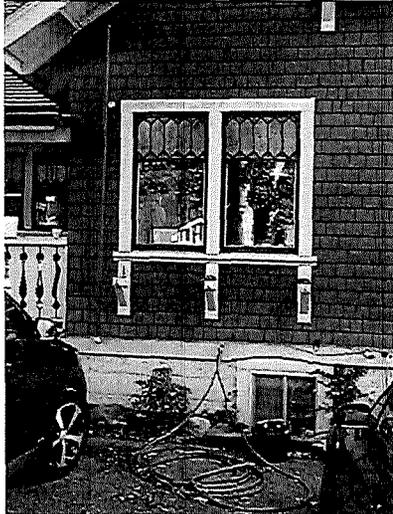
N4	Original twinned wood window with lower casement sash and fixed lozenge-muntined upper sash featuring patterned etched glass	good	Prepare and paint
