Final Report Boundary/Shaw Creek ISMP

January 2012

RE: **BOUNDARY/SHAW CREEK ISMP**
Final Report Submission
Our File 0323.059-300

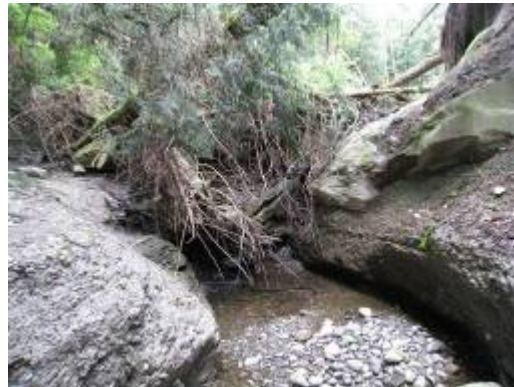
Debris Jams in Shaw Creek between 120 Street and Highway 10

- Unstable obstructions such as debris jam, large woody debris, and sediment was noted in Shaw Creek upstream of Highway 10. These pose the risk of culvert blockage and should be monitored, anchored, or removed.

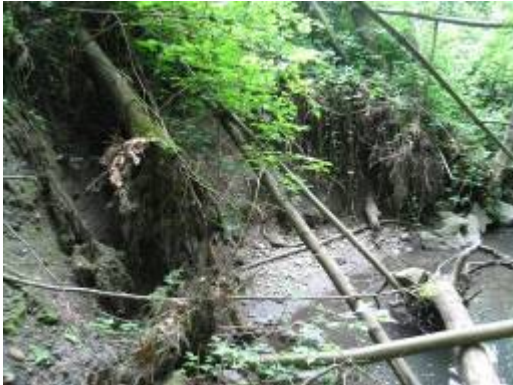
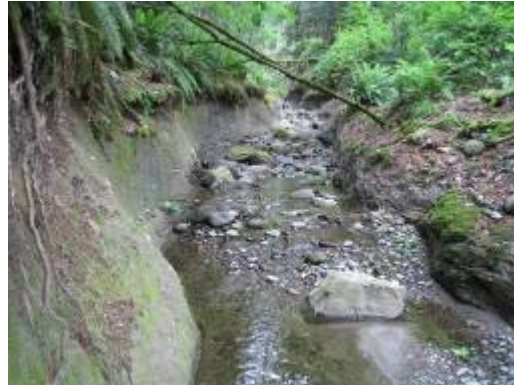
**Bank Erosion in Shaw Creek
downstream of Highway 10 culvert**

- Severe erosion and unstable obstructions observed in Shaw Creek between 120 Street and Highway 10; and
- Erosion at the top end of Shaw Creek at storm sewer outfall and through the 6007 Scott Road property including bank stabilization needs.

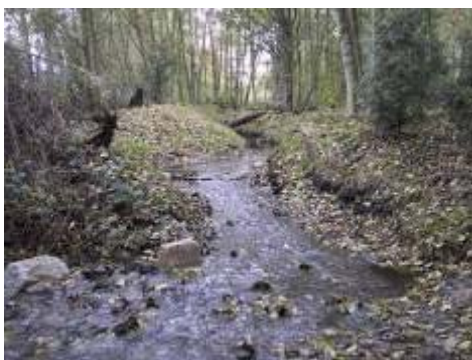
The Corporation of Delta and the Pacific Salmon Foundation Rearing Channel

An 80 m rearing channel in the shape of a horseshoe was created in a low lying area adjacent to Watershed Creek. The rearing channel has three 15 m gravel riffles, each with a 10 cm drop to provide spawning habitat. Large woody debris and boulders were placed for cover and bank stabilization. Seven 3 m Douglas Fir trees were planted along the channel edge to help provide shade and cover and moderate the water temperatures during the warmer calendar days. Two gravel trails furnished with trail benches lead to the stream to provide access for future public fish releases. Four interpretive signs installed along the stream edge provide information about the chum salmon life cycle and the benefits of the stream

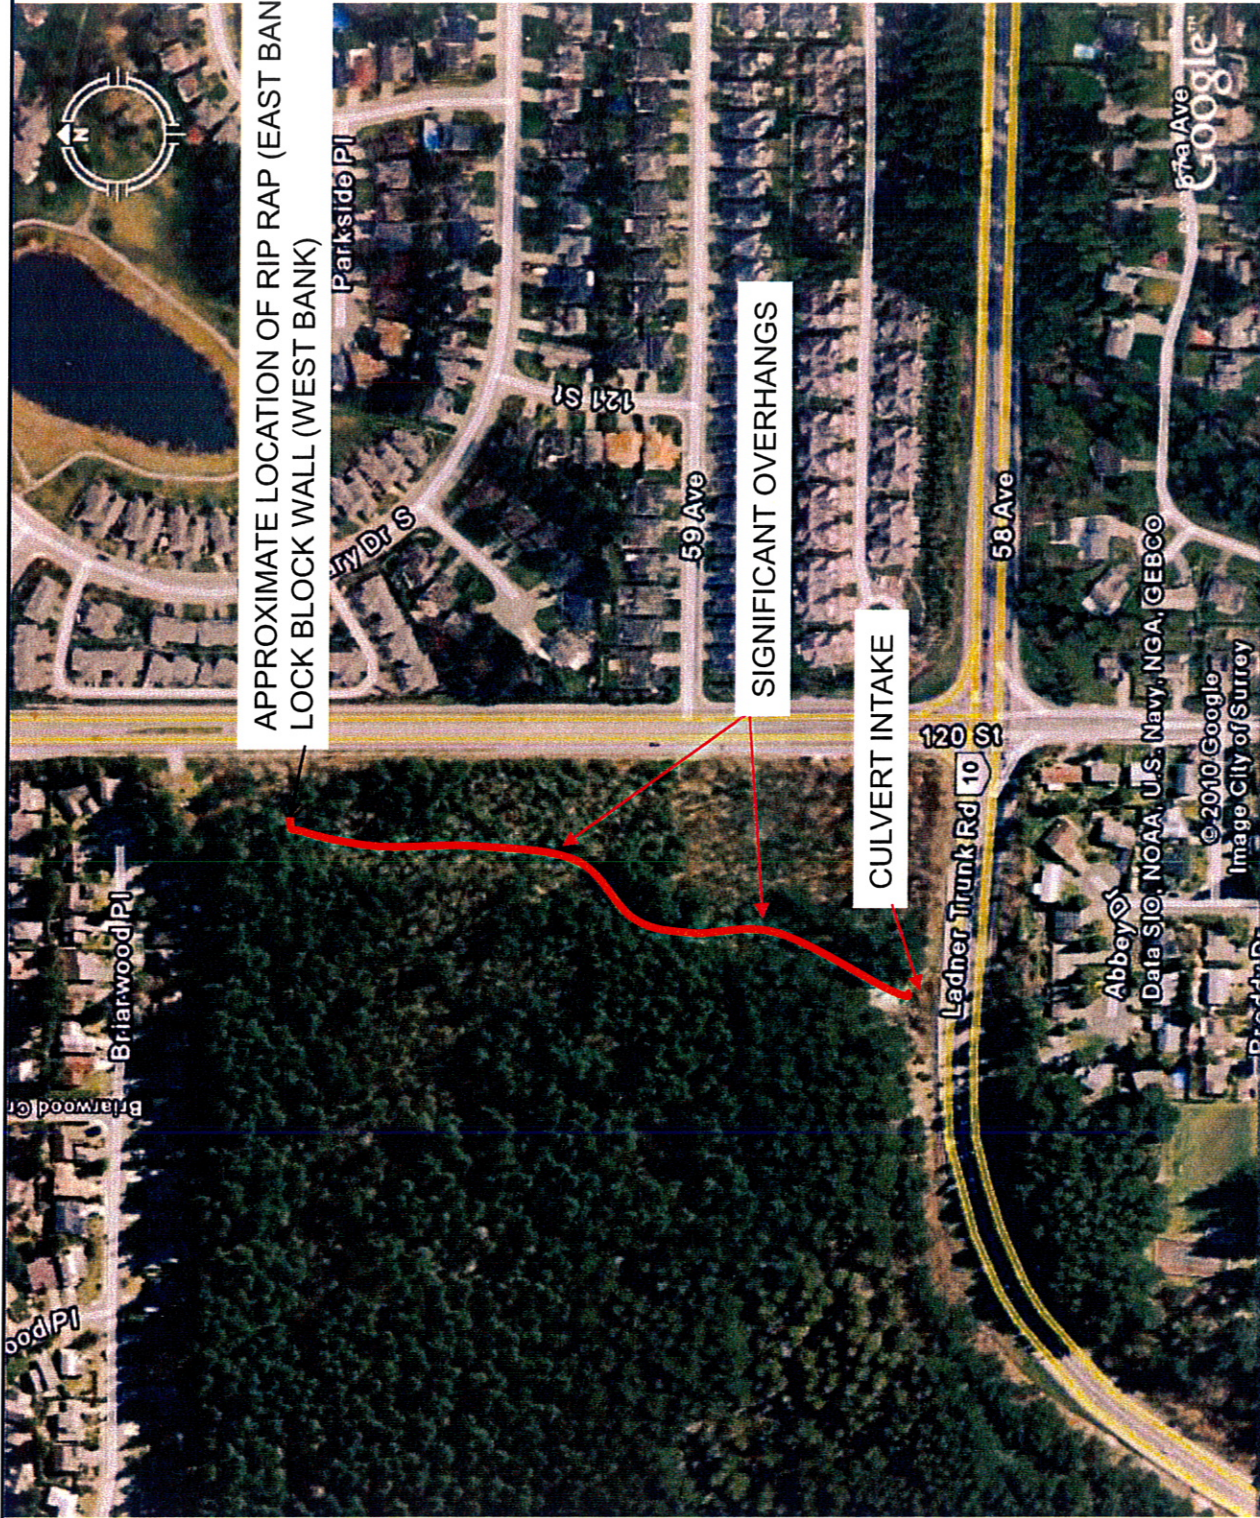
DWG NO.: MAP 3

APPROXIMATE LOCATION OF RIP RAP (EAST BANK) & LOCK BLOCK WALL (WEST BANK)

SIGNIFICANT OVERHANGS

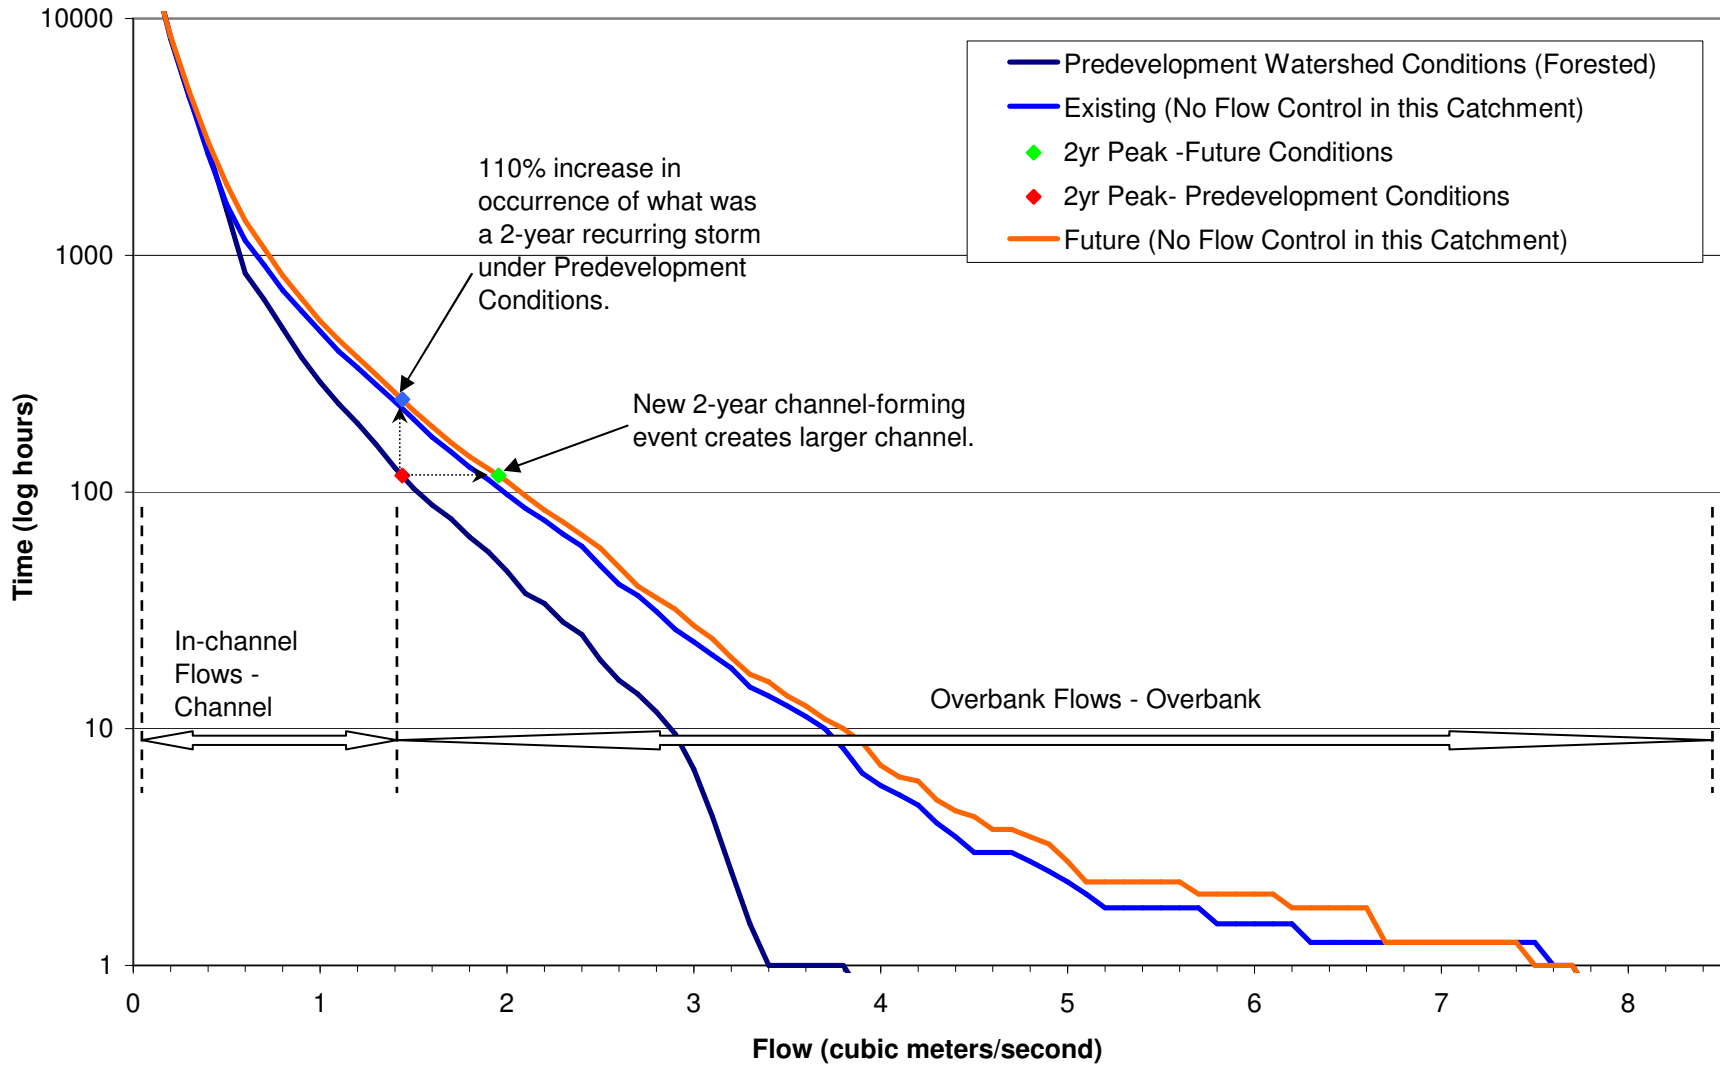
Exceedance Duration Curve for Watershed Creek At BNSF Railway

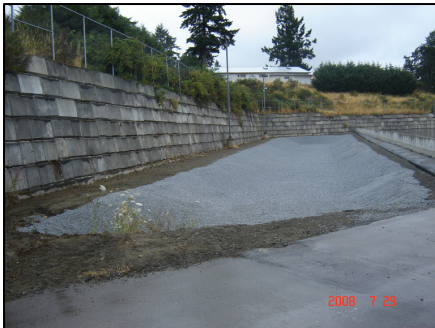
Surface infiltration can also be promoted by the used of permeable pavers or other pervious surfacing materials.

Surface Infiltration Swale

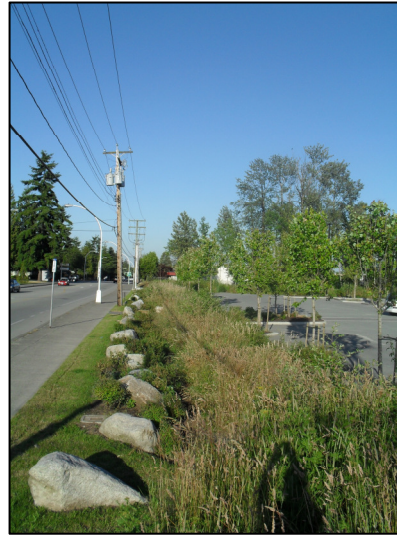
Bio-Retention Swale
