FERGUS CREEK INTEGRATED STORMWATER MANAGEMENT PLAN
PROJECT 4802-707-00
FOR
CITY OF SURREY

FINAL REPORT

September 2010

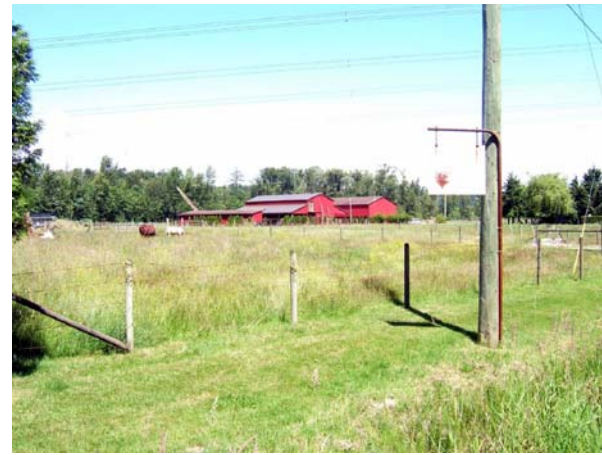
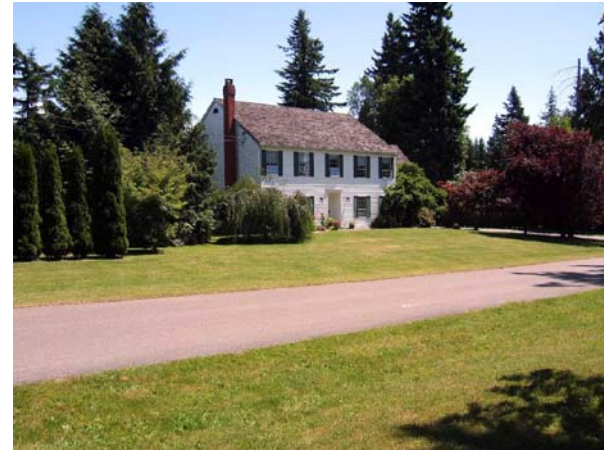
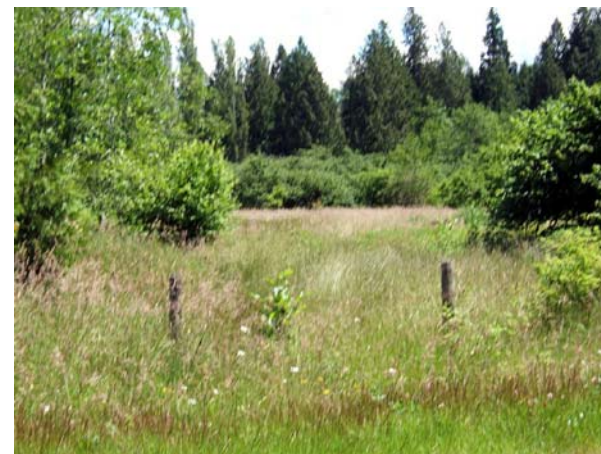
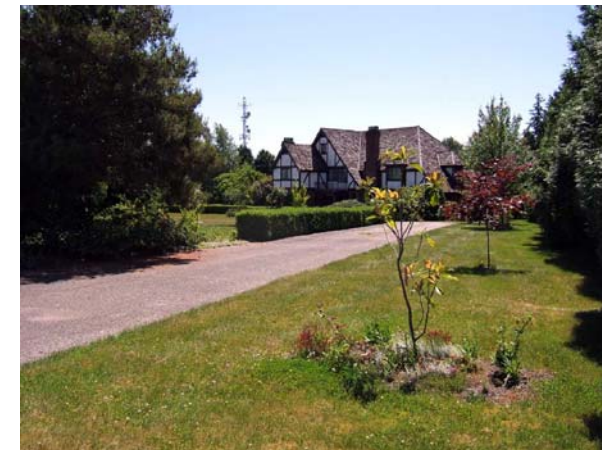
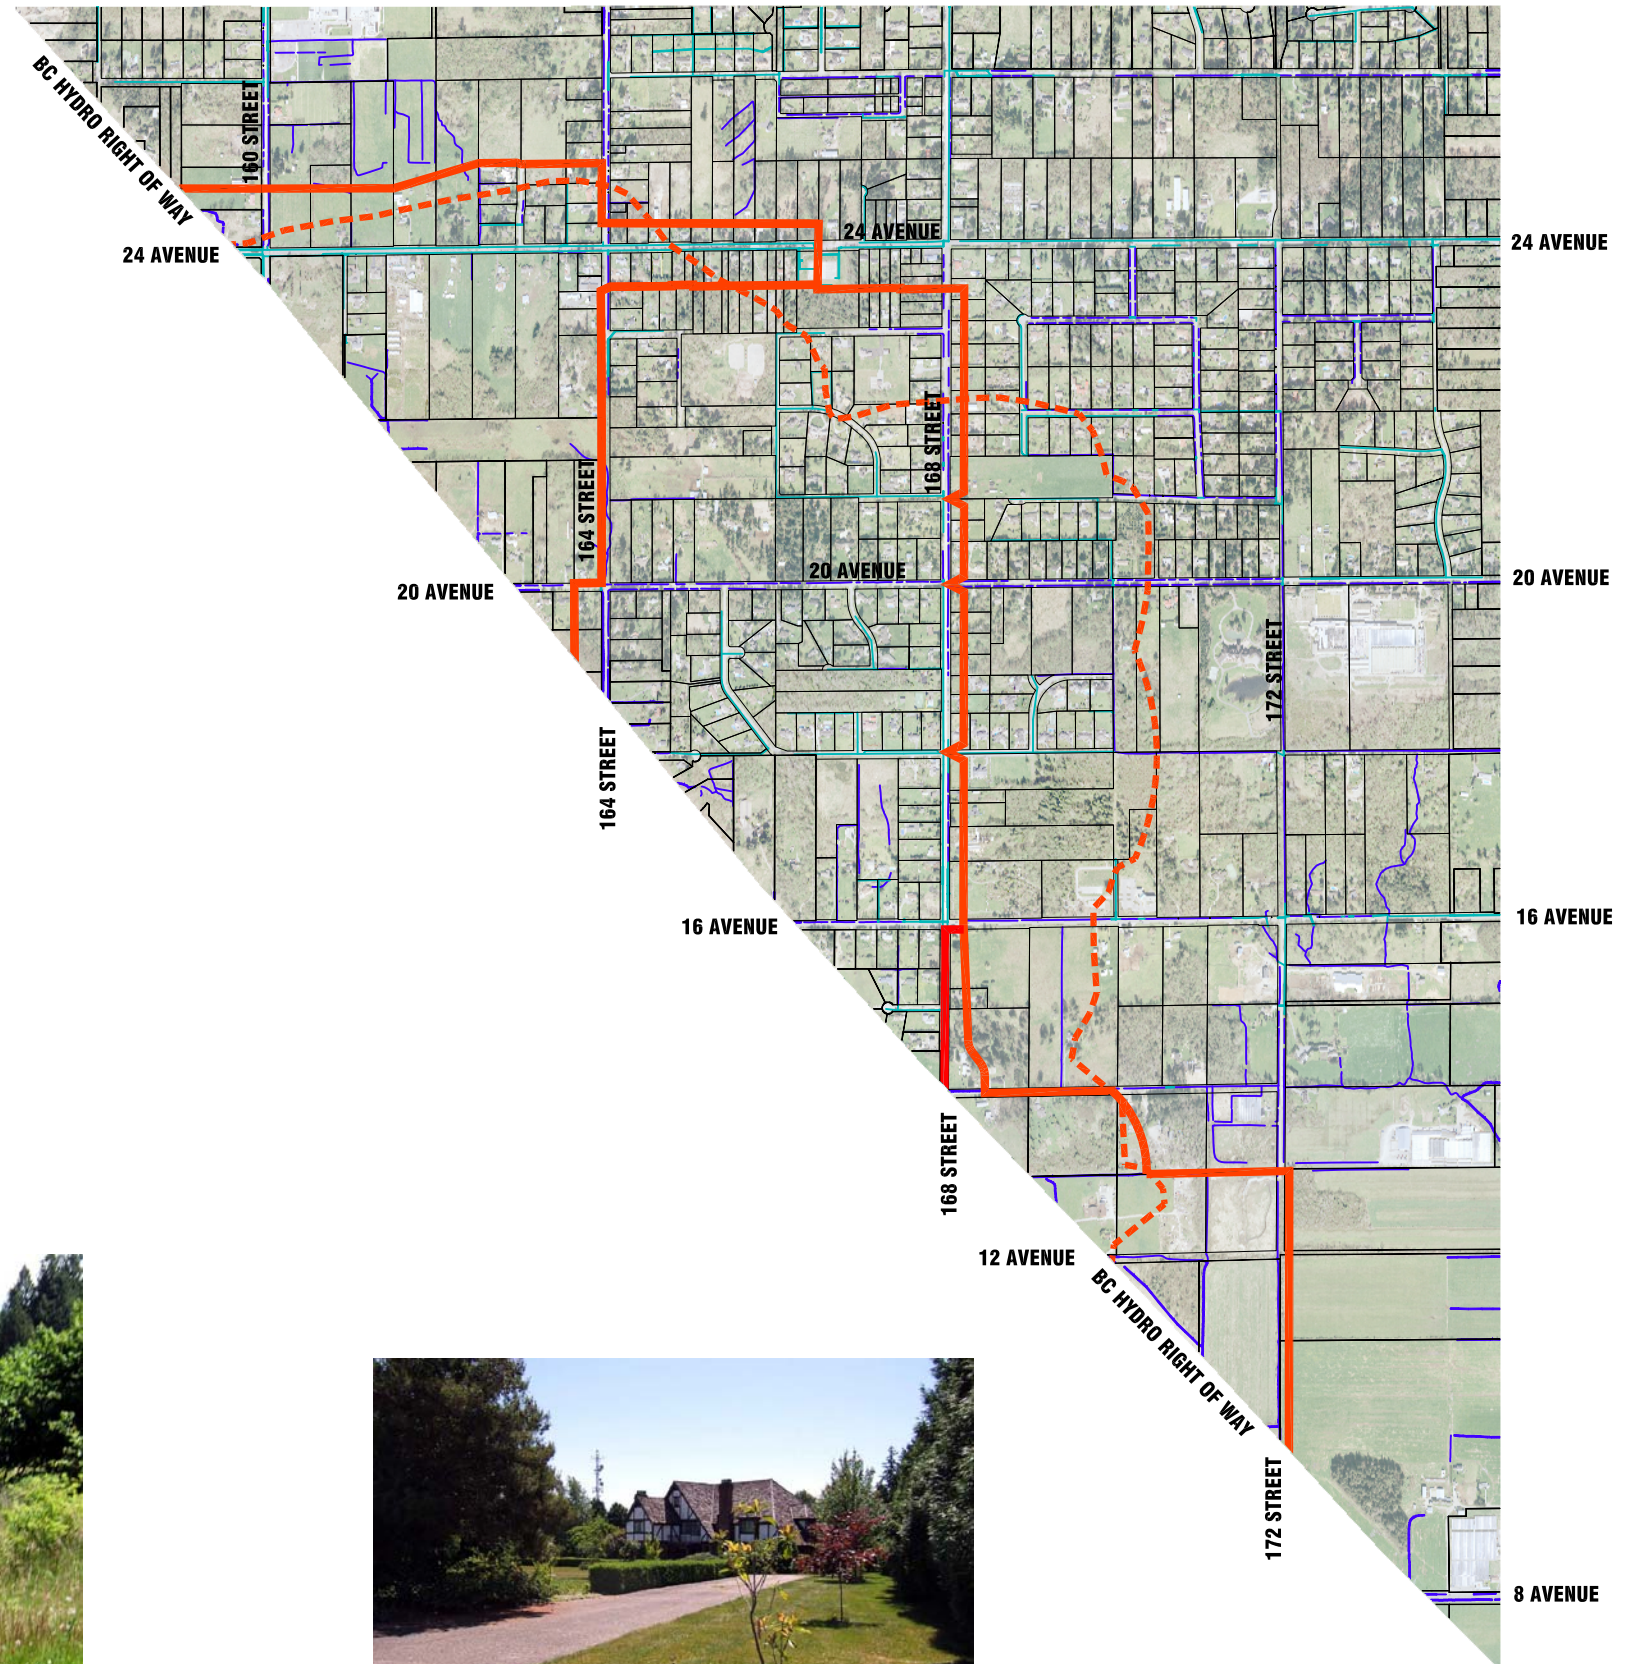
FERGUS CREEK ISMP
Rural Areas
Figure 1.3

The rural areas have been included within Grandview Heights Neighbourhood Concept Plan Area 2, which is being planned concurrently with the creation of the ISMP for Fergus Creek. This parallel process allows watershed criteria and values to be established and entrenched within the NCP prior to redevelopment of the rural area. Typical views of the rural areas can be seen on **Figure 1.3**. The area is composed

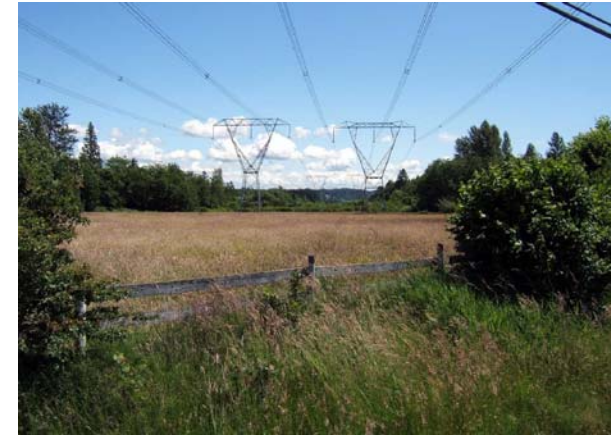
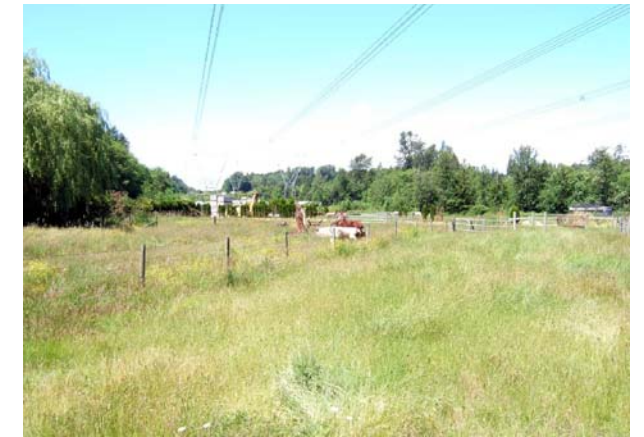
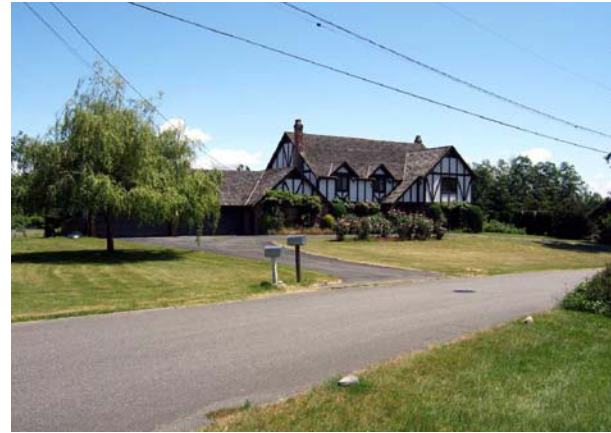
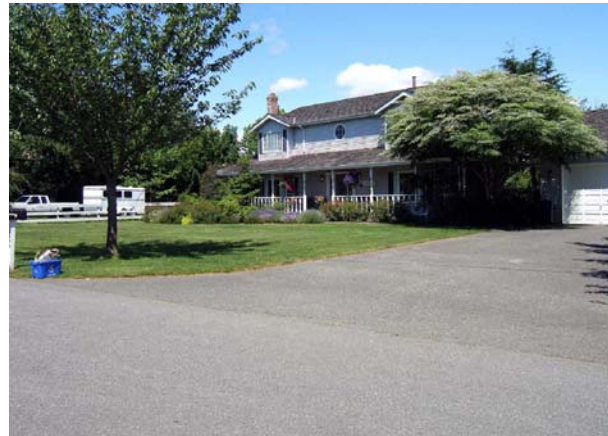
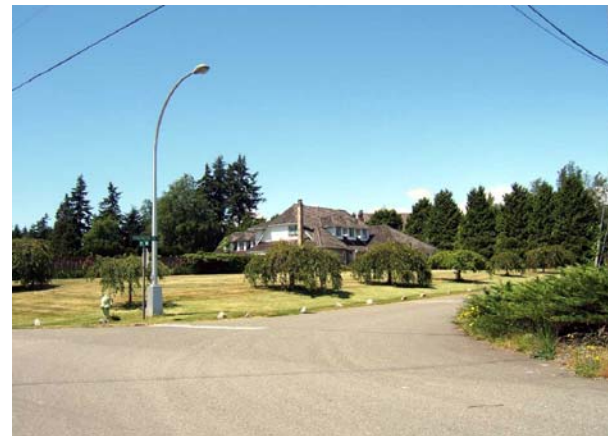
FERGUS CREEK ISMP
Highway 99 Corridor
Figure 1.4

The Highway 99 corridor is undergoing redevelopment following the approval of the Highway 99 Corridor Plan. The Plan calls for the area to be redeveloped with commercial, business park and light industrial land uses. The redevelopment will alter the nature of this portion of the watershed. Mitigation strategies have been established for this area as part of the planning process to manage the changes from landforms shown on **Figure 1.4** to commercial/industrial.

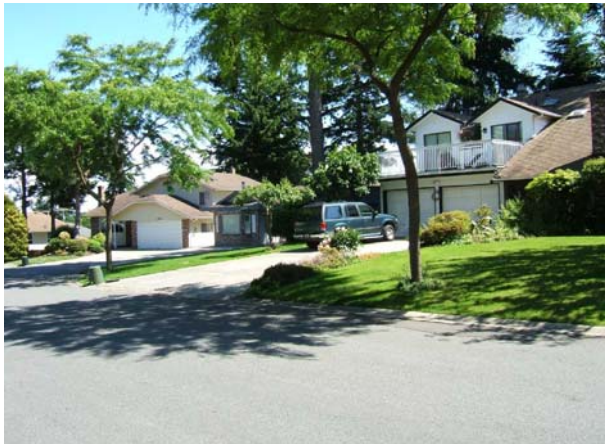
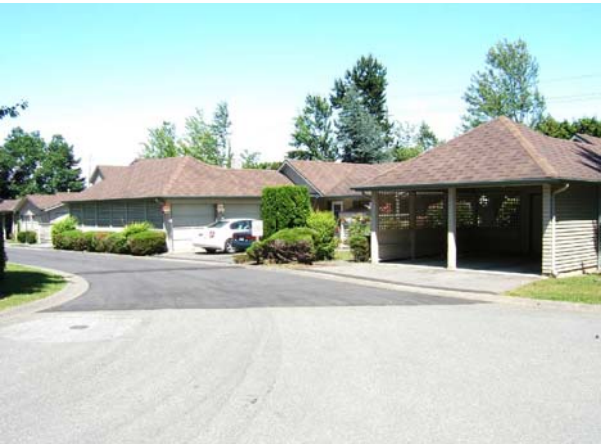
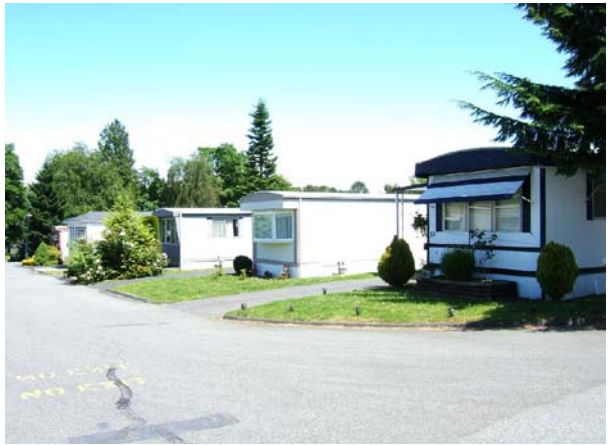
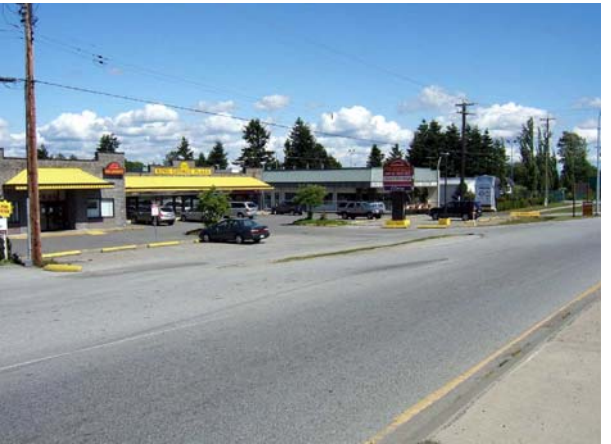
FERGUS CREEK ISMP
Existing Suburban Development
Figure 1.5

The area west of King George Highway has undergone the greatest changes to date with near full development as shown on **Figure 1.5**. This portion of the watershed will redevelop with increased density of housing and increased business and commercial land uses. These changes will result in increased impervious surfaces.

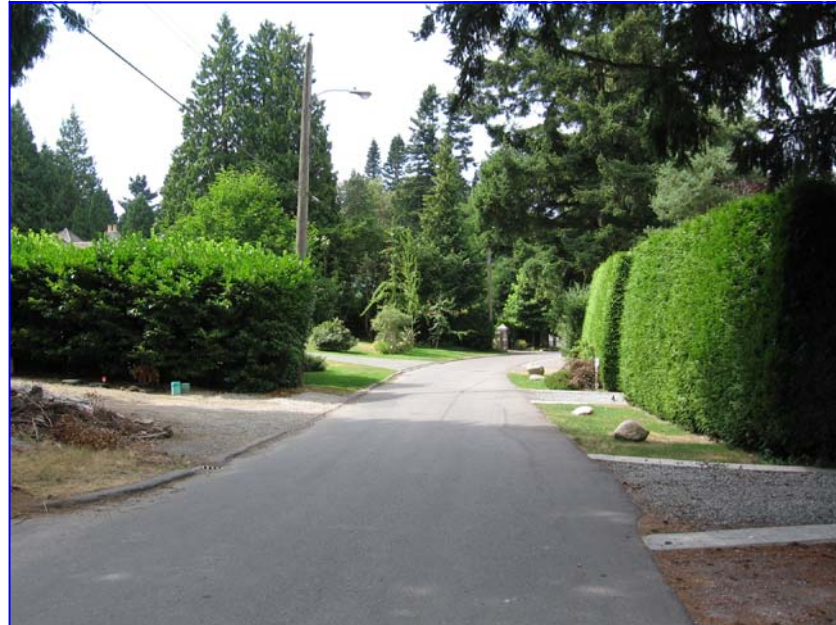
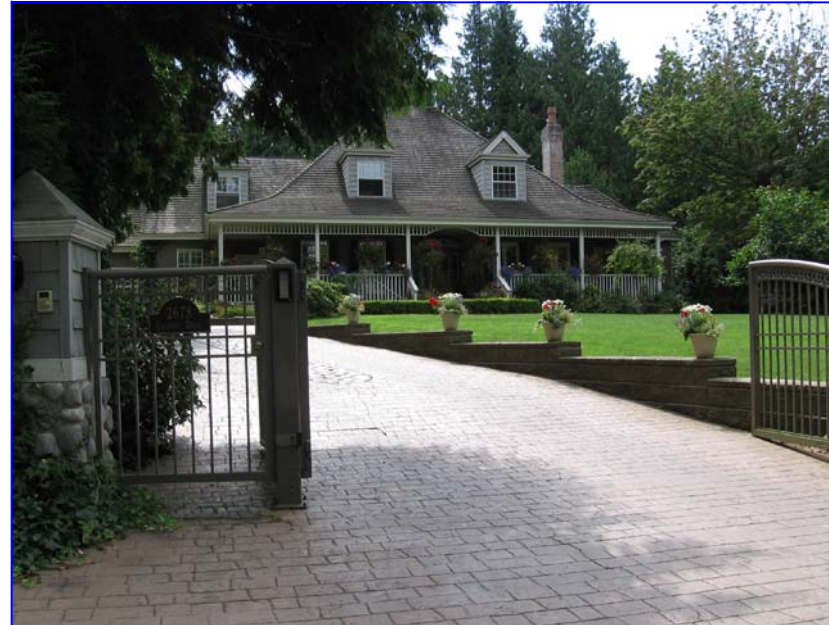
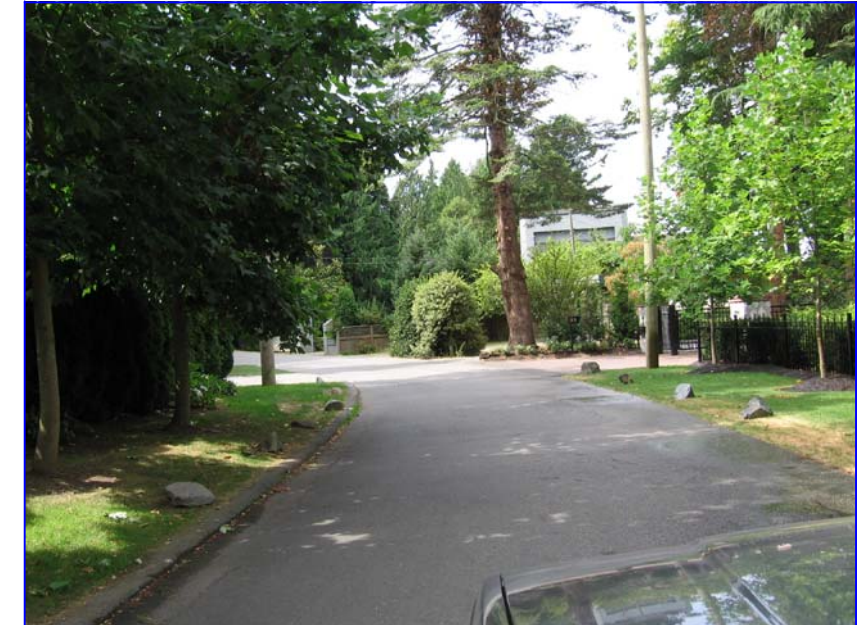
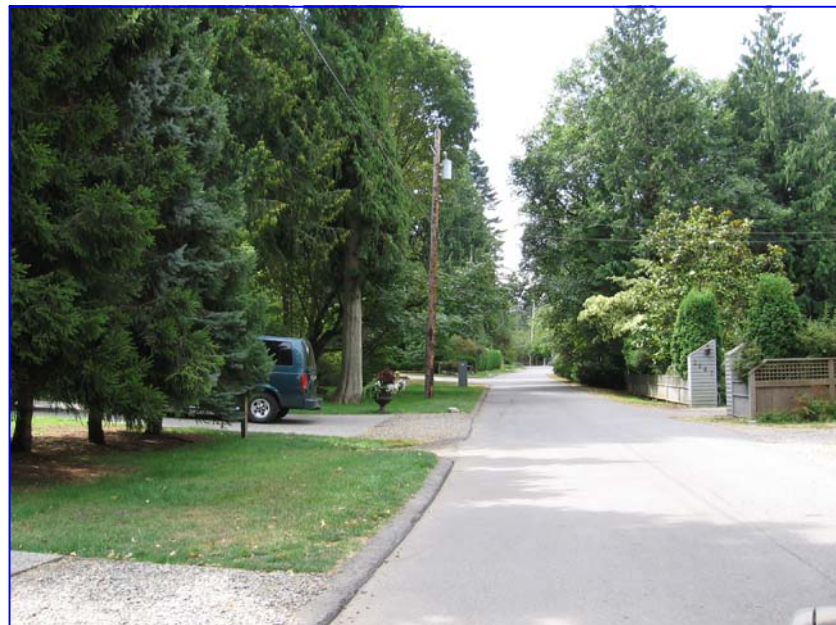
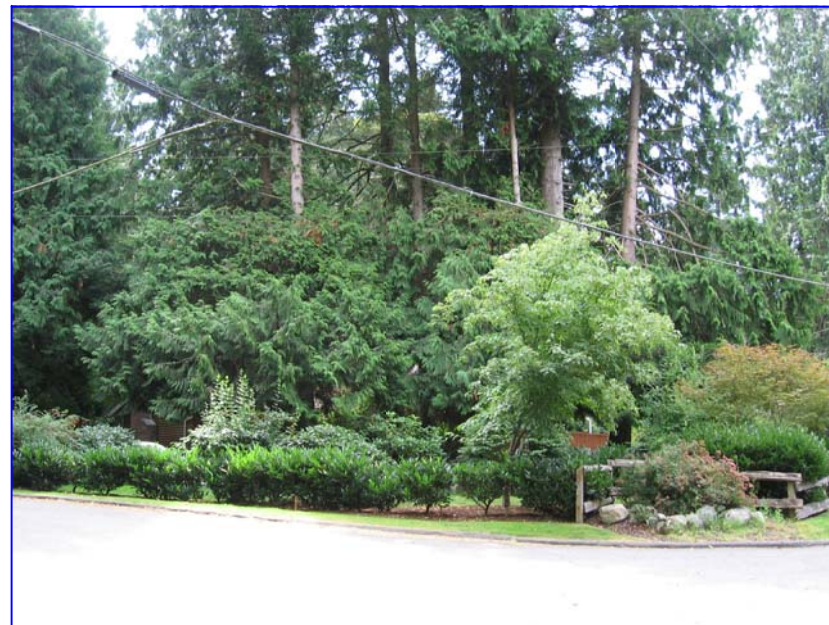
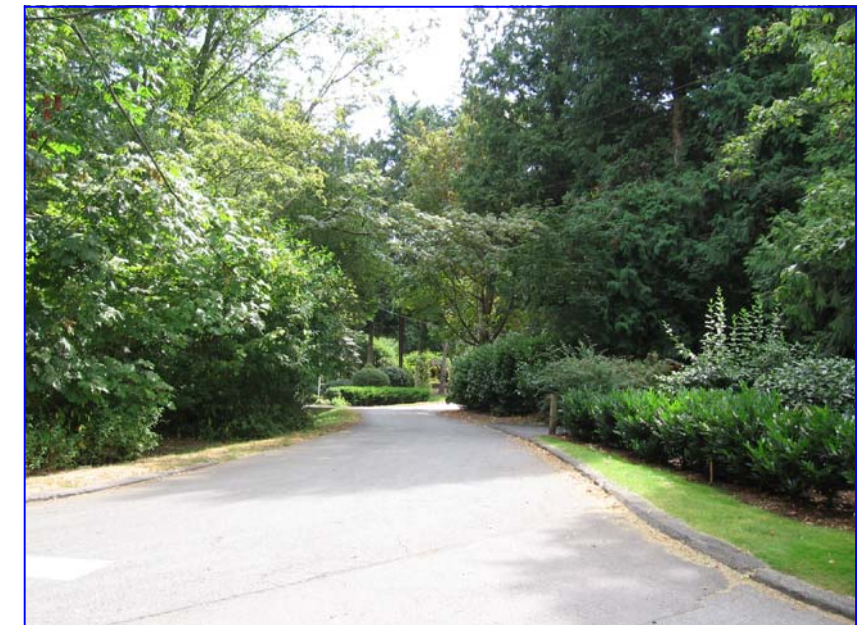
FERGUS CREEK ISMP
 Units per Acre: 2
 Percent Impervious: 35
 Housing Type: Detached
 Figure 2.1 - Location

The **Figures 2.1** through **2.17** depict examples of possible redevelopment in the rural areas in Grandview Heights.

Figure	In or Out of Fergus Creek Watershed	Land Use	Percent Impervious	Residential Density Units per Acre	Land Use Zone Designation
Figure 2.1 - Location	Out	Detached	35	2	RH
Figure 2.1 - Photos	Out	Detached	35	2	
Figure 2.2 - Location	Out	Detached	60	4	RF
Figure 2.2 - Photos	Out	Detached	60	4	
Figure 2.3 - Location	Out	Detached	70	6	RF-12
Figure 2.3 - Photos	Out	Detached	70	6	
Figure 2.4 - Location	Out	Detached	60	8	RF-12C
Figure 2.4 - Photos	Out	Detached	60	8	
Figure 2.5 - Location	Out	Detached	70	10	RF-9C and RF-12C
Figure 2.5 - Photos	Out	Detached	70	10	
Figure 2.6 - Location	Out	Multi-family	70	10	RM-15
Figure 2.6 - Photos	Out	Multi-family	70	10	
Figure 2.7 - Location	Out	Multi-family	75	12	RM-15
Figure 2.7 - Photos	Out	Multi-family	75	12	
Figure 2.8 - Location	Out	Multi-family	75	14	RM-15
Figure 2.8 - Photos	Out	Multi-family	75	14	
Figure 2.9 - Location	Out	Multi-family	55	14	RM-15
Figure 2.9 - Photos	Out	Multi-family	55	14

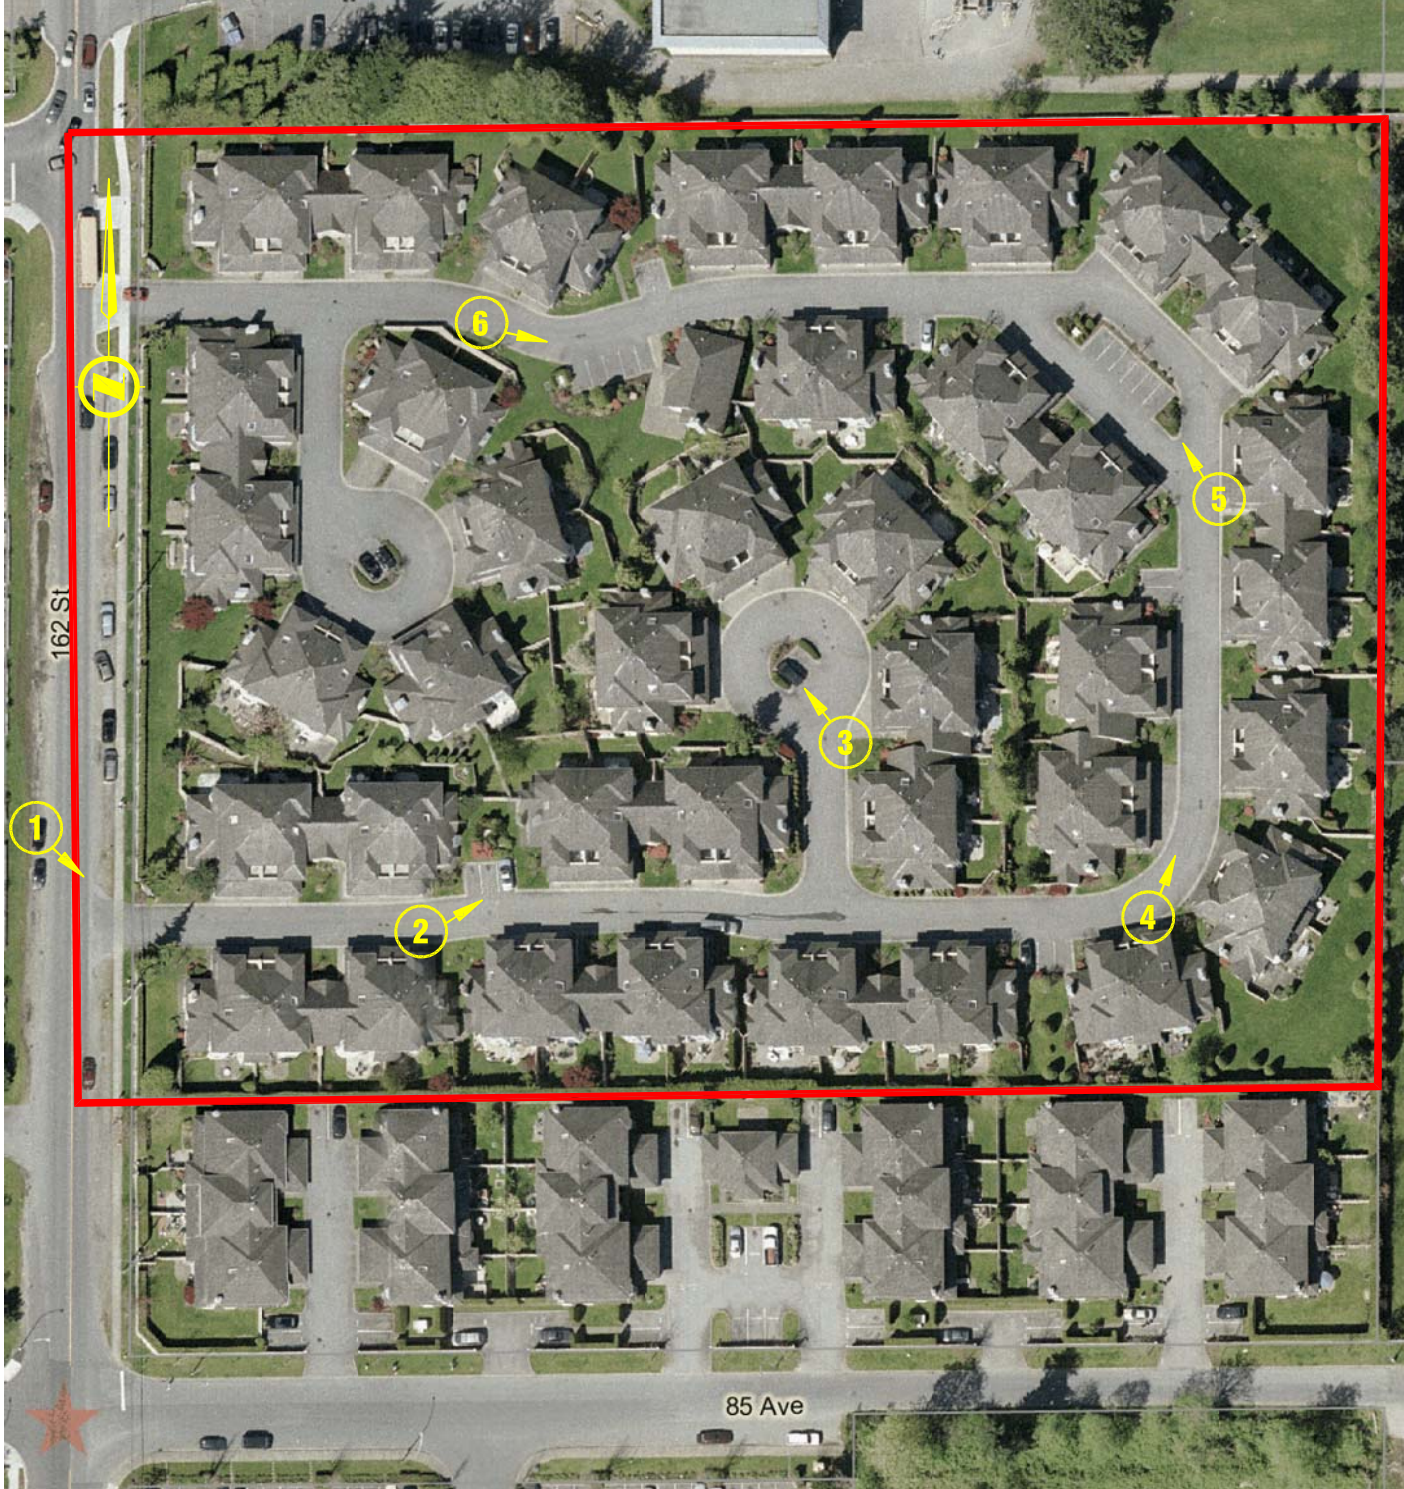
FERGUS CREEK ISMP
 Units per Acre: 10
 Percent Impervious: 70
 Housing Type: Multi-Family
 Figure 2.6 - Location

The level of imperviousness is linked to the number of housing units, whether single family or multi-family. This can be seen when comparing a range of development types and particularly when looking at **Figure 2.5** and **Figure 2.6**. As shown, the percent imperviousness is similar both development irrespective of housing type.

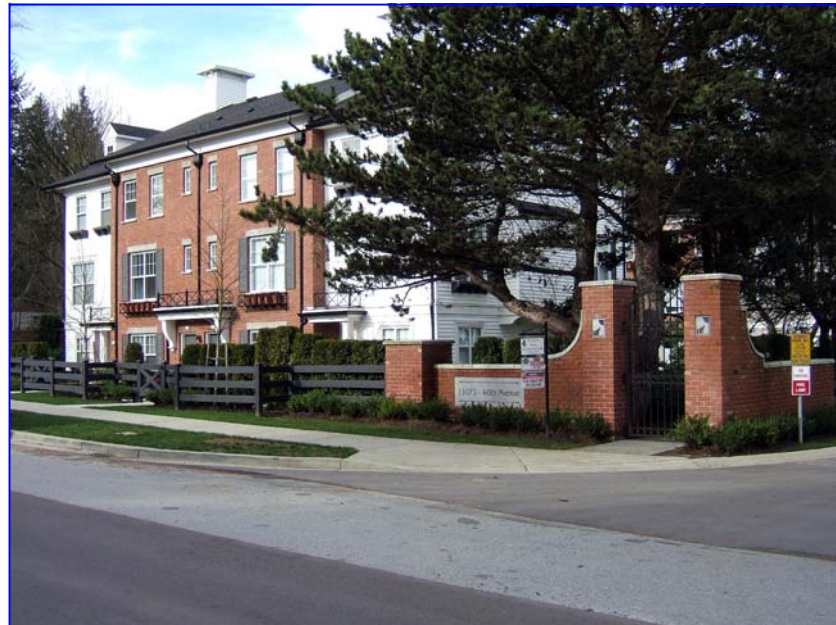
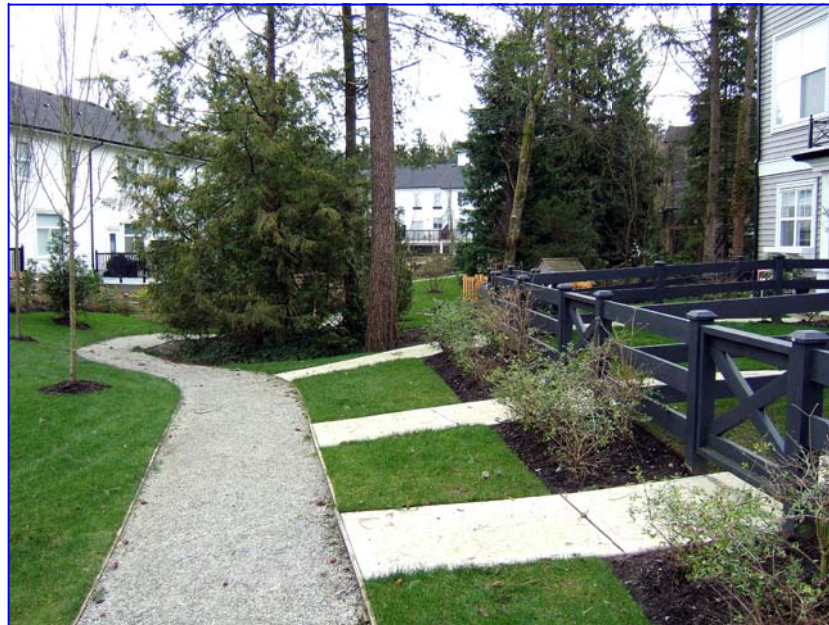
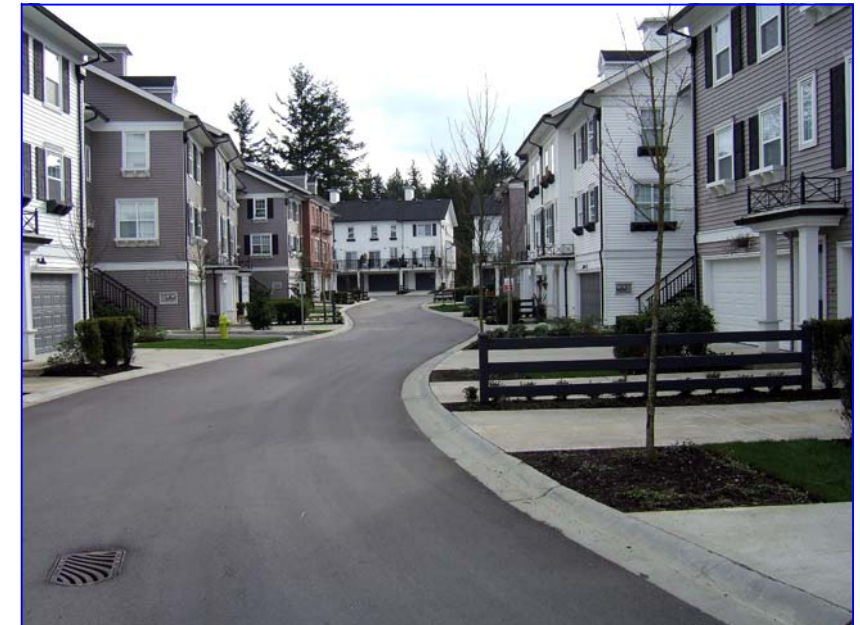
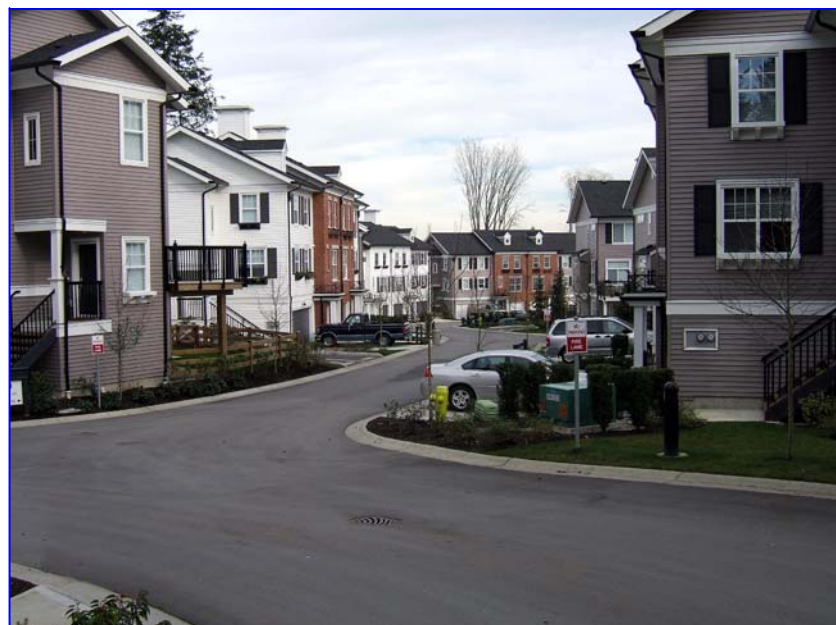
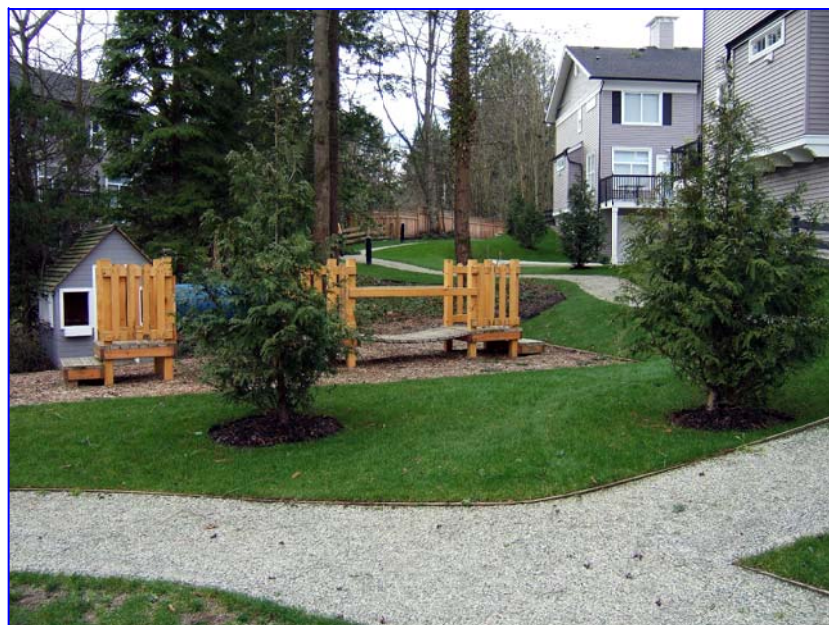
FERGUS CREEK ISMP
 Units per Acre: 14
 Percent Impervious: 55
 Housing Type: Multi-Family
 Figure 2.9 - Location

As second item of note is the variability of the imperviousness in the examples. This is directly related to the relative proportion of hard surfaces that would produce stormwater runoff. There are important differences in the examples shown. **Figure 2.8** and **Figure 2.9** have dramatically different imperviousness from similar density and Land Use Zones. The primary difference is in the number of floors of the housing units and the location of the parking spaces.

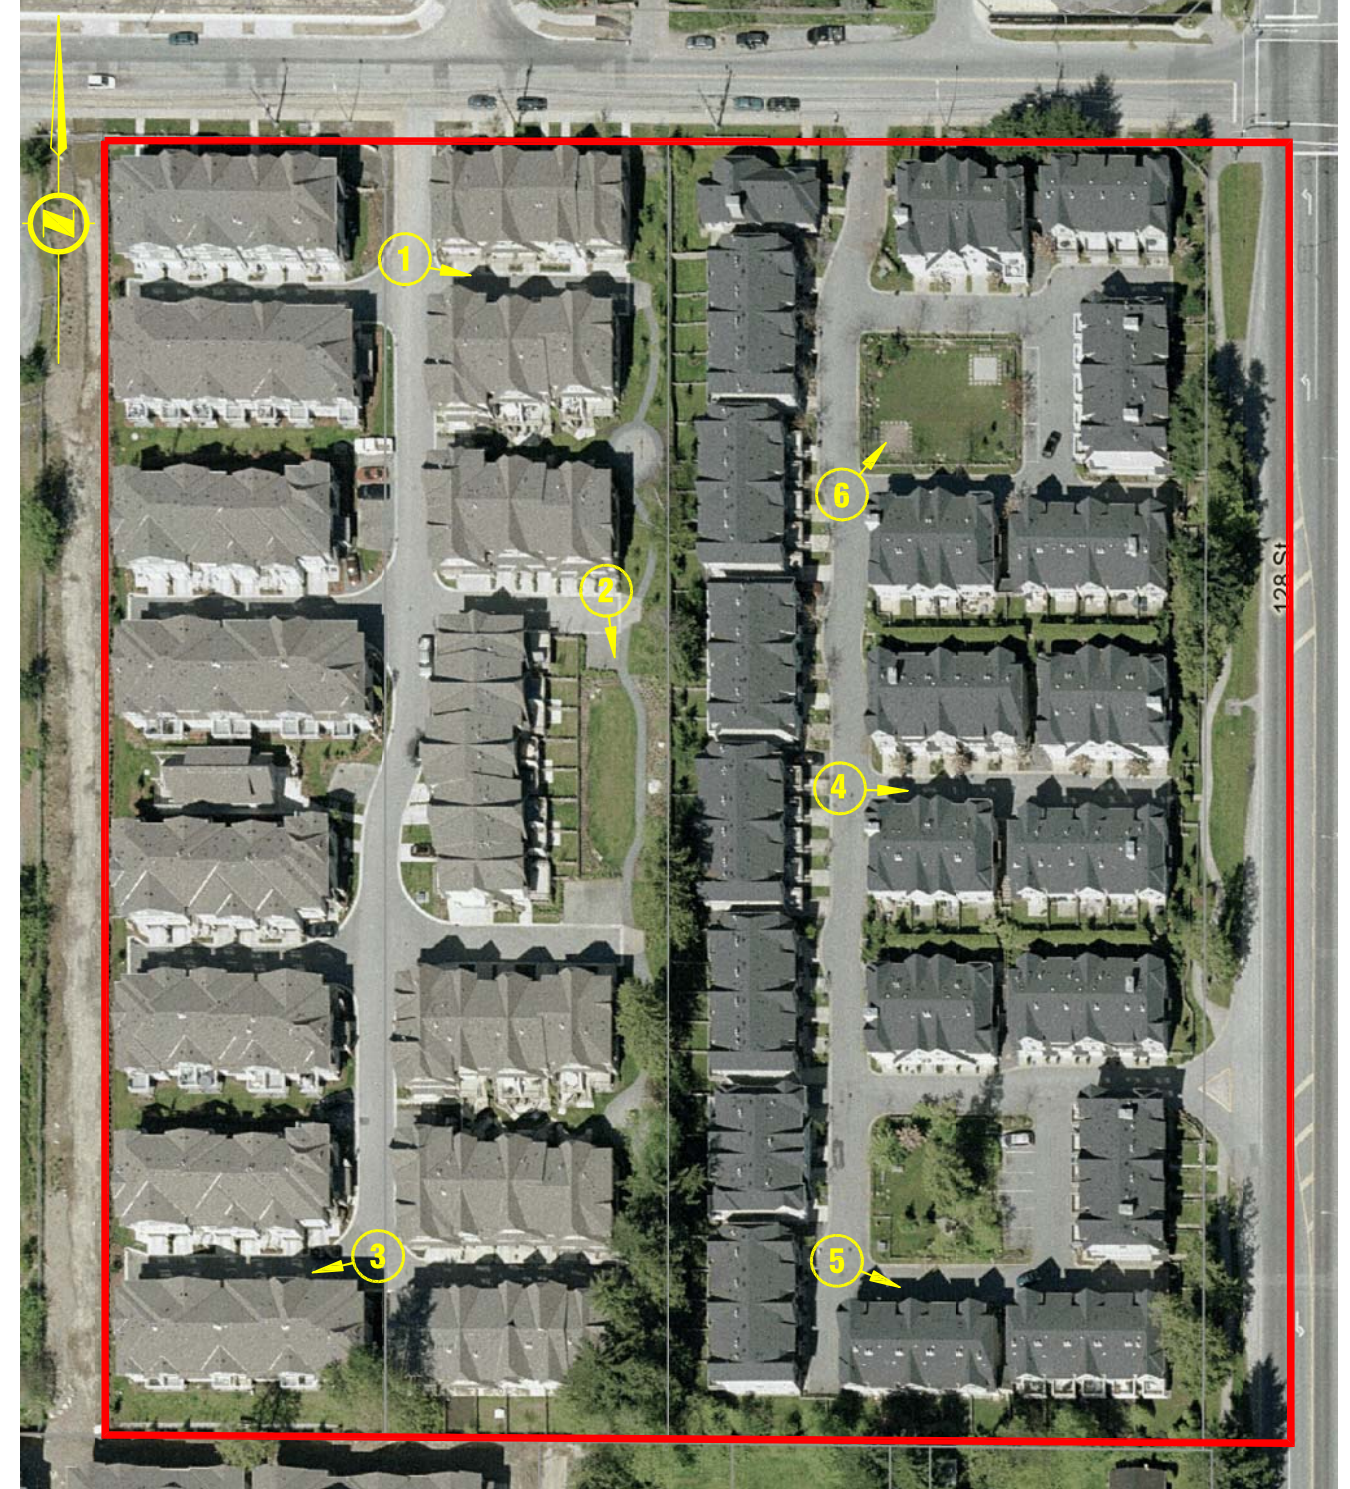
FERGUS CREEK ISMP
 Units per Acre: 20
 Percent Impervious: 80
 Housing Type: Multi-Family
 Figure 2.10 - Location

Figure 2.10 - Location	Out	Multi-family	80	20	RM-30
Figure 2.10 - Photos	Out	Multi-family	80	20	
Figure 2.11 - Location	Out	Multi-family	40	18	N/A
Figure 2.11 - Photos	Out	Multi-family	40	18	
Figure 2.12 - Location	In	Agricultural	2	N/A	A-1
Figure 2.12 - Photos	In	Agricultural	2	N/A	
Figure 2.13 - Location	In	Rural Residential	15	1	RA
Figure 2.13 - Photos	In	Rural Residential	15	1	
Figure 2.14 - Location	In	Trailer Park	80	8	RM-M
Figure 2.14 - Photos	In	Trailer Park	80	8	
Figure 2.15 - Location	In	Commercial	95	N/A	C-8 and CHI
Figure 2.15 - Photos	In	Commercial	95	N/A	
Figure 2.16 - Location	In	Detached	60	4	RF
Figure 2.16 - Photos	In	Detached	60	4	
Figure 2.17 - Location	In	Multi-family	60	9	RM-15
Figure 2.17 - Photos	In	Multi-family	60	9

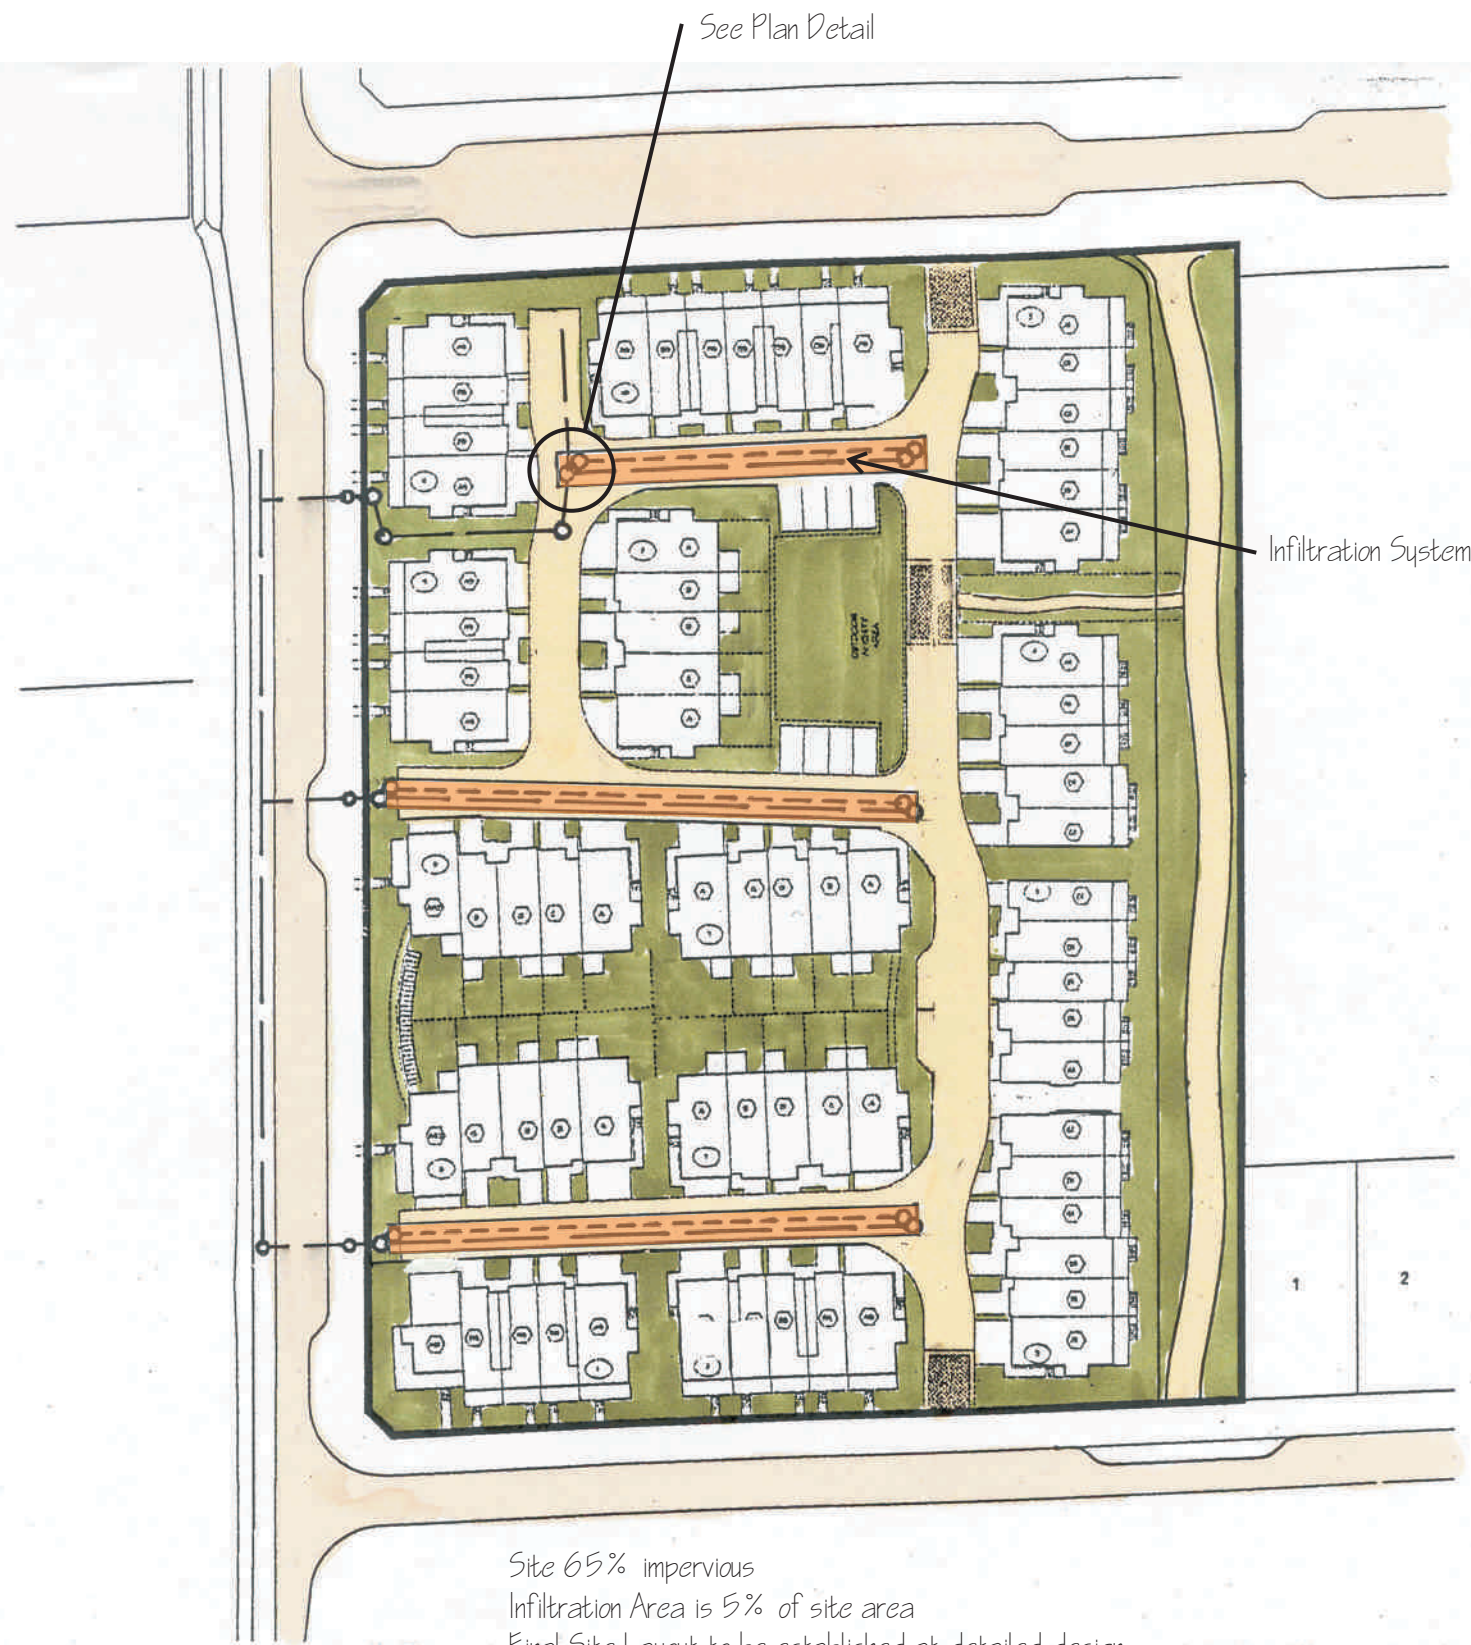
TYPICAL PLAN

Site 65% impervious
 Infiltration Area is 5% of site area
 Final Site Layout to be established at detailed design

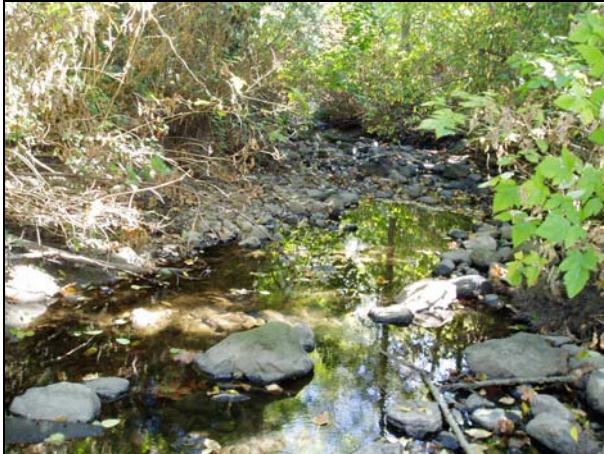
Photograph 7 – Downstream view of degraded channel below 14th Avenue stormwater connections. Substrate dominated by boulder material and clay with “pock marked” clay surfaces indicating scour and transport of smaller cobble and boulder material -

Field indicators confirm the presence of bank erosion and channel degradation attributed to stormwater related impacts to watershed hydrology and channel morphology. Field observations suggest that the most significant bed scour and bank erosion locations are located immediately below stormwater discharges or culvert crossings (Photograph 7 & 8). Gartner Lee (2000) identified a number of erosional areas with six (6) specific sites noted within Reach 5, below a major stormwater outfall, which was noted to indicate significant bed and bank scour during the 2005 and 2006 field surveys. Similarly, scour and bank erosion immediately below the Highway 99 culvert in reach 4 was observed during the 2005/2006 assessments, while Gartner Lee (2000) identified four (4) specific erosion concerns within reach 4. The observation of scour below culvert crossings implies that the culverts may be undersized and as a result, impoundments may result in an increase in the duration and magnitude of storm flows, ultimately affecting the duration of channel forming events. In addition, summer low flows appear limited with respect to the channel's bankfull width with isolated pools and extensive areas of dry/dewatered channel observed in the upper reaches (upper reach 5 through 7) during the September 2005 surveys, which is assumed to be the result of urbanization and the extensive impervious areas to the west of Highway 99.

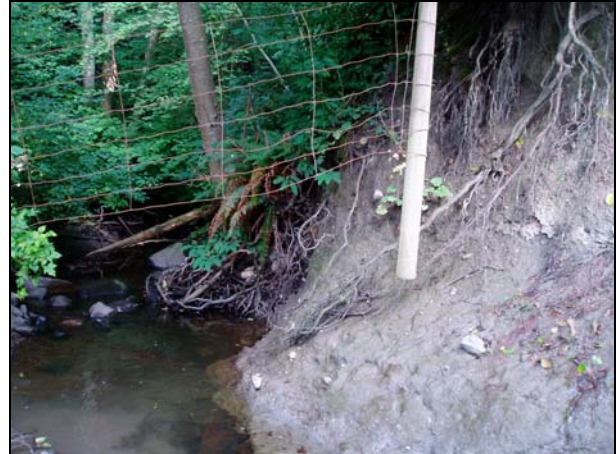
Photograph 8 – Downstream view of bank erosion/channel widening below Highway 99 culvert outlet. Note hanging fence post depicting the relatively recent changes to the channel.

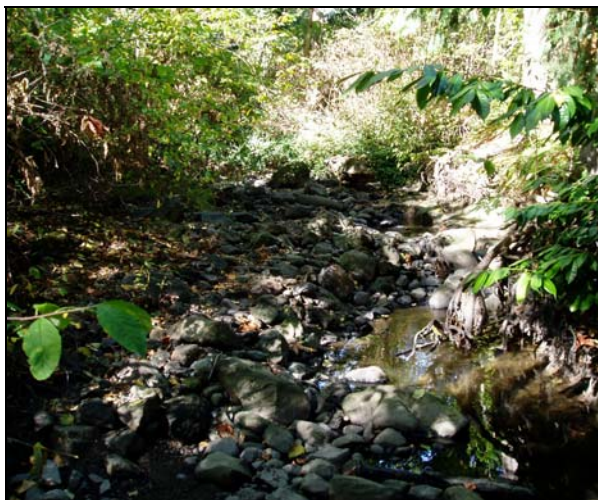
Photograph 9 – Low flow channels appear disproportionate to the channel’s bankfull width with isolated residual pools.

While a detailed assessment was not conducted, preliminary observations and field indicators suggest that the mainstem of Fergus Creek is not in equilibrium with the current hydrologic regime. Low flow channels were noted to appear disproportionate to the channel’s bankfull width (Photograph 9) and evidence of bed scour, bank erosion and initial channel widening (Photograph 10) suggest ongoing channel adjustments. The aforementioned channel adjustments were observed primarily within Reaches 5 through 3. Further downstream along the channel continuum field observations within Reach 2 indicate localized aggradation with a distinct change in substrate characterized by a shift from predominantly boulder and cobble to predominantly gravel and fines (Photograph 11 & 12).

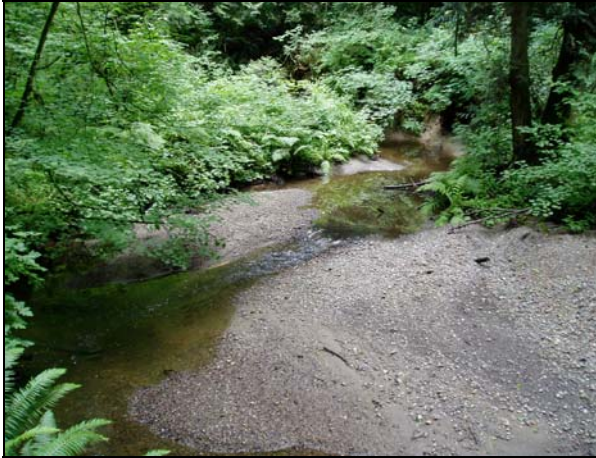
Photograph 10 – Upstream view of modified channel through Reach 3. Visible bank slumping suggests initial channel widening.

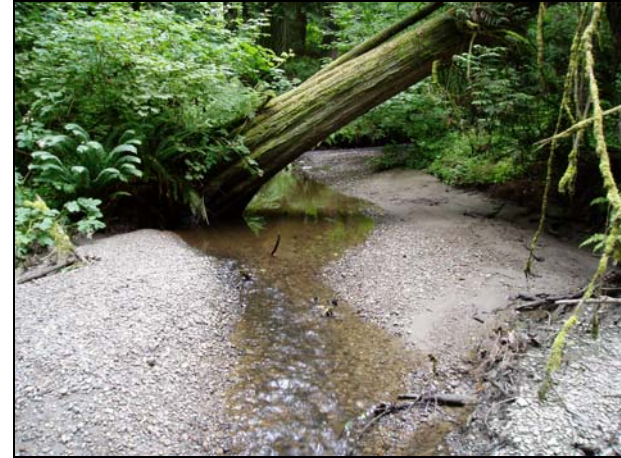
Photograph 11 – Upstream view of side bars of homogenous textured gravel substrate within Reach 4. Evidence of localized aggradation.

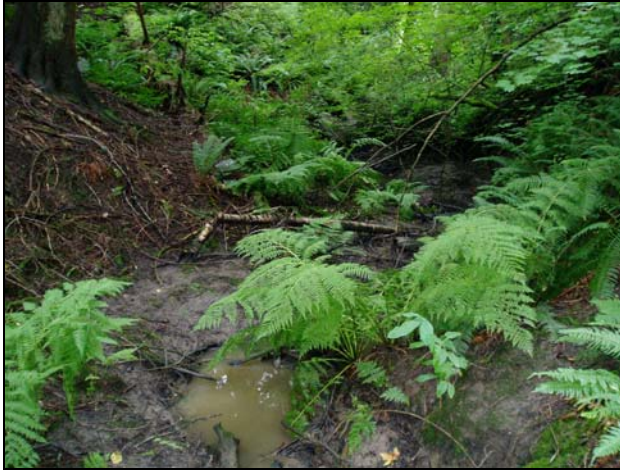
Photograph 13 – Upstream view of marginal habitat at Tributary 2.1. Negligible residual pools, poor substrate and high ambient turbidity.

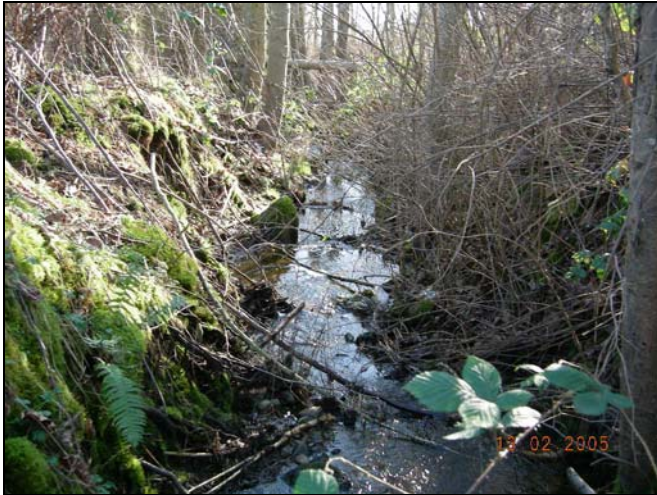
Photograph 15 – Class B watercourse confirmed above confluence with 20th Avenue Ditch. Drainage originates as property line ditches in agricultural field located south of 161st Street and 24th Avenue

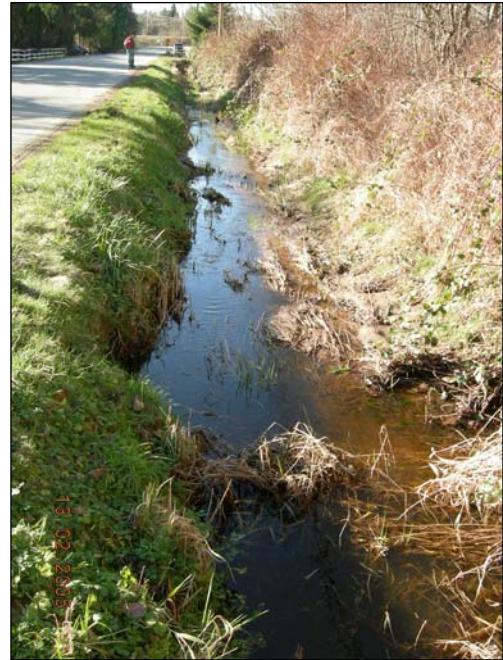
Photograph 16 – 20th Avenue ditch receives significant flows and drains west to a Class A tributary of Fergus Creek.
