FERGUS CREEK INTEGRATED STORMWATER MANAGEMENT PLAN
PROJECT 4802-707-00
FOR
CITY OF SURREY

FINAL REPORT

September 2010

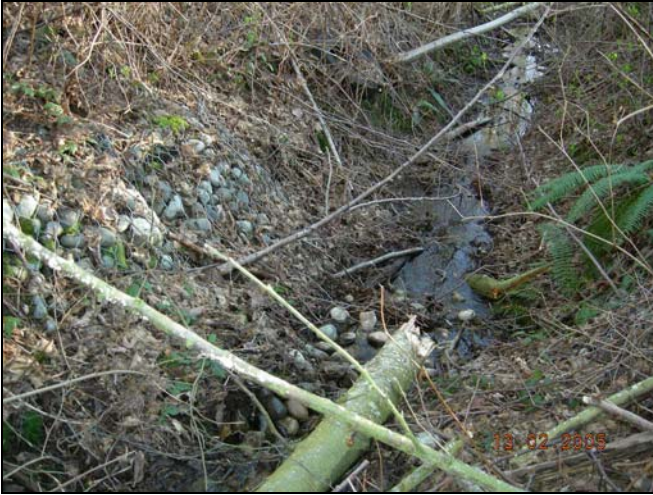
Photograph 17 – Downstream view of 164th Street right-of-way channel. Rock gabion weirs located throughout channel length.

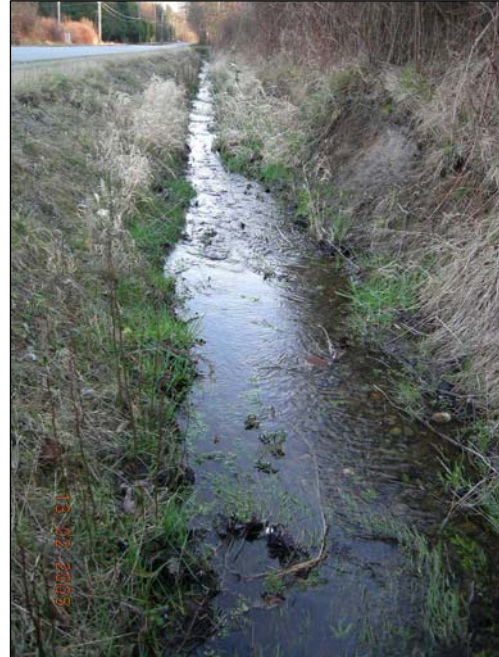
Photograph 18 – Downstream view of 164th Street west ditch with alluvial substrate, visible scour and sustained flows.

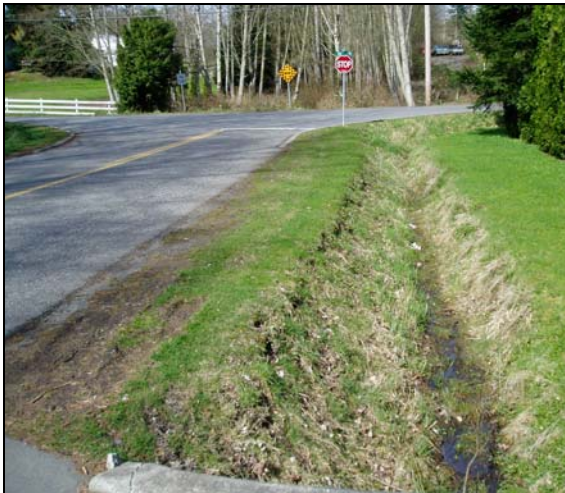
Photograph 19 – 164th Street East ditch below 20th Avenue. Grass lined ditch with negligible flow and no significant scour.

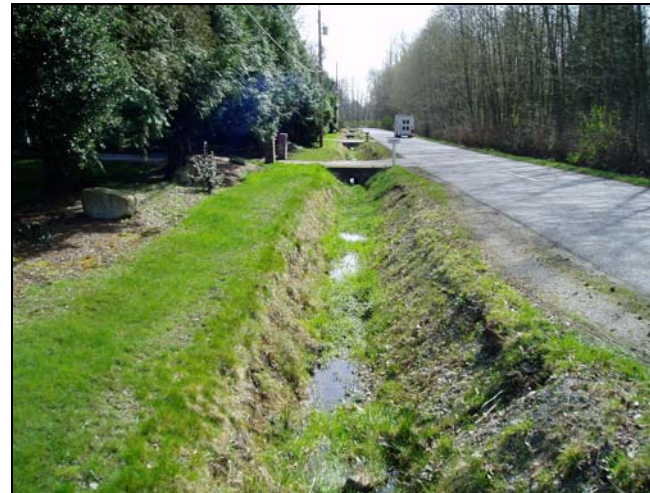
Photograph 20 – Downstream view of 164th Street East ditch. Increased flow with localized scour, mineral alluvium and direct connectivity to Class A watercourse below 16th Avenue.

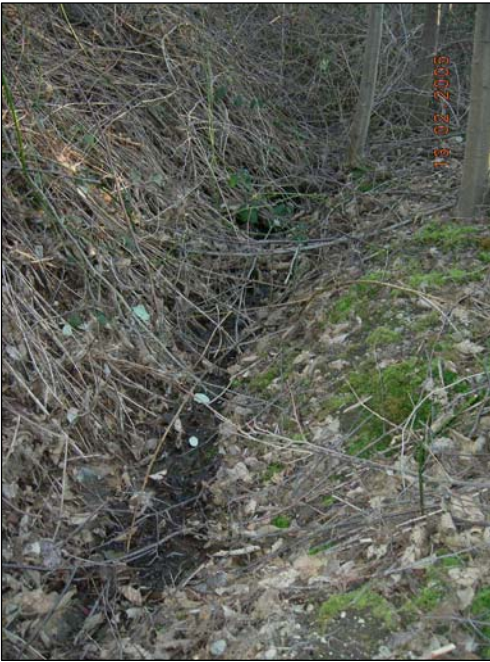
Photograph 21 – Abandoned property line drainage ditches located south of 18th Avenue.

4. ENKON recommends that the Class B watercourses mapped by the City of Surrey in the southern portion of the plan area located south of the 18th Avenue cul-de-sac accessed from 164th Street be reclassified as Class C watercourses. Field observation confirmed the lack of any direct downstream connectivity of these watercourses which appear to be historical property line interceptor drainages. While the area has standing water suitable for potential amphibian habitat, there is no connectivity to downstream fisheries resources and flows surcharging from the isolated ditches disperses to ground within the hydro right-of-way (Photograph 21).

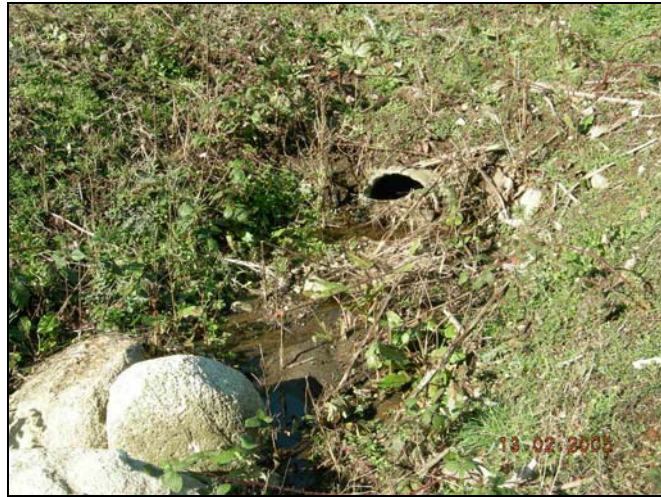
Photograph 22 – Manmade drainage ditch located north of residential property at 16691 16th Avenue. No direct downstream connectivity.

5. The watercourse originating as a drainage ditch at the rear of the private residential lots originating at 16691 16th Avenue is recommended for reclassified to a Class C watercourse based on the lack of direct channel connectivity with downstream resources (Photograph 22). The watercourse enters a concrete culvert above a private residence with unclear downstream connectivity. With respect to remapping of the areas drainage, ENKON encountered an additional east-west interceptor ditch/swale at approximately 60m upstream from the concrete culvert inlet. ENKON recommends a classification of Class C for the previously unmapped small ditch/swale.

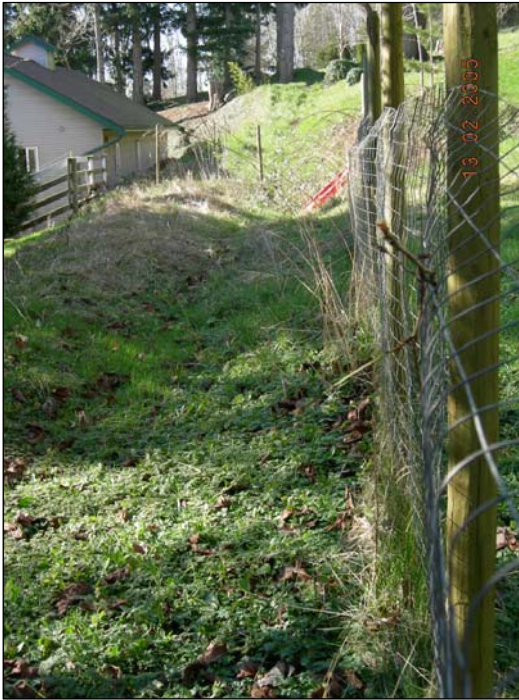
Photograph 23 – Class C swale located above residential property located at 16733 16th Avenue.

The lower Class B watercourse was observed as an abandoned swale below a swimming pool with no evidence of flow, scour or potential downstream connectivity (Photograph 23). ENKON recommends that all watercourses in the vicinity of 16691 be reclassified as Class C watercourses.

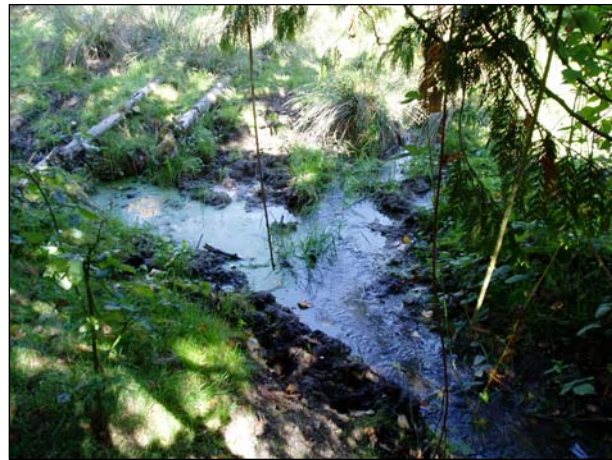
Photograph 26 – Upstream view of confluence of east and west branches of Trib 4.1. Note visible bank destabilization and negligible pool depth due to livestock related impacts.

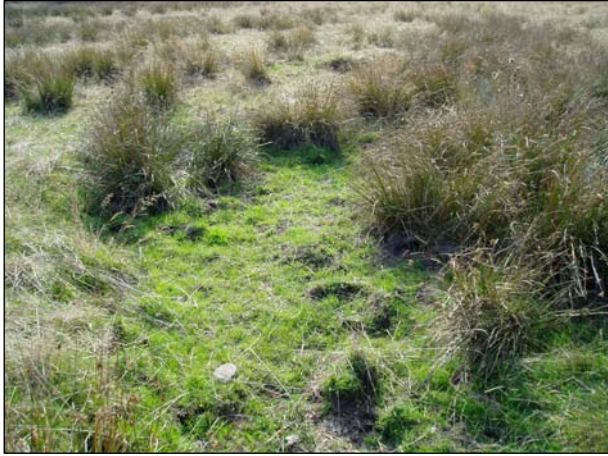
Photograph 27 – Poorly defined drainage channel/swale defined by grass lined depression with hydrophytes (*juncus sp.*) at margins of the west branch of Trib 4.1.

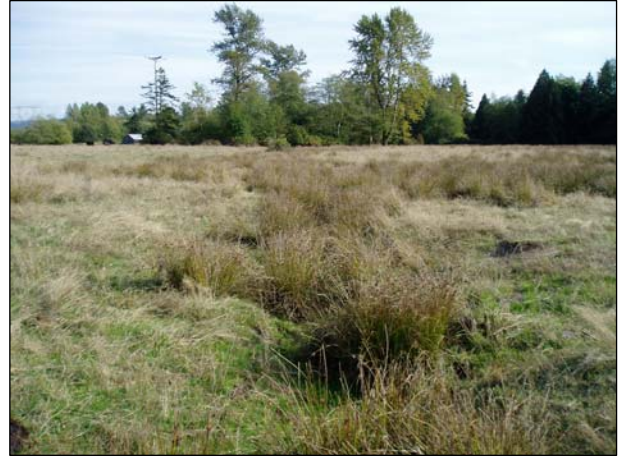
Photograph 28 – Downstream view of the west branch of Trib 4.1. Drainage channel poorly defined but distinguished by linear depression characterized by hydrophyte growth.
