1. Planning Report - Application No. 7921-0264-00, 7921-0264-01
6617 - 181 Street; 6618 - 180 Street

RE: **By-law No. 21332 and By-law No. 20992
Development Application No. 79 21-0264-00**

To permit subdivision into thirteen (13) single family small lots and one (1) riparian open space (park) lot.

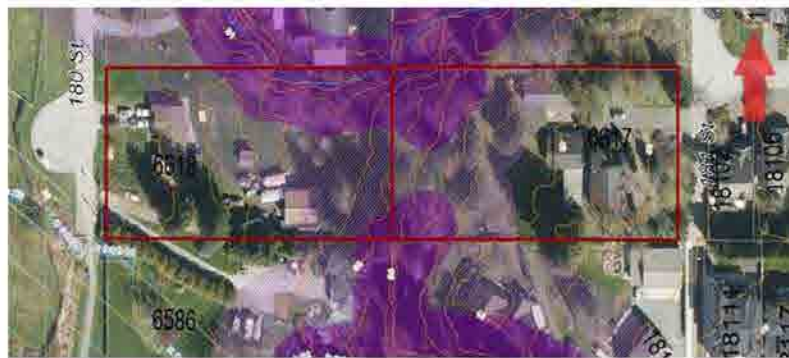
Figure 1: Subject Site relative to City of Surrey Hazard Lands DPA

It is understood that areas within the subject development property fall within the City of Surrey Hazard Lands Development Permit Area (Figure 1).

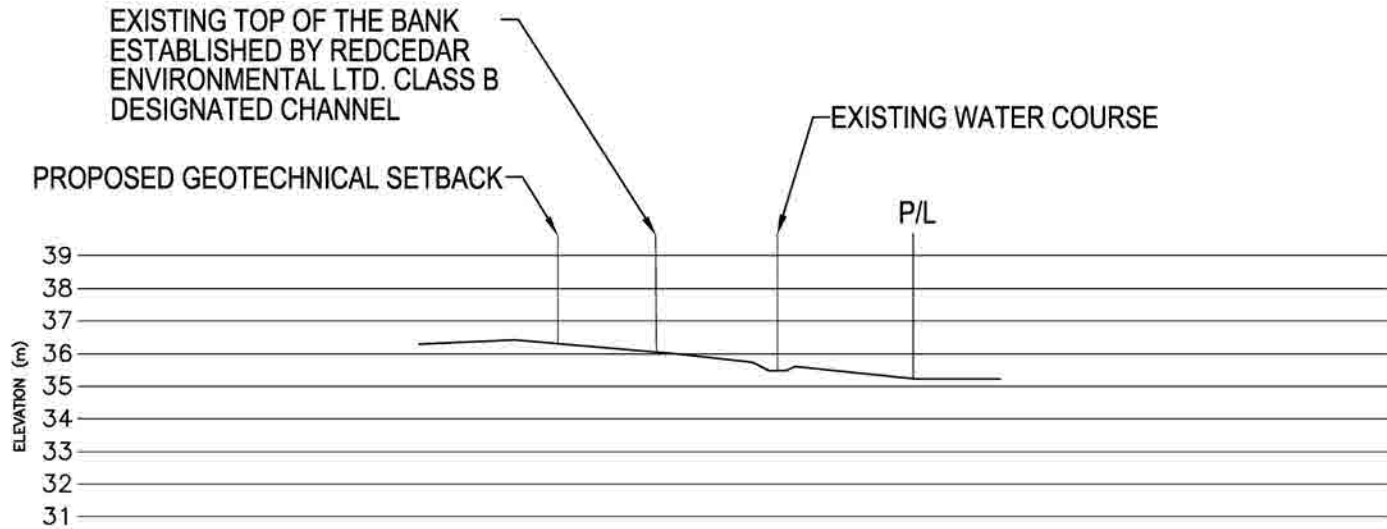
Title SECTION A - A'		
Date December 21, 2021	Scale 1:150	Drawing no. 21-9249-SEC-02

SECTION A-A'

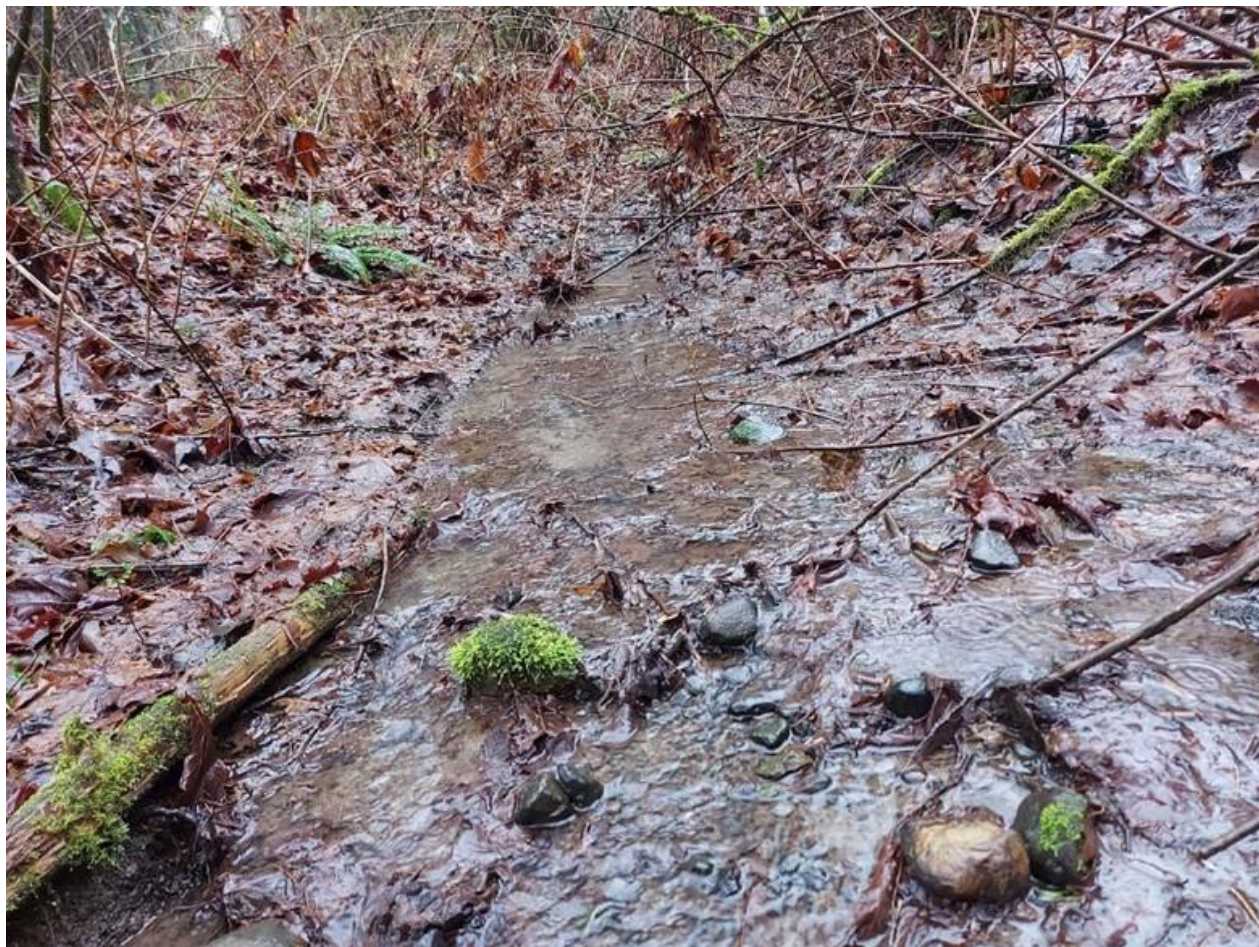
Photograph 1. View of WCI1, a Class B stream. Aside from overhanging vegetation, the channel was virtually absent of cover for fish including a lack of large woody debris, overhanging banks, pools, and large substrate materials. (Photograph taken February 1, 2021).

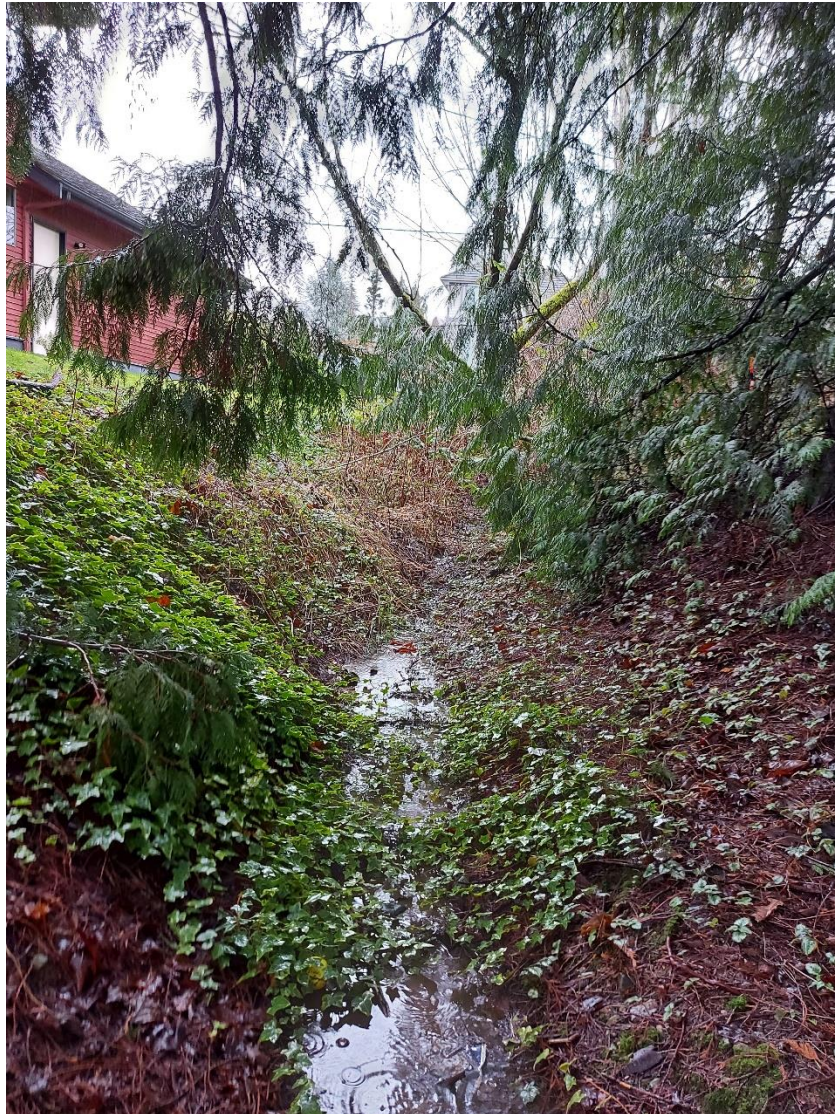
Photograph 2. View of Ditch 1 facing east. The transition to the Class B stream (not pictured) is located just to the west of this location (Photograph taken February 1, 2021).

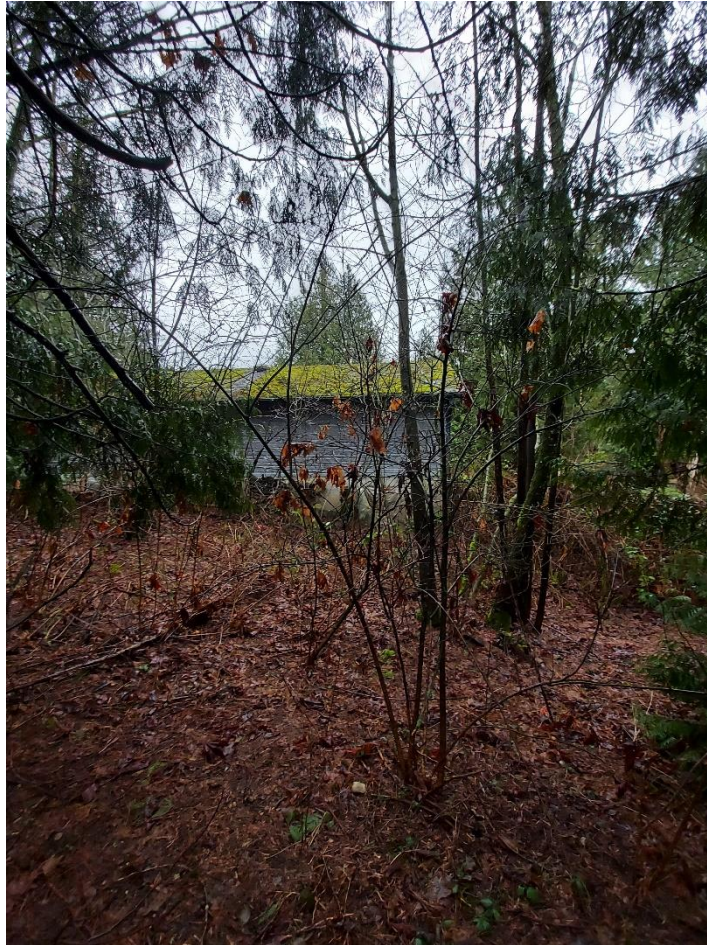
Photograph 3. View of habitat from within the proposed SPA of WC1, facing south. An outbuilding on the subject property can be seen at the rear of the photo. This area would provide some habitat value for local songbirds (Photograph taken February 1, 2021).

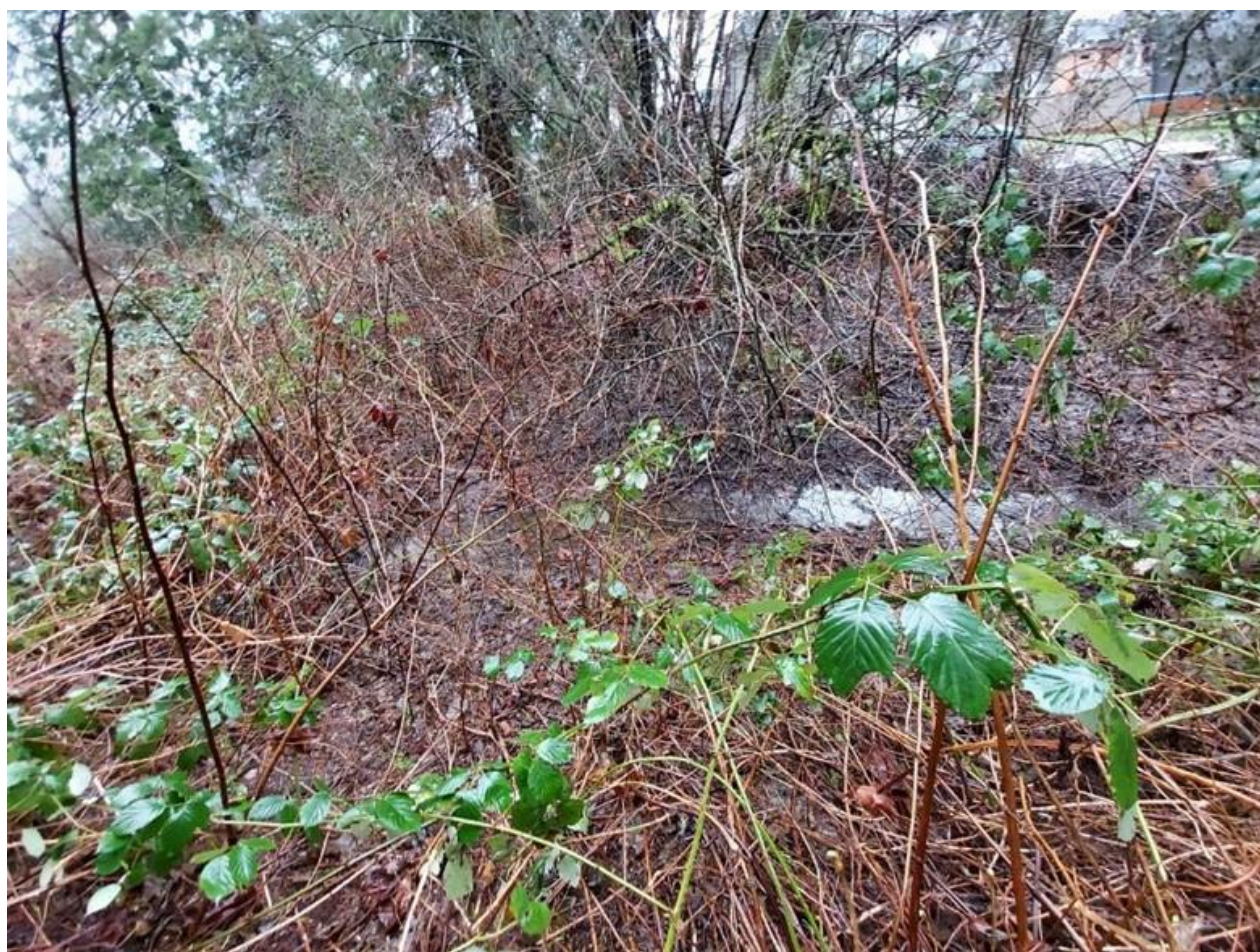
Photograph 4. View of WC1 stream facing north on the adjacent property. Himalayan blackberry is visible growing along the bank of the stream. This area can be rehabilitated with removal of invasive species and installation of native plants. (Photograph taken February 1, 2021).

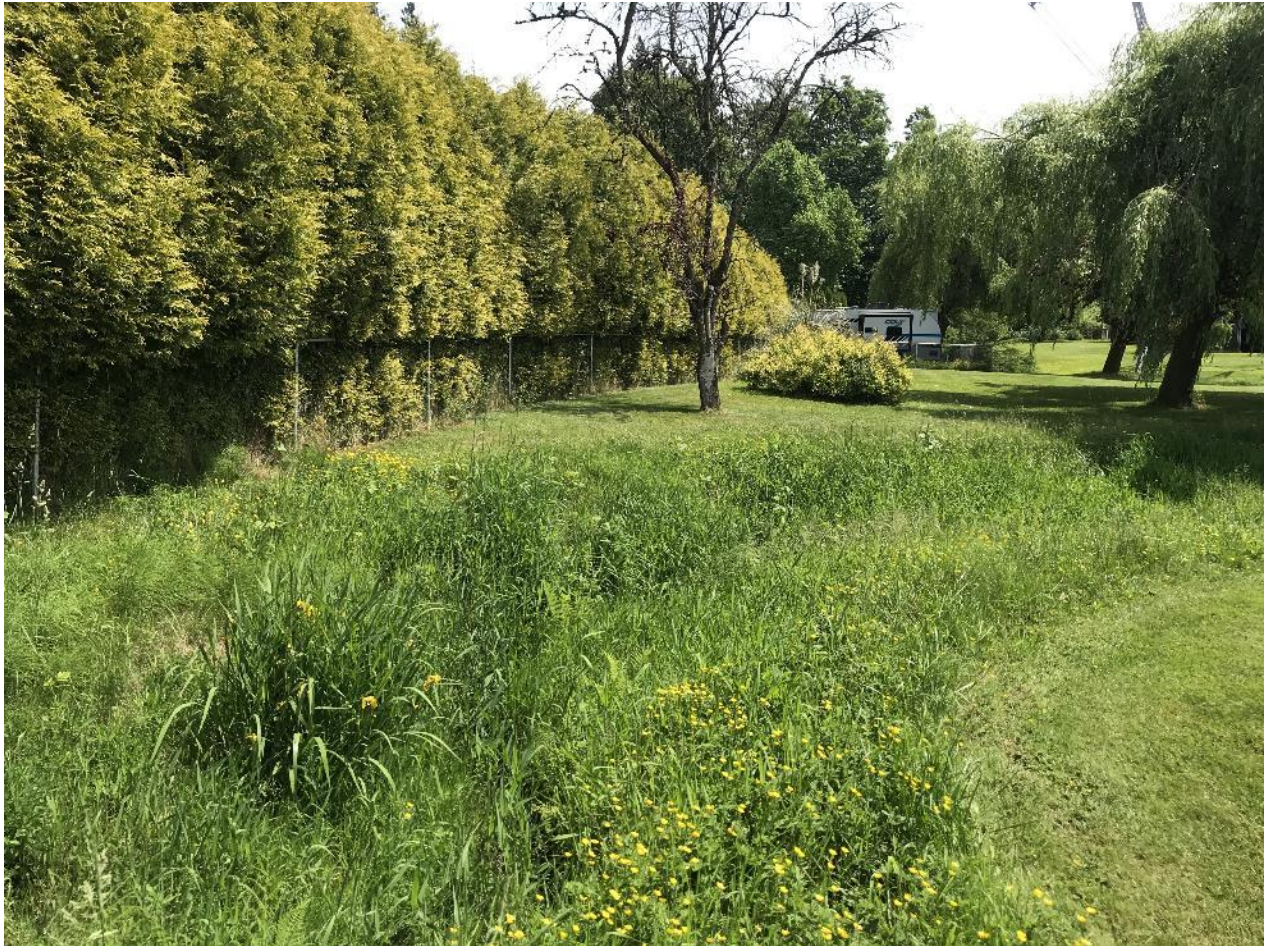
Photograph 5. View of WC2, facing east, on the neighbouring property. The channel is not visible under the long grass. The proposed variance to the setback is located on the other side of the fence to the left of the frame. The area pictured would remain unchanged (Photograph taken June 3, 2021).

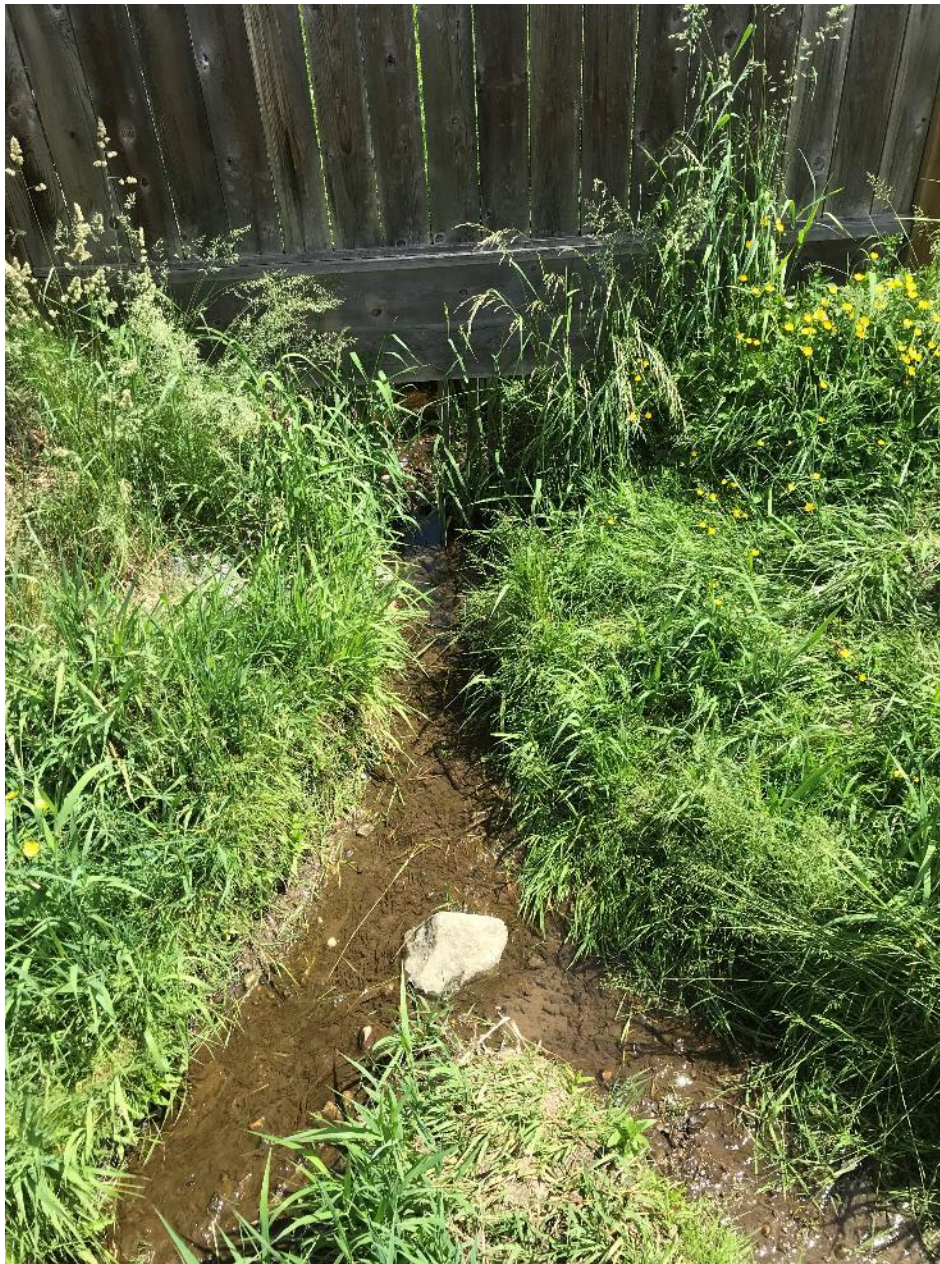
Photograph 6. View of WC2 facing east. This location is where the watercourse leaves the neighbouring property and flows through two pipes under a pedestrian path before flowing across the utility ROW to the west of the subject properties.

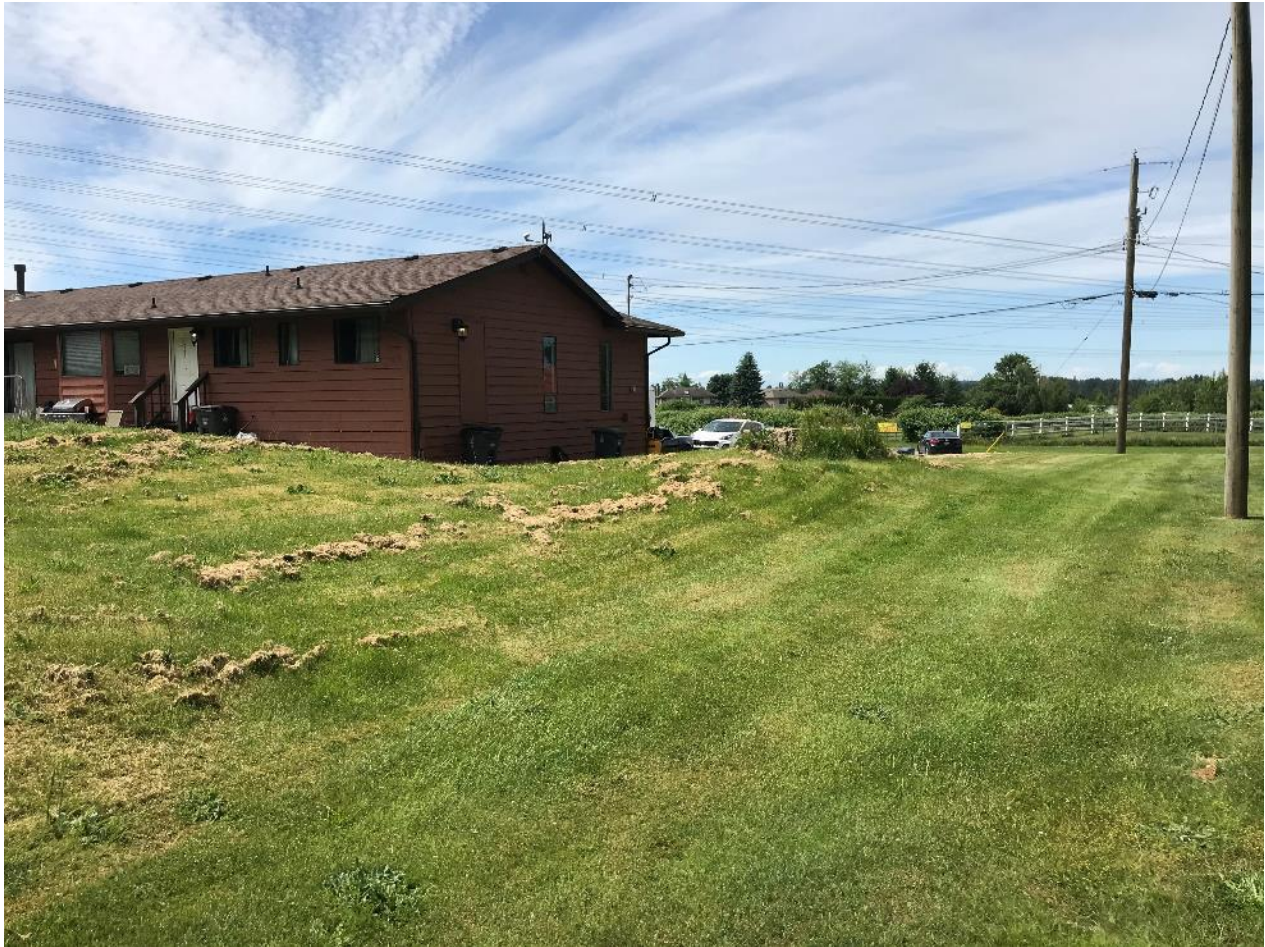
Photograph 7. View of western subject property from behind the house, facing southwest. WC1 flows to the right of the frame (not pictured). The low cut grasses provided low value habitat, and would likely only provide foraging habitat for a few species of songbirds (Photo taken June 3, 2021).

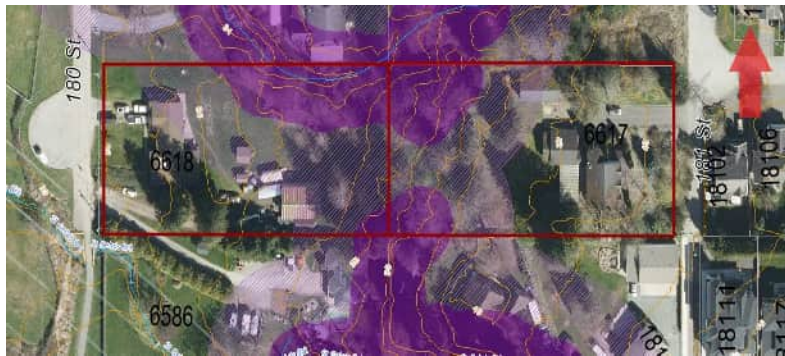
Figure 1: Subject Site relative to City of Surrey Hazard Lands DPA

It is understood that areas within the subject property fall within the City of Surrey Hazard Lands Development Permit Area (Figure 1), including “Steep Slope 10-30 meter Buffer Area.”

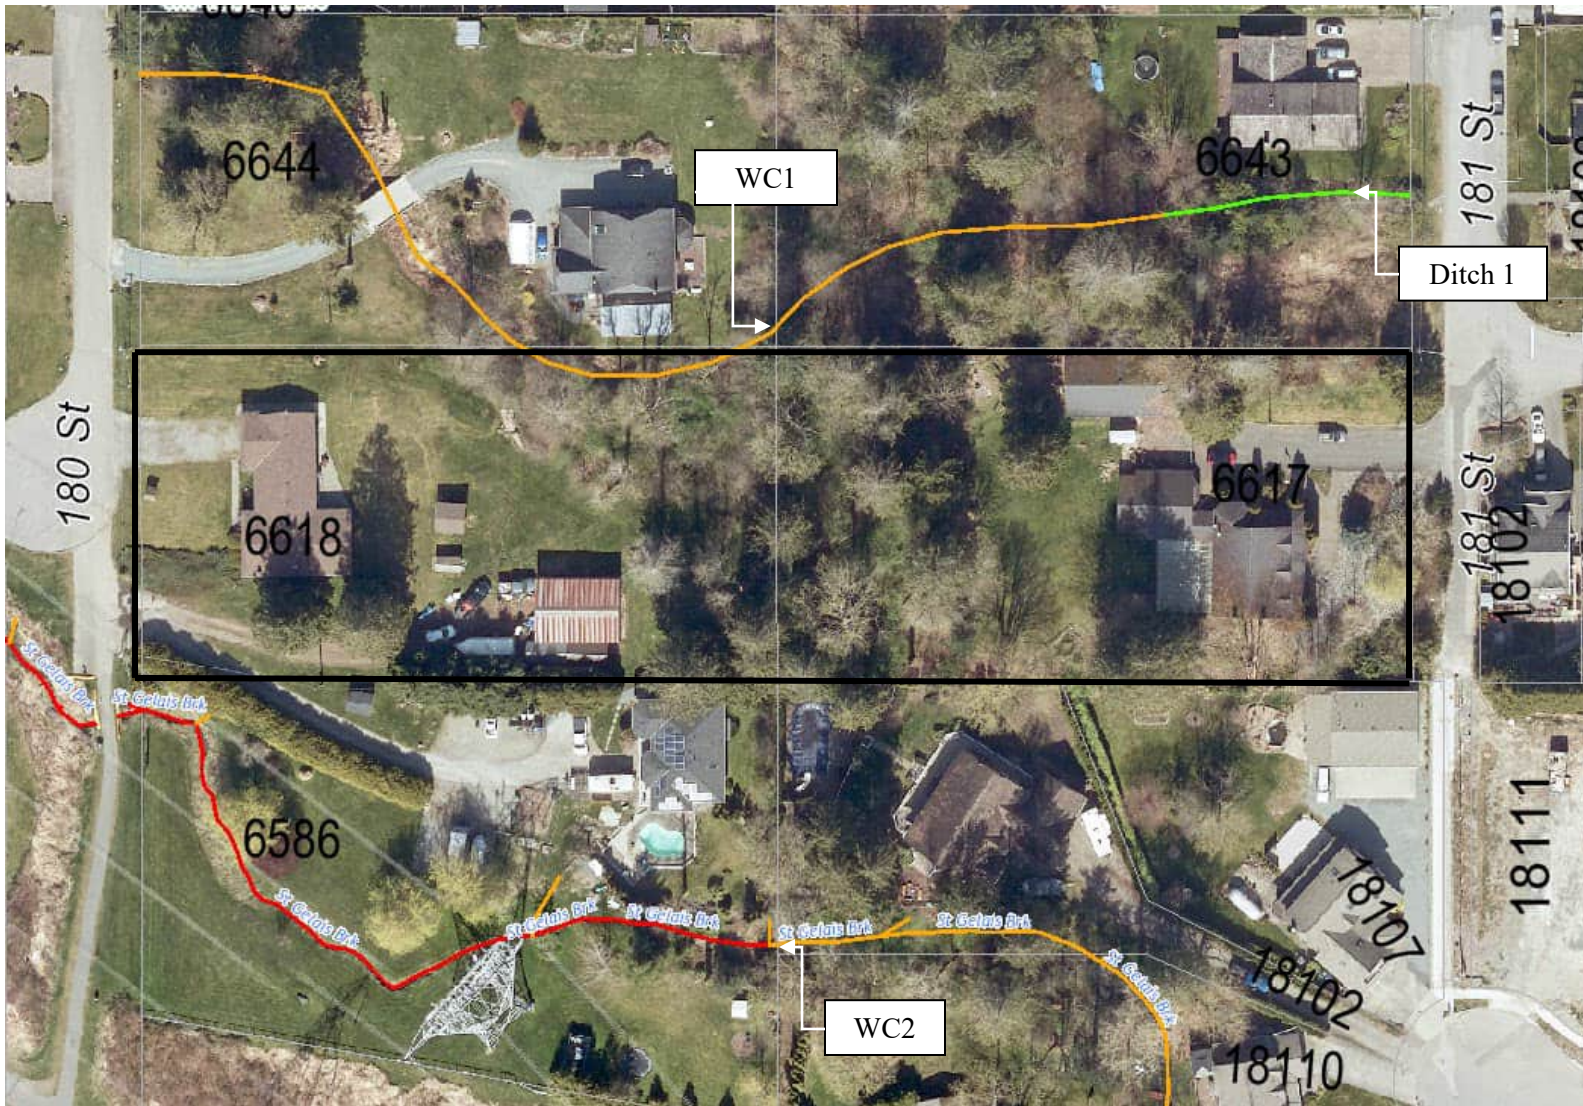
Figure 1. Annotated aerial photograph of the subject properties (black outline). Streams are shown in red/orange and ditch 1 is shown in green.

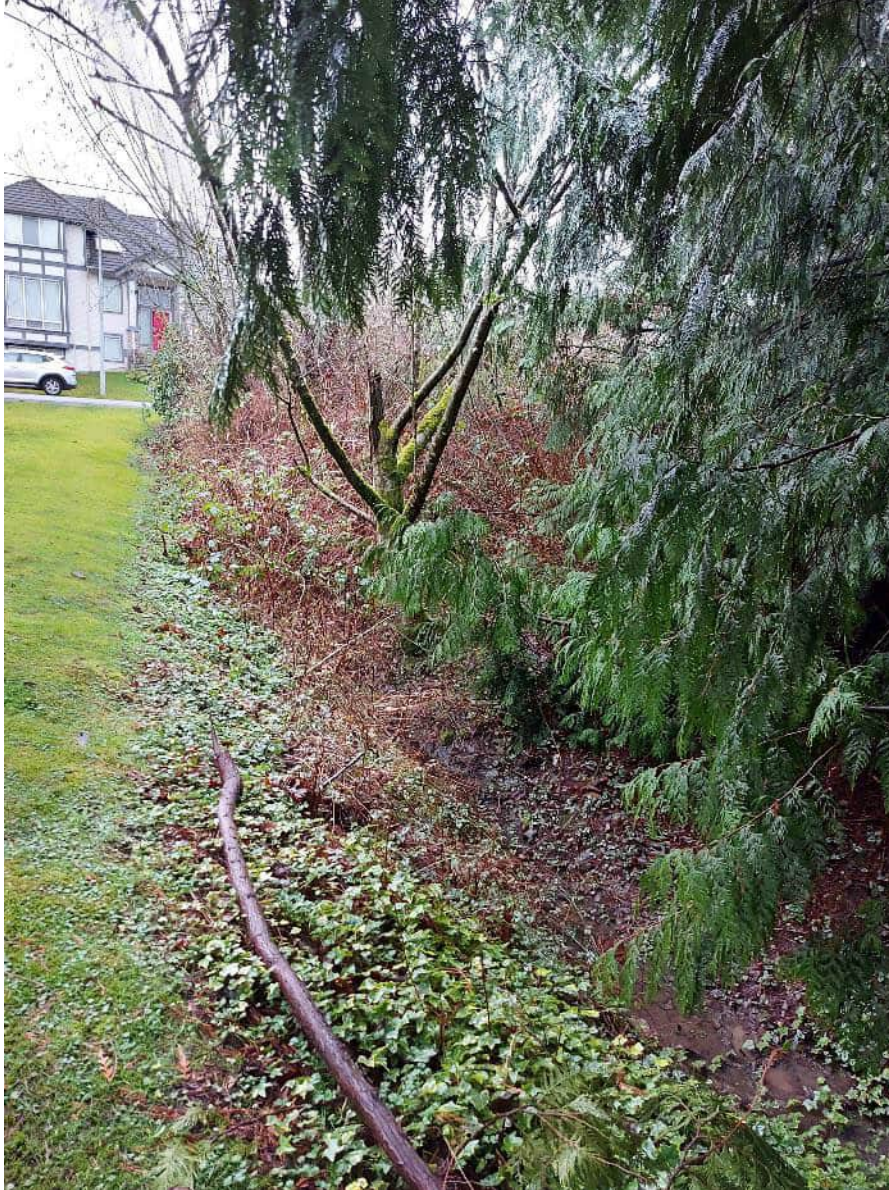
Photograph 1. View of Ditch 1, north of the subject property facing east. The ditch was conveying marginal flows even during a significant rainfall event. (Photo taken February 1, 2021).

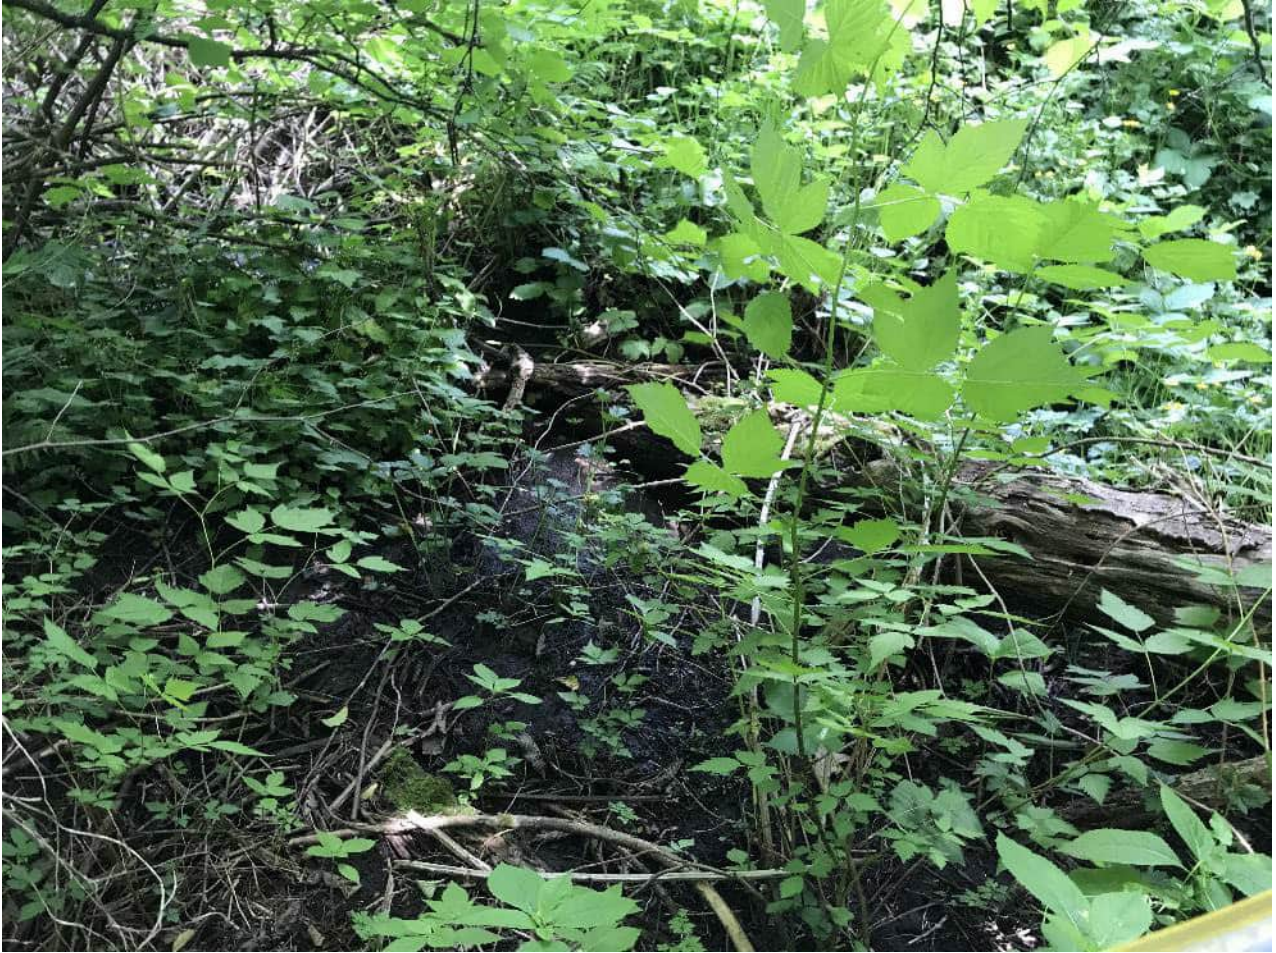
Photograph 2. View of WC1. At the time of the June assessment water levels were low. A blackberry monoculture is present at the rear of the photo (Photo taken June 3, 2021).

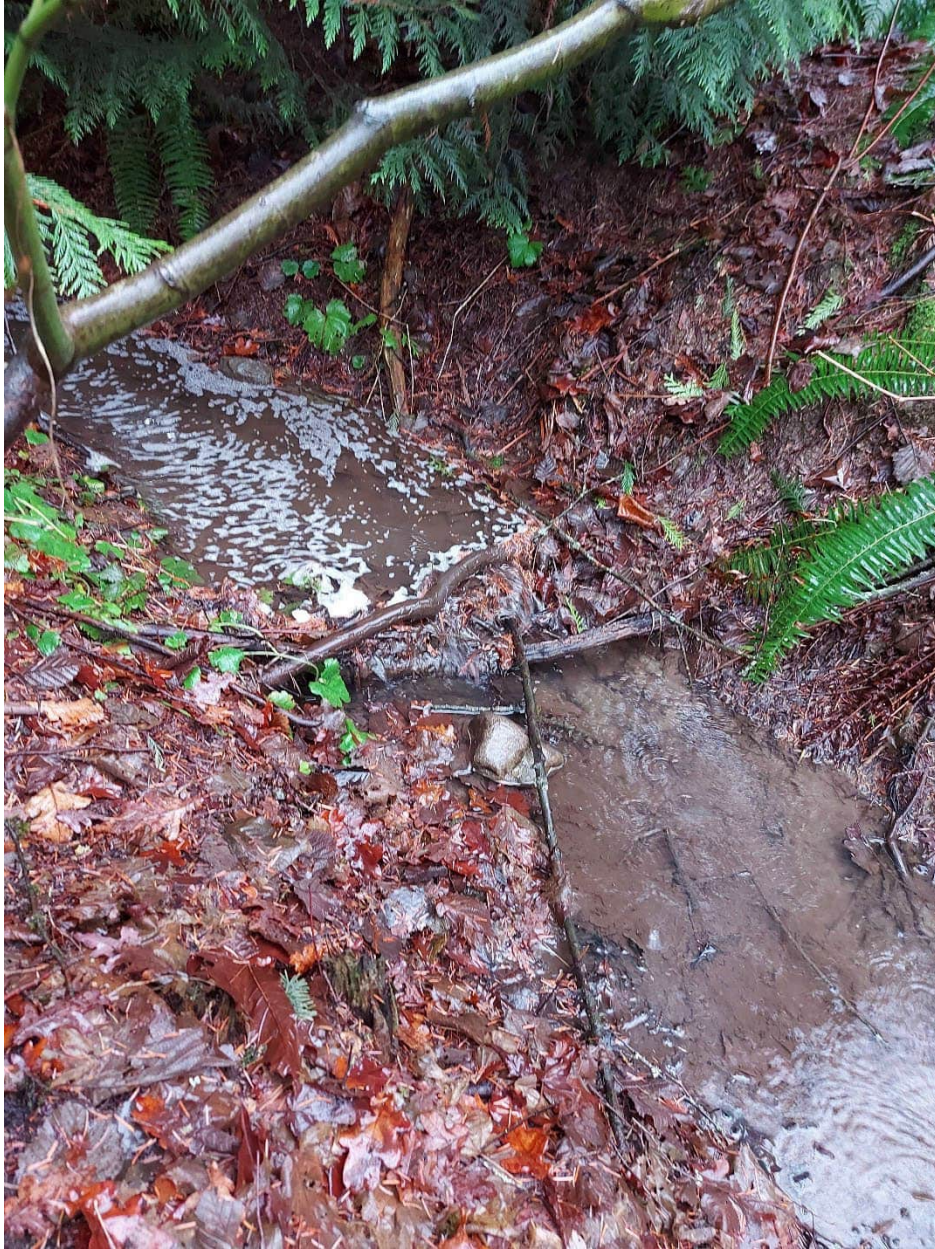
Photograph 3. View of WC1 during higher flows (Photo taken February 1, 2021).

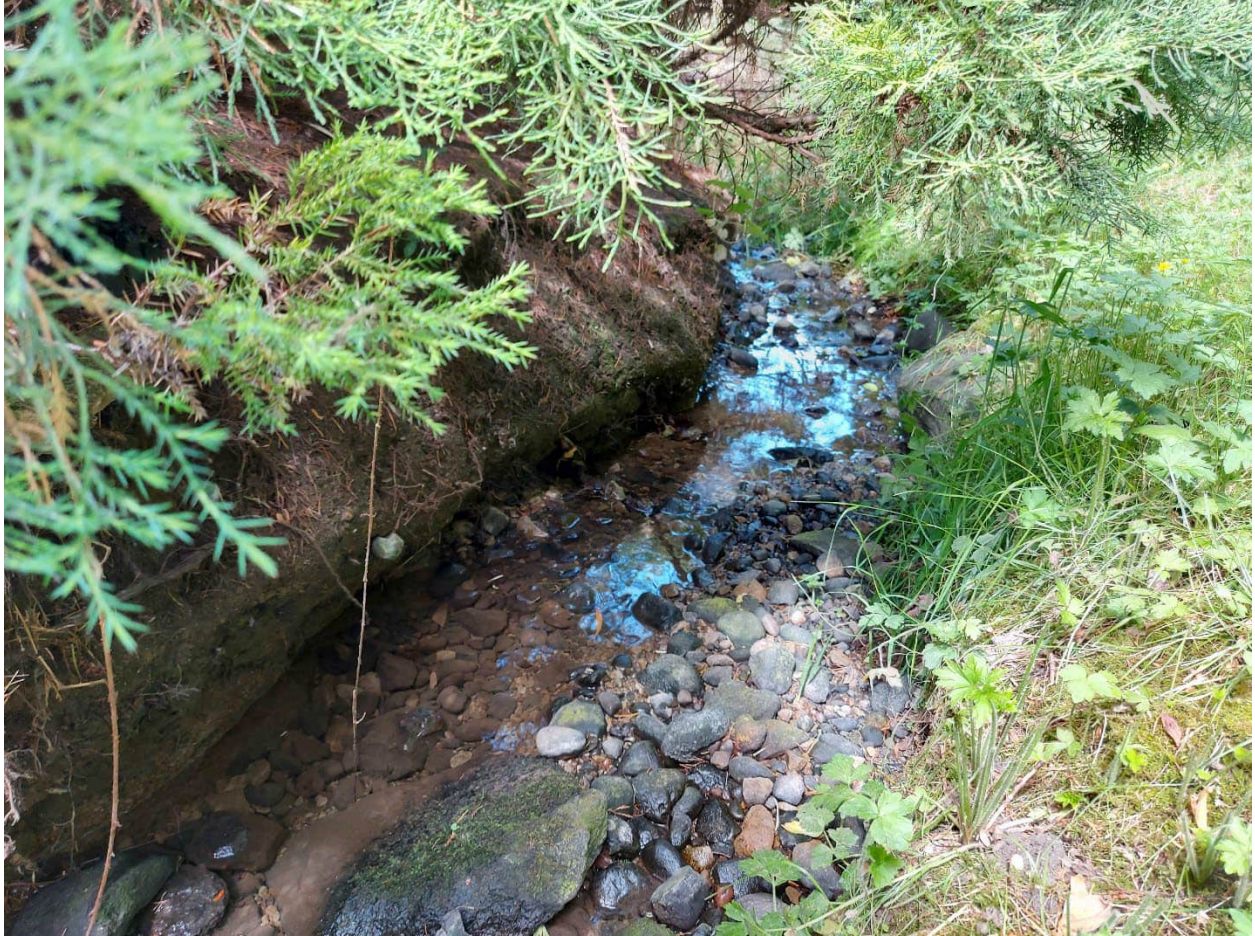
Photograph 4. View of channel bed of WC2. (Photo taken June 9, 2021).

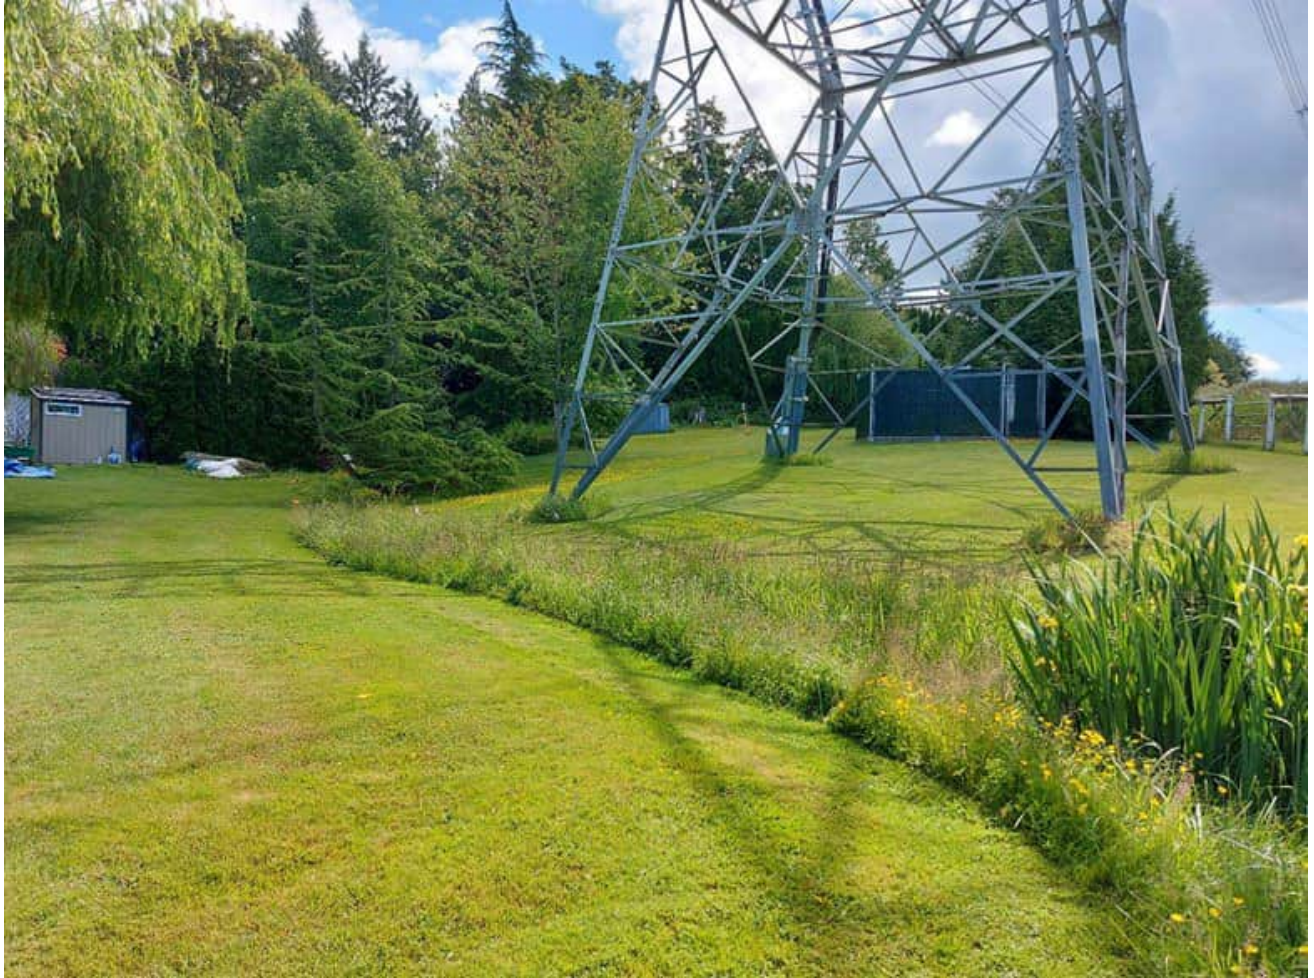
Photograph 5. View of WC2 facing east. WC2 flows within the longer grassed area (Photo taken June 9, 2021).
