Township of Langley
Anderson Creek ISMP
Final Report

April 2014

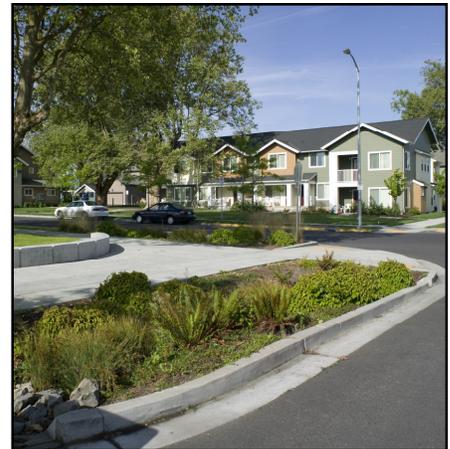
- Flexible in terms of size and infiltration.
- In-ground bio-retention systems.
- Ponding depths generally limited to 300mm or less for aesthetics, safety, and rapid draw down. Certain situations may allow deeper ponding depths.
- Deep rooted perennials and bushes encouraged.
- Native vegetation that is tolerant of hydrologic variability, salts and environmental stress.
- Modify soil with compost.
- Provide positive overflow.
- Maintenance is required to ensure long-term functionality.

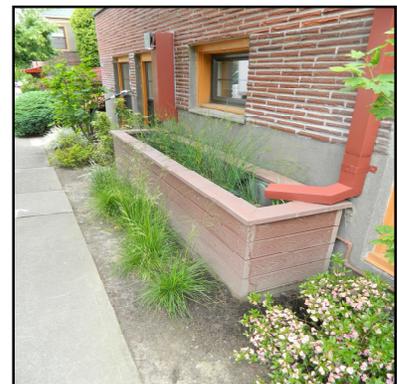
- A form of bio-retention, but differ from rain gardens in that they are above ground systems.
- Reduces stormwater runoff volume, flow rate and controls atmospheric temperature in urban settings.
- Improves aesthetic appeal of streets.
- Provides shade to nearby buildings to reduce energy costs.

- Requires limited space.
- Flexible for use in areas of various shapes and sizes.
- Provides a cost-effective way of treating stormwater as the ratio of cost to volume of runoff treated is lower than many other stormwater best management practices.

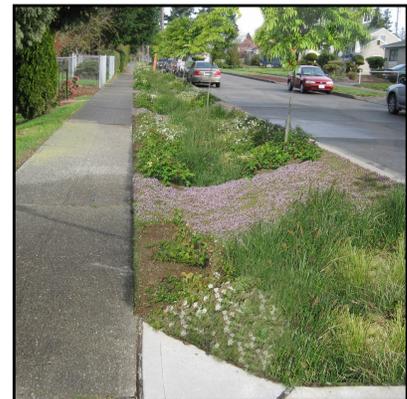
- Swale planting is typically sodded lawn and can also include low-growing native vegetation that is water resistant and drought tolerant.
- Longitudinal slopes range from 1 to 6%.
- Side slopes range from 3:1 to 5:1.
- Bottom width of 0.6 to 1.2m. Top width between 0.8 to 2m.
- Convey the 5-year storm event with a minimum of 150mm of freeboard.
- Designed for non-erosive velocities up to the 5-year storm event.
- Design to aesthetically fit into the landscape, where possible.
- Significantly slow the rate of runoff conveyance compared to pipes.
- Refer to Township of Langley Subdivision and Development Servicing Bylaw 2011 No.4861, Drainage Supplementary Drawings, TLD 3 - Swale.

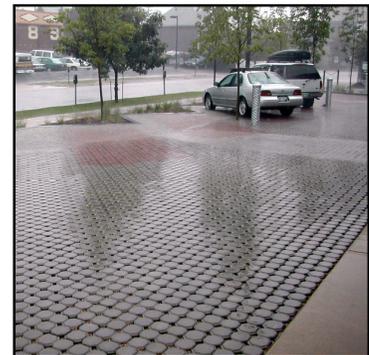
- Almost entirely for peak rate control.
- Short duration storage.
- Minimize safety risks, potential property damage, and user inconvenience by limiting to local roads, walkways, and mews areas having lighter traffic loadings.
- Emergency overflows may be required.
- Maximum ponding depths should be assessed.
- Adequate surface slope to outlet.
- Infiltration testing is required.

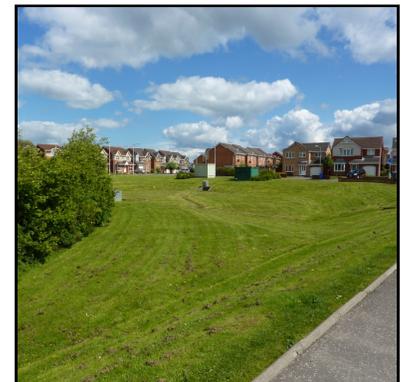
- Size of storage and outlet structure is to be designed according to municipal design objectives to control downstream flooding, stream bank erosion, and allow for adequate freeboard.
- For water quality purposes, the pond should be designed to allow for 20% dead storage volume for sediment accumulation.
- Emergency overflows should be incorporated into the design to manage larger storm events.

- Provide trash rack, hood or other protection to prevent clogging of outlet with trash and debris.
- Vegetation should be grass or other native species.

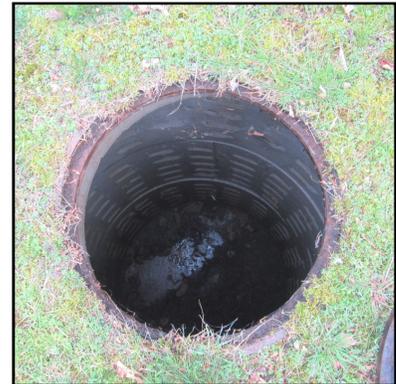
- Basic design requirements for a drywells and rock pits include storage volume and infiltration rate of the subgrade soils.
- Infiltrate rate of subgrade soils must be sufficient to drain the stored runoff within 72 hours and the surrounding soils must not be compacted
- Drywells require an adequately sized overflow outlet for large storm events, while rock pits should be designed to be sufficiently large enough to avoid flooding and overflow.
- At least one observation well is required for a drywell.
- Excavation of the rock pit hole or bottom of rock pit structure should be above at least 0.3m above the seasonal high water table or bedrock.
- Refer to Township of Langley *Subdivision and Development Servicing Bylaw 2011 No.4861*, Drainage Supplementary Drawings TLD 6 Rock Pit and TLD 7 Drainage Drywell.

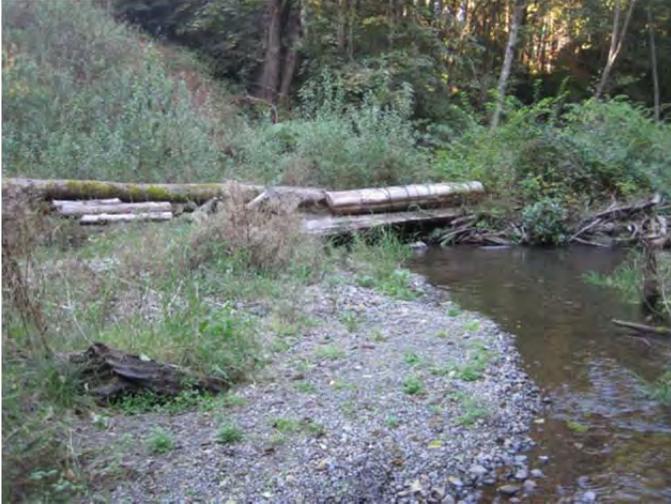
Photograph 1. ↑

Looking downstream from AND-01 sampling location with bank reinforcement structure in background (October 3, 2012).

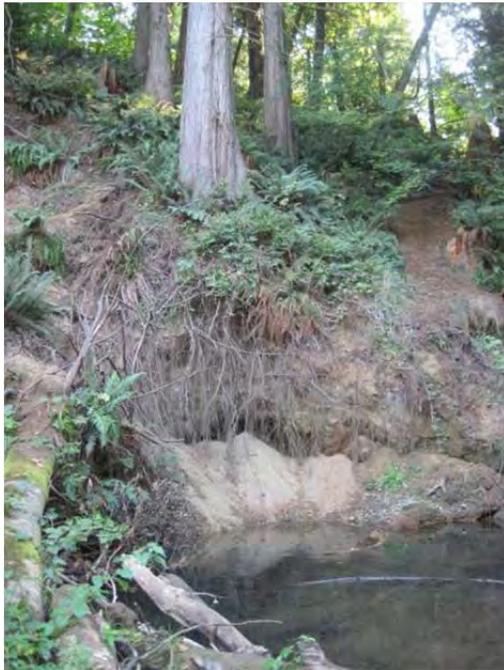
Photograph 3. ↑

Upstream of the AND-01 sample site looking at bank erosion (October 4, 2012).

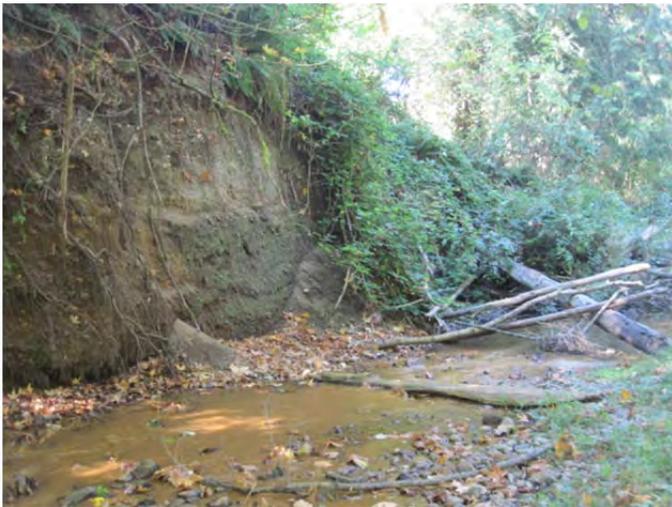
Photograph 7. ↑
Downstream of AND-02 sample location, looking at bank erosion along the left bank (October 3, 2012).

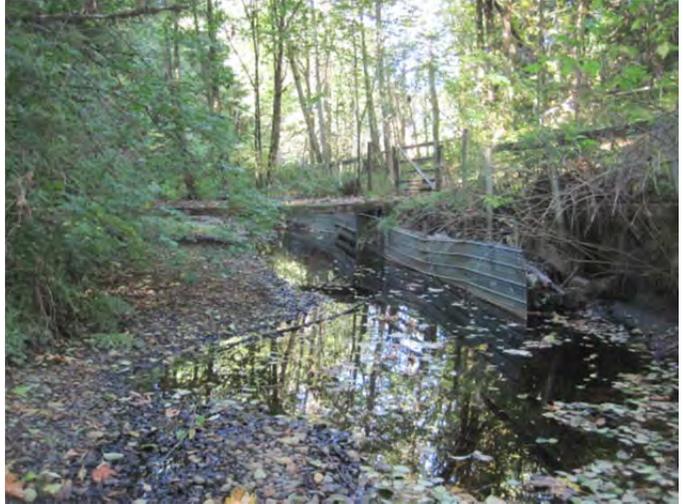
Photograph 10. ↑
Looking upstream from AND-03 sample location from a footbridge across the stream, towards bank armouring along left bank (October 3, 2012).

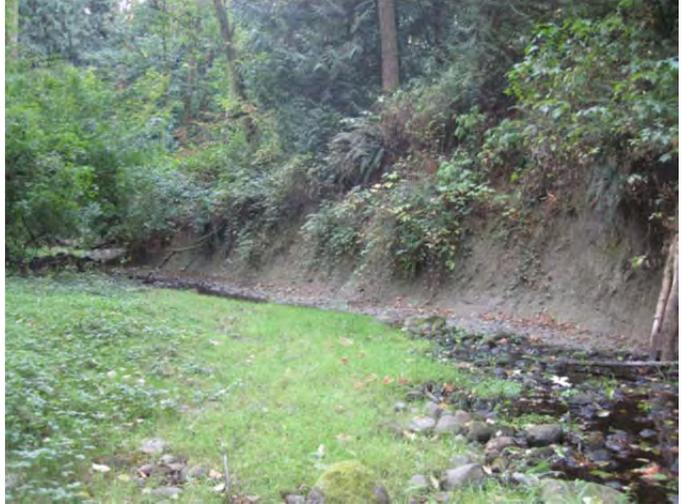
Photograph 14. ↑

Downstream of the AND-04 sample location at erosion along the stream bank (October 3, 2012).

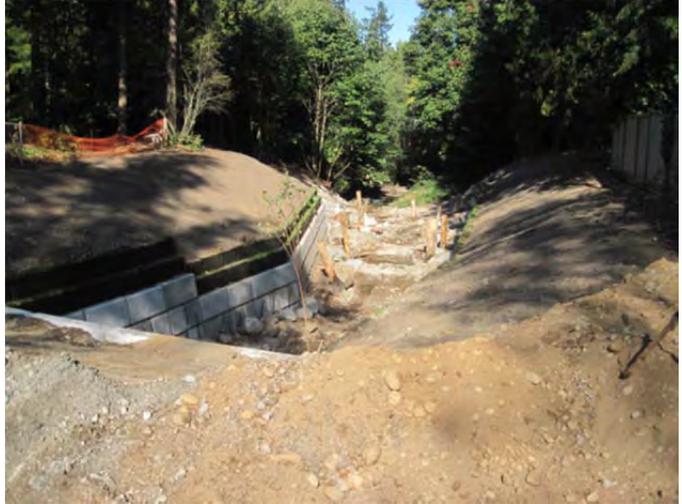
Photograph 18. ↑

Looking downstream from 36th Avenue at new in-stream works along Anderson Creek (October 4, 2012).
