BYLAW NO. 19616

A bylaw to enter into a heritage revitalization agreement  
.....

**HERITAGE REVITALIZATION AGREEMENT**

# OLD ANNIE DALE SCHOOL

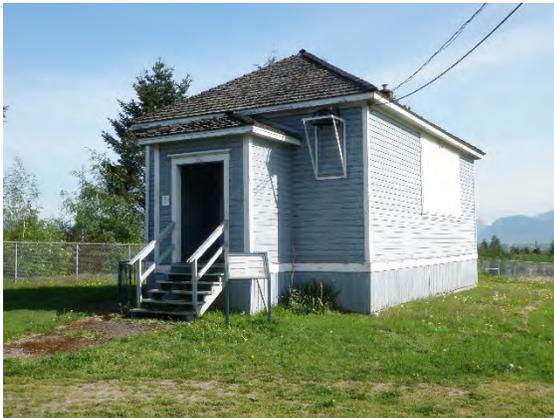
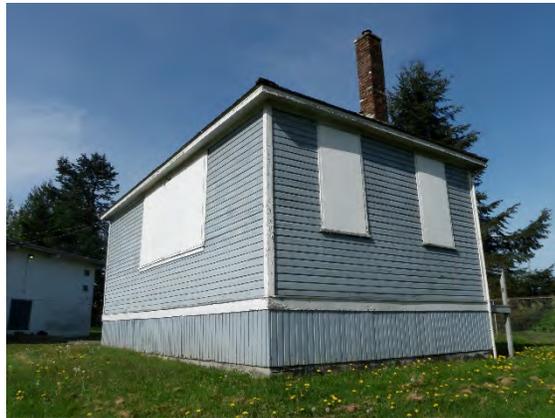
Old Anniedale School is in good condition overall. It was moved to the present location some 40 years ago. Some structural components of the building were improved at the time.

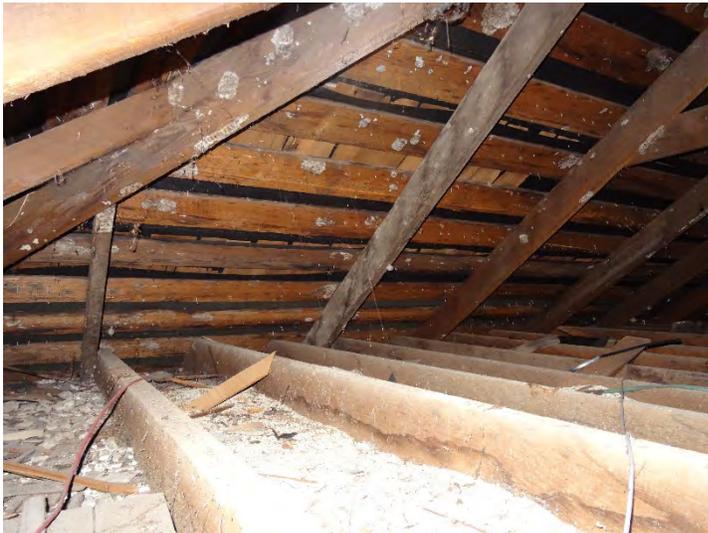
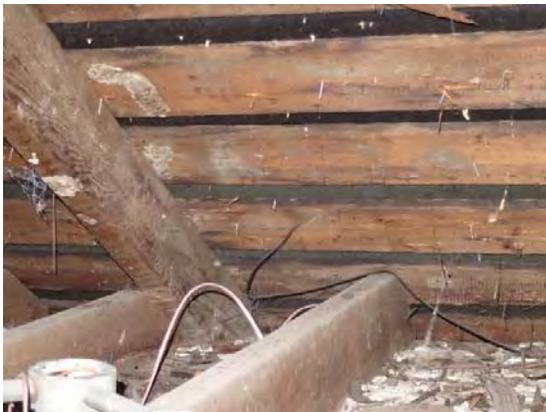
One rare occurrence of rafter coinciding with ceiling joist.

The two hip joints of the common rafters and hip rafters are a masterpiece of carpentry with no evidence of nails, strictly relying on compression. However, as winds and seismic events apply to the structure horizontally and uplift forces, it would be desirable to use steel connectors for the hip ridge joint and for the jacks attached to hip rafters.
