City of Surrey

Erickson Creek Integrated Stormwater Management Plan

September 2010

**Re: ERICKSON CREEK INTEGRATED STORMWATER MANAGEMENT PLAN
FINAL REPORT**

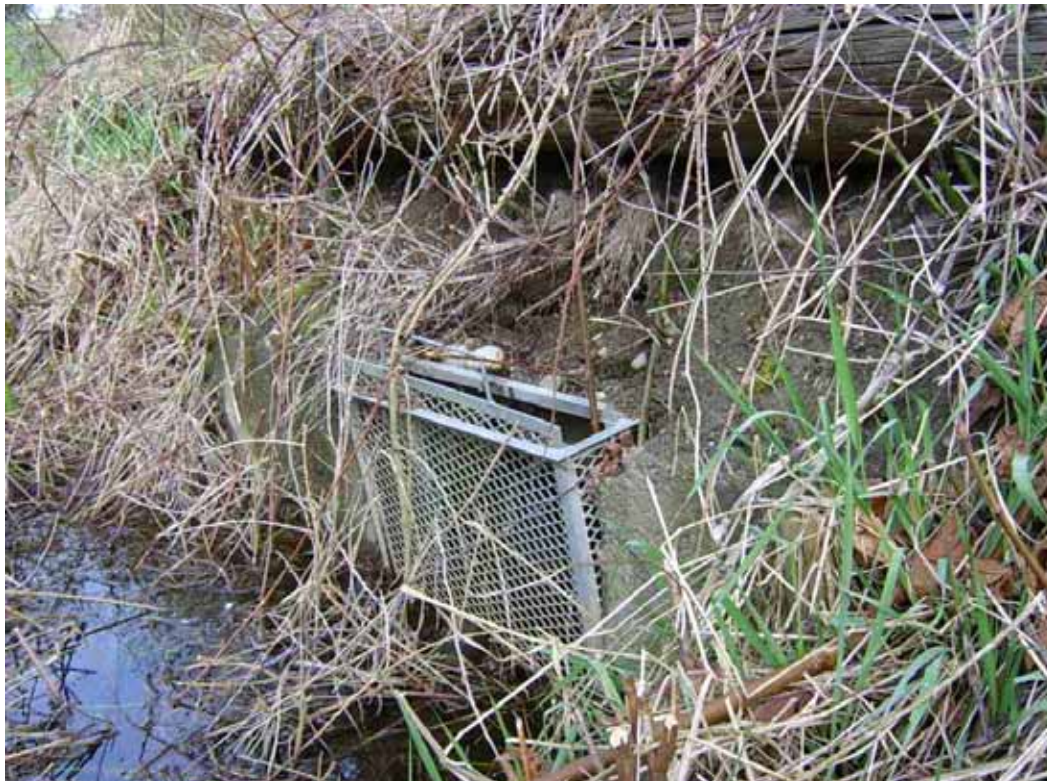
Photo 10: Metal grates cover most culverts under a small access road at EC-4. Open culverts are only accessible during high flows.

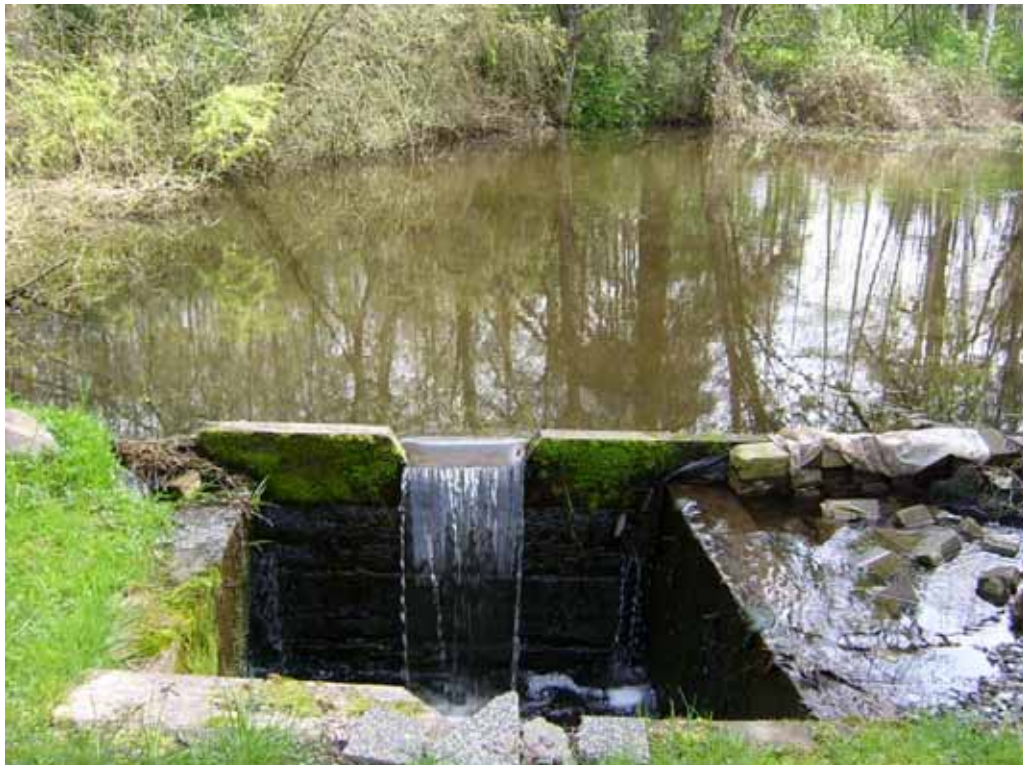
Photo 11: Pond outlet in EC-4 may present a barrier during low flow (0.94 m drop measured during April assessment).

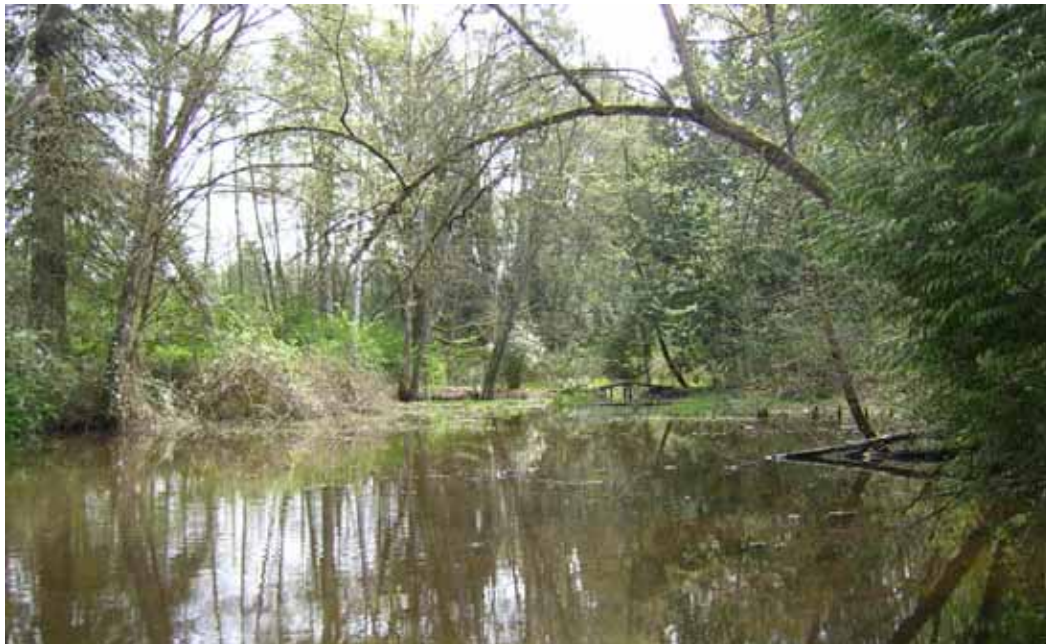
Photo 12: Pond habitat of EC-4

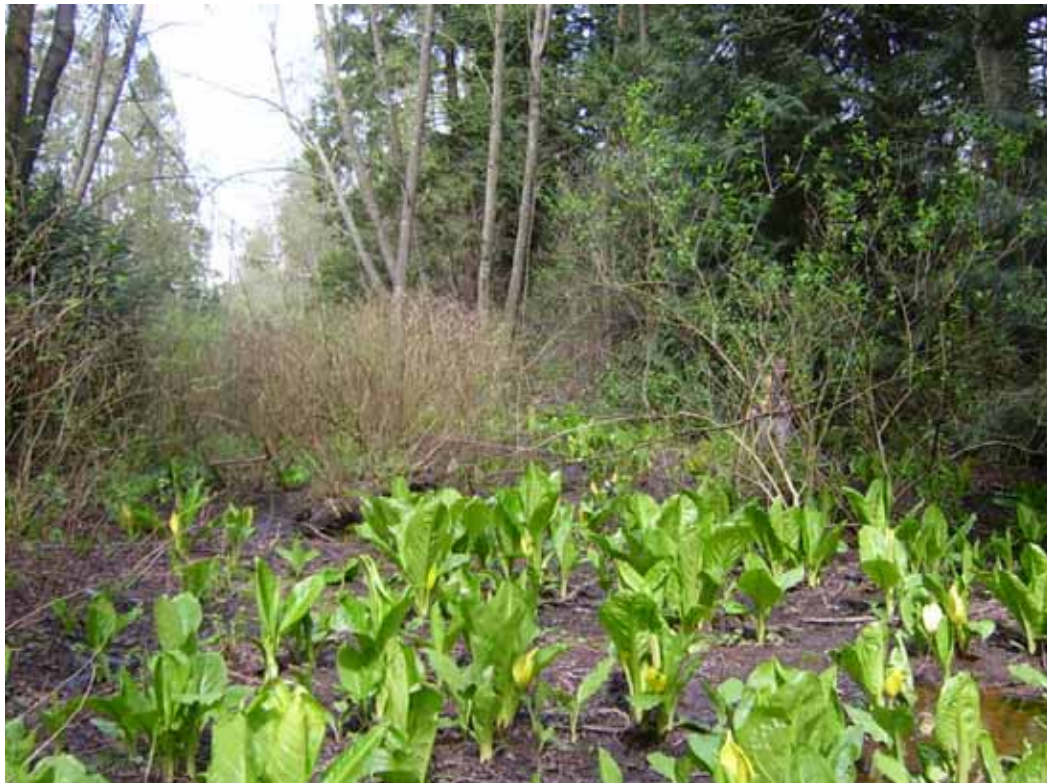
Photo 13: EC-4 includes a marshy channel; spawning gravels are absent.

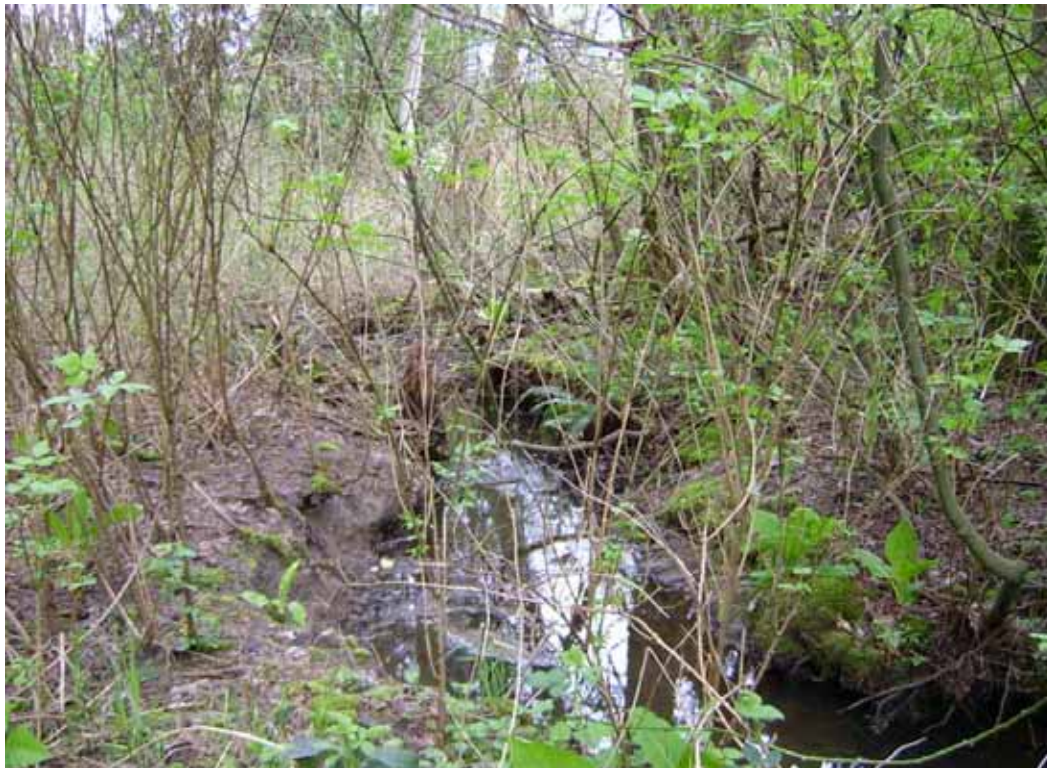
Photo 14: EC-4 flows through forested riparian area with abundant cover. Some spawning gravels are present in the upper section.

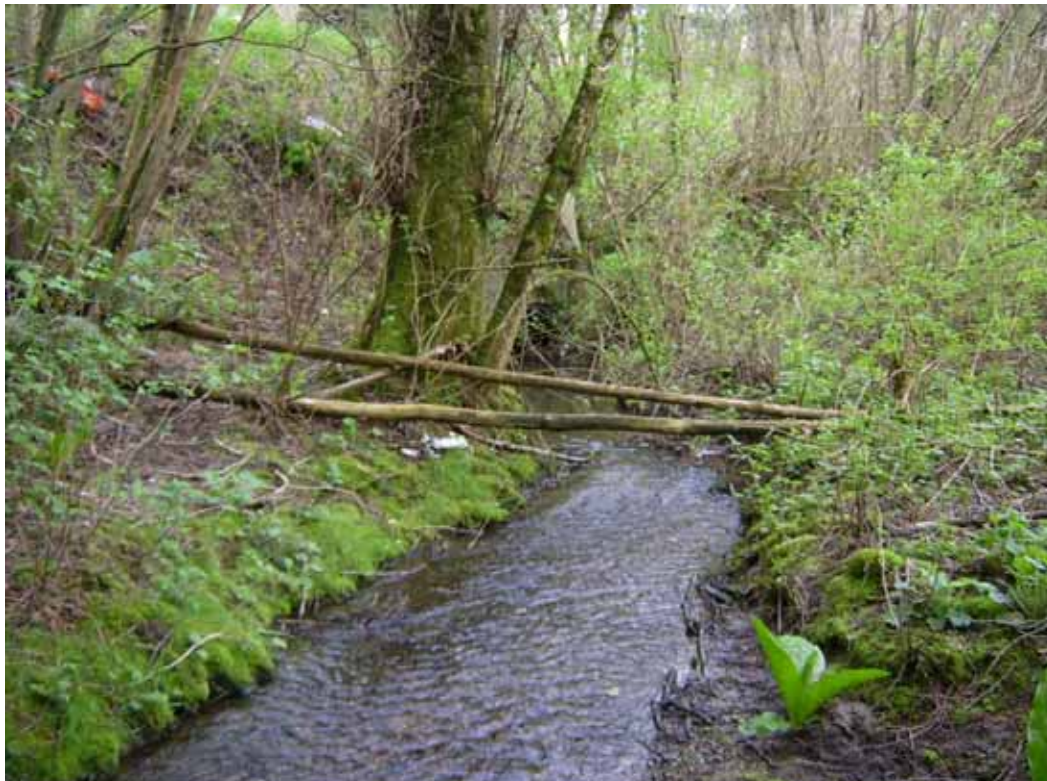
Photo 15: Excellent rearing habitat throughout EC-6. Gravels in lower portion of reach provide excellent spawning habitat.

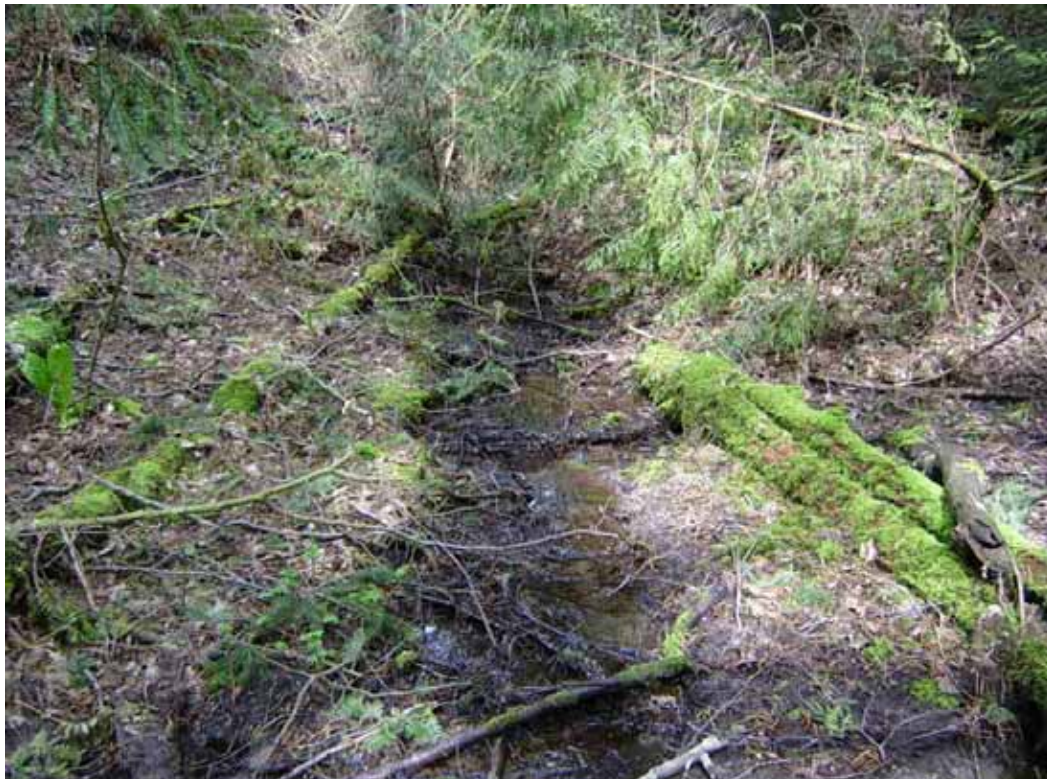
Photo 16: EC-7 is a tributary to EC-6. Channel was not flowing during April assessment.

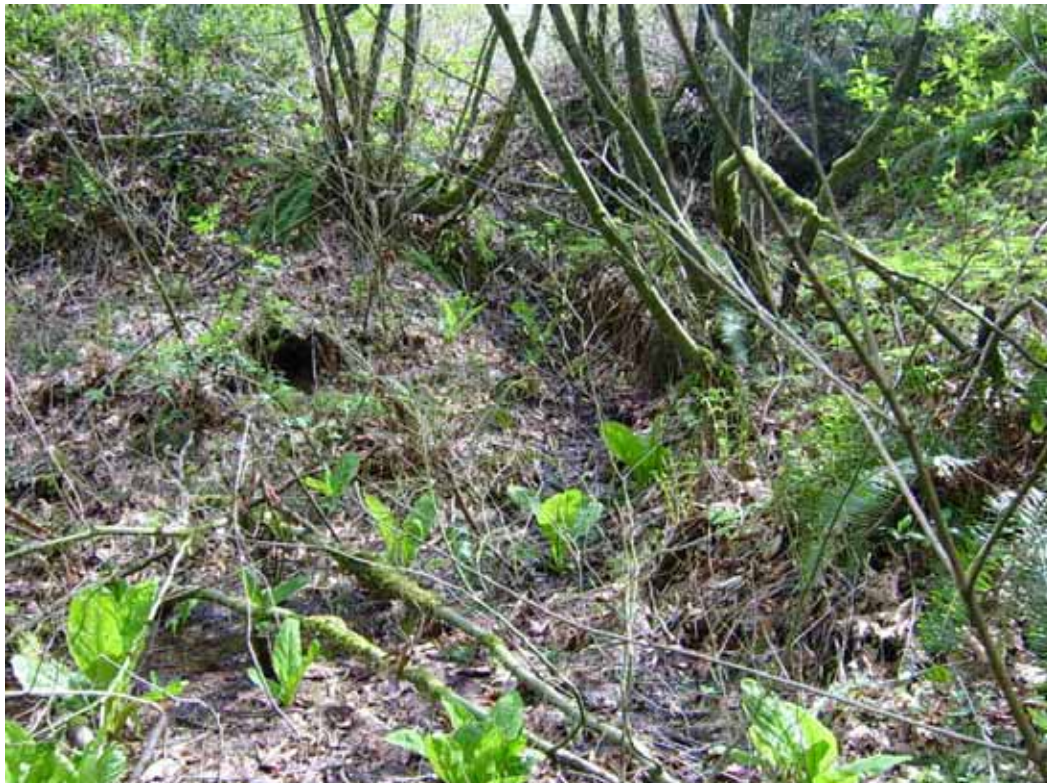
Photo 17: EC-8 is a tributary to EC-6. Channel was not flowing during April assessment.

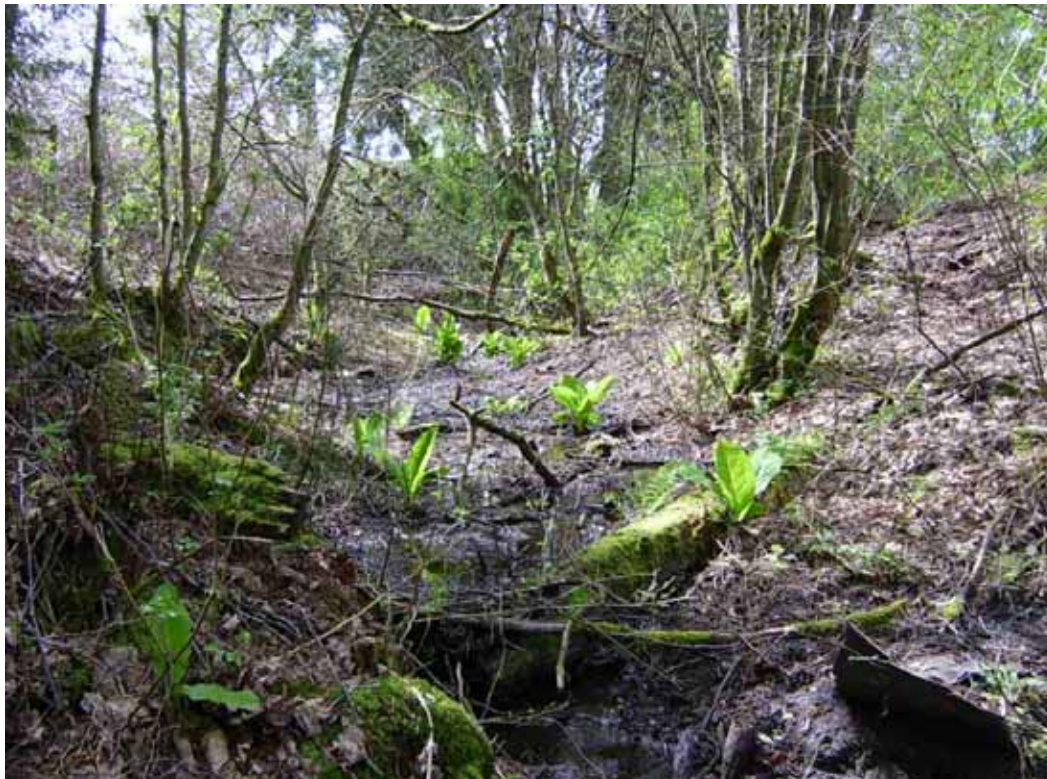
Photo 18: EC-9 is a tributary to EC-6. Channel had minimal flow in April and no flow during July assessment.

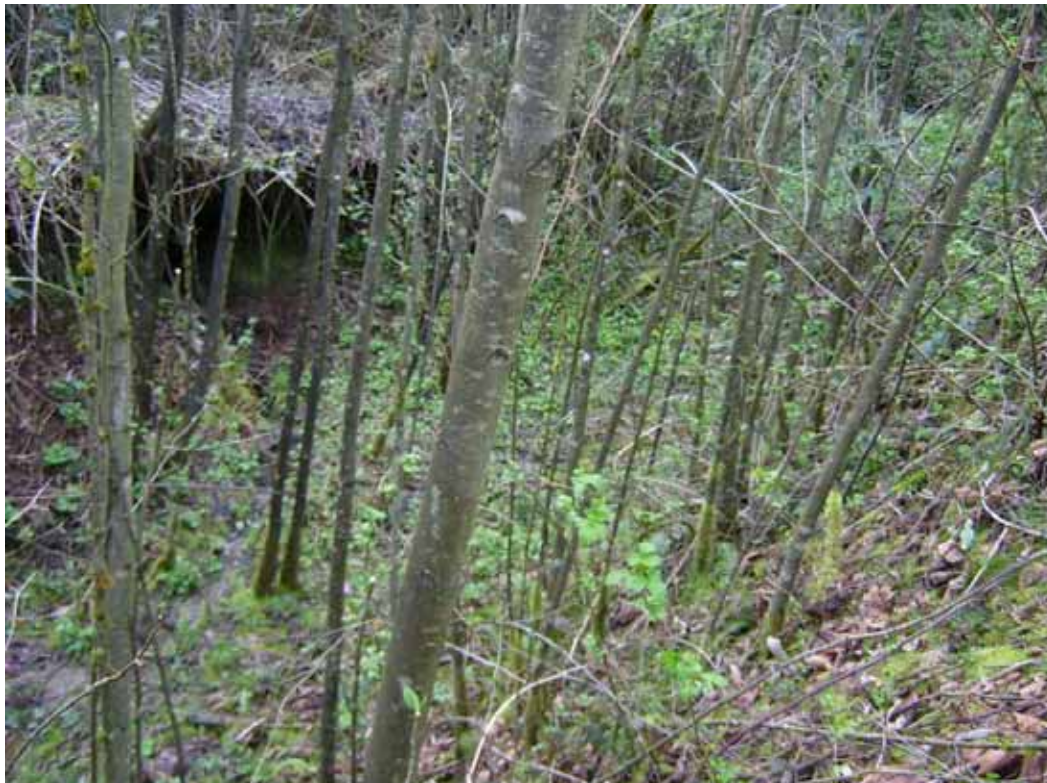
Photo 19: Breaks Brook BB-1 had no flow during April assessment. The channel is defined in a small gully and may have historically conveyed larger volumes of water.

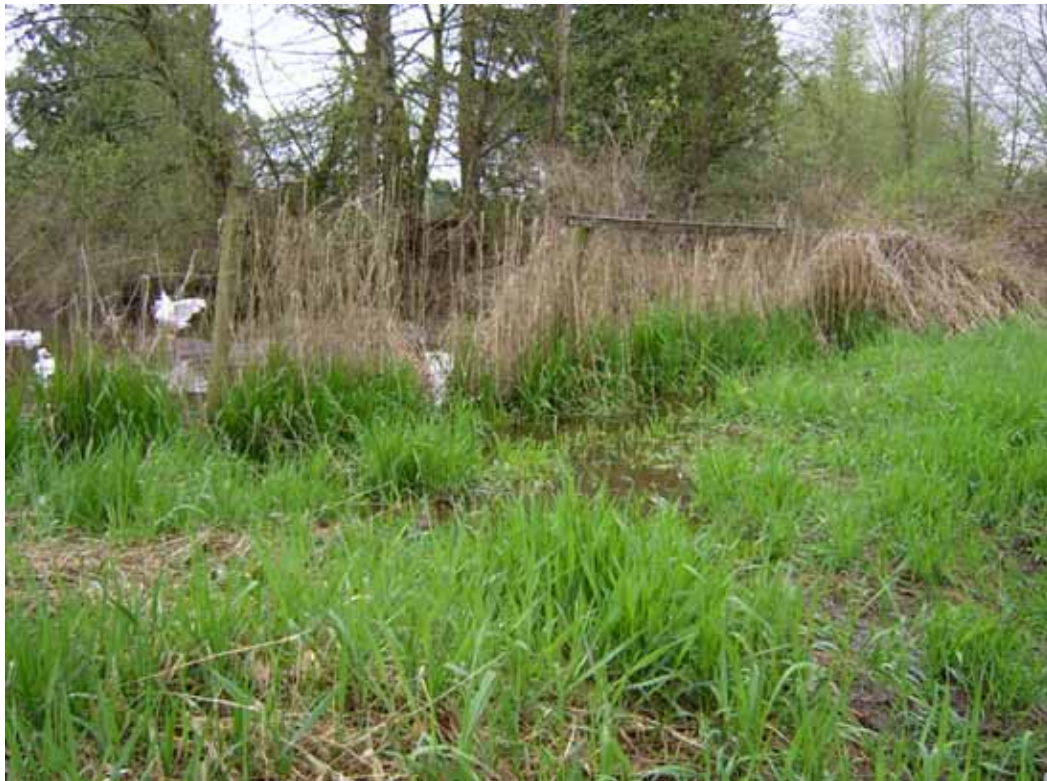
Photo 20: Laura Brook LB-1 confluence with Erickson Creek.

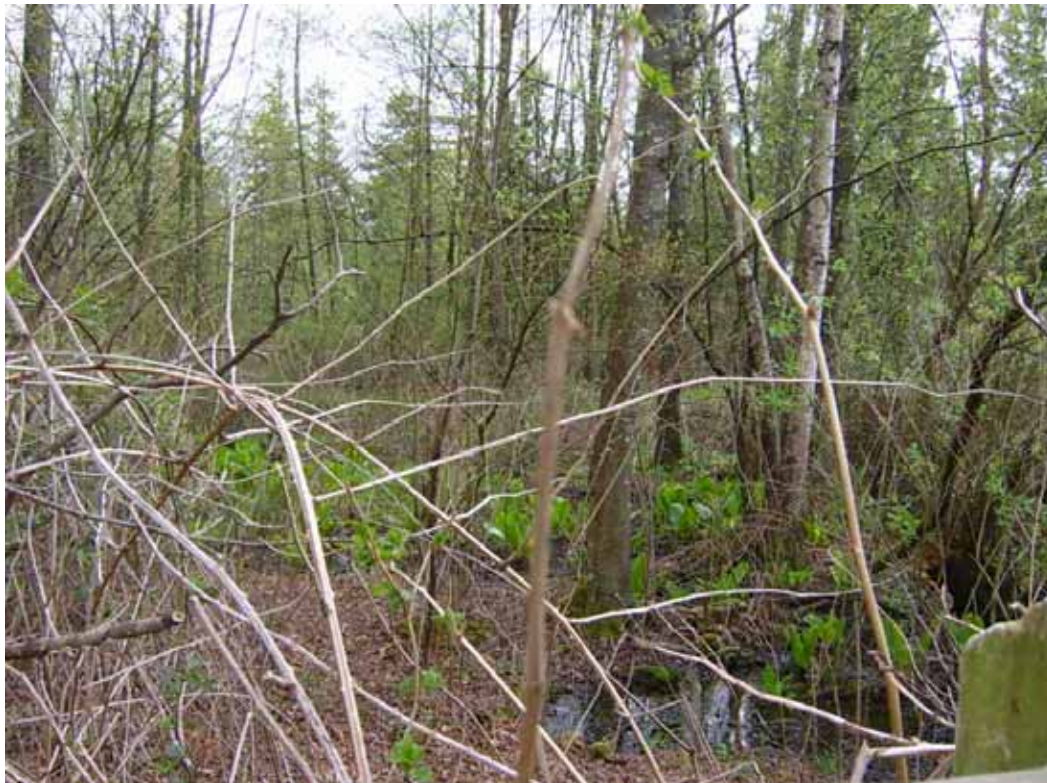
Photo 21: LB-3 above 184 Street is undefined and swampy, and does not provide good rearing habitat.

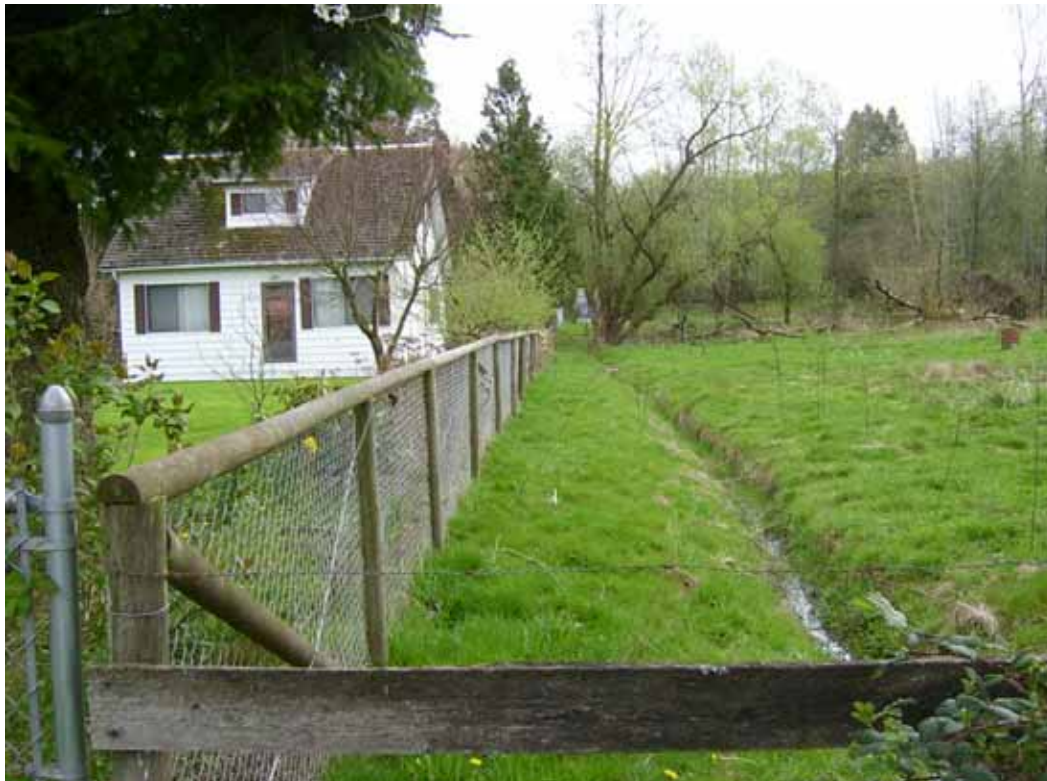
Photo 22: LB-4 above 184 Street has been channelized along fence line and does not provide good habitat. Habitat may improve upstream where the riparian area is largely undeveloped.

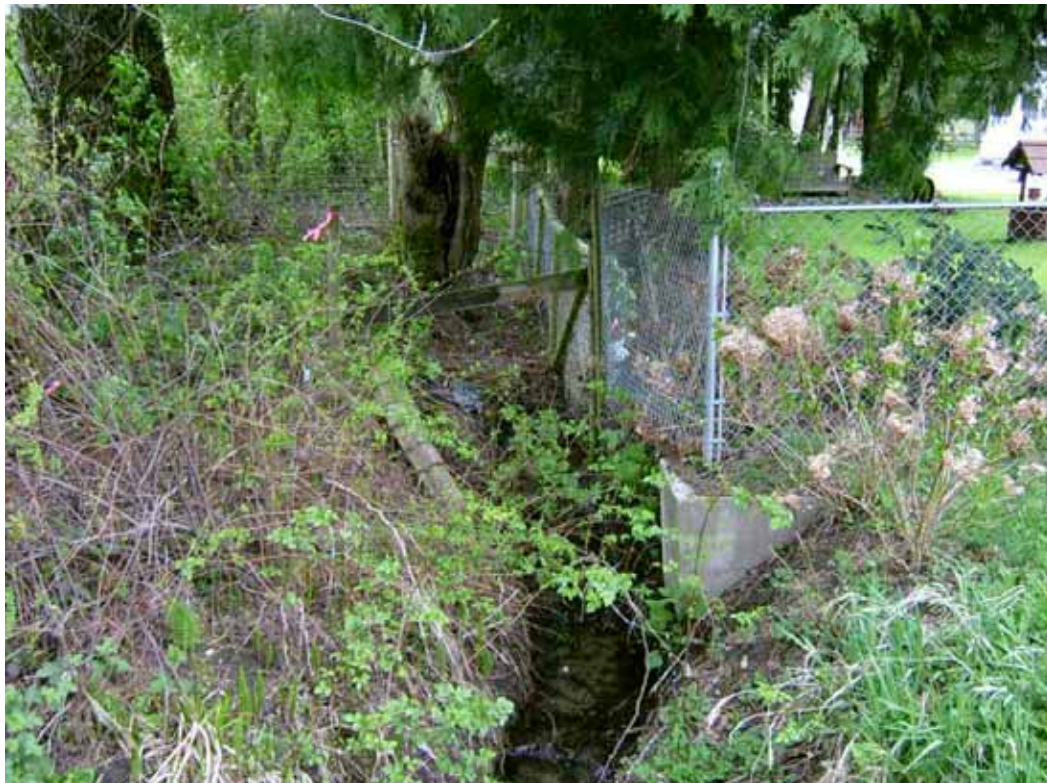
Photo 23: LB-5 provides good salmonid rearing habitat, with abundant forested cover and limited spawning gravels at the roadside assessment area.

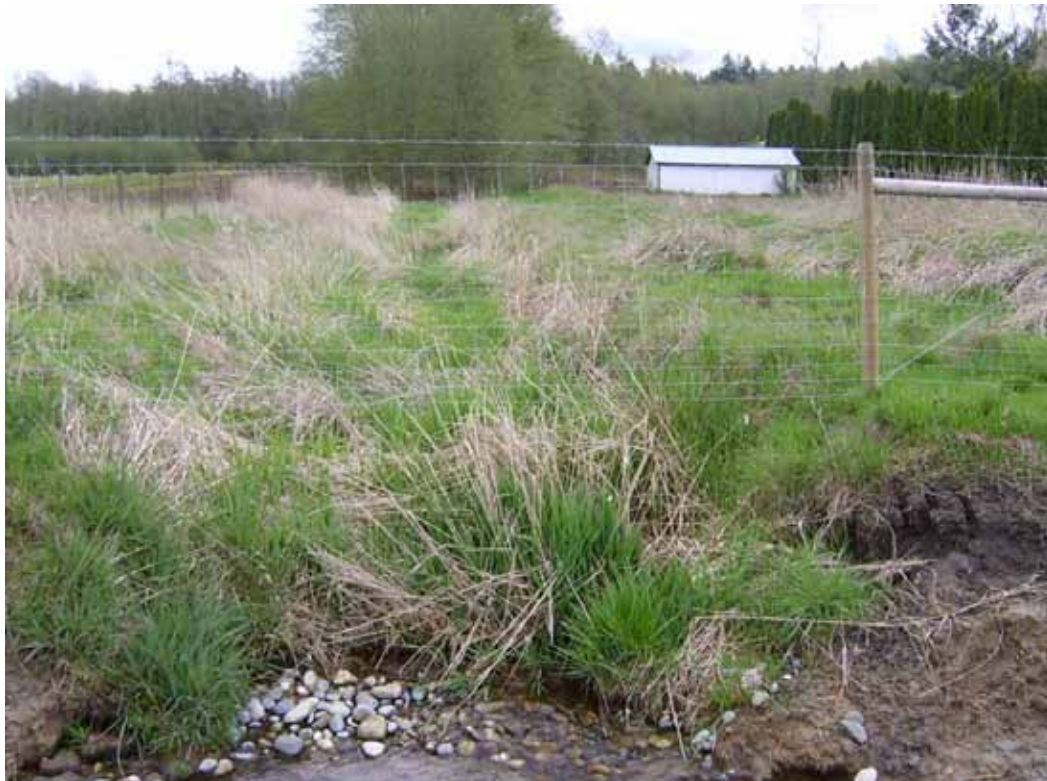
Photo 24: LB-6 originates in a forested area and flows through an agricultural field with a riparian buffer for most of its length. Poor spawning and rearing habitat at confluence with 184 Street ditch, but habitat may improve upstream.

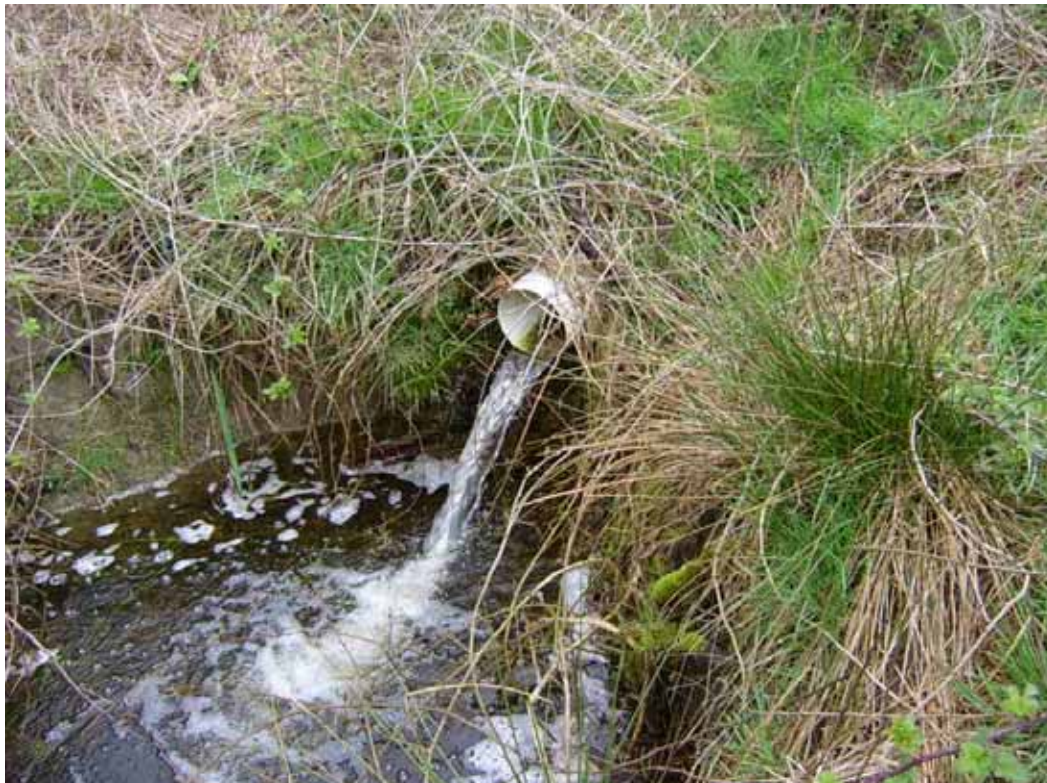
Photo 25: Vandrishe Brook VB-1 has a barrier at the inlet of the lower pond.

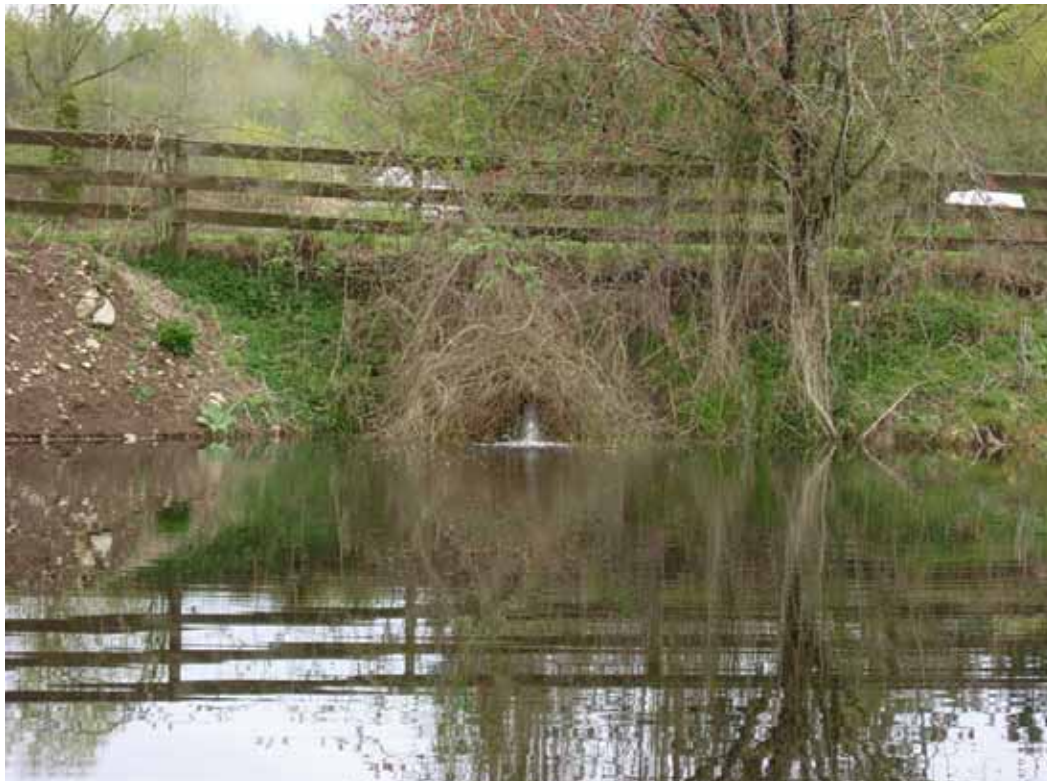
Photo 26: VB-1 has a possible barrier at the inlet of the second pond.

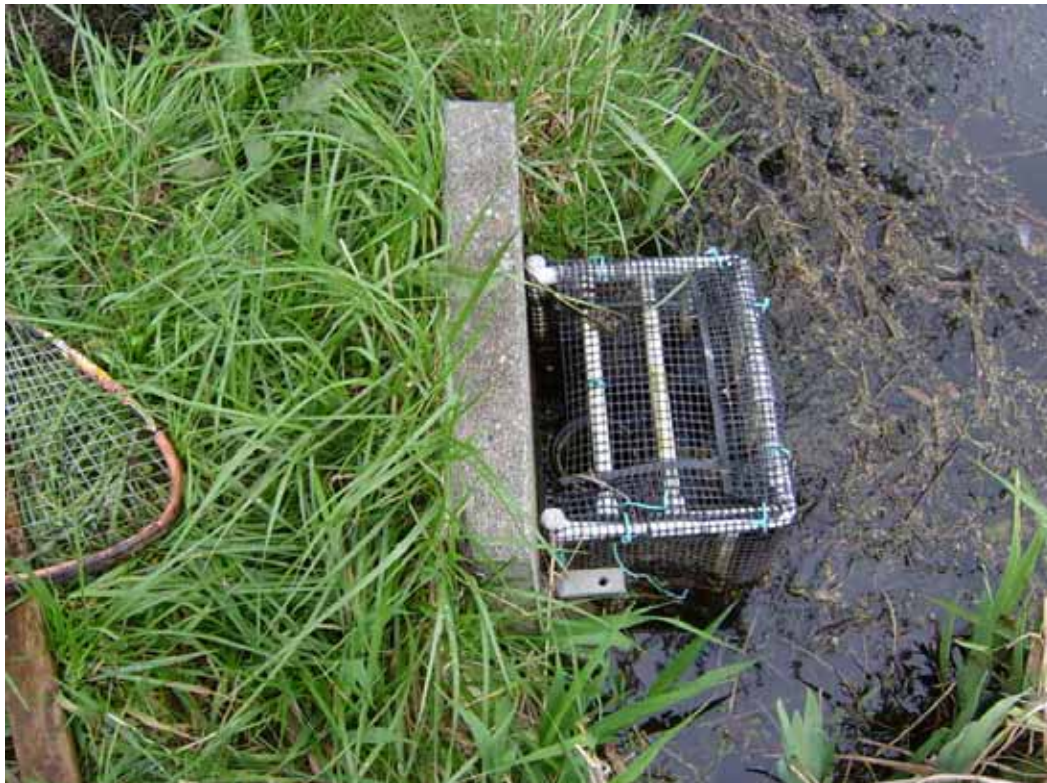
Photo 27: Outlets of third pond in VB-1 are barriers to salmonid migration.

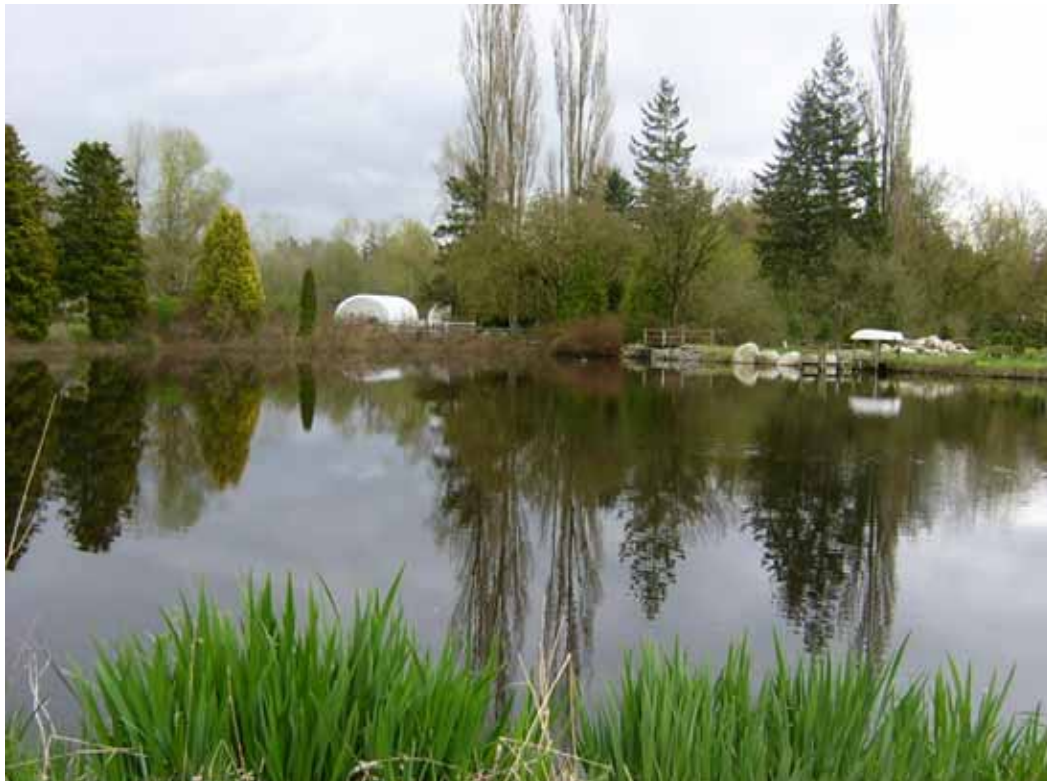
Photo 28: Third pond of VB-1.

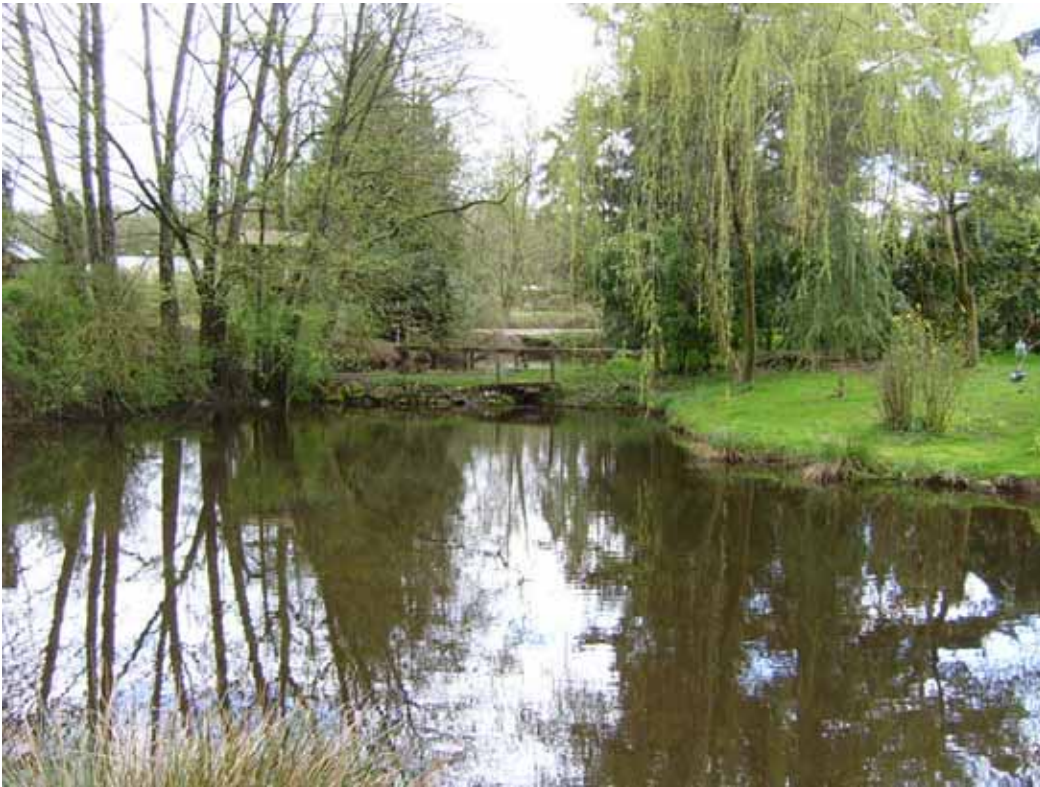
Photo 31: VB-4 ponds provide excellent rearing habitat. “Coho” reportedly present in ponds.

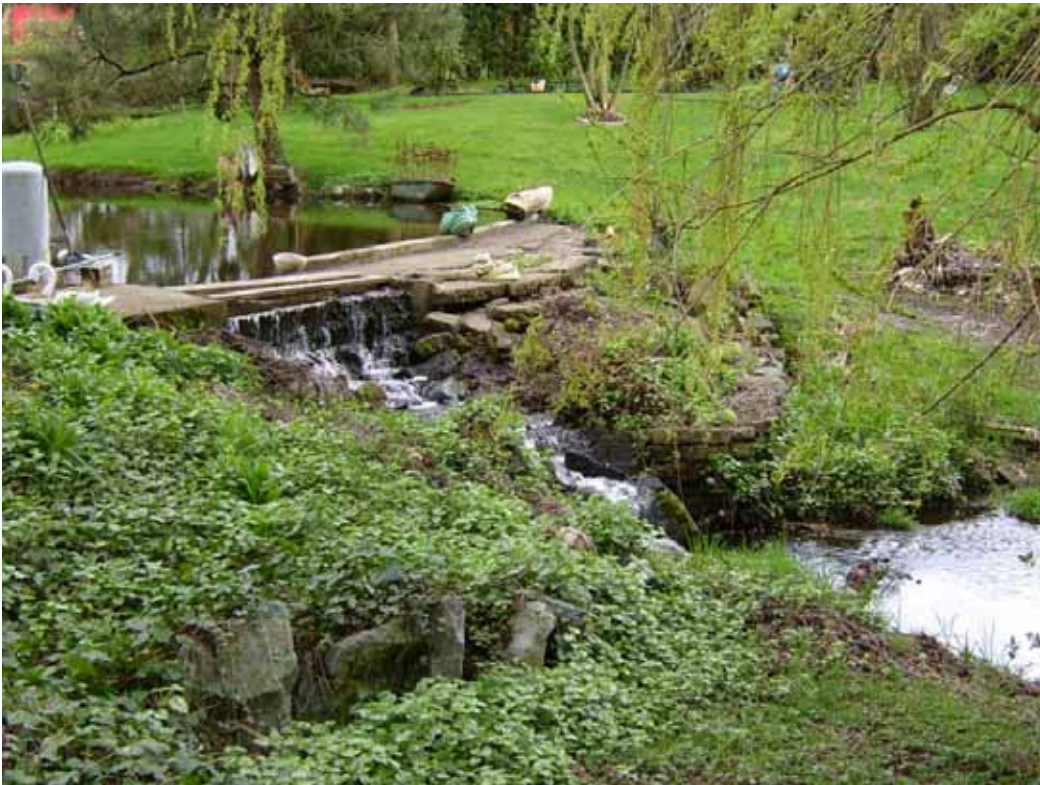
Photo 32: Falls at VB-4 may be a fish barrier.

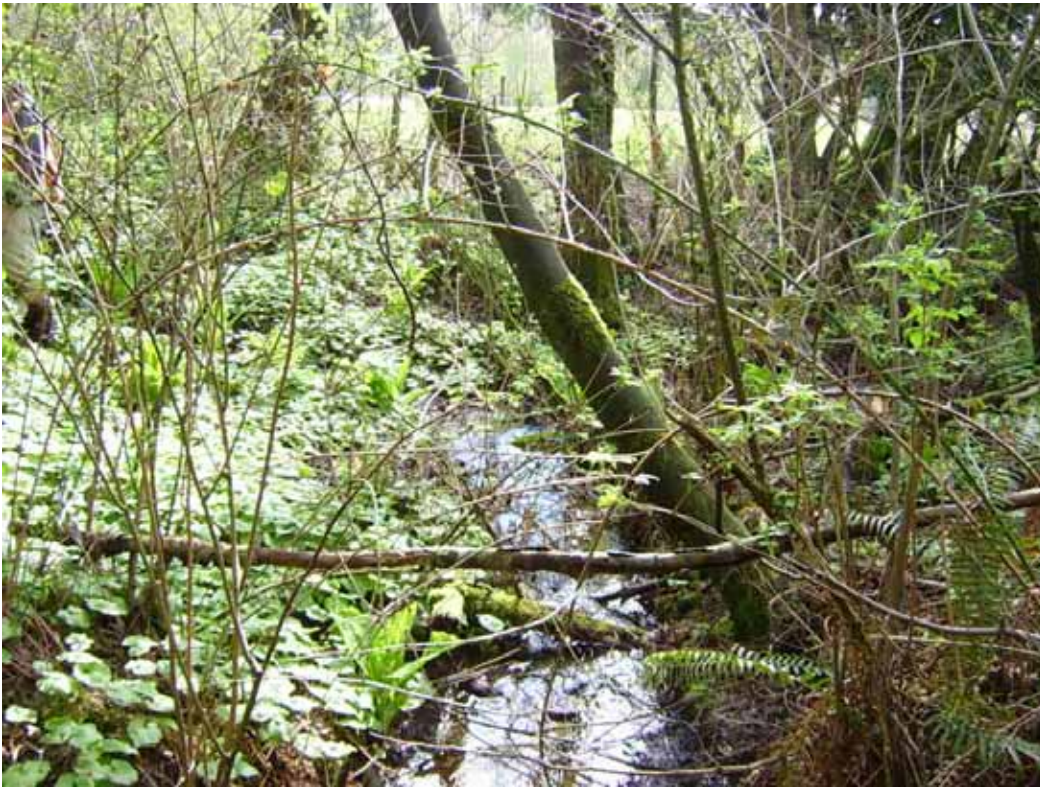
Photo 33: Overall rearing habitat of VB-5 is poor as part of channel flows underground. Spawning substrate is absent.

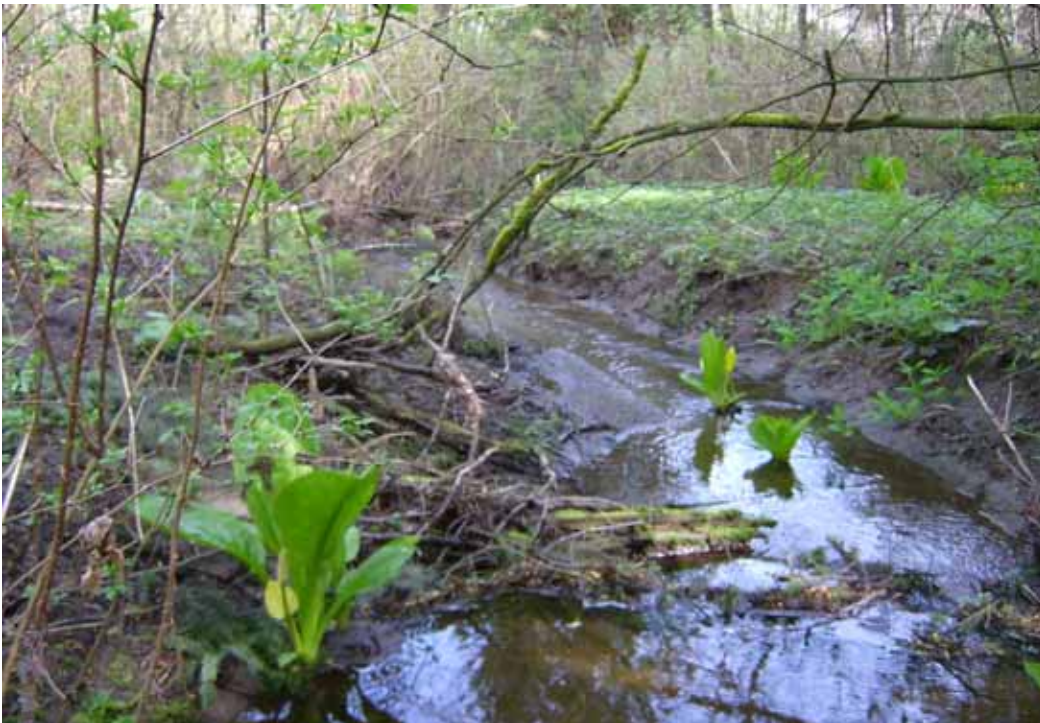
Photo 34: Justin Brook JB-1 provides good rearing habitat, with localized gravels for spawning. Cover is abundant.

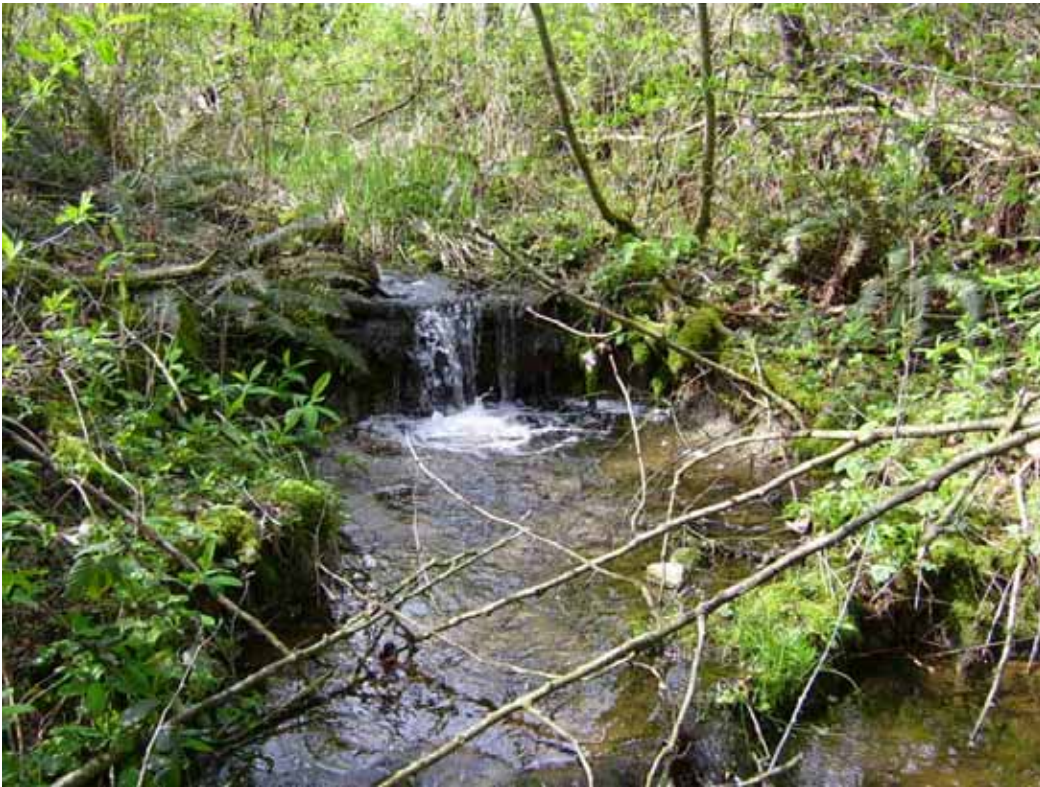
Photo 35: Small falls at JB-1 should not be a barrier to fish migration.

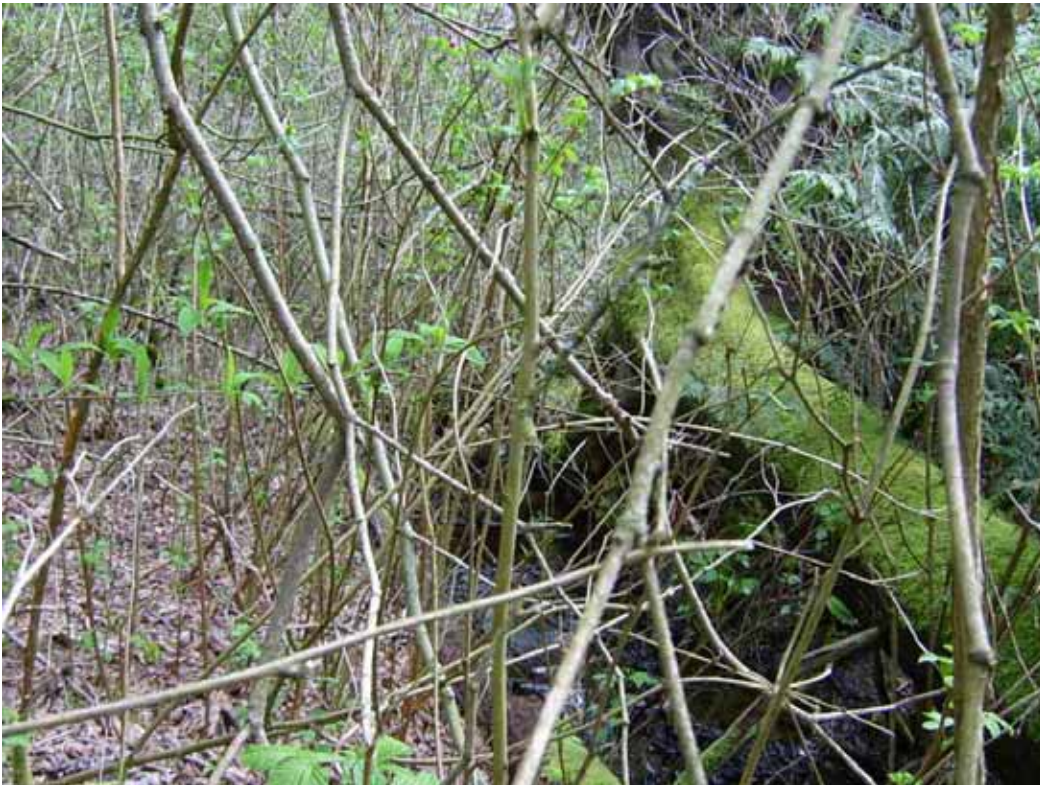
Photo 36: Dall Brook, DB-1 provides low to moderate rearing habitat. Lack of gravels limit spawning habitat.

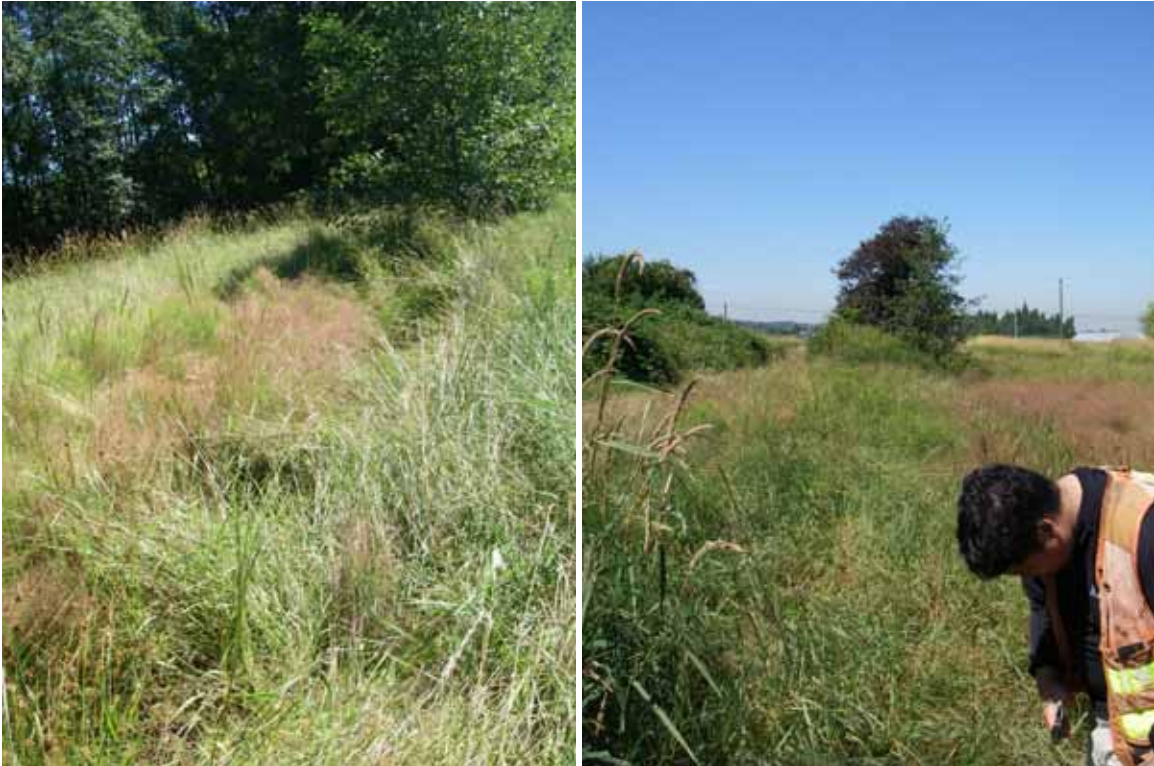
Photo 37 Laughlin Creek LC-1 is a defined grassy channel with poor riparian cover. Bed material is predominantly fines
and 38:

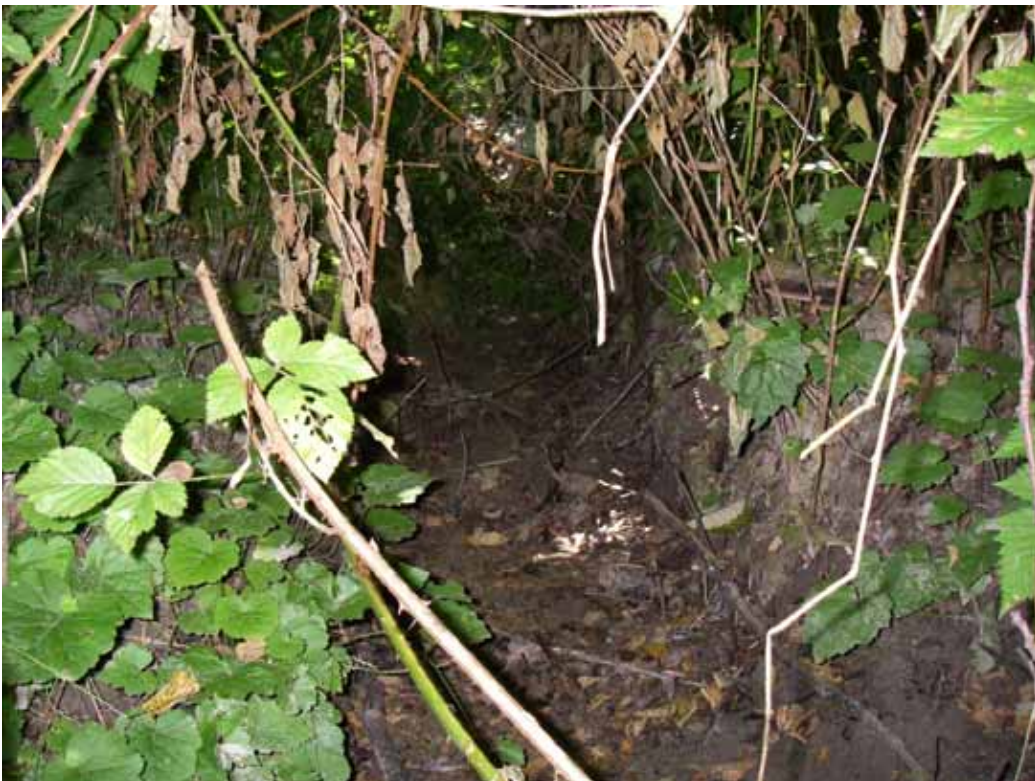
Photo 39: LC-2 was dry in July.
