City of Surrey

Erickson Creek Integrated Stormwater Management Plan

September 2010

**Re: ERICKSON CREEK INTEGRATED STORMWATER MANAGEMENT PLAN
FINAL REPORT**

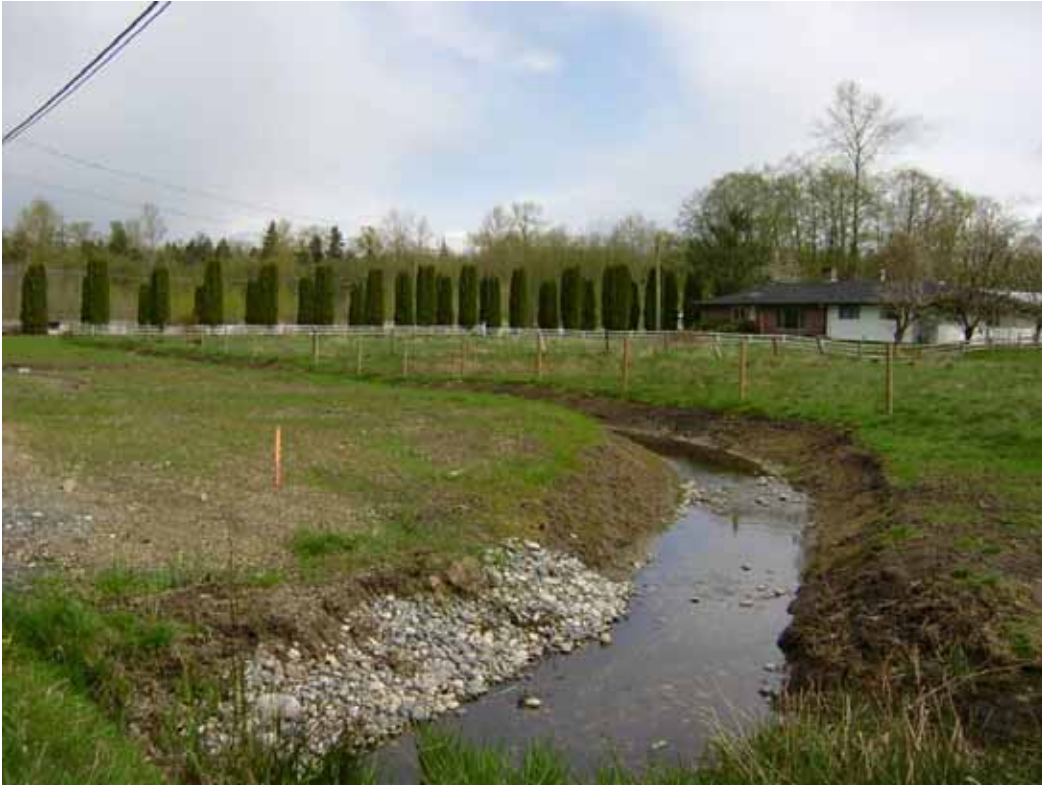
Photo 43: Moderate rearing habitat exists in 184th St ditch, however cover is limited. Spawning may occur in gravels in 3100 block of 184 Street however the ditch is heavily silted.

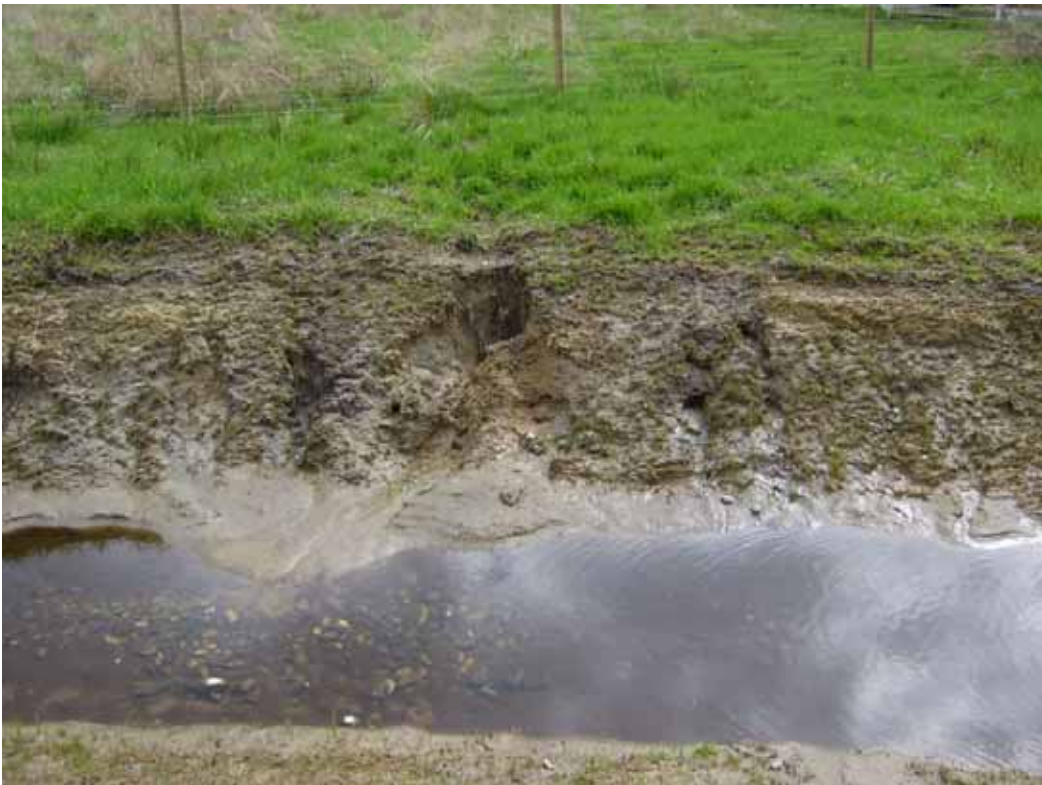
Photo 44: 184th Street ditch shows signs of erosion.

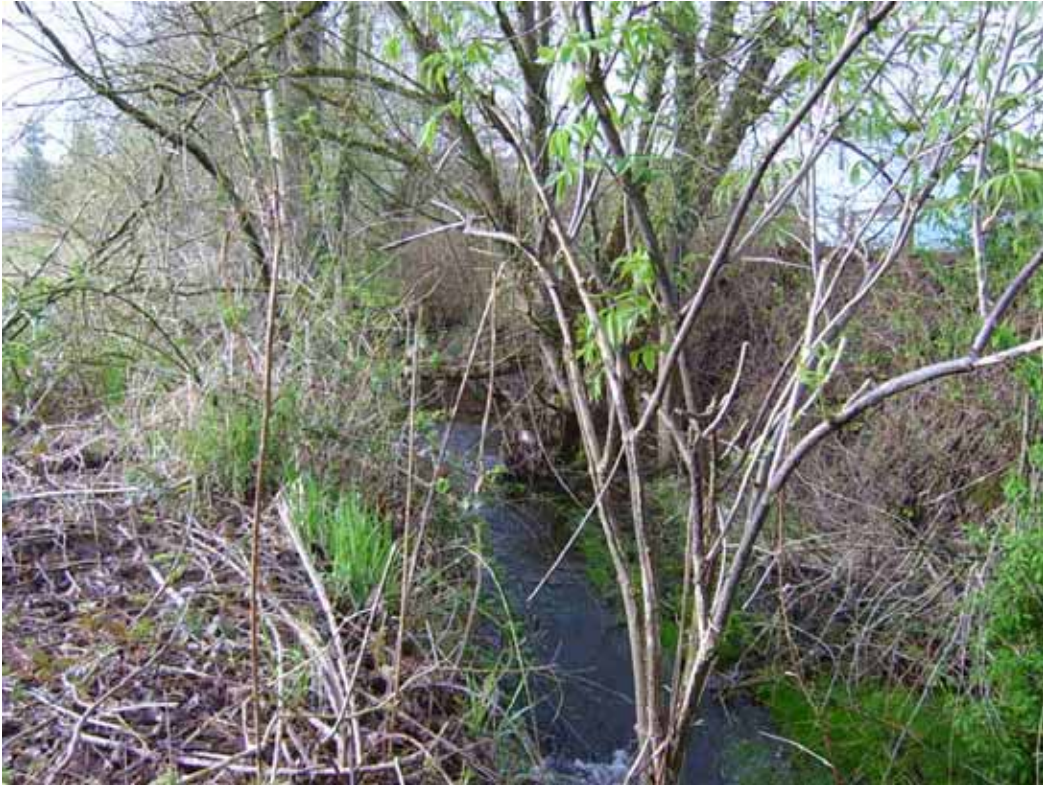
Photo 45: Moderate rearing habitat but poor spawning habitat in 180th Street ditch due to unsuitable substrates. Sparse riparian cover.

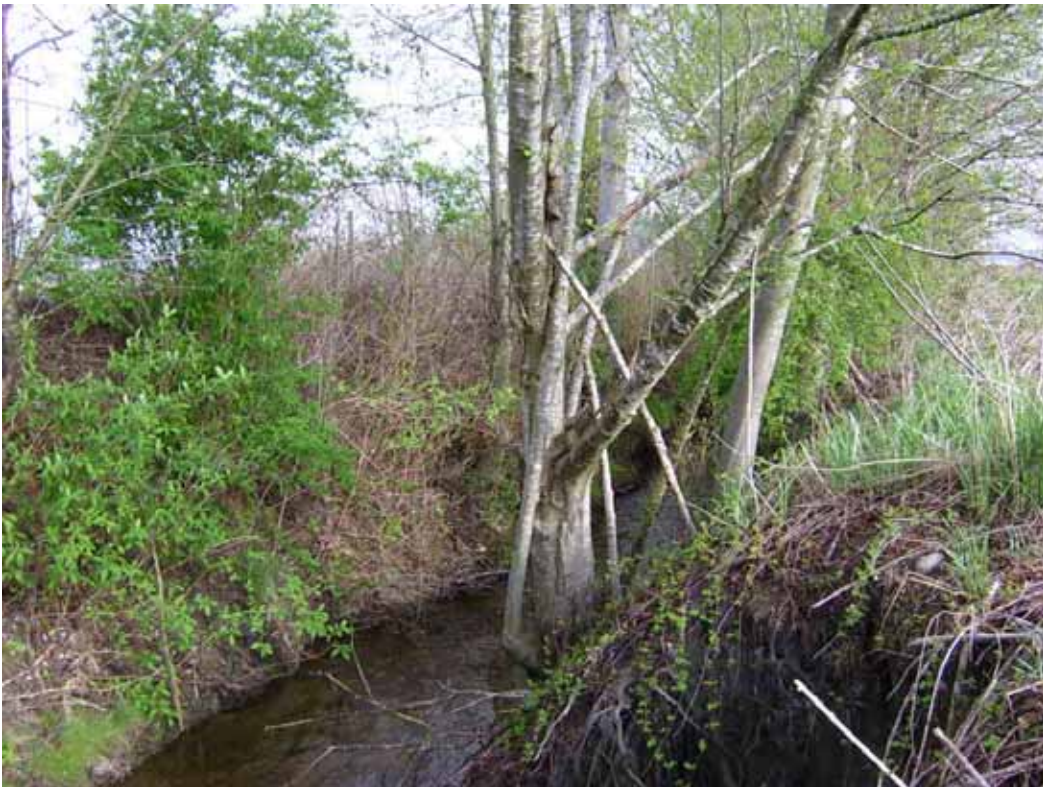
Photo 46: 180th Street ditch shows signs of erosion.

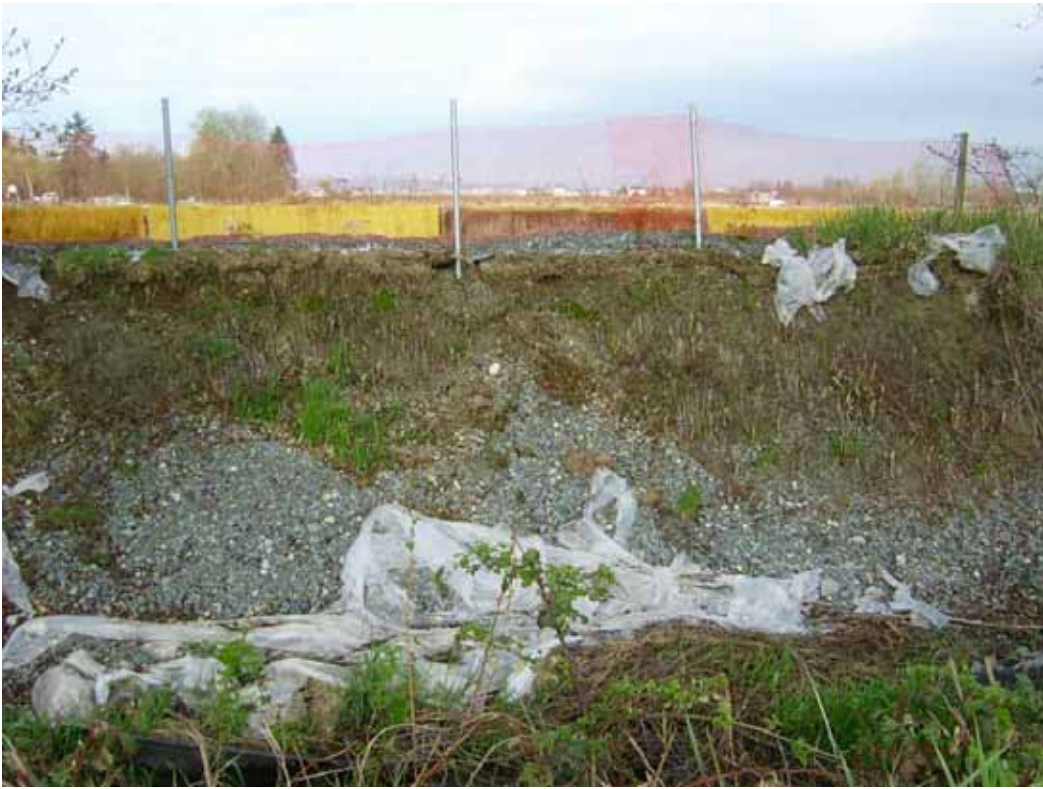
Photo 47: 180th Street ditch shows signs of erosion.

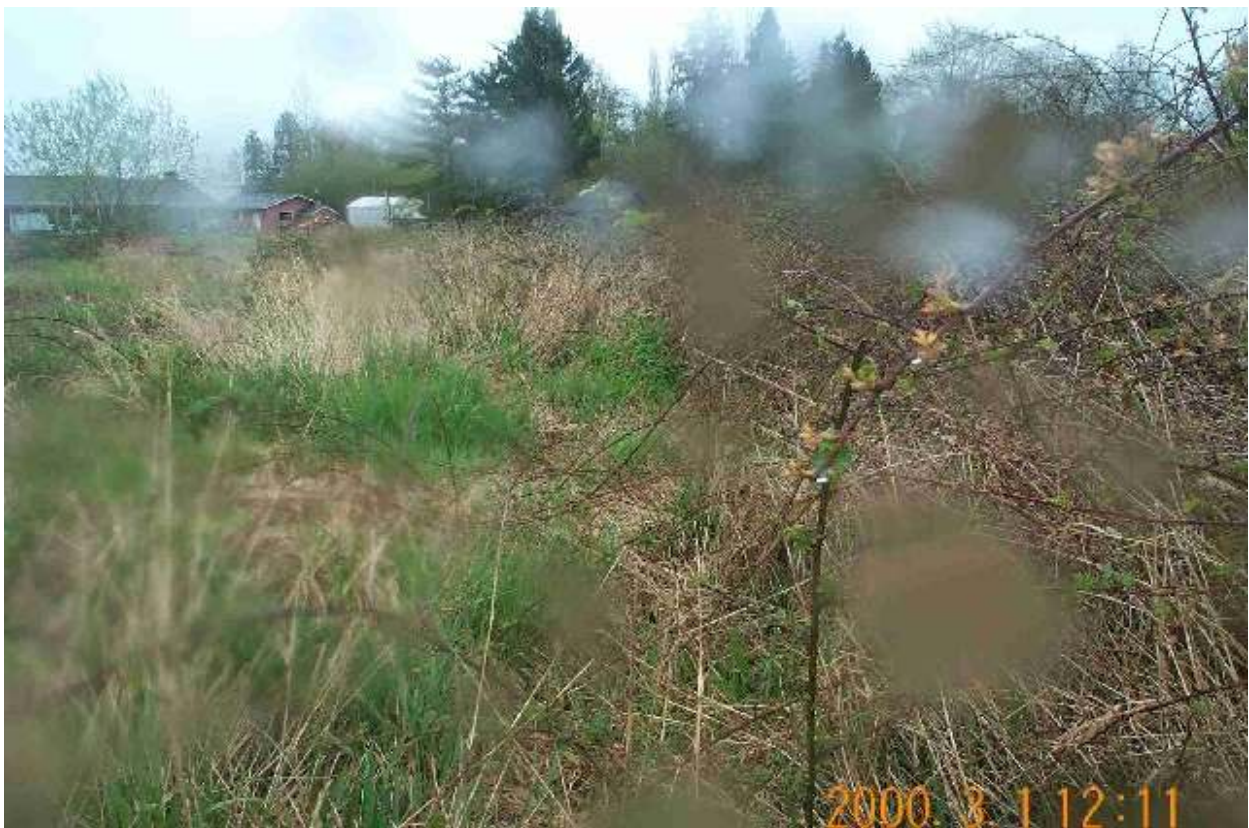
Photos P1000101.jpg

Comment: Side channel is well defined and banks are heavily vegetated.

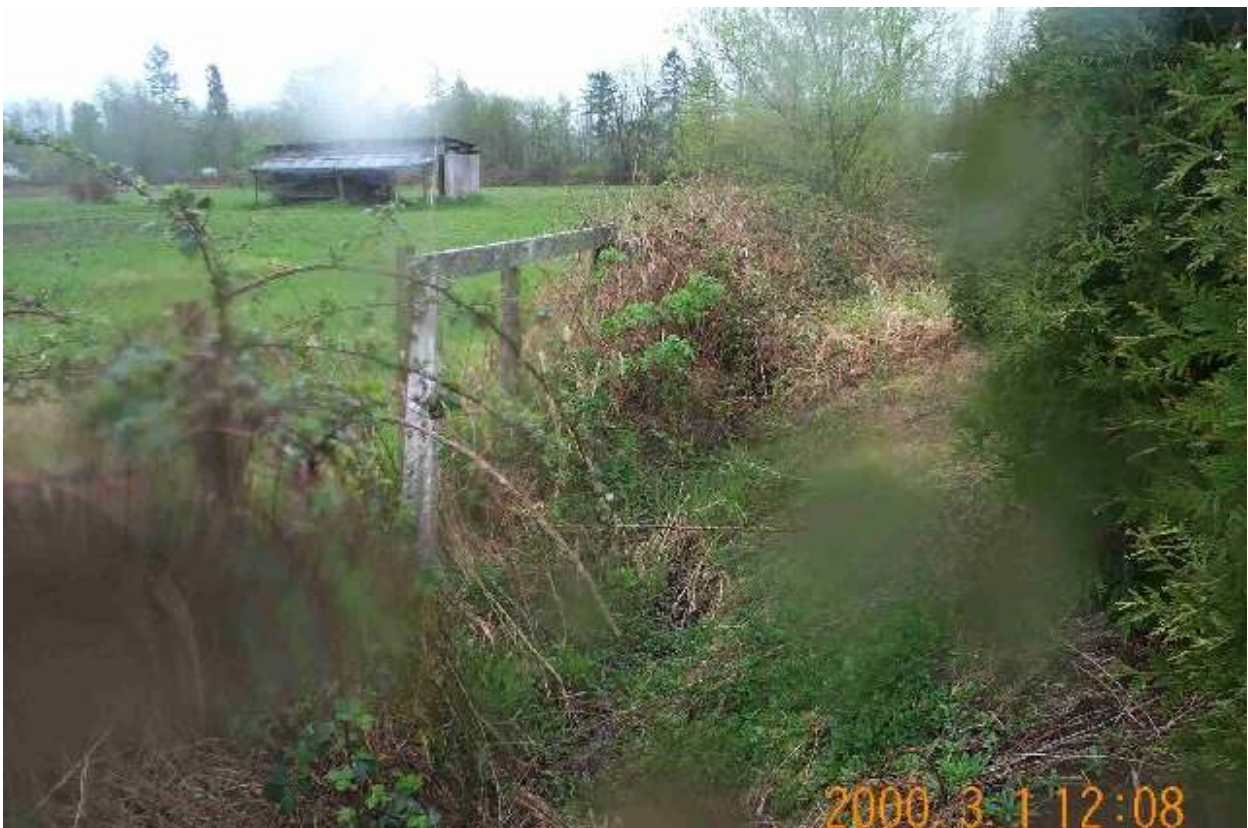
Photos P1000100.jpg

Comment: Side channel is well defined and banks are composed of grass.

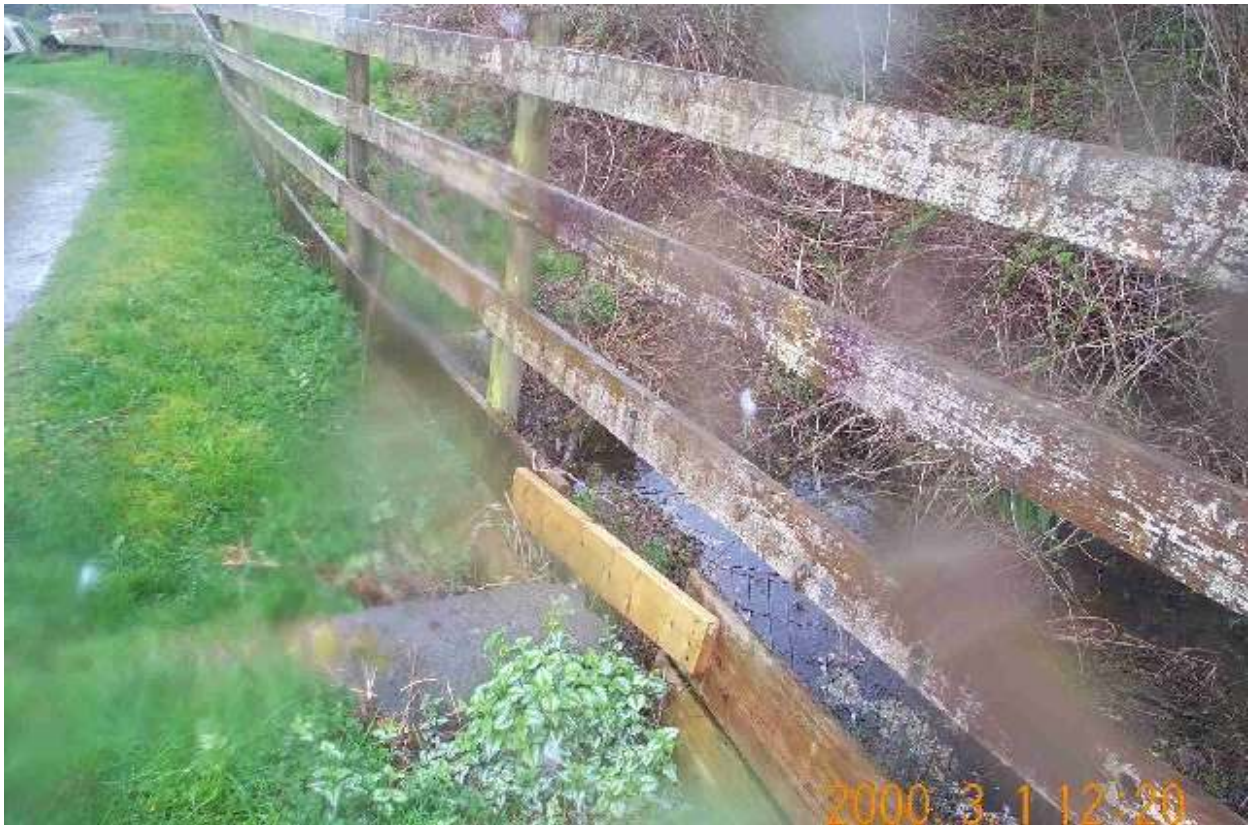
Photos P1000102.jpg

Comment: Outlet of two 450 mm diameter culverts that drain a private pond. One of the culverts is for high flow conditions.

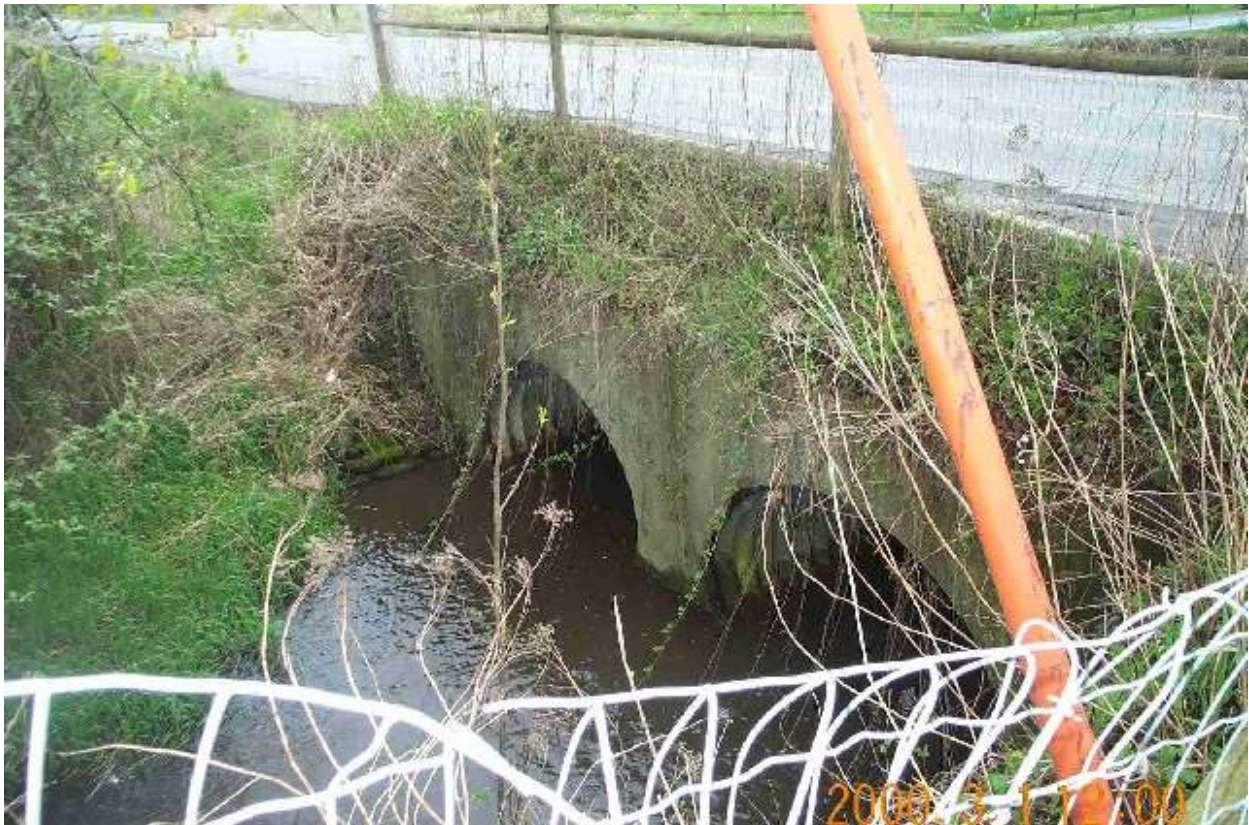
Photos P1000104.jpg

Comment: Twin 1500 mm diameter culverts with concrete headwall and concrete sandbag wingwalls built underneath 32nd Avenue.

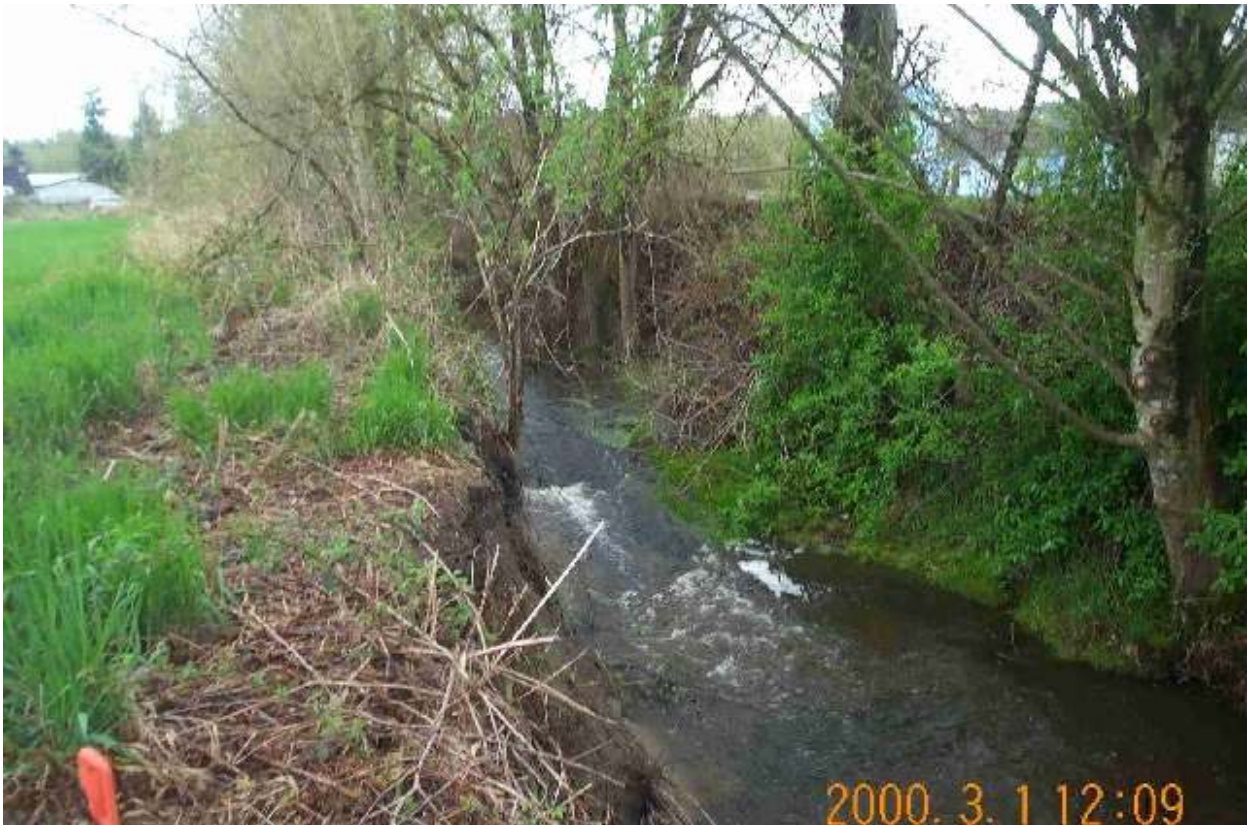
Photos P1000107.jpg

Channel Dimensions:	Left Bank Height:	3.5 m	Site Feature:	Erosion
	Left Bank Slope (H:V):	0.5:1		
	Right Bank Height:	2.5 m	Bank:	Right
	Right Bank Slope (H:V):	0.6:1	Length:	10 m
	Low Flow Channel Width:	3.0 m	Height:	2.5 m
	Low Flow Channel Depth:	m

Comment: East bank undercut with roots exposed. Erosion section is approximately 10 m long.

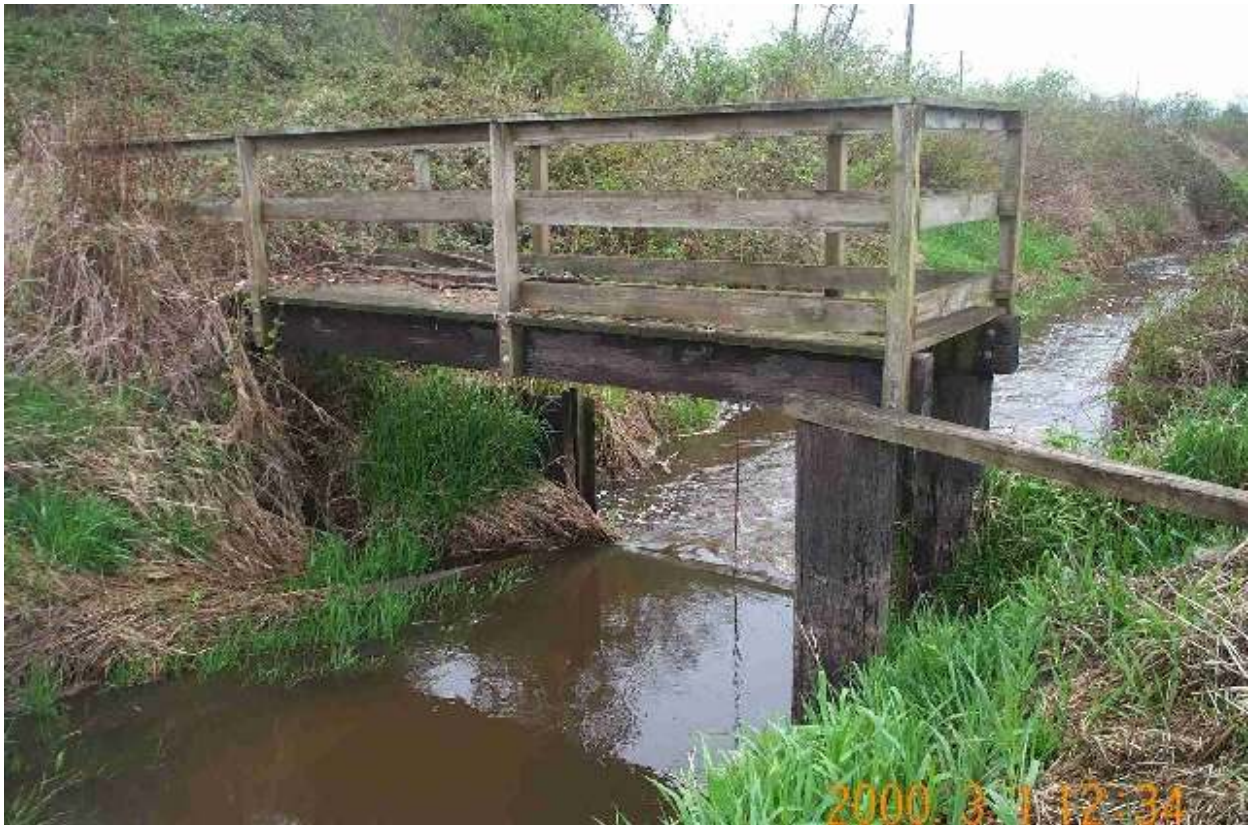
Photos P1000111.jpg

Channel Dimensions:	Left Bank Height:	3.5 m	Site Feature:	Obstruction
	Left Bank Slope (H:V):	0.7:1		
	Right Bank Height:	3.0 m	Obstruction Type:	Ped Bridge
	Right Bank Slope (H:V):	0.8:1		
	Low Flow Channel Width:	3.0 m		
	Low Flow Channel Depth:	0.6 m

Comment: Pedestrian bridge forms a weir whose elevation is controlled by a gate. An inlet for an irrigation pump is located upstream from the weir.

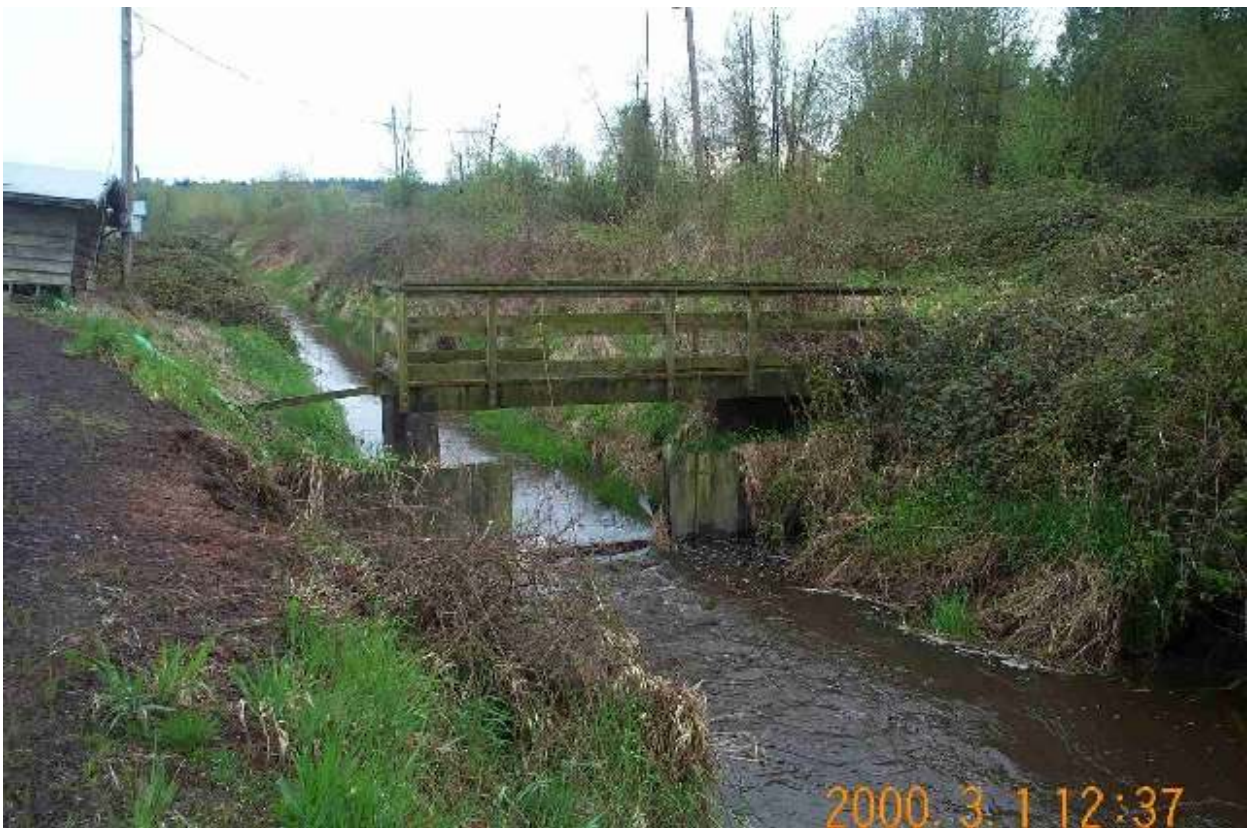
Photos P1000112.jpg

Comment: Confluence with ditch draining field to the west. Channel banks are steep sided and heavily vegetated.

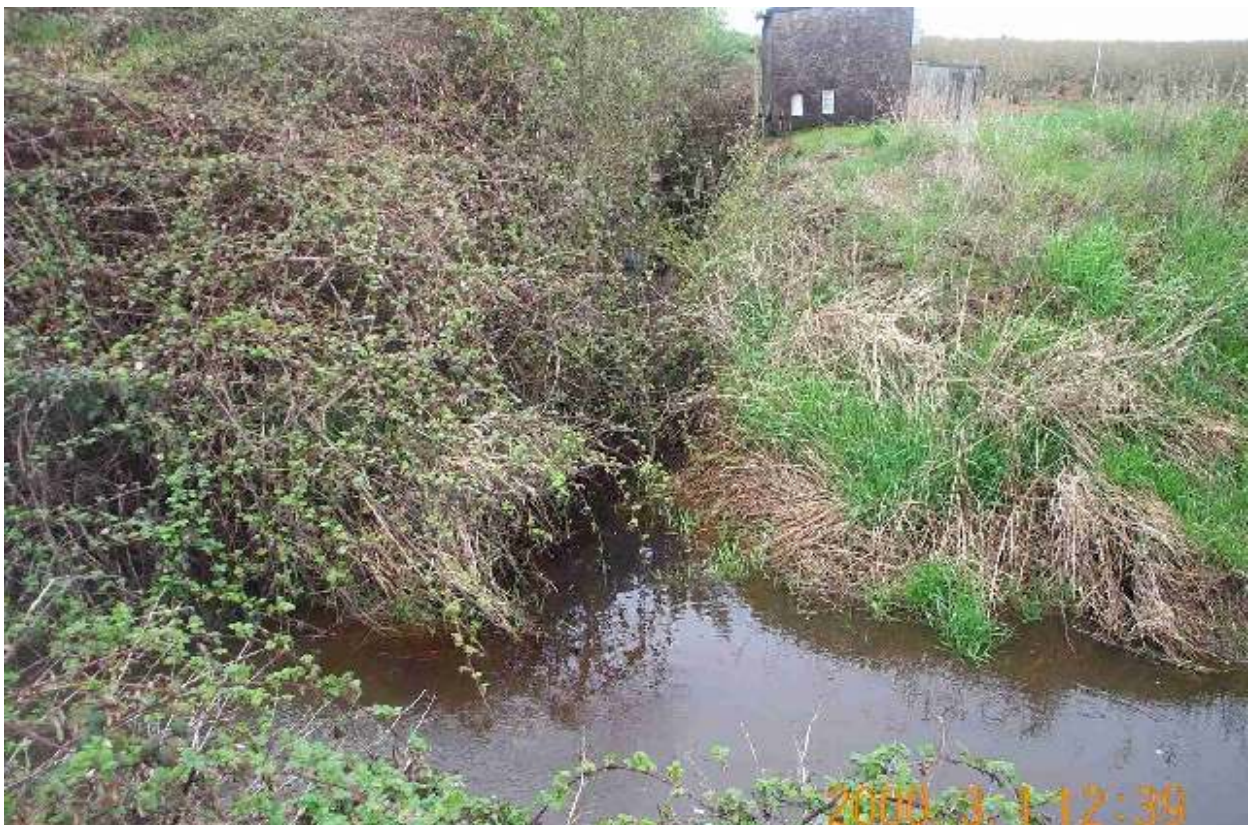
Photos P1000113.jpg

Comment: Confluence with ditch draining field to the west. Channel banks are steep sided and heavily vegetated.

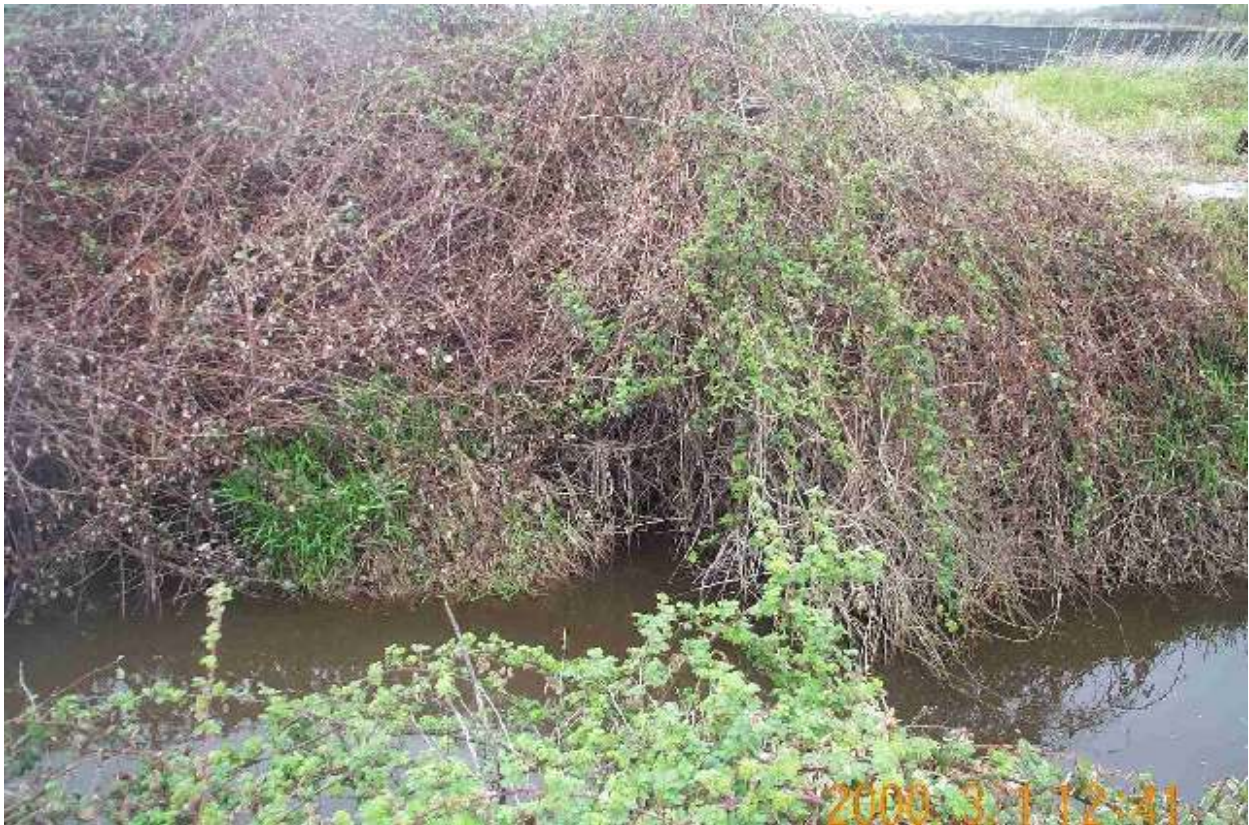
Photos P1000114.jpg

Comment: Confluence with ditches draining field from both east and west. Channel banks composed of grass.

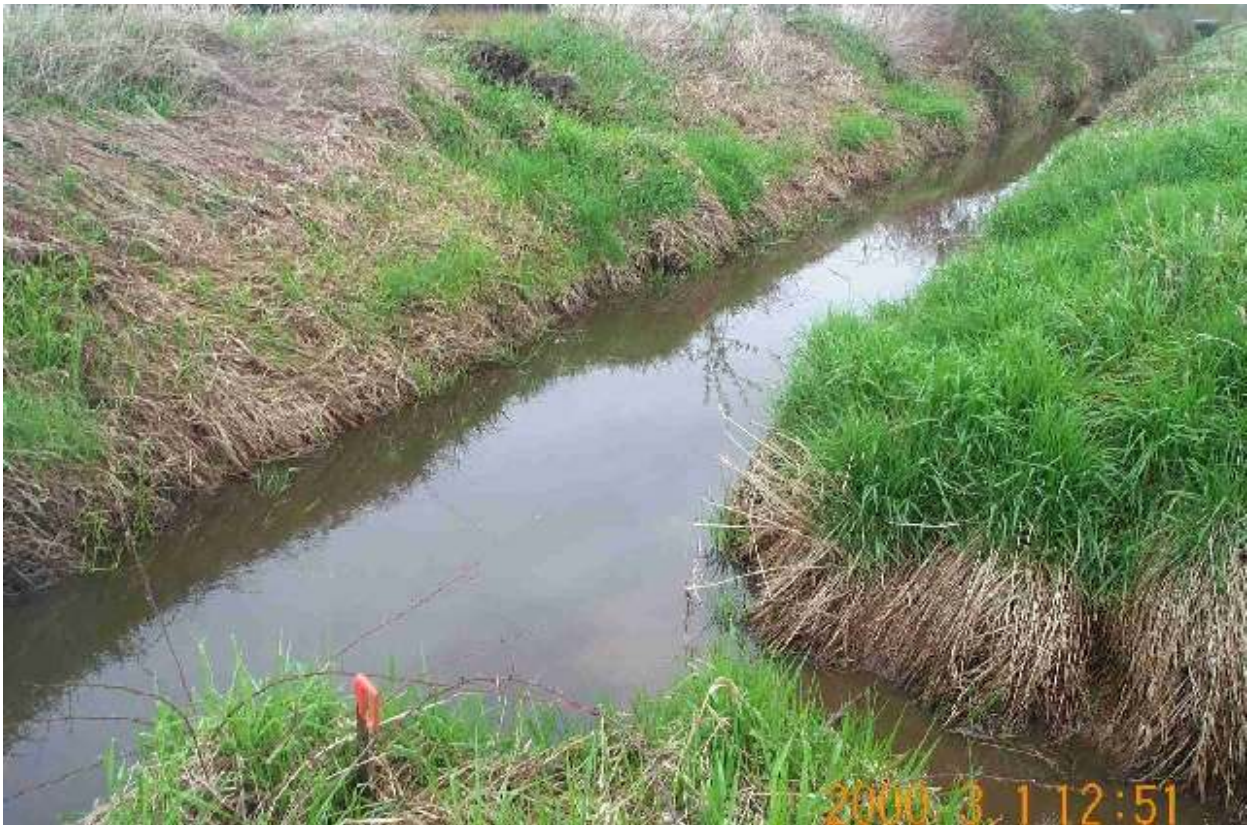
Photos P1000117.jpg

Comment: Confluence with ditches draining field from both east and west. Channel banks composed of grass.

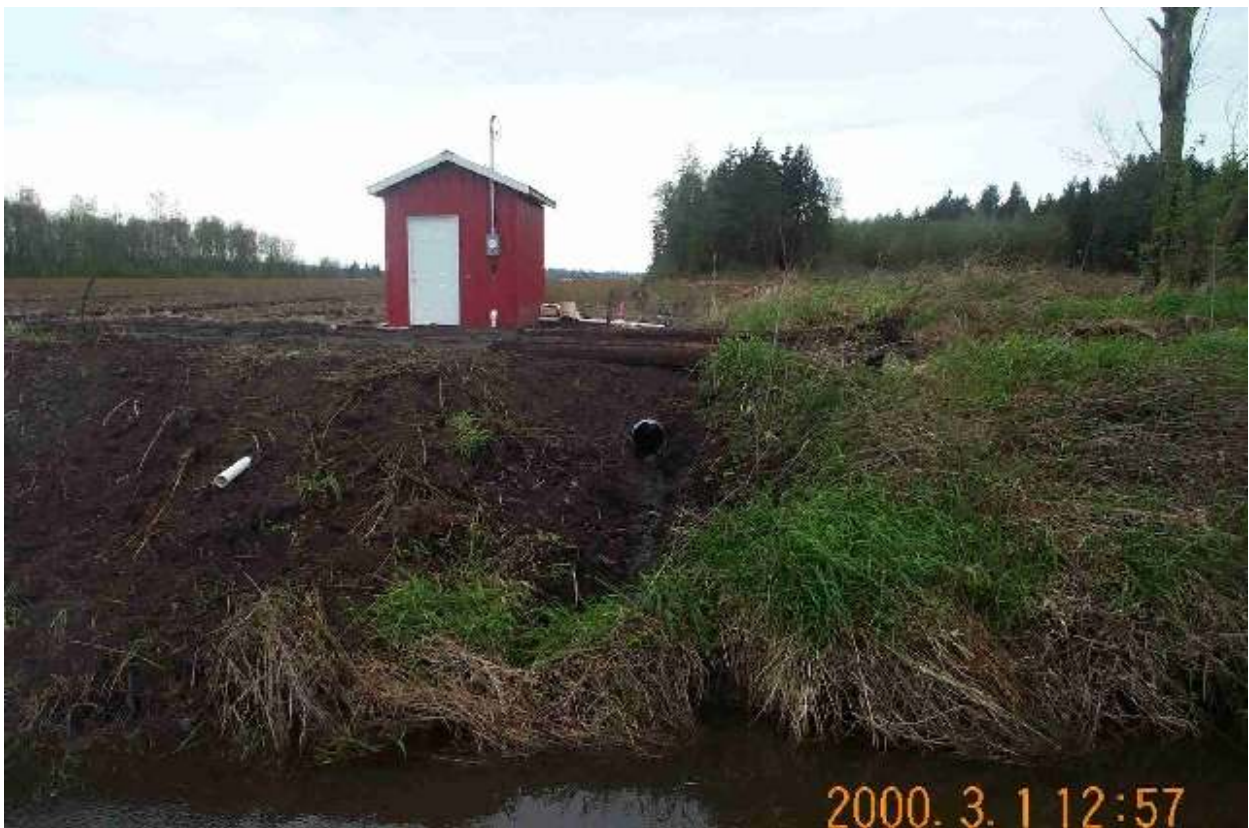
Photos P1000119.jpg

Comment: Confluence with ditch draining field to the west via a culvert.

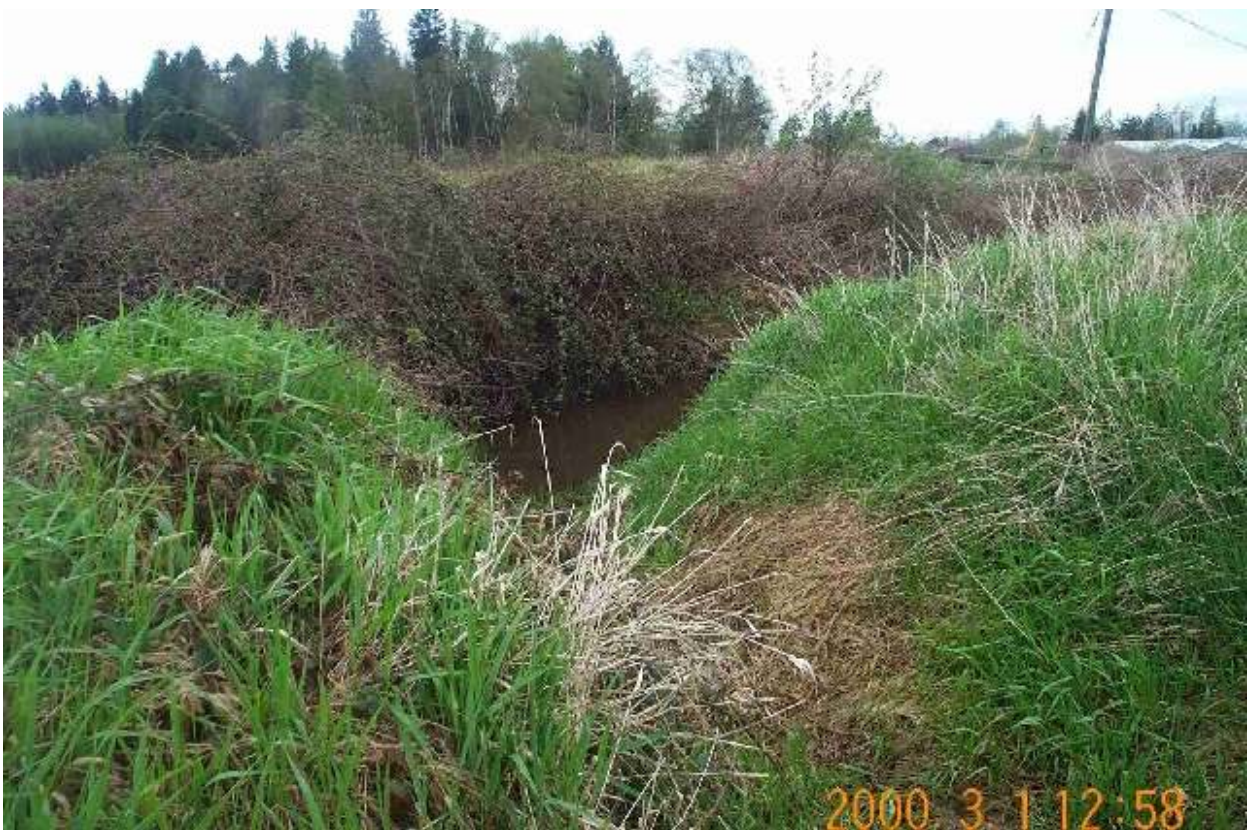
Photos P1000120.jpg

Comment: Confluence with ditch draining field to the east. Channel banks composed of grass.

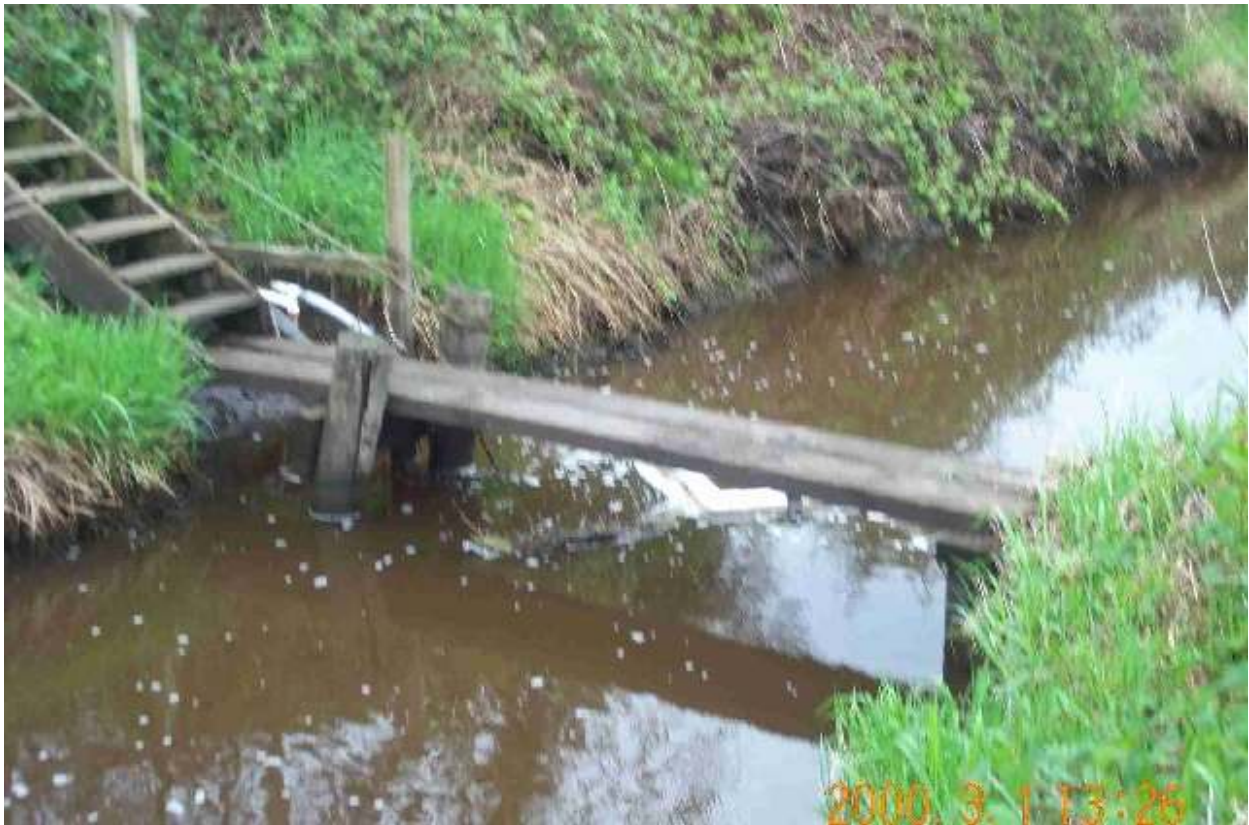
Photos P1000127.jpg

Comment: Pedestrian bridge that also anchors an irrigation pump inlet. Bridge has 2 piers and is approximately 0.5 m above the surveyed water surface elevation.

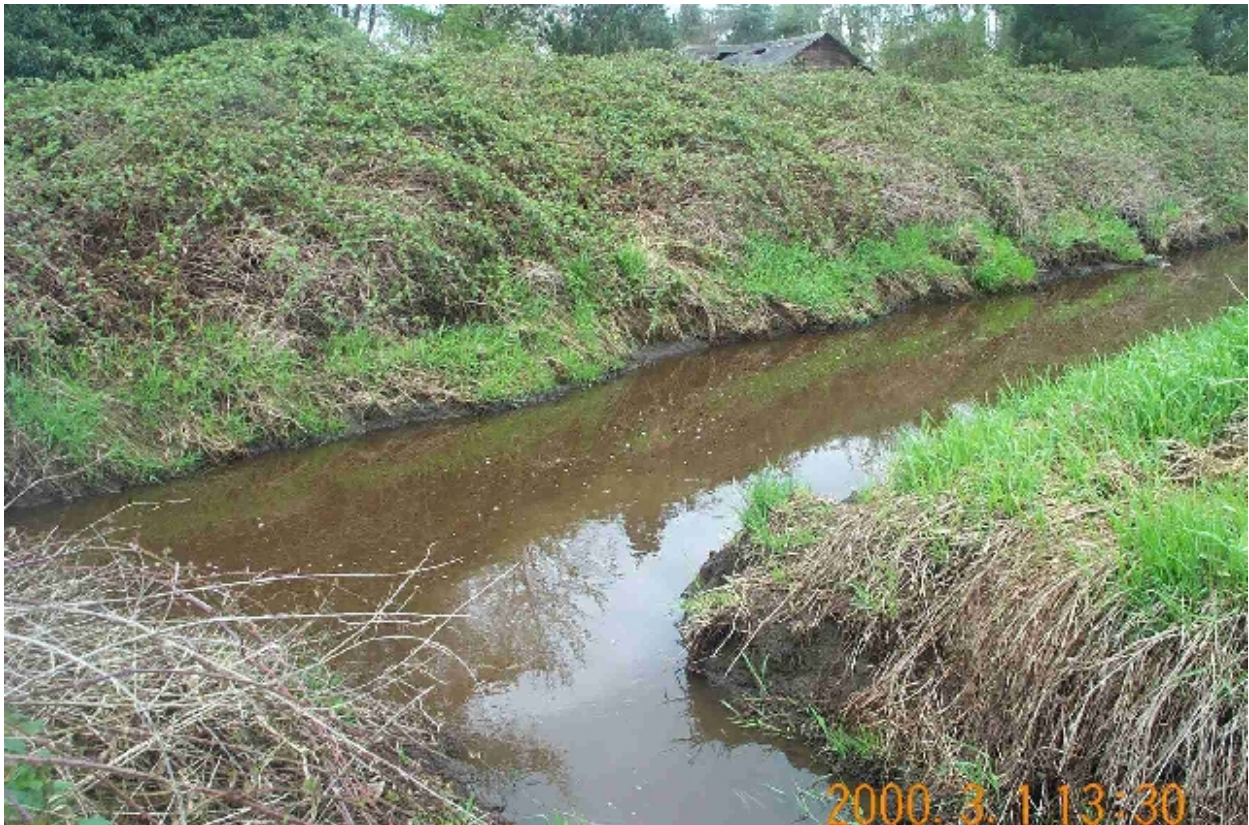
Photos P1000128.jpg

Comment: Confluence with ditch draining field to the east with some erosion of the channel banks.

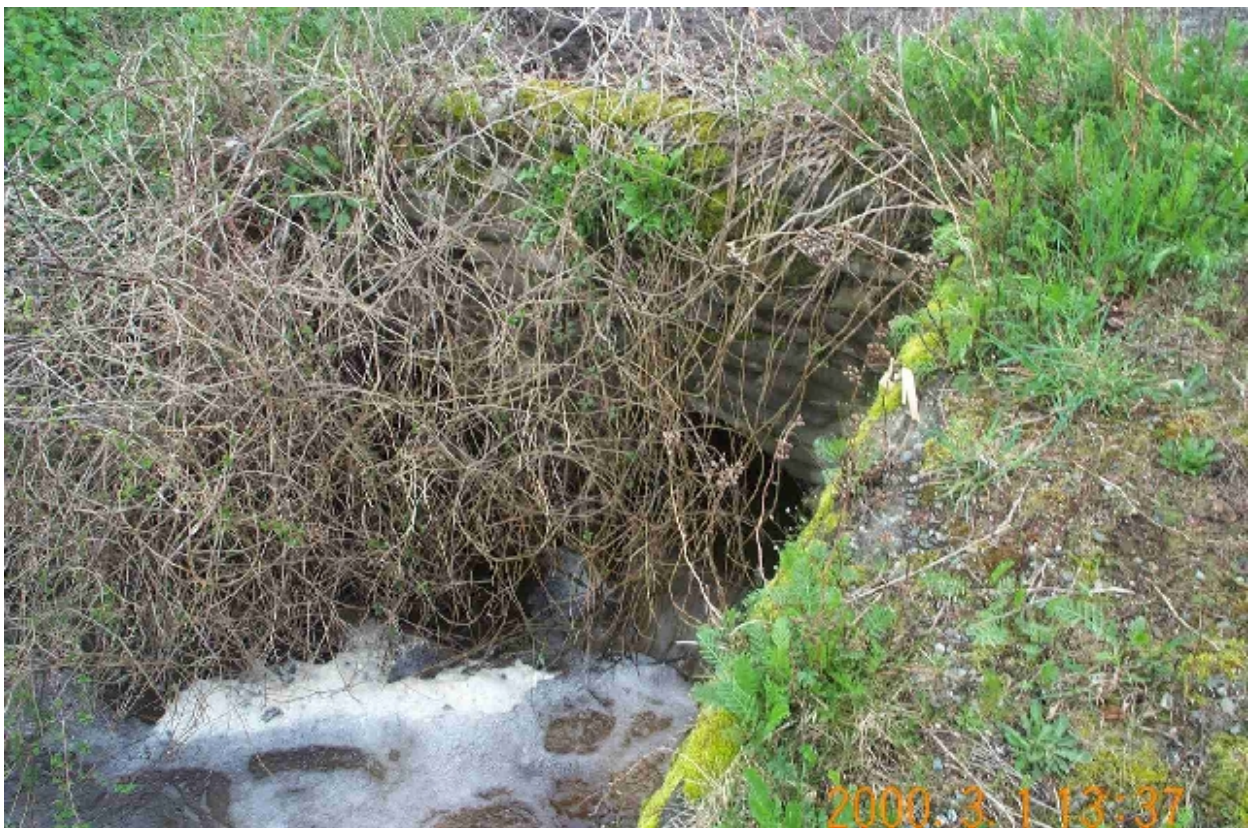
Photos P1000129.jpg

Comment: 750 mm diameter culvert with concrete sandbag headwall and wingwalls.

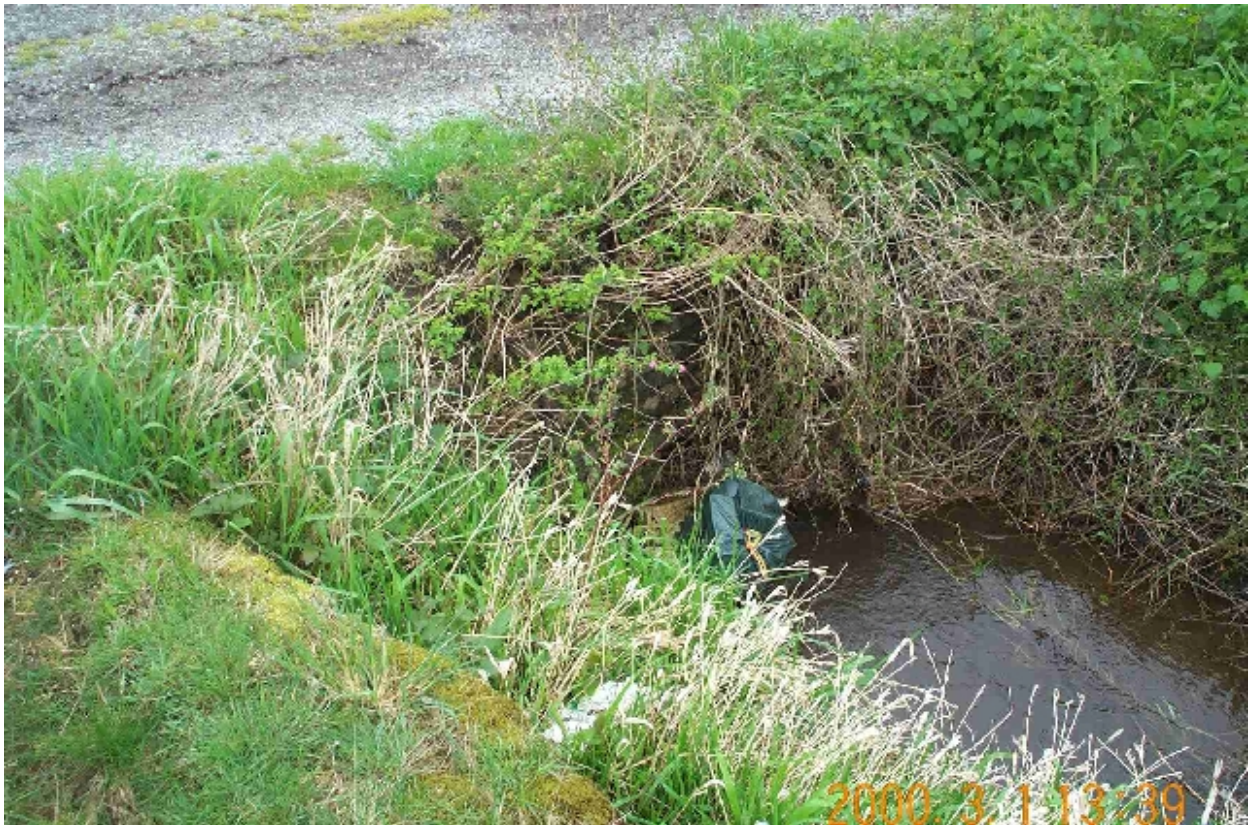
Photos P1000130.jpg

Channel Dimensions:	Left Bank Height:	2.5 m	Site Feature:	Culvert Inlet
	Left Bank Slope (H:V):	0.7:1		
	Right Bank Height:	1.5 m	Type:	CSP
	Right Bank Slope (H:V):	1:1	Diameter:	750mm
	Low Flow Channel Width:	1.0 m	Stability Issue:	Plugged
	Low Flow Channel Depth:	0.3 m

Comment: 750 mm diameter culvert with concrete sandbag headwall and wingwalls. Inlet is plugged with debris and garbage.

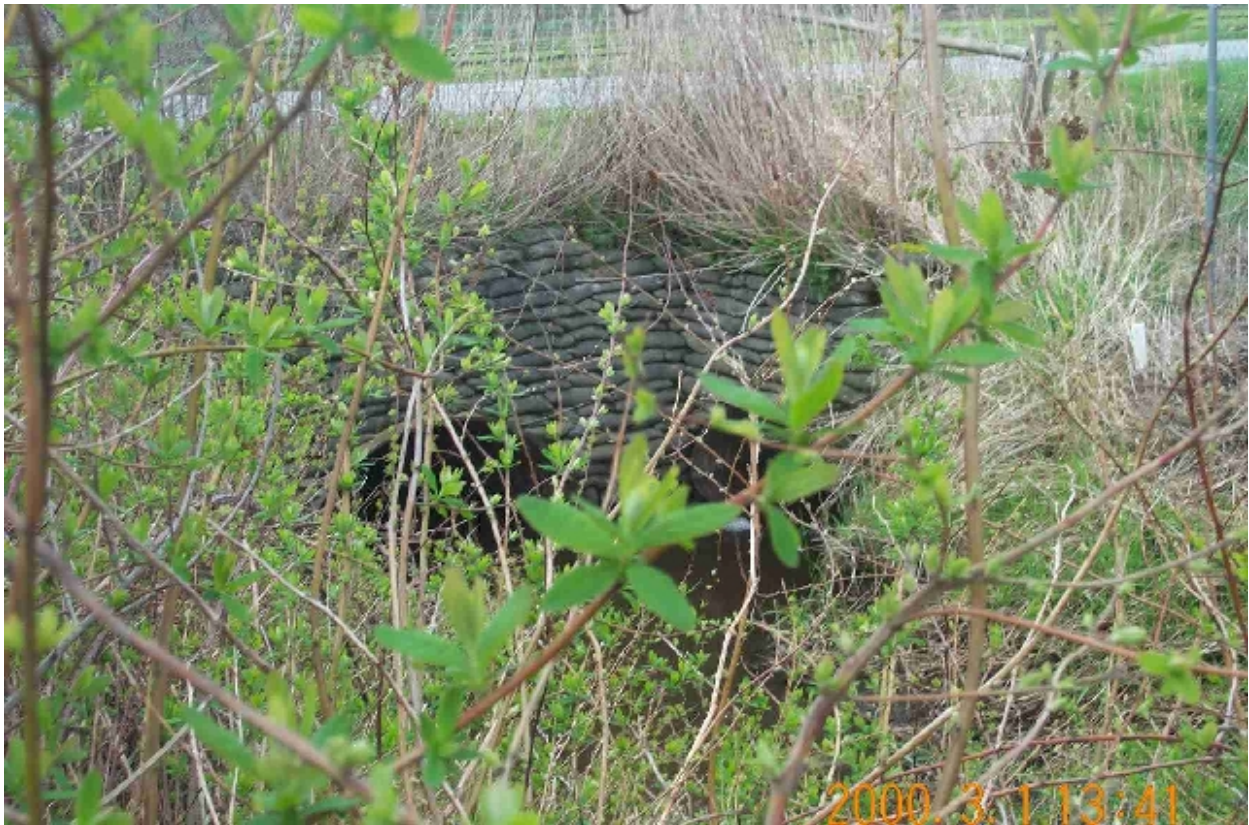
Photos P1000131.jpg

Comment: 900 mm diameter culvert with concrete sandbag headwall. Outlet is also a confluence with Erickson ditch.
