City of Surrey

Erickson Creek Integrated Stormwater Management Plan

September 2010

**Re: ERICKSON CREEK INTEGRATED STORMWATER MANAGEMENT PLAN
FINAL REPORT**

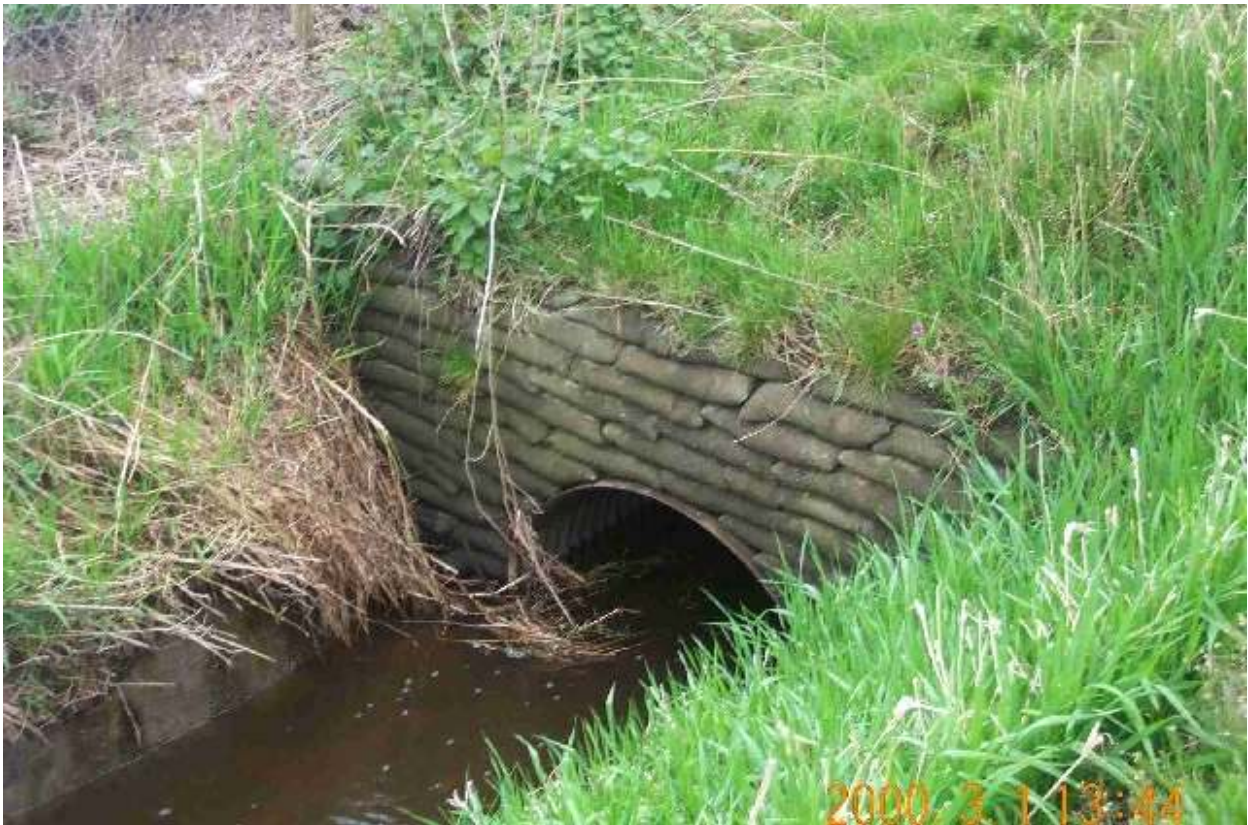
Photos P1000132.jpg

Comment: 900 mm diameter culvert with concrete sandbag headwall.

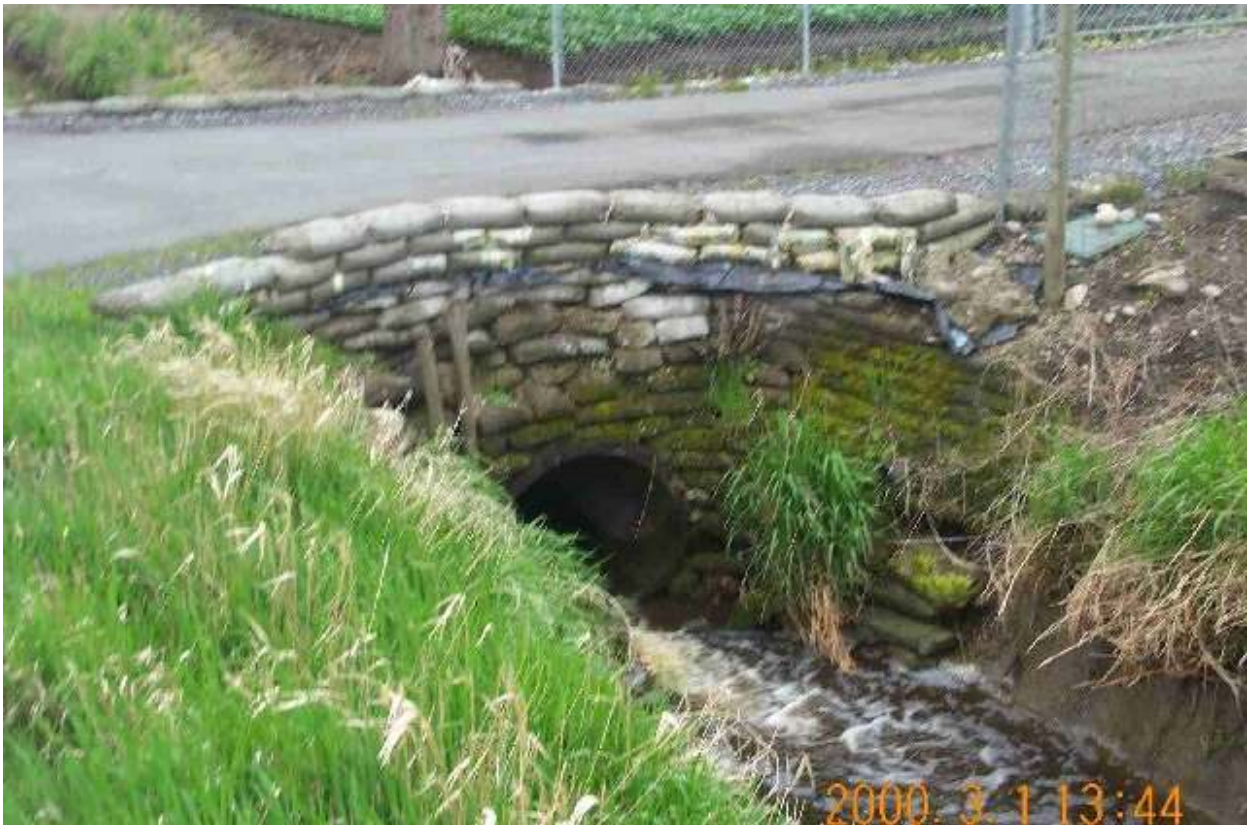
Photos P1000133.jpg

Comment: 750 mm diameter culvert with concrete sandbag headwalls built underneath a private driveway. Some sandbags in the headwall are damaged or have been replaced.

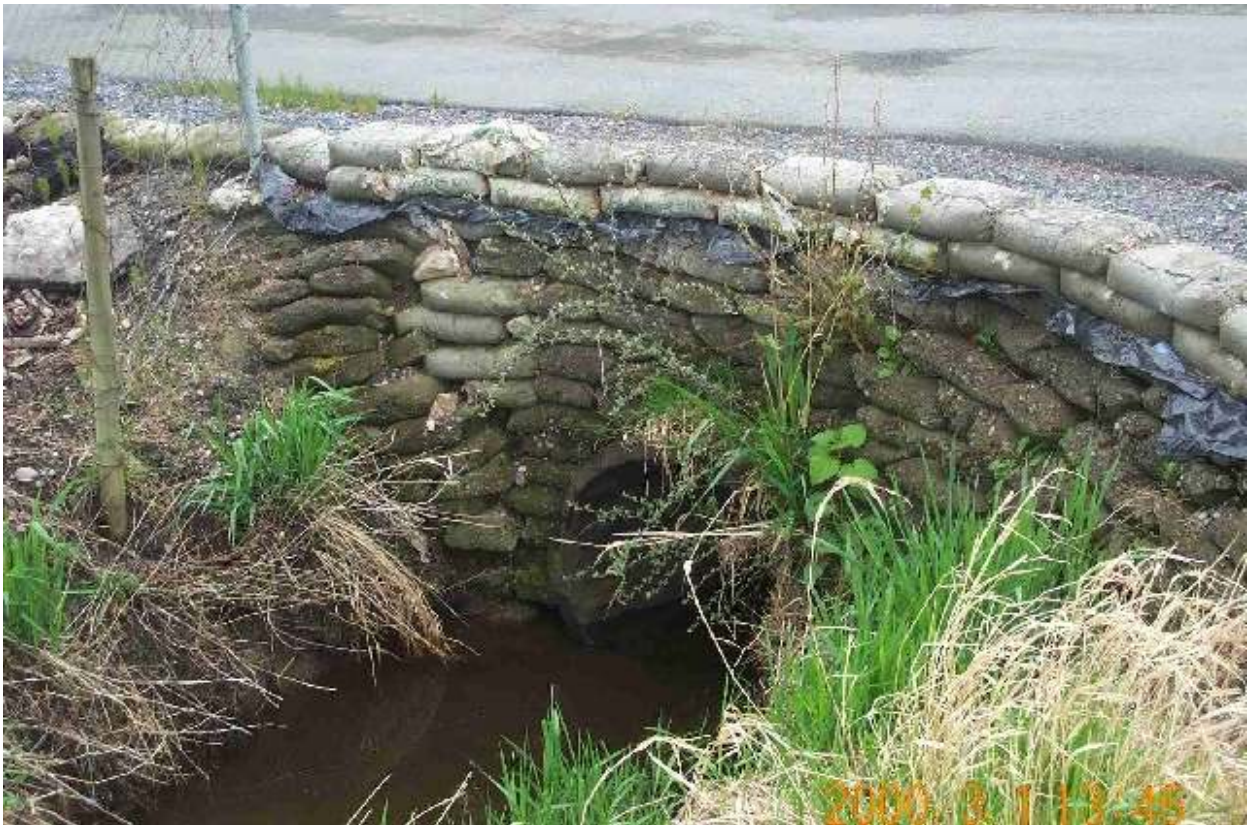
Photos P1000134.jpg

Comment: 750 mm diameter culvert with concrete sandbag headwalls built underneath a private driveway. Some sandbags in the headwall are damaged or have been replaced.

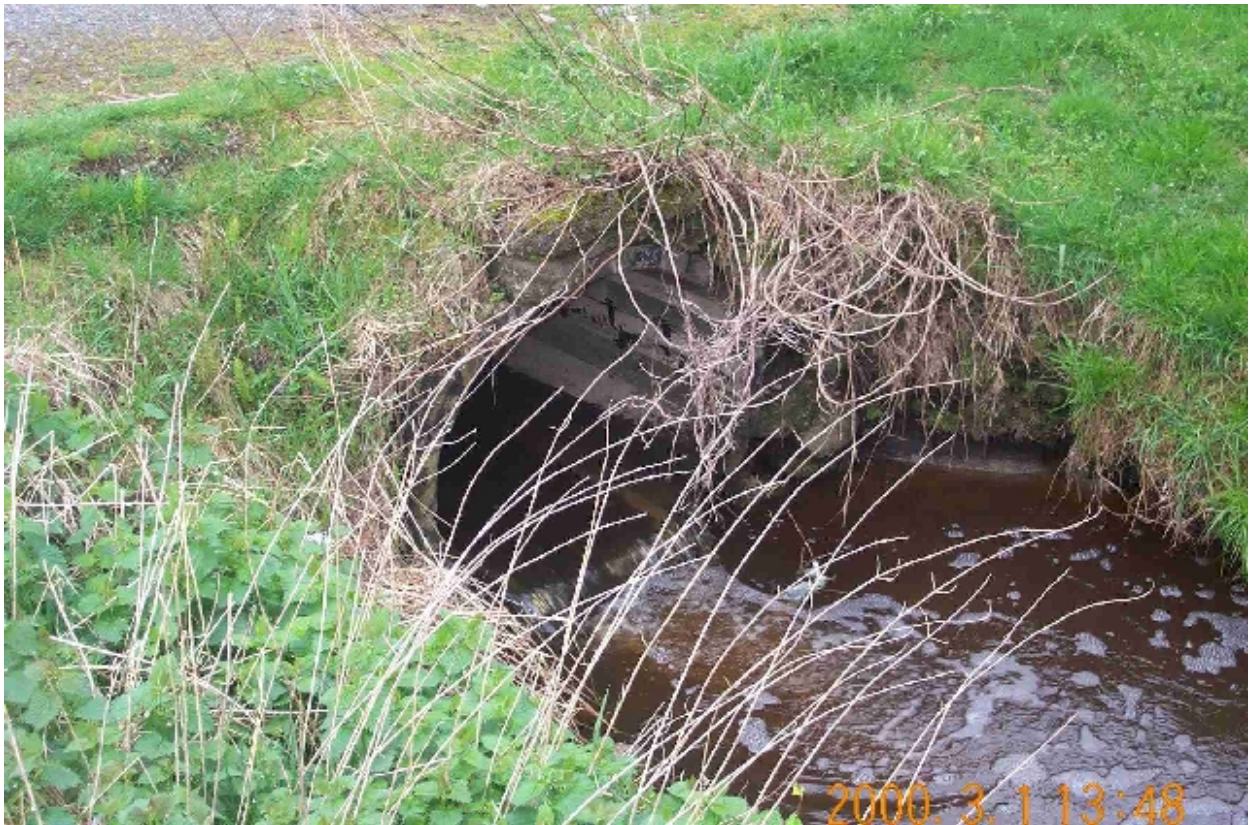
Photos P1000135.jpg

Comment: 1000 mm diameter culvert built underneath a private driveway.

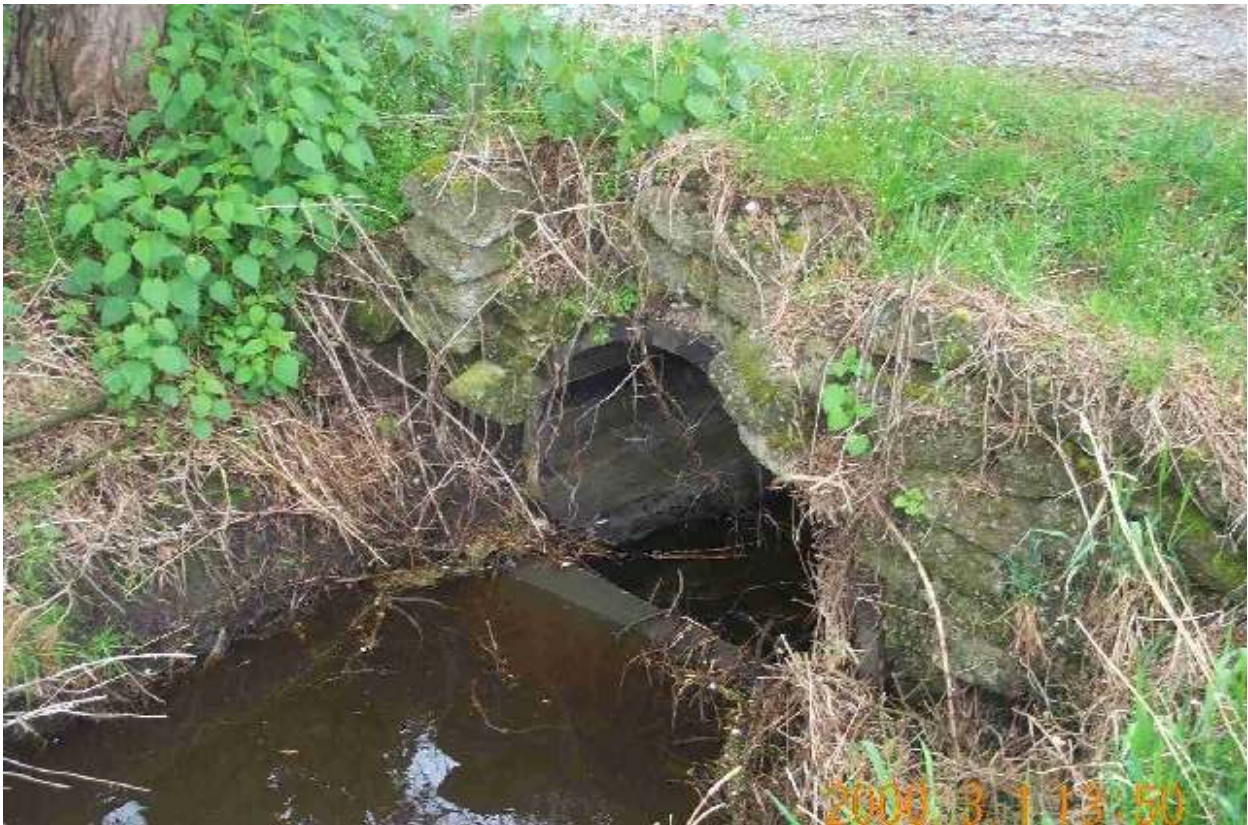
Photos P1000136.jpg

Comment: 750 mm diameter culvert with concrete sandbag headwalls built underneath a private driveway. Some sandbags in the headwall are damaged or have been replaced.

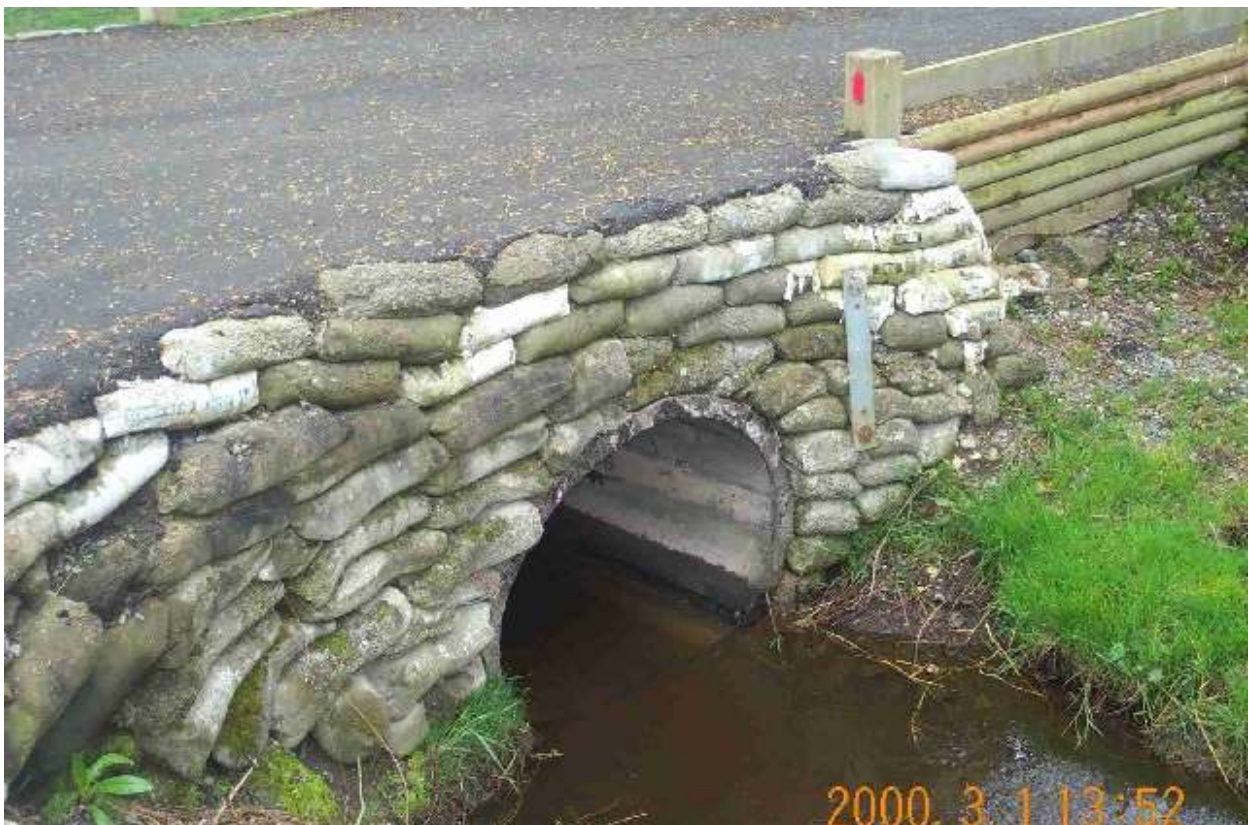
Photos P1000137.jpg

Comment: 1000 mm diameter culvert with a concrete sandbag headwall built underneath a private driveway. Sandbag headwall is bulging outwards and some sandbags have been replaced at the upper portion of the headwall.

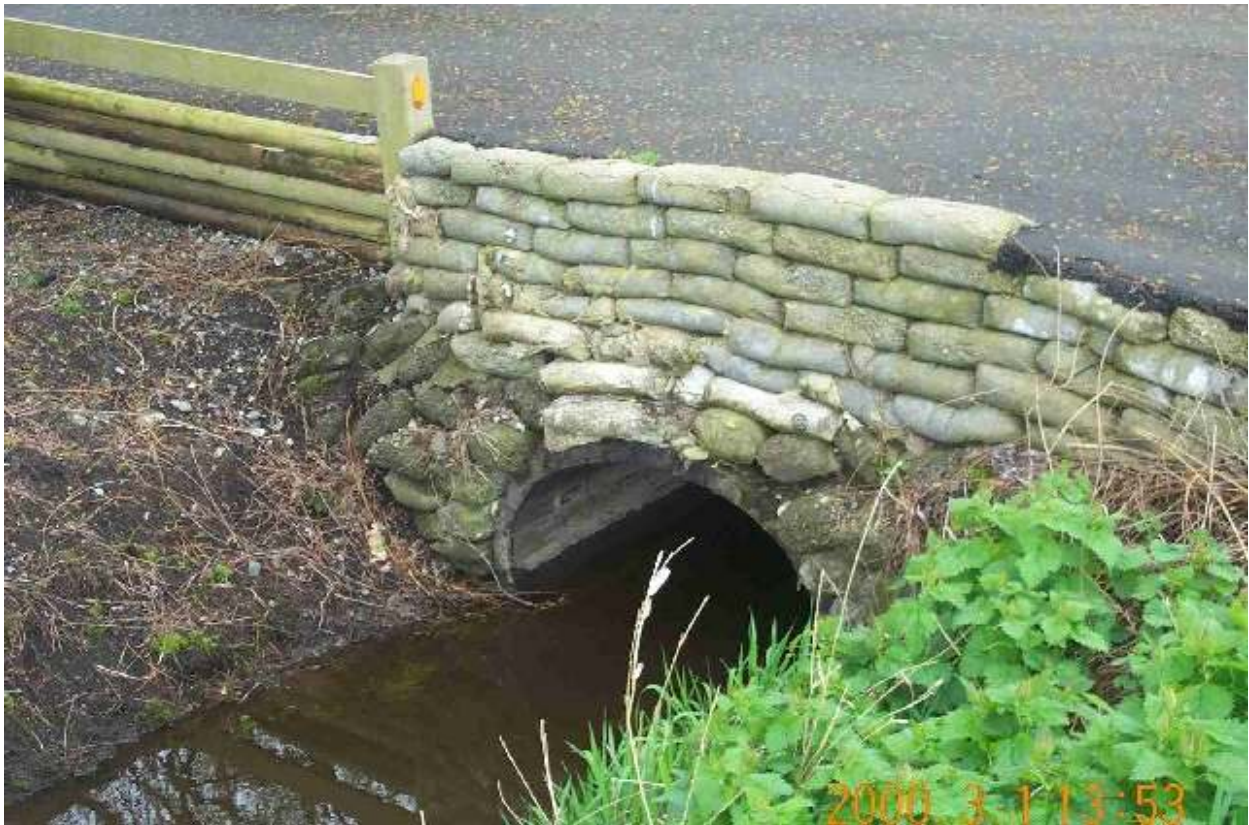
Photos P1000138.jpg

Comment: 1000 mm diameter culvert with a concrete sandbag headwall built underneath a private driveway. Sandbag headwall is bulging outwards and some sandbags have been replaced at the upper portion of the headwall.

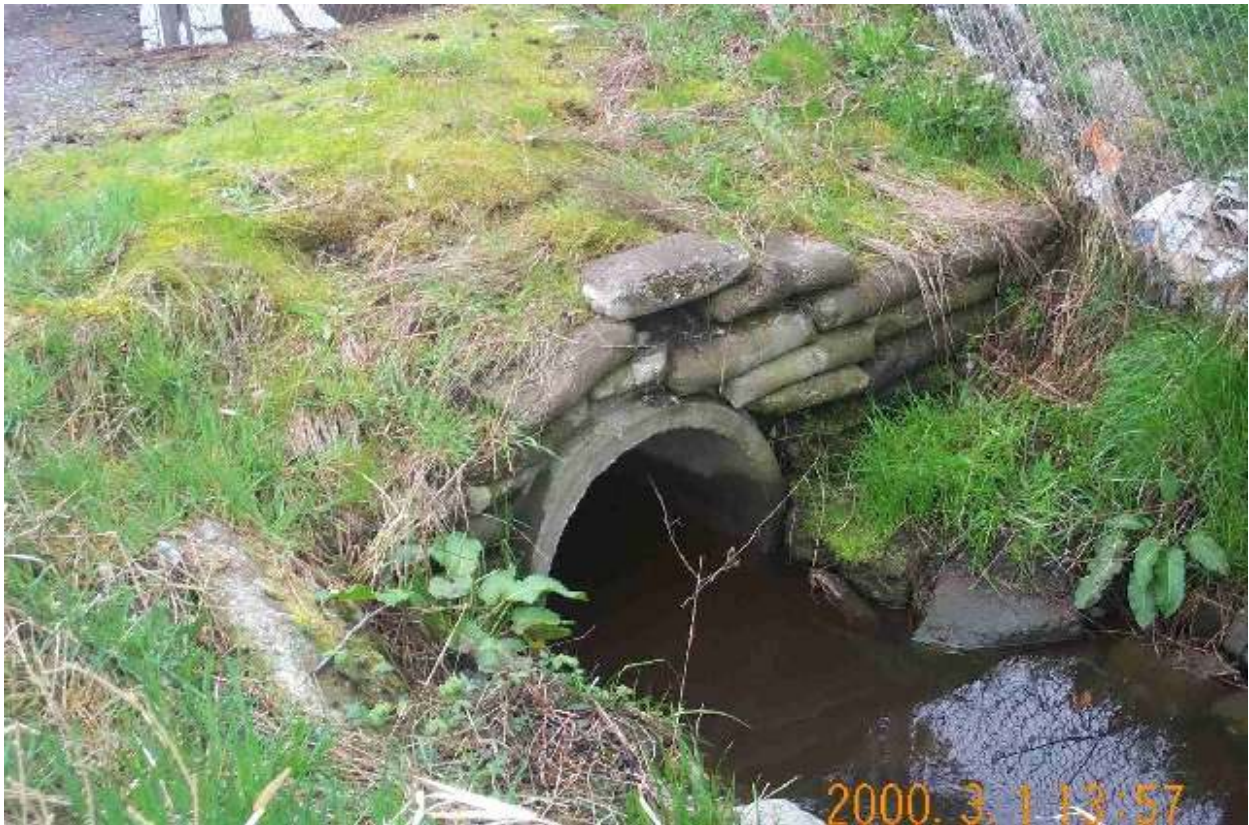
Photos P1000139.jpg

Comment: 750 mm diameter culvert with concrete sandbag headwall built underneath a private driveway.

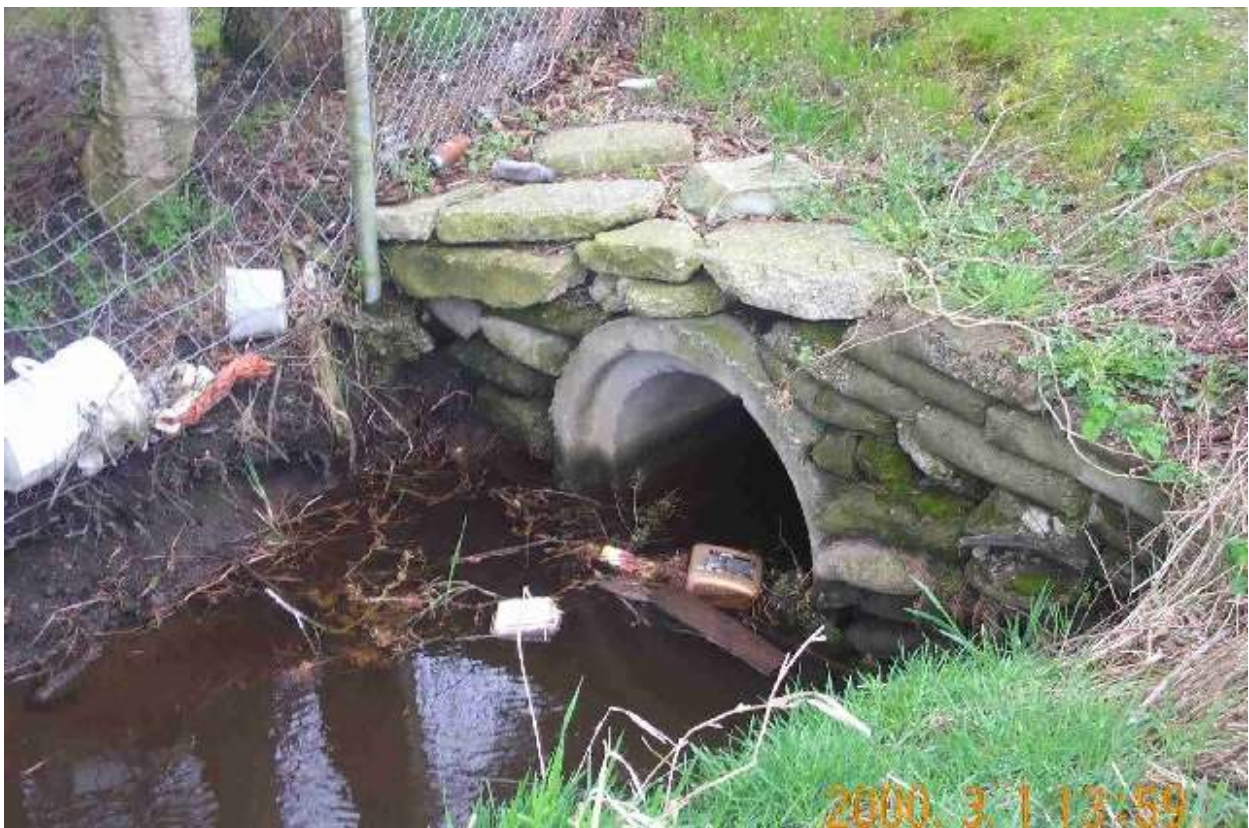
Photos P1000140.jpg

Comment: 750 mm diameter culvert with concrete sandbag headwall built underneath a private driveway. Some debris collected at concrete inlet.

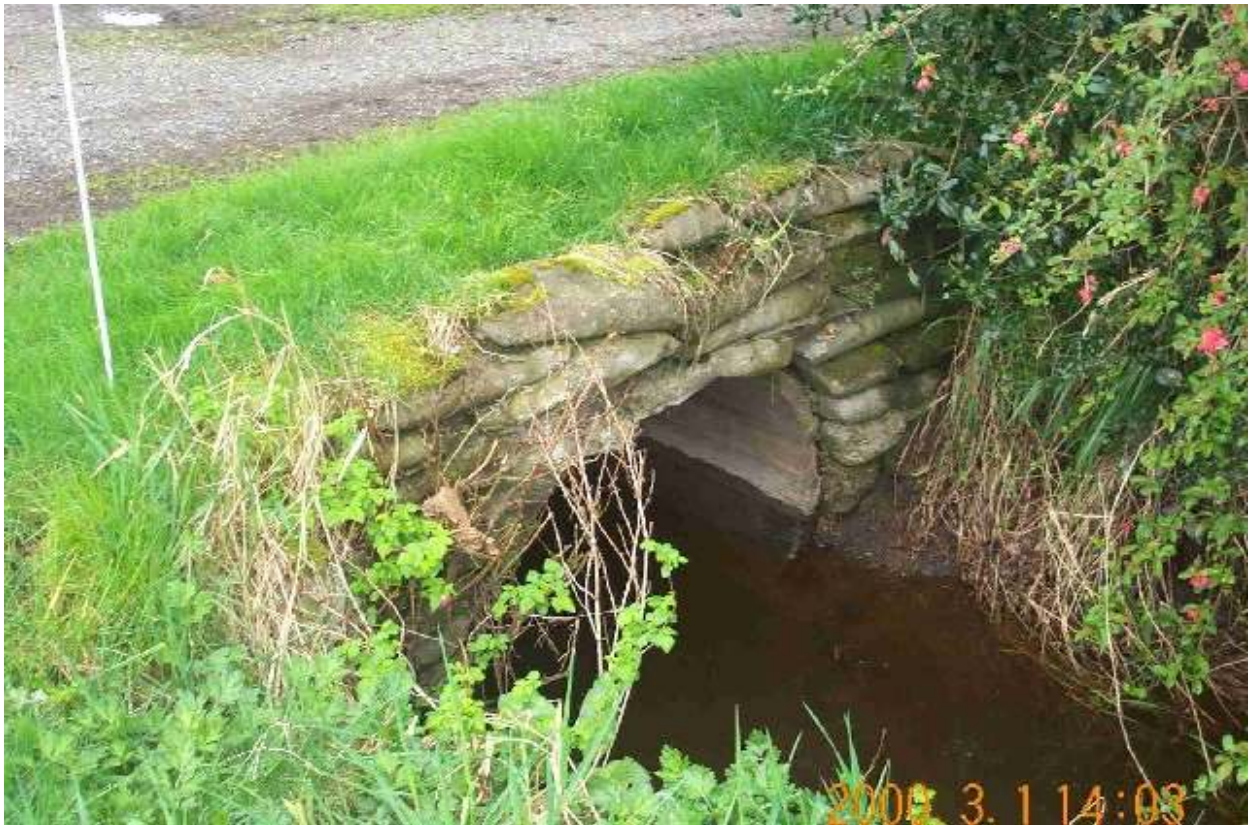
Photos P1000141.jpg

Comment: 1000 mm diameter culvert with concrete sandbag headwall built underneath a private driveway.

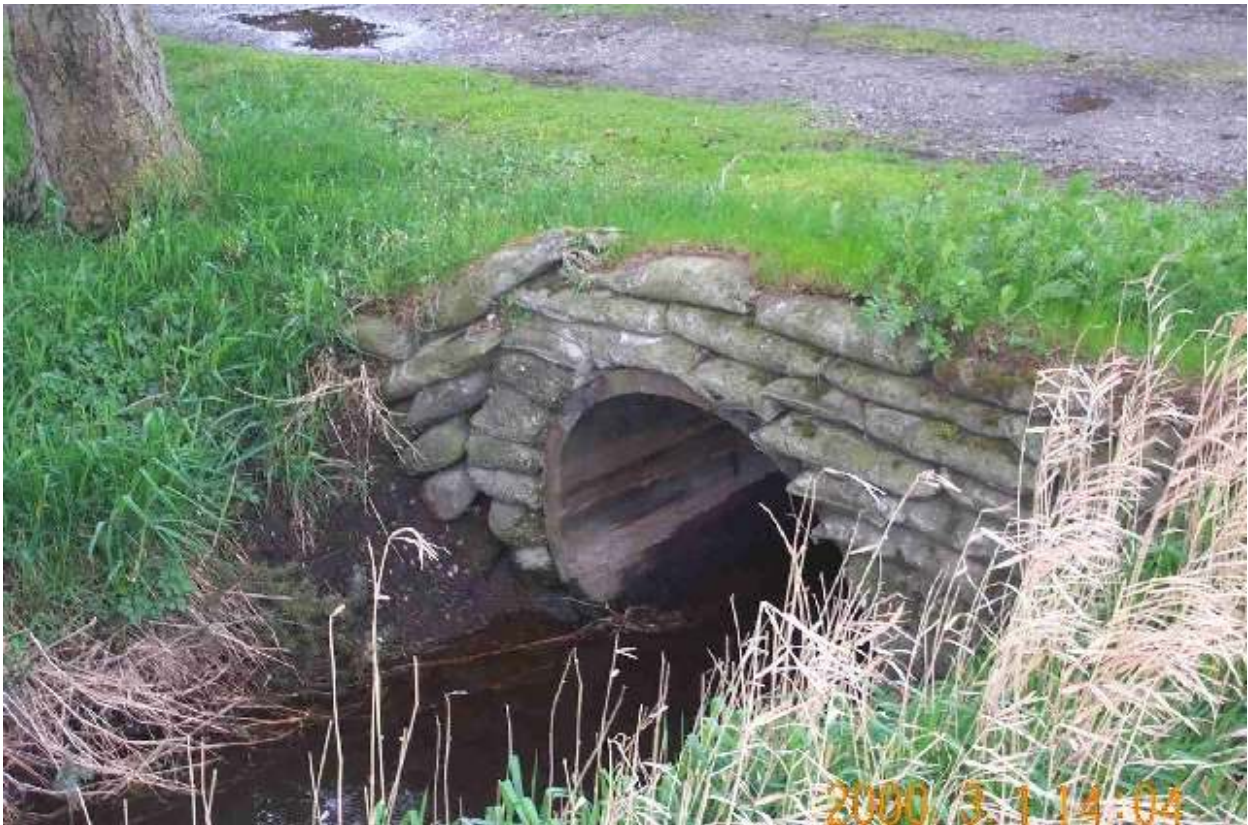
Photos P1000142.jpg

Comment: 1000 mm diameter culvert with concrete sandbag headwall built underneath a private driveway.

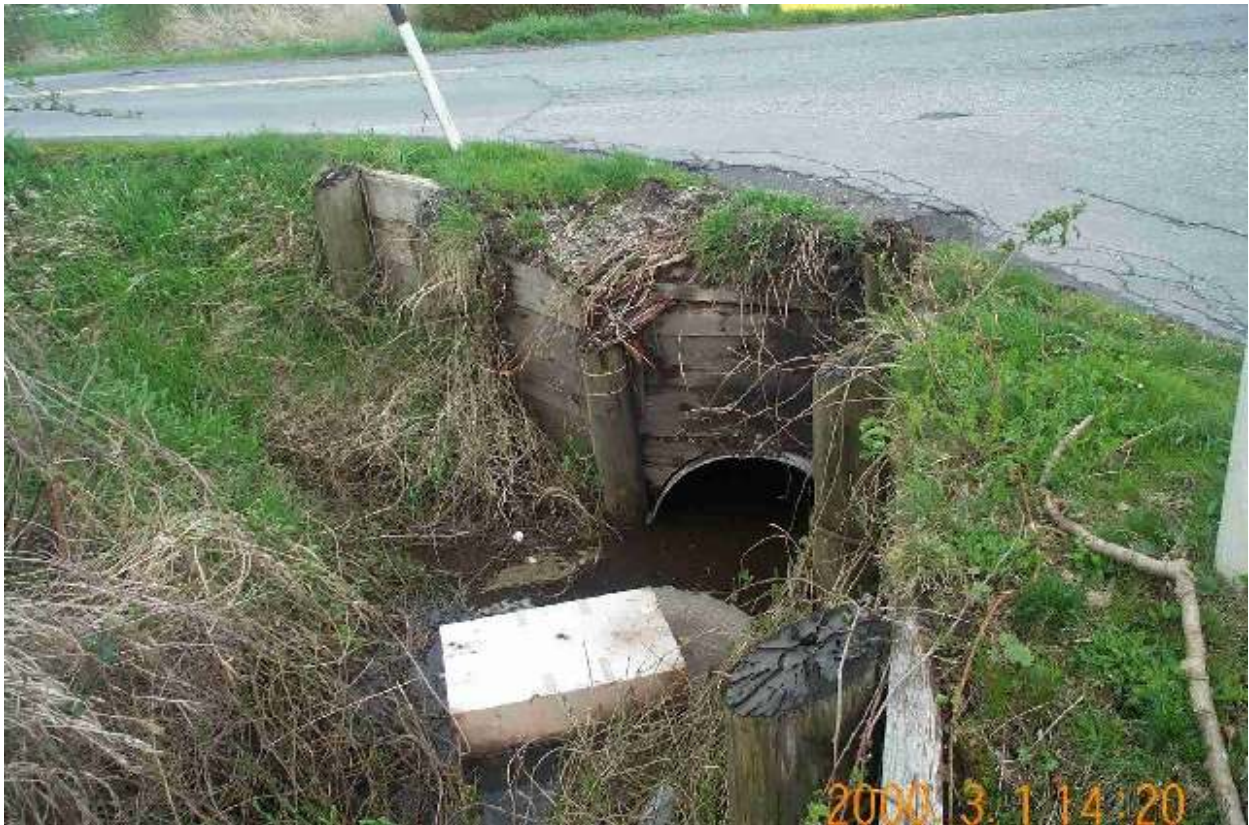
Photos P1000148.jpg

Comment: 1200 mm diameter culvert with timber headwall built underneath 184th Street.

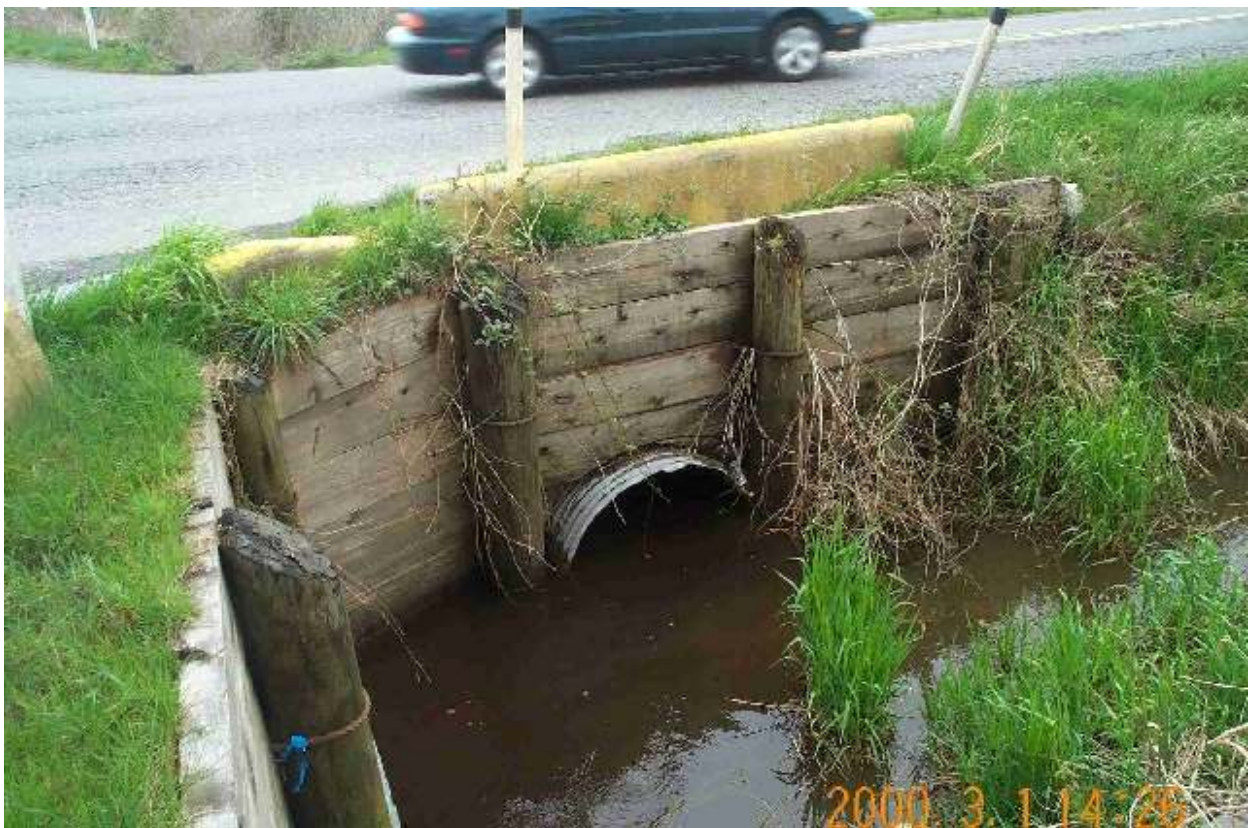
Photos P1000149.jpg

Channel Dimensions:	Left Bank Height:	2.0 m	Site Feature:	Culvert Inlet
	Left Bank Slope (H:V):	0.5:1		
	Right Bank Height:	0.0 m	Type:	CSP
	Right Bank Slope (H:V):	Vertical	Diameter:	1200mm
	Low Flow Channel Width:	0.0 m	Stability Issue:	
	Low Flow Channel Depth:	0.8 m

Comment: 1200 mm diameter culvert with timber headwall built underneath 184th Street. Confluence with partial flow from east side ditch on 184th Street.

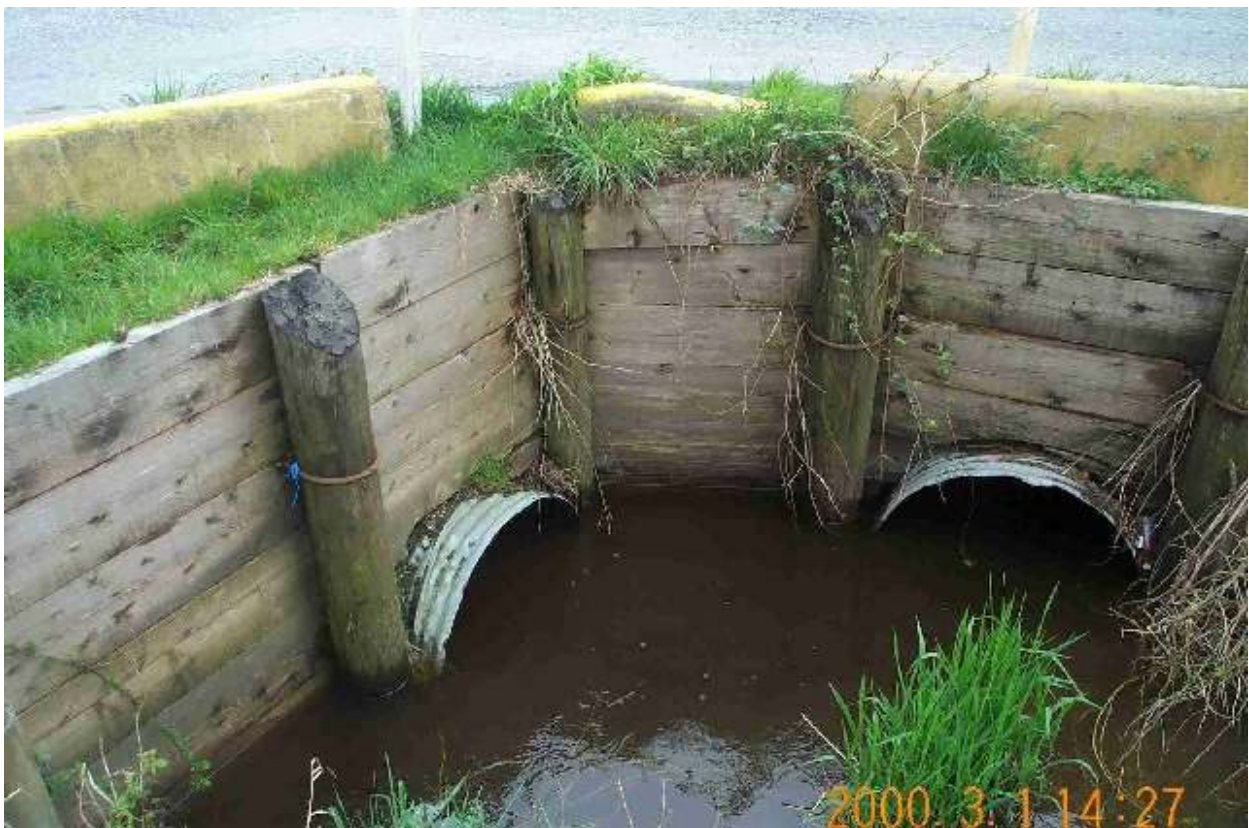
Photos P1000150.jpg

Channel Dimensions:	Left Bank Height:	2.0 m	Site Feature:	Culvert Outlet
	Left Bank Slope (H:V):	0.5:1		
	Right Bank Height:	0.0 m	Type:	CSP
	Right Bank Slope (H:V):	Vertical	Diameter:	1200mm
	Low Flow Channel Width:	0.0 m	Stability Issue:	
	Low Flow Channel Depth:	0.8 m

Comment: 1200 mm diameter culvert with timber headwall built underneath 40th Avenue.

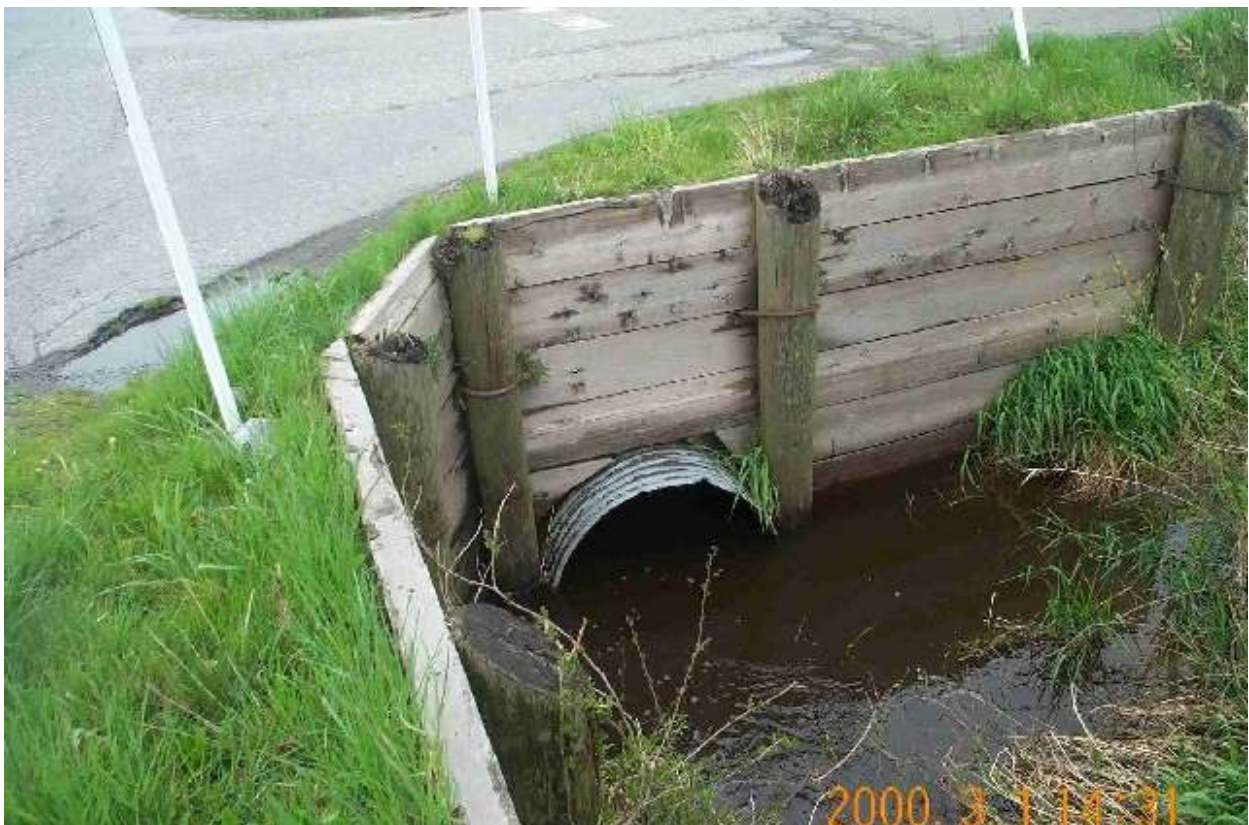
Photos P1000151.jpg

Channel Dimensions:	Left Bank Height:	2.2 m	Site Feature:	Culvert Inlet
	Left Bank Slope (H:V):	0.5:1		
	Right Bank Height:	0.0 m	Type:	
	Right Bank Slope (H:V):	Vertical	Diameter:	1200mm
	Low Flow Channel Width:	0.0 m	Stability Issue:	
	Low Flow Channel Depth:	0.5 m

Comment: 1200 mm diameter culvert with timber headwall built underneath 40th Avenue.

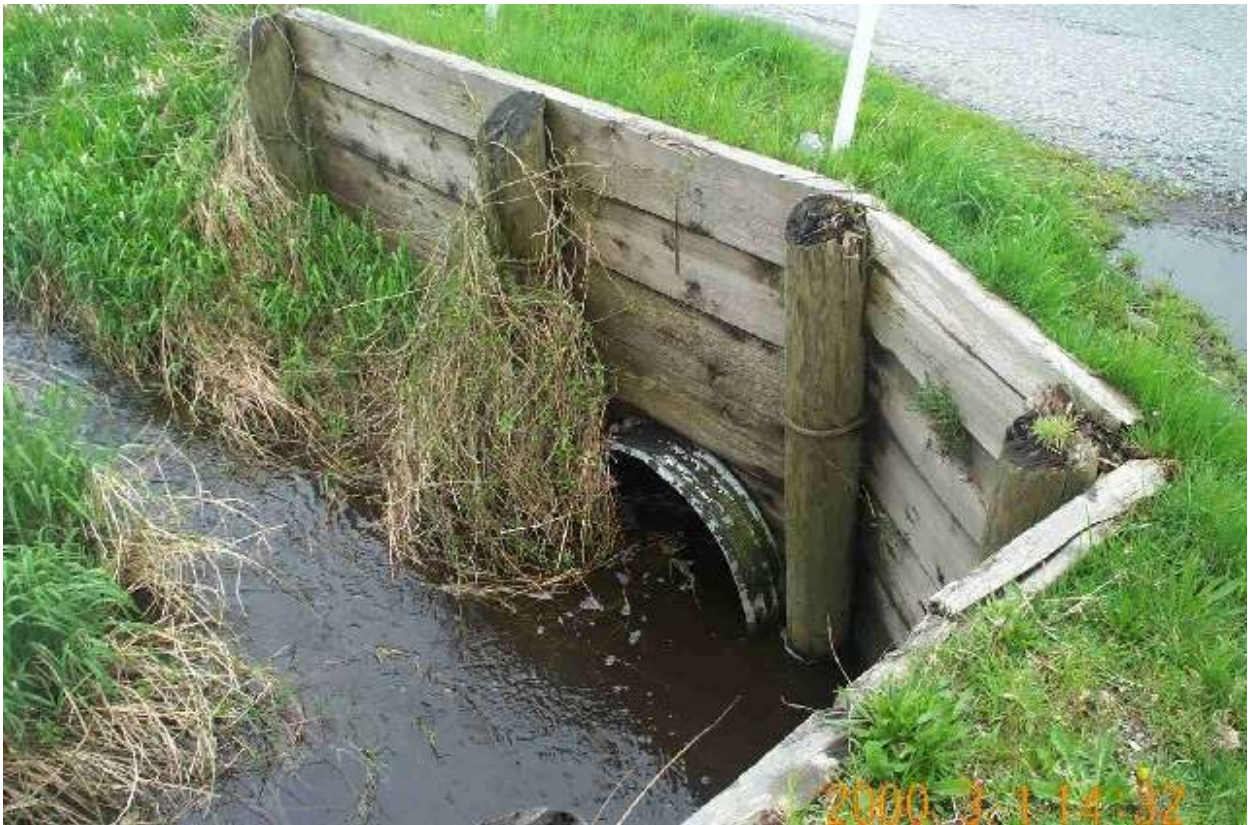
Photos P1000152.jpg

Channel Dimensions:	Left Bank Height:	0.0 m	Site Feature:	Culvert Inlet
	Left Bank Slope (H:V):	Vertical		
	Right Bank Height:	0.0 m	Type:	CSP
	Right Bank Slope (H:V):	Vertical	Diameter:	1200mm
	Low Flow Channel Width:	0.0 m	Stability Issue:	
	Low Flow Channel Depth:	0.0 m

Comment: 1200 mm diameter culvert with timber headwall built underneath 184th Street. Confluence with partial flow from east side ditch on 184th Street.

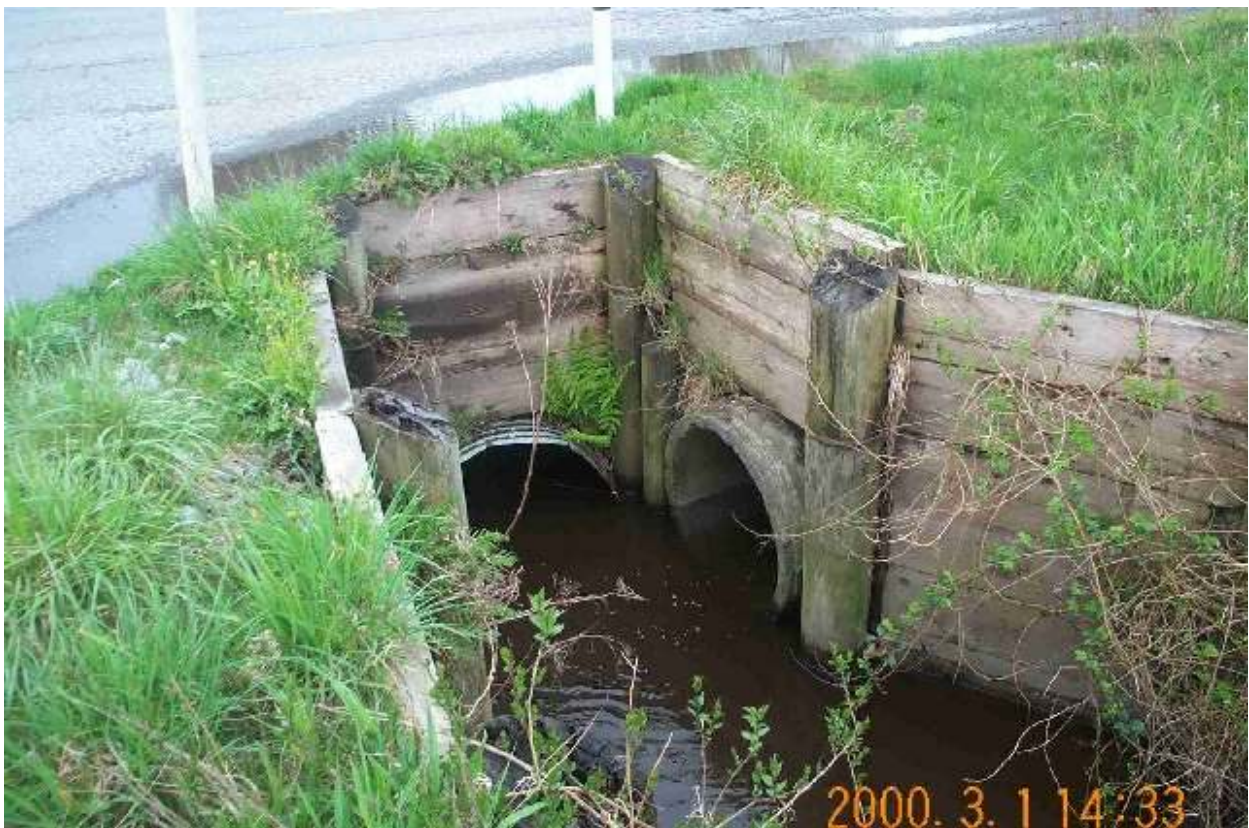
Photos P1000153.jpg

Channel Dimensions:	Left Bank Height:	2.2 m	Site Feature:	Culvert Outlet
	Left Bank Slope (H:V):	0.5:1		
	Right Bank Height:	0.0 m	Type:	CSP
	Right Bank Slope (H:V):	Vertical	Diameter:	1200mm
	Low Flow Channel Width:	0.0 m	Stability Issue:	
	Low Flow Channel Depth:	0.6 m

Comment: 1200 mm diameter culvert with timber headwall built underneath 184th Street. Confluence with west side ditch on 184th Street.

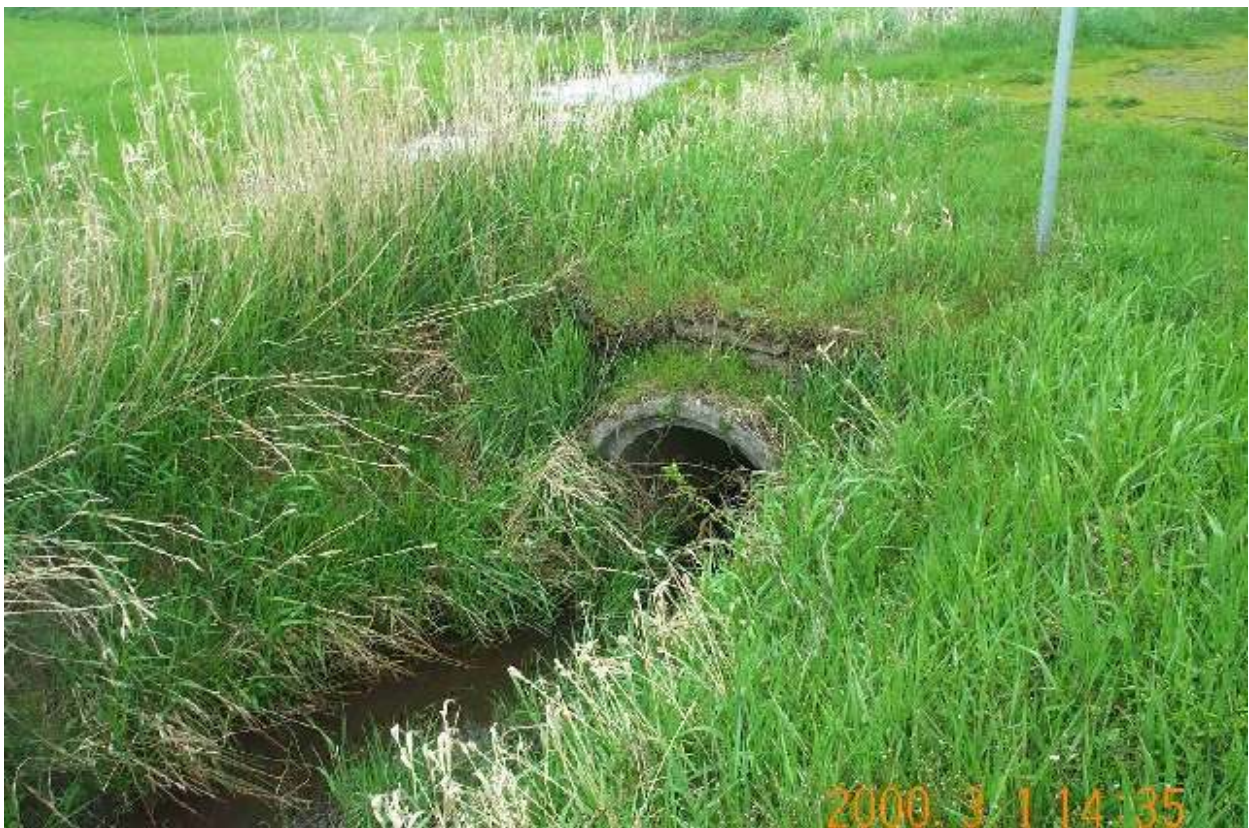
Photos P1000154.jpg

Channel Dimensions:	Left Bank Height:	2.0 m	Site Feature:	Culvert Inlet
	Left Bank Slope (H:V):	0.6:1		
	Right Bank Height:	2.5 m	Type:	Concrete
	Right Bank Slope (H:V):	0.6:1	Diameter:	900mm
	Low Flow Channel Width:	1.0 m	Stability Issue:	
	Low Flow Channel Depth:	0.2 m

Comment: 900 mm diameter culvert with concrete sandbag headwall and built underneath a vehicle access to a private field.

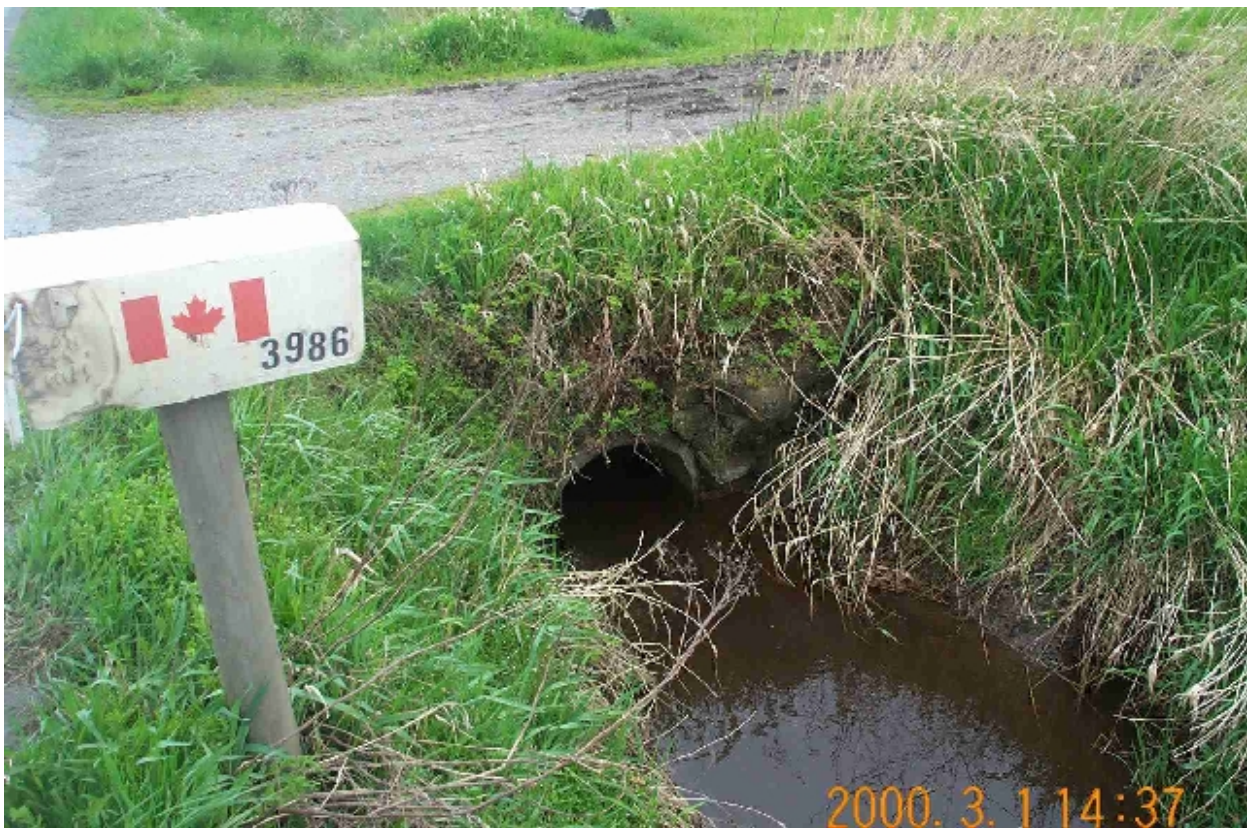
Photos P1000155.jpg

Channel Dimensions:	Left Bank Height:	2.0 m	Site Feature:	Culvert Outlet
	Left Bank Slope (H:V):	0.6:1		
	Right Bank Height:	2.5 m	Type:	Concrete
	Right Bank Slope (H:V):	0.6:1	Diameter:	900mm
	Low Flow Channel Width:	1.5 m	Stability Issue:	
	Low Flow Channel Depth:	0.3 m

Comment: 900 mm diameter culvert with concrete sandbag headwall and built underneath a vehicle access to a private field.

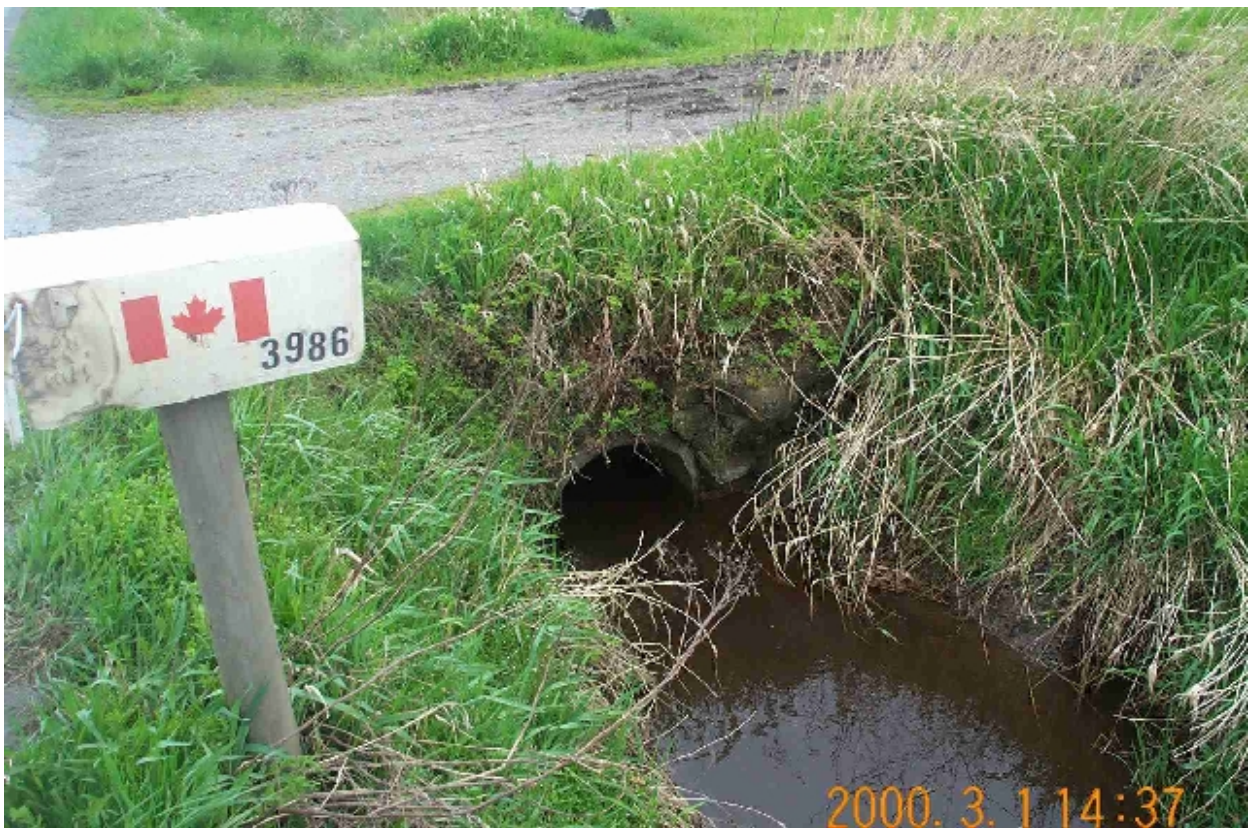
Photos P1000155.jpg

Channel Dimensions:	Left Bank Height:	2.0 m	Site Feature:	Culvert Inlet
	Left Bank Slope (H:V):	0.7:1		
	Right Bank Height:	2.5 m	Type:	Concrete
	Right Bank Slope (H:V):	0.6:1	Diameter:	900mm
	Low Flow Channel Width:	1.2 m	Stability Issue:	
	Low Flow Channel Depth:	0.2 m

Comment: 900 mm diameter culvert with concrete sandbag headwall and built underneath a vehicle access to a private field.

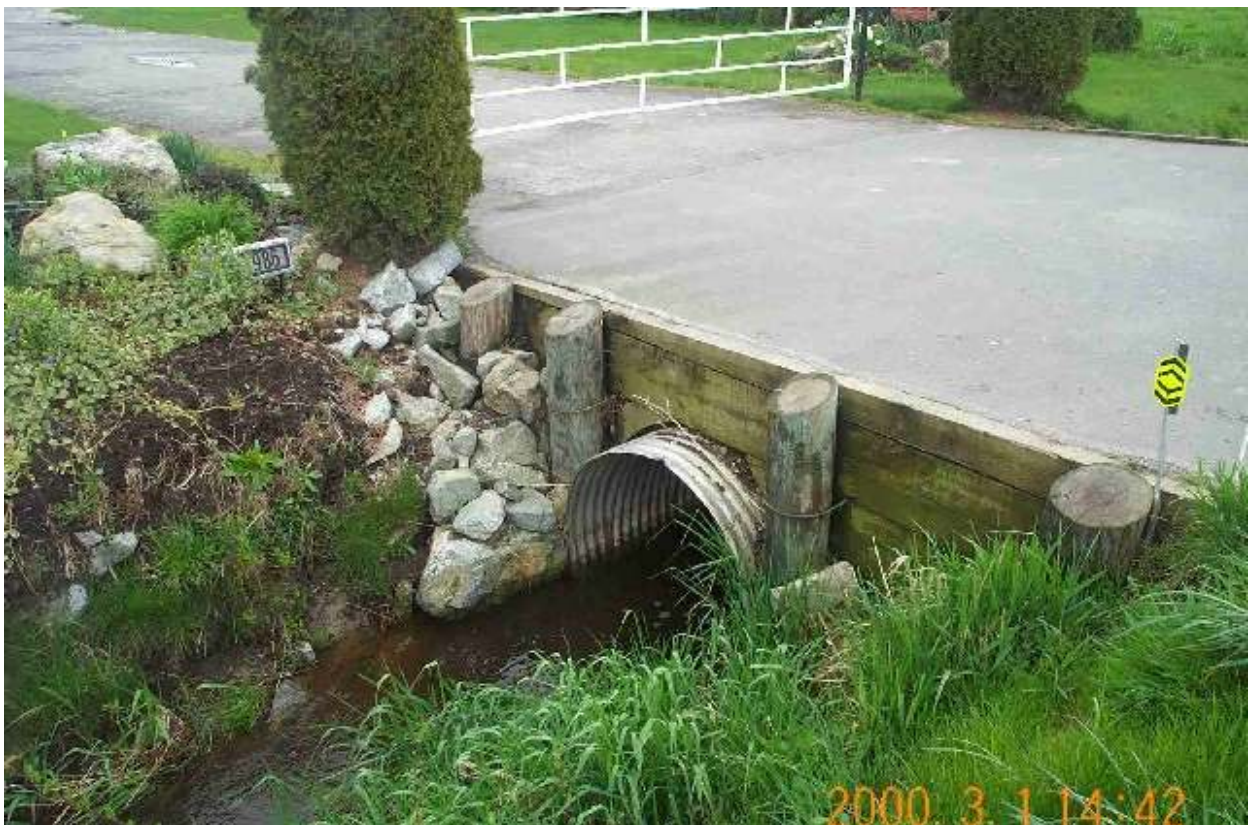
Photos P1000157.jpg

Channel Dimensions:	Left Bank Height:	2.2 m	Site Feature:	Culvert Outlet
	Left Bank Slope (H:V):	0.7:1		
	Right Bank Height:	1.2 m	Type:	CSP
	Right Bank Slope (H:V):	0.7:1	Diameter:	1200mm
	Low Flow Channel Width:	1.2 m	Stability Issue:	
	Low Flow Channel Depth:	0.3 m

Comment: 1200 mm diameter culvert with timber headwall and built underneath a private driveway. Outlet is armored with rip rap.
