City of Surrey

Erickson Creek Integrated Stormwater Management Plan

September 2010

**Re: ERICKSON CREEK INTEGRATED STORMWATER MANAGEMENT PLAN
FINAL REPORT**

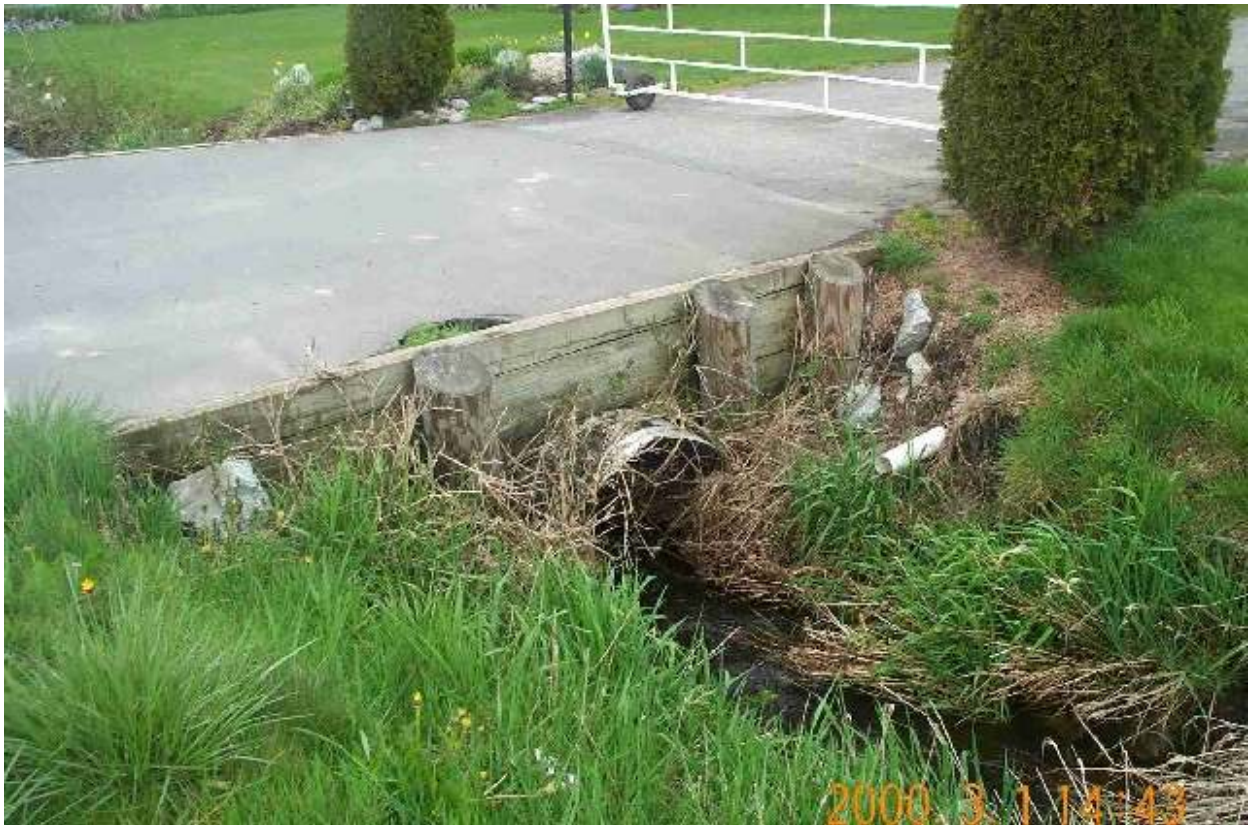
Photos P1000158.jpg

Channel Dimensions:	Left Bank Height:	2.2 m	Site Feature:	Culvert Inlet
	Left Bank Slope (H:V):	0.7:1		
	Right Bank Height:	1.2 m	Type:	CSP
	Right Bank Slope (H:V):	0.7:1	Diameter:	1200mm
	Low Flow Channel Width:	1.2 m	Stability Issue:	
	Low Flow Channel Depth:	0.3 m

Comment: 1200 mm diameter culvert with timber headwall and built underneath a private driveway.

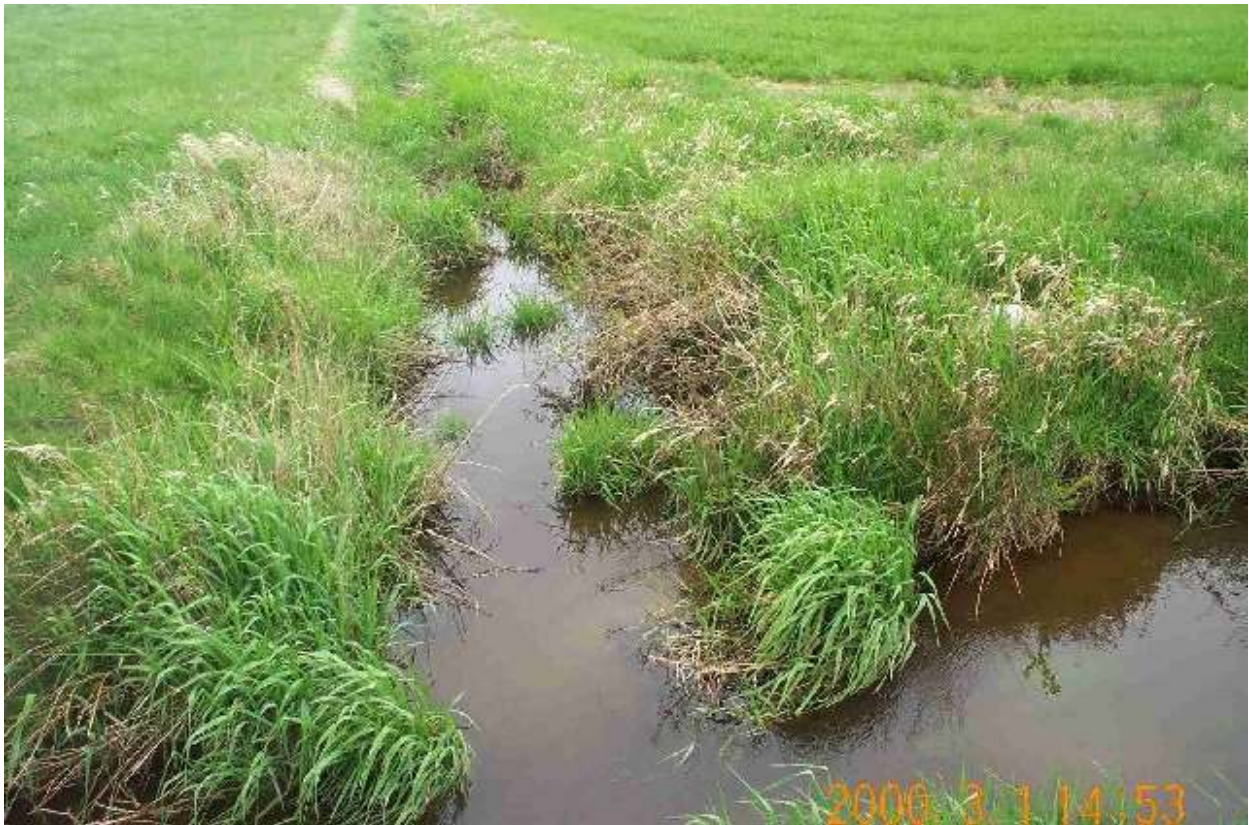
Photos P1000160.jpg

Channel Dimensions:	Left Bank Height:	1.8 m	Site Feature:	Confluence
	Left Bank Slope (H:V):	0.7:1		
	Right Bank Height:	1.6 m		
	Right Bank Slope (H:V):	0.6:1		
	Low Flow Channel Width:	1.5 m		
	Low Flow Channel Depth:	0.4 m

Comment: Confluence with ditch draining field to the east.

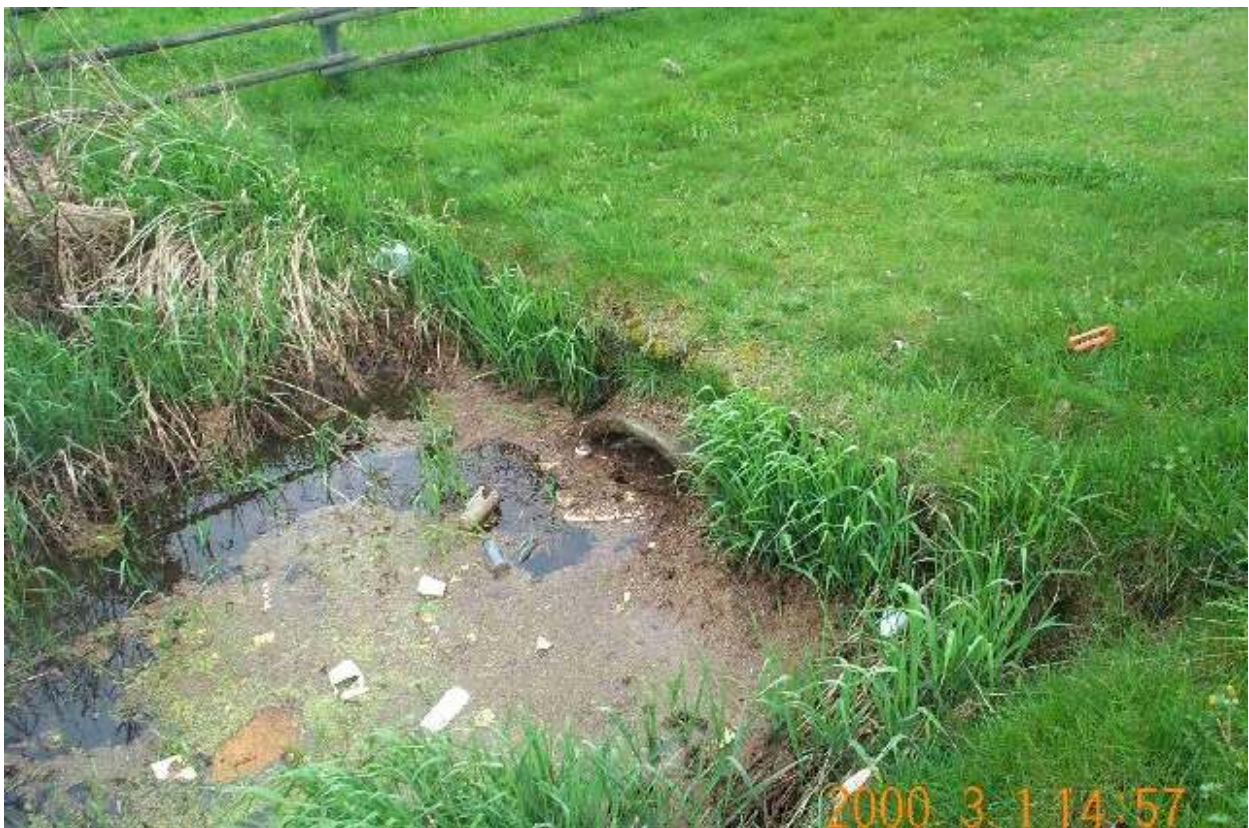
Photos P1000161.jpg

Channel Dimensions:	Left Bank Height:	1.8 m	Site Feature:	Culvert Outlet
	Left Bank Slope (H:V):	0.8:1		
	Right Bank Height:	1.2 m	Type:	Concrete
	Right Bank Slope (H:V):	0.8:1	Diameter:	900mm
	Low Flow Channel Width:	2.5 m	Stability Issue:	
	Low Flow Channel Depth:	0.6 m

Comment: 900 mm diameter culvert with no headwall built underneath a private driveway.

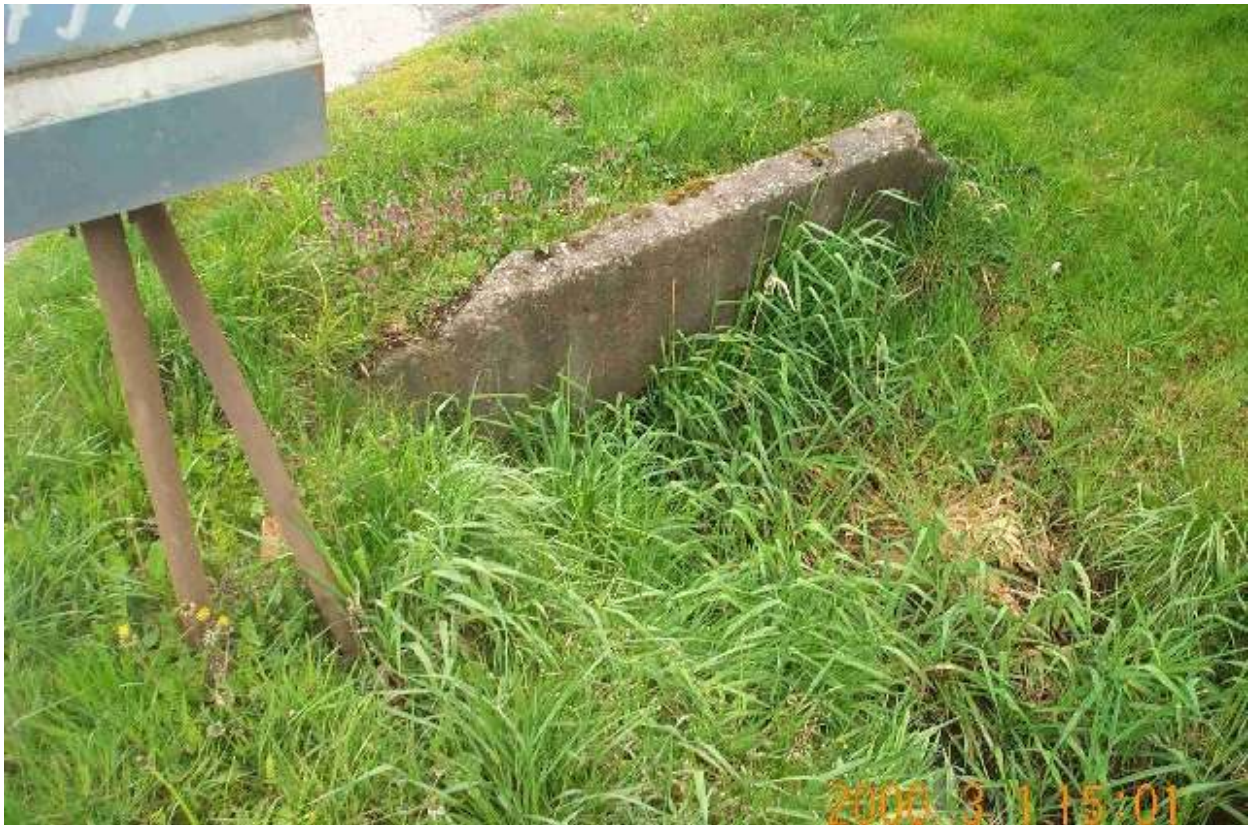
Photos P1000162.jpg

Channel Dimensions:	Left Bank Height:	0.8 m	Site Feature:	Culvert Outlet
	Left Bank Slope (H:V):	0.8:1		
	Right Bank Height:	2.0 m	Type:	Concrete
	Right Bank Slope (H:V):	0.6:1	Diameter:	450mm
	Low Flow Channel Width:	0.8 m	Stability Issue:	
	Low Flow Channel Depth:	0.2 m

Comment: 450 mm diameter culvert with concrete headwall built underneath a private driveway. The headwall is bulging outwards.

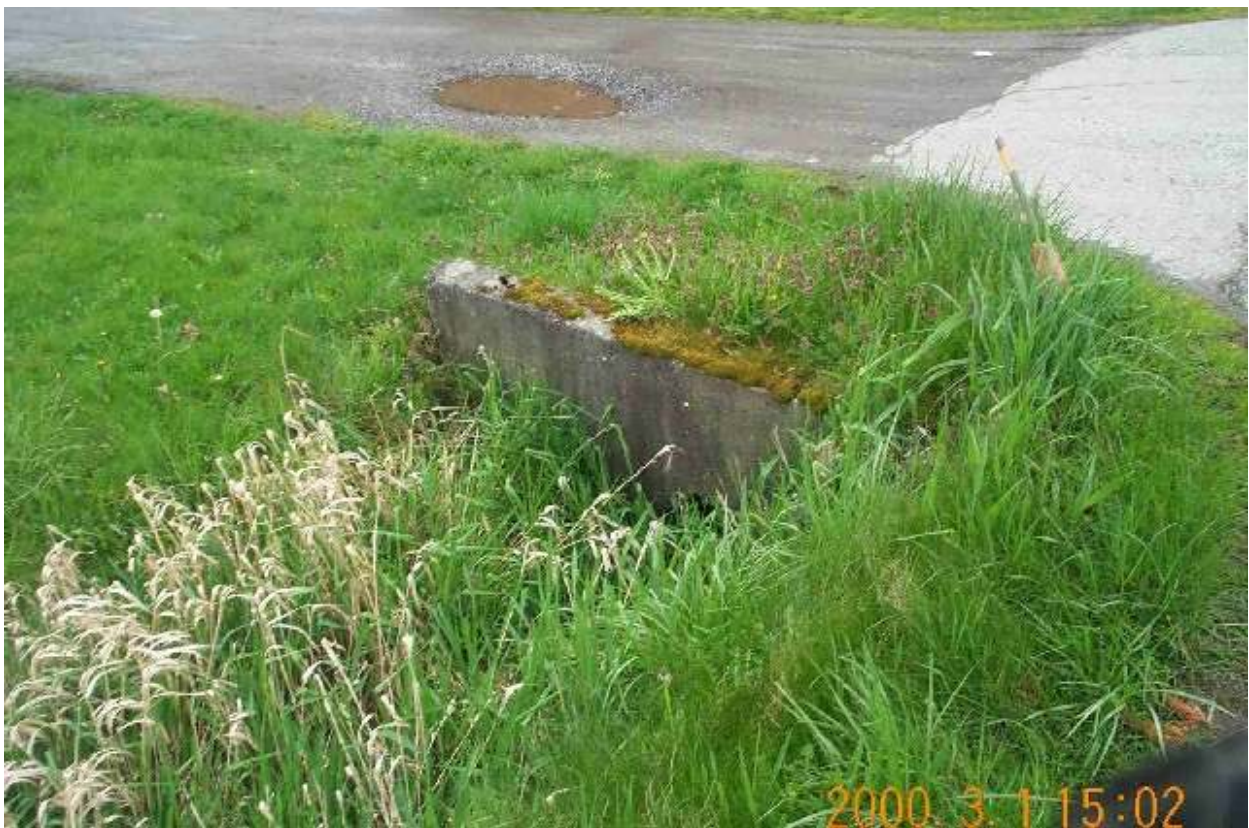
Photos P1000163.jpg

Channel Dimensions:	Left Bank Height:	0.8 m	Site Feature:	Culvert Inlet
	Left Bank Slope (H:V):	0.8:1		
	Right Bank Height:	2.0 m	Type:	Concrete
	Right Bank Slope (H:V):	0.6:1	Diameter:	450mm
	Low Flow Channel Width:	1.0 m	Stability Issue:	
	Low Flow Channel Depth:	0.2 m

Comment: 450 mm diameter culvert with concrete headwall built underneath a private driveway. The headwall is bulging outwards.

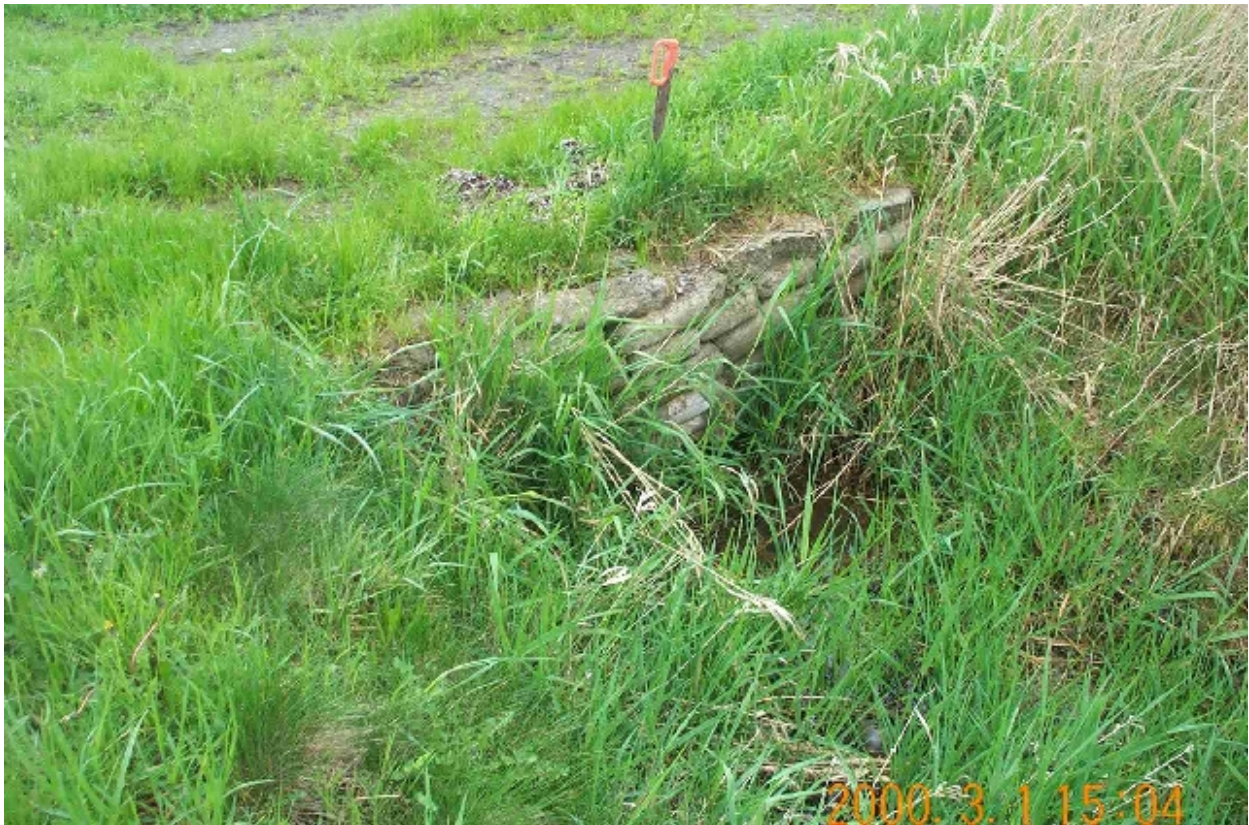
Photos P1000164.jpg

Channel Dimensions:	Left Bank Height:	1.0 m	Site Feature:	Culvert Outlet
	Left Bank Slope (H:V):	0.6:1		
	Right Bank Height:	1.8 m	Type:	PVC
	Right Bank Slope (H:V):	0.6:1	Diameter:	450mm
	Low Flow Channel Width:	1.0 m	Stability Issue:	
	Low Flow Channel Depth:	0.2 m

Comment: 450 mm diameter culvert with concrete sandbag headwall built underneath a private driveway. The headwall is bulging outwards.

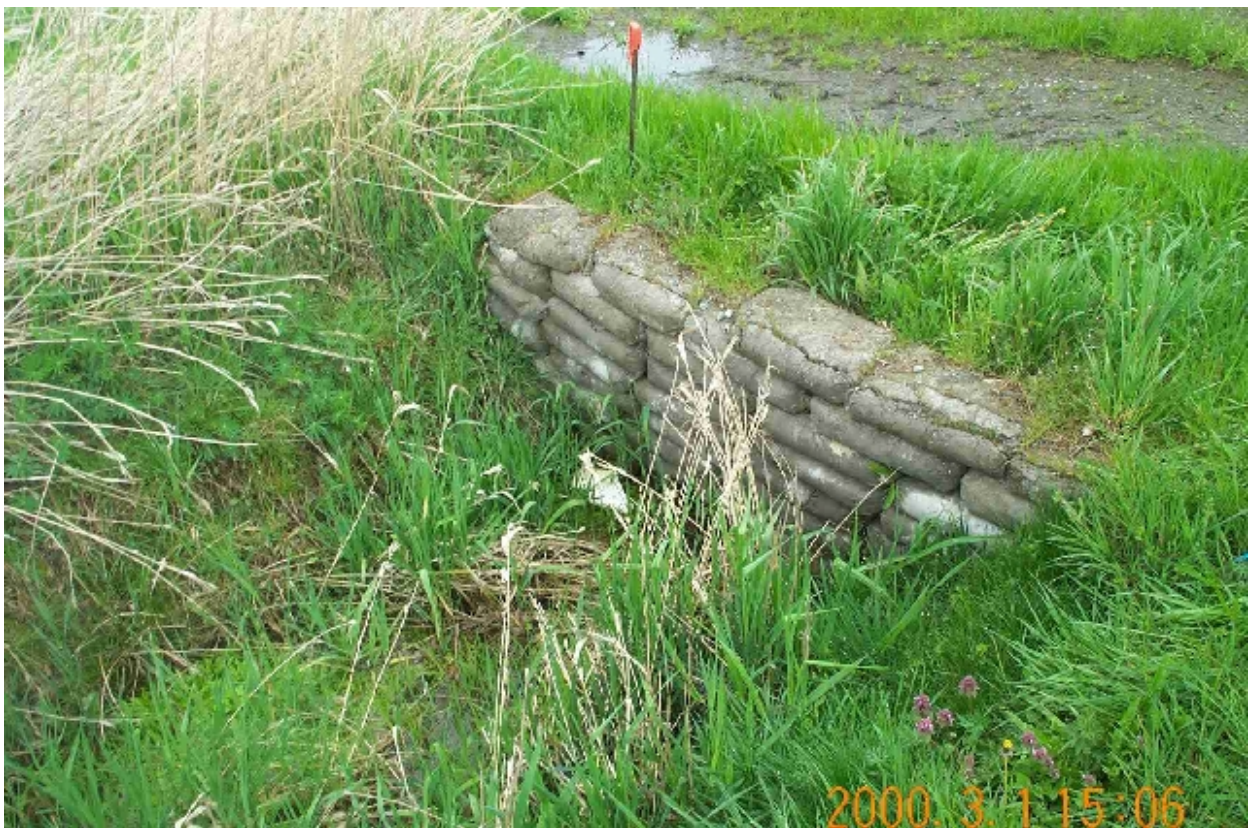
Photos P1000165.jpg

Channel Dimensions:	Left Bank Height:	1.0 m	Site Feature:	Culvert Inlet
	Left Bank Slope (H:V):	0.6:1		
	Right Bank Height:	1.8 m	Type:	PVC
	Right Bank Slope (H:V):	0.6:1	Diameter:	450mm
	Low Flow Channel Width:	1.0 m	Stability Issue:	
	Low Flow Channel Depth:	0.2 m

Comment: 450 mm diameter culvert with concrete sandbag headwall built underneath a private driveway. The headwall is bulging outwards.

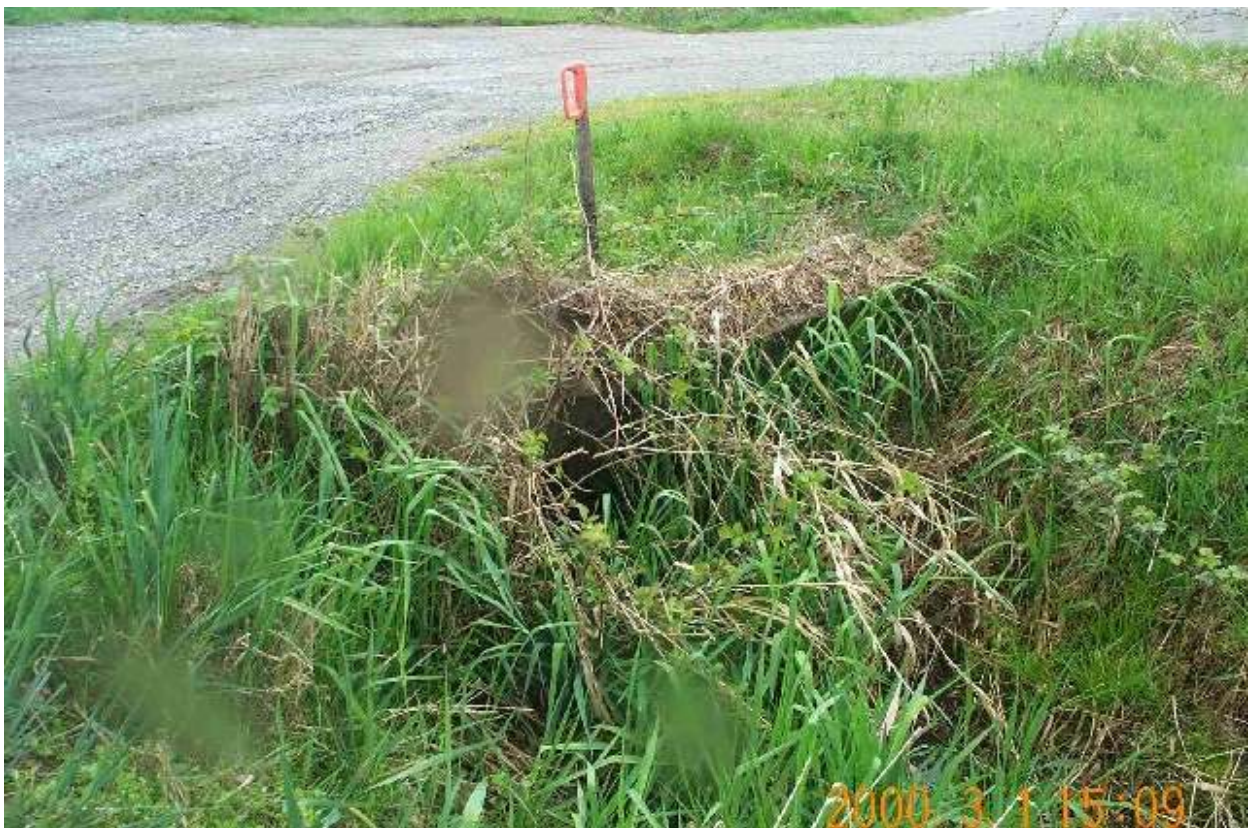
Photos P1000166.jpg

Channel Dimensions:	Left Bank Height:	1.2 m	Site Feature:	Culvert Outlet
	Left Bank Slope (H:V):	0.6:1		
	Right Bank Height:	1.6 m	Type:	Concrete
	Right Bank Slope (H:V):	0.8:1	Diameter:	600mm
	Low Flow Channel Width:	1.0 m	Stability Issue:	
	Low Flow Channel Depth:	0.2 m

Comment: 600 mm diameter culvert with cinder block headwall build underneath a private driveway. The headwall is bulging outwards.

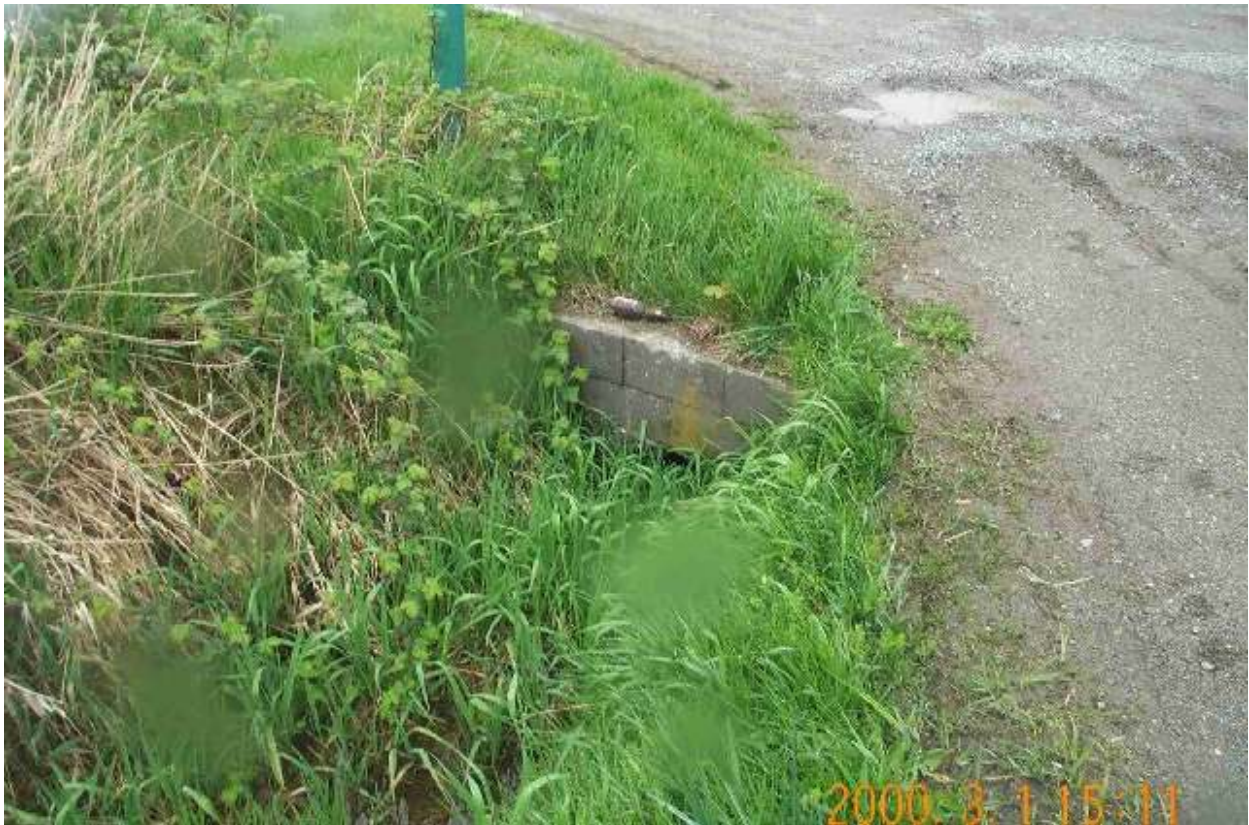
Photos P1000167.jpg

Channel Dimensions:	Left Bank Height:	1.5 m	Site Feature:	Culvert Inlet
	Left Bank Slope (H:V):	0.6:1		
	Right Bank Height:	1.8 m	Type:	Concrete
	Right Bank Slope (H:V):	0.6:1	Diameter:	600mm
	Low Flow Channel Width:	1.0 m	Stability Issue:	
	Low Flow Channel Depth:	0.2 m

Comment: 600 mm diameter culvert with cinder block headwall build underneath a private driveway.

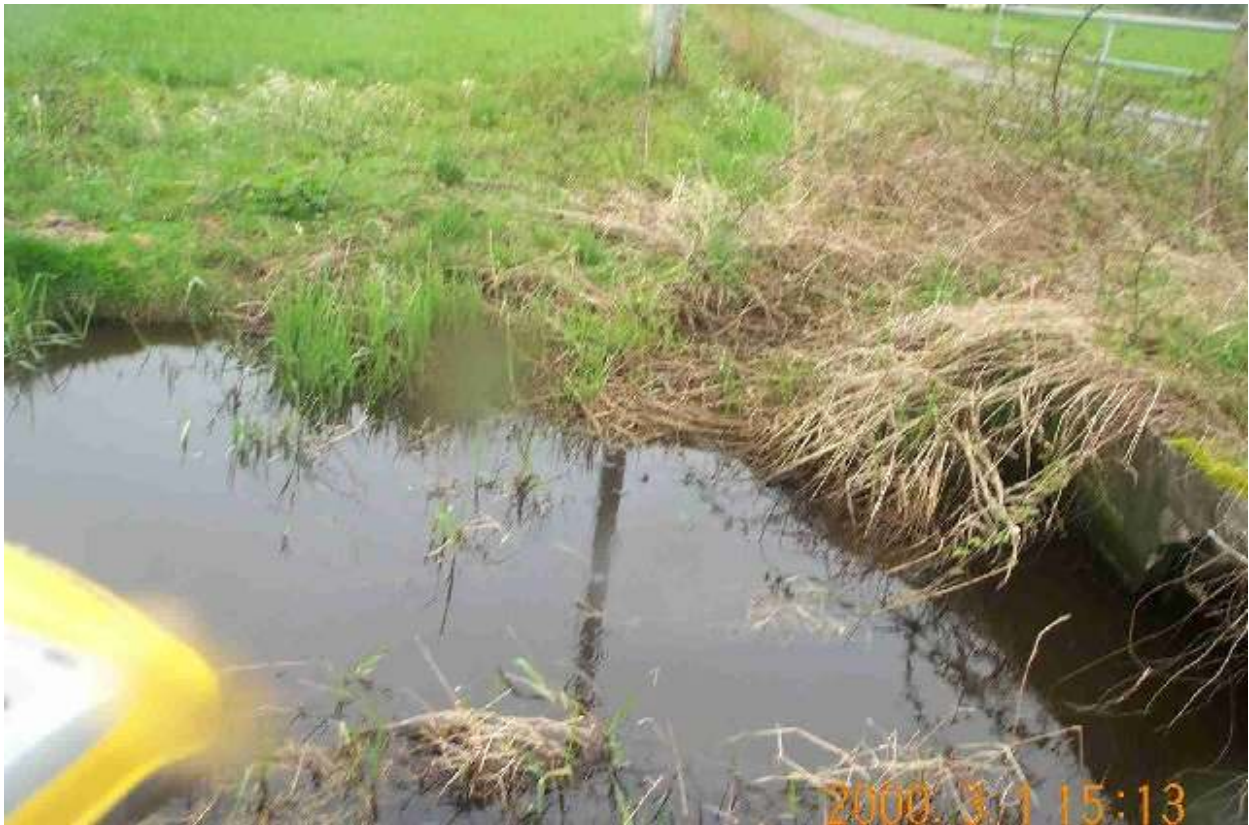
Photos P1000168.jpg

Channel Dimensions:	Left Bank Height:	1.5 m	Site Feature:	Culvert Outlet
	Left Bank Slope (H:V):	0.6:1		
	Right Bank Height:	0.8 m	Type:	Concrete
	Right Bank Slope (H:V):	0.6:1	Diameter:	900mm
	Low Flow Channel Width:	3.0 m	Stability Issue:	
	Low Flow Channel Depth:	0.3 m

Comment: 900 mm diameter culvert with cinder block headwall built underneath a private driveway.

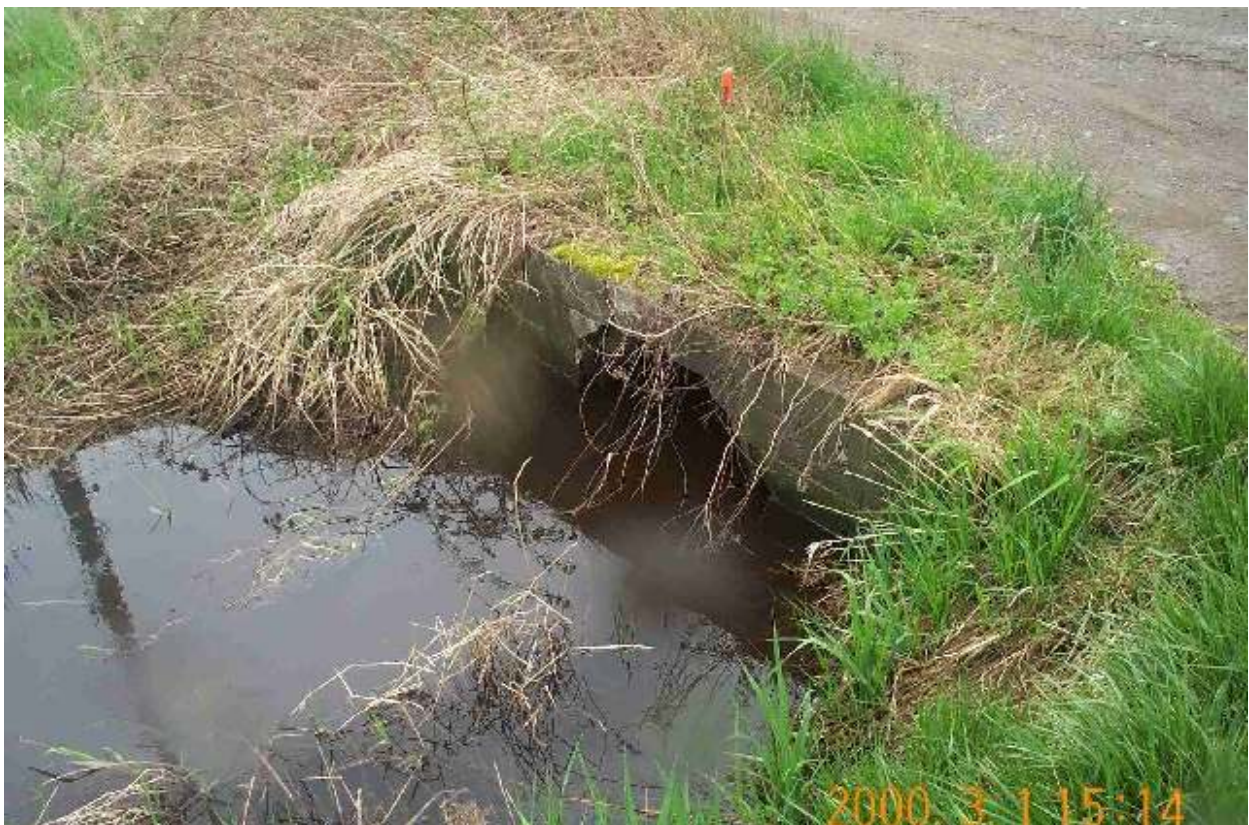
Photos P1000169.jpg

Channel Dimensions:	Left Bank Height:	1.5 m	Site Feature:	Culvert Inlet
	Left Bank Slope (H:V):	0.6:1		
	Right Bank Height:	1.0 m	Type:	Concrete
	Right Bank Slope (H:V):	0.6:1	Diameter:	900mm
	Low Flow Channel Width:	2.0 m	Stability Issue:	
	Low Flow Channel Depth:	0.4 m

Comment: 900 mm diameter culvert with cinder block headwall built underneath a private driveway.

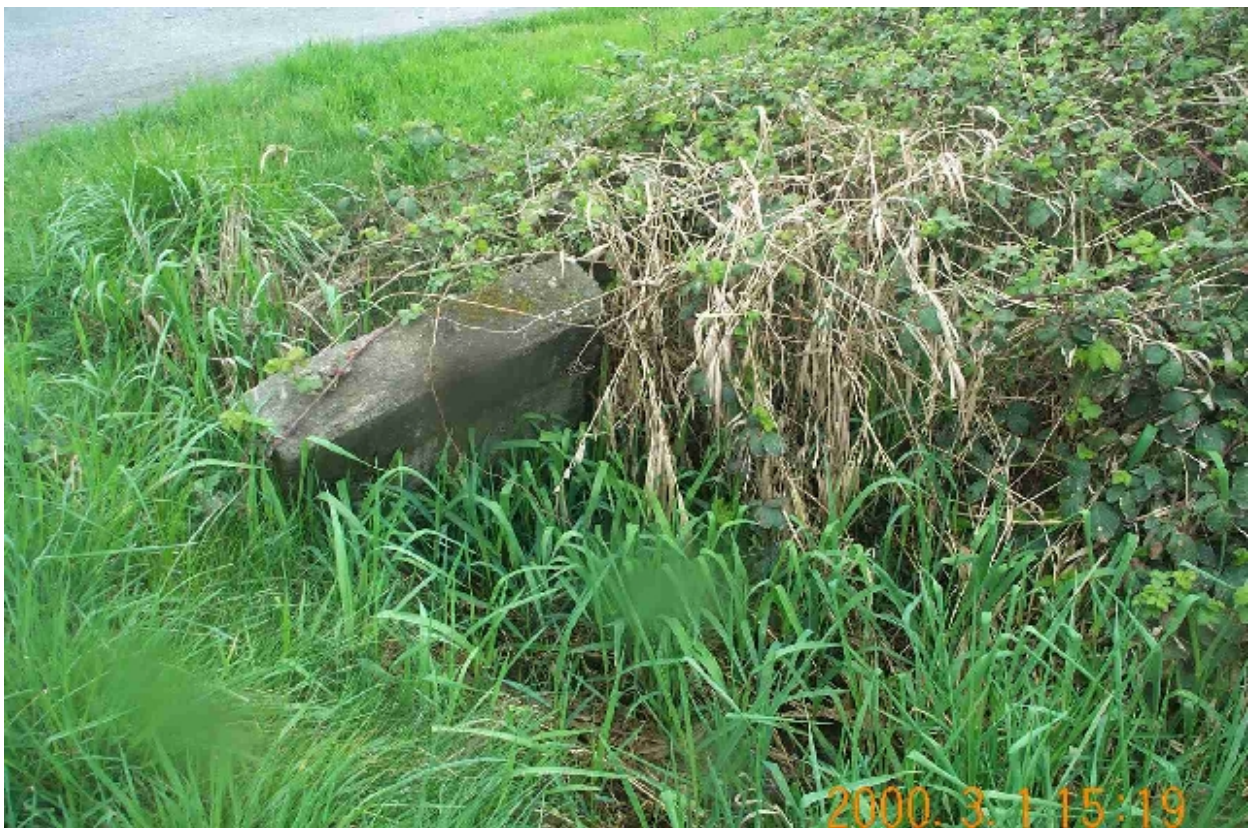
Photos P1000171.jpg

Channel Dimensions:	Left Bank Height:	1.0 m	Site Feature:	Culvert Outlet
	Left Bank Slope (H:V):	0.7:1		
	Right Bank Height:	1.6 m	Type:	Concrete
	Right Bank Slope (H:V):	0.7:1	Diameter:	450mm
	Low Flow Channel Width:	0.6 m	Stability Issue:	
	Low Flow Channel Depth:	0.2 m

Comment: 450 mm diameter culvert with cinder block headwall build underneath a private driveway. The headwall is bulging outwards.

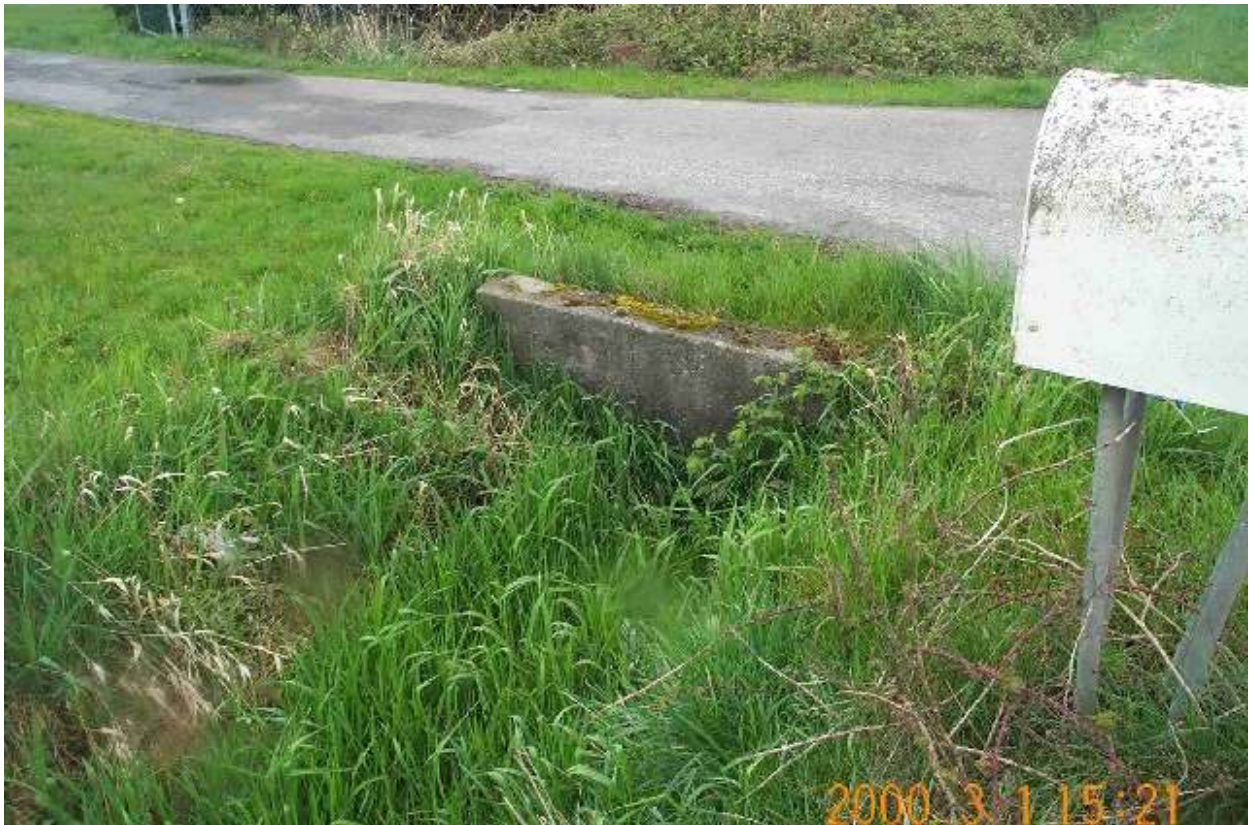
Photos P1000172.jpg

Channel Dimensions:	Left Bank Height:	1.0 m	Site Feature:	Culvert Inlet
	Left Bank Slope (H:V):	1:1		
	Right Bank Height:	1.6 m	Type:	Concrete
	Right Bank Slope (H:V):	0.7:1	Diameter:	450mm
	Low Flow Channel Width:	1.0 m	Stability Issue:	
	Low Flow Channel Depth:	0.2 m

Comment: 450 mm diameter culvert with cinder block headwall build underneath a private driveway.

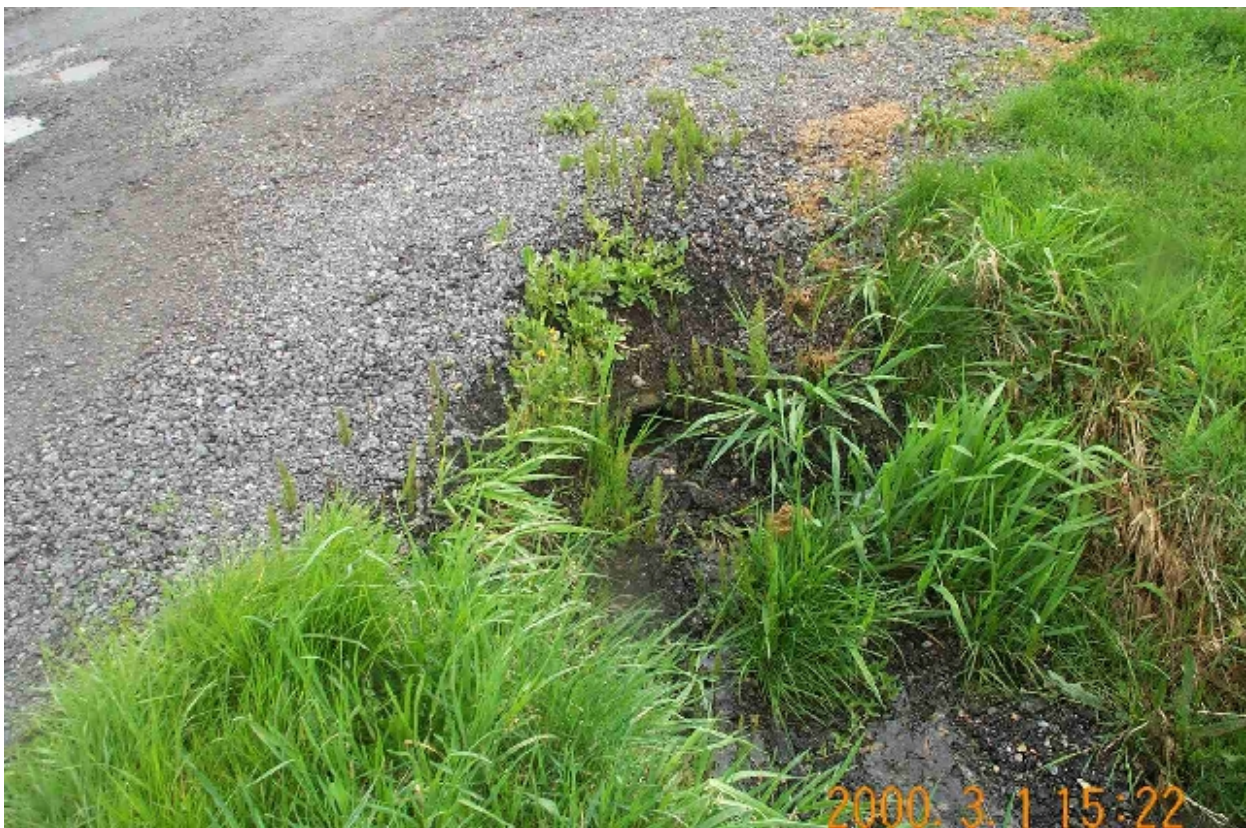
Photos P1000173.jpg

Channel Dimensions:	Left Bank Height:	0.8 m	Site Feature:	Culvert Outlet
	Left Bank Slope (H:V):	0.6:1		
	Right Bank Height:	1.5 m	Type:	Concrete
	Right Bank Slope (H:V):	0.6:1	Diameter:	450mm
	Low Flow Channel Width:	1.0 m	Stability Issue:	Plugged
	Low Flow Channel Depth:	0.2 m

Comment: 450 mm diameter culvert with no headwall. The outlet is plugged with gravel that has sluffed off from the private driveway.

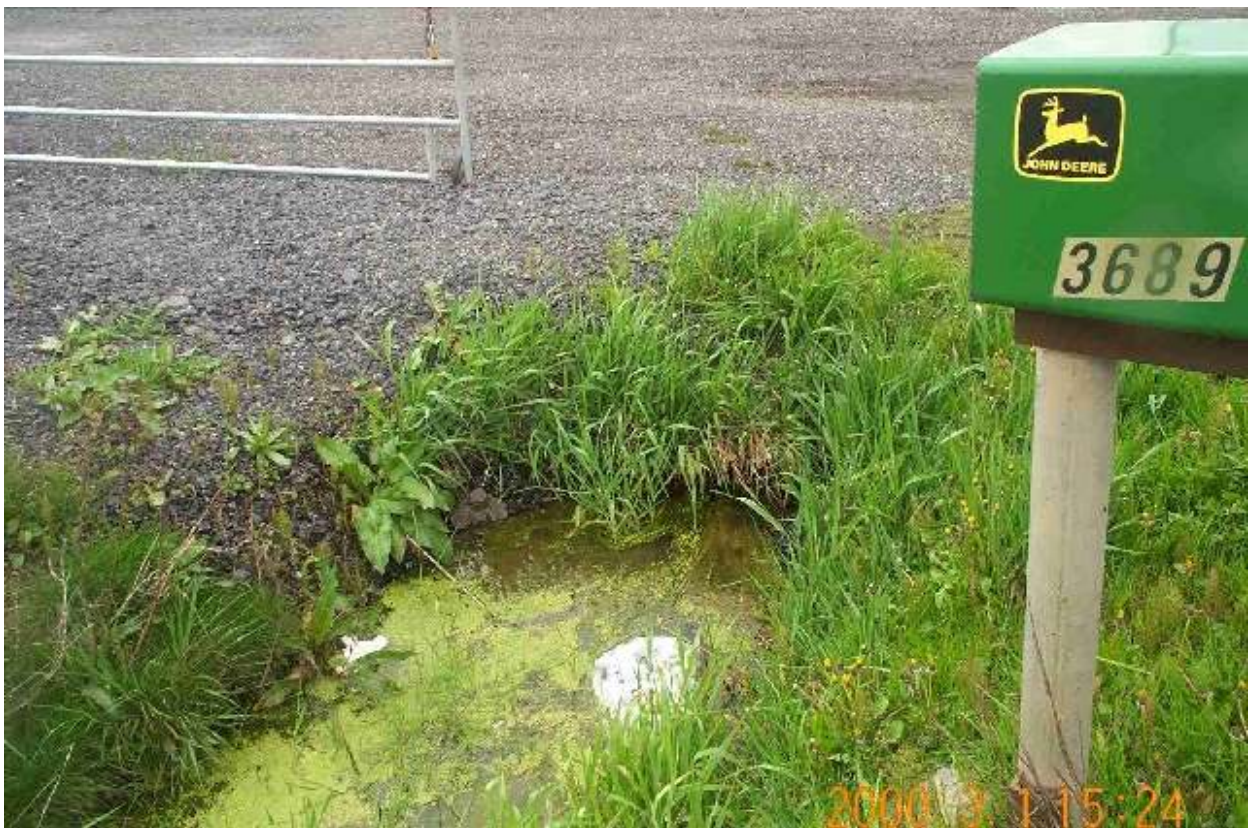
Photos P1000174.jpg

Channel Dimensions:	Left Bank Height:	0.8 m	Site Feature:	Culvert Inlet
	Left Bank Slope (H:V):	0.6:1		
	Right Bank Height:	1.5 m	Type:	Concrete
	Right Bank Slope (H:V):	0.6:1	Diameter:	450mm
	Low Flow Channel Width:	1.2 m	Stability Issue:	
	Low Flow Channel Depth:	0.3 m

Comment: 450 mm diameter culvert with no headwall.

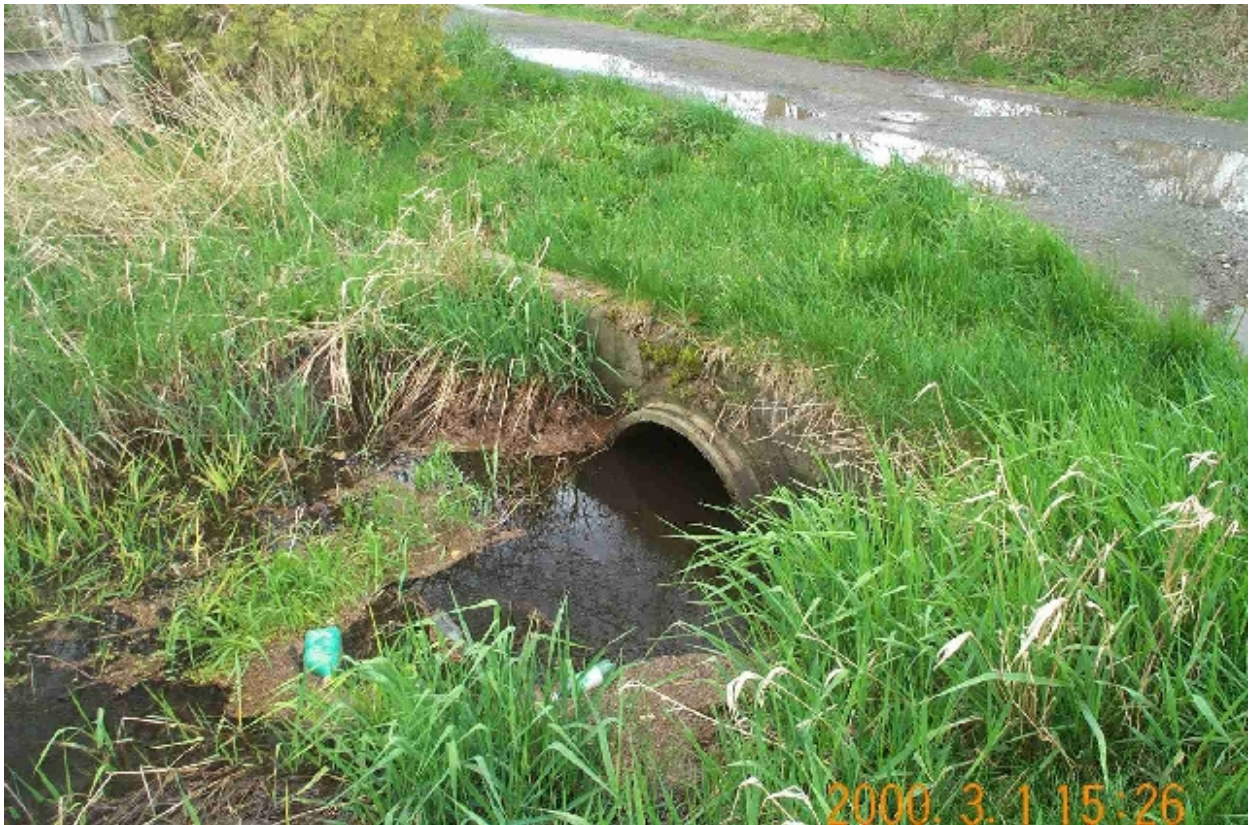
Photos P1000175.jpg

Channel Dimensions:	Left Bank Height:	1.8 m	Site Feature:	Culvert Outlet
	Left Bank Slope (H:V):	0.6:1		
	Right Bank Height:	1.0 m	Type:	Concrete
	Right Bank Slope (H:V):	0.8:1	Diameter:	900mm
	Low Flow Channel Width:	3.0 m	Stability Issue:	
	Low Flow Channel Depth:	0.6 m

Comment: 900 mm diameter culvert with concrete headwall built underneath a private driveway.

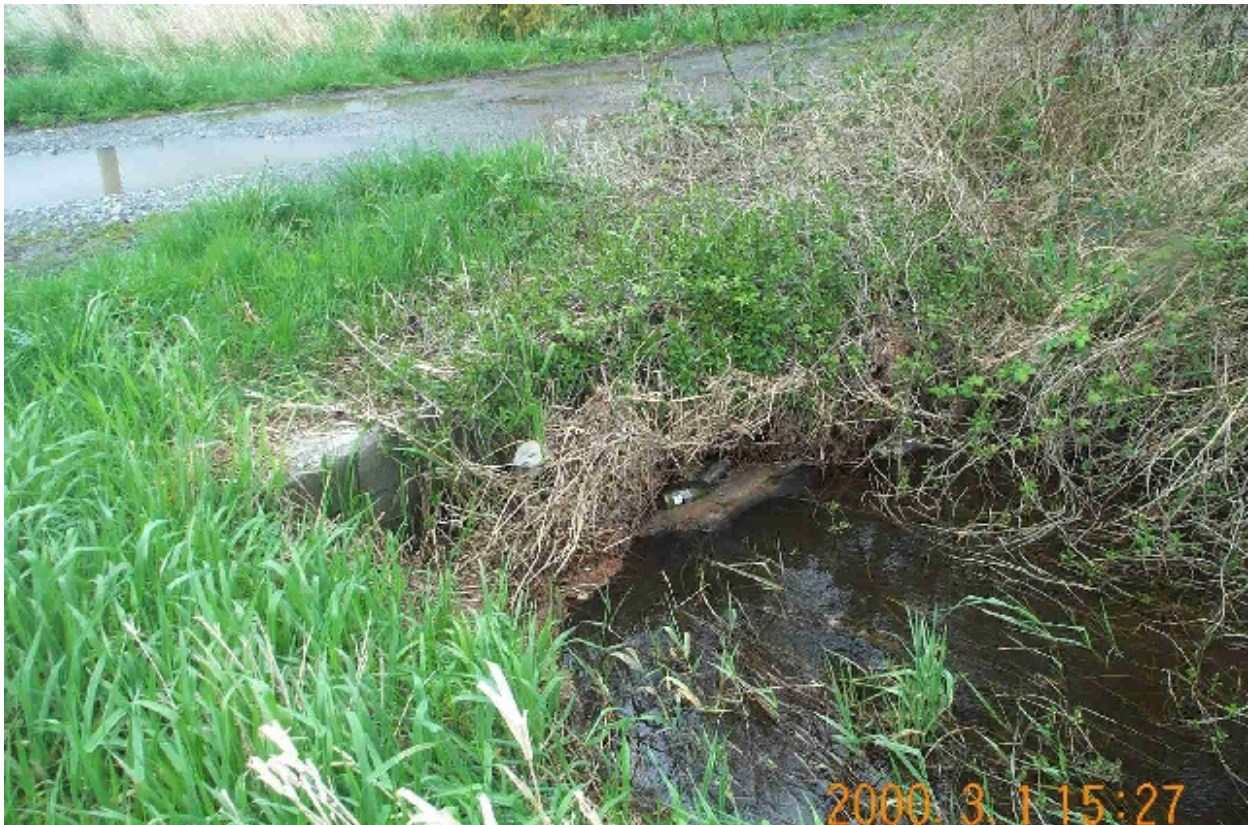
Photos P1000176.jpg

Channel Dimensions:	Left Bank Height:	1.8 m	Site Feature:	Culvert Inlet
	Left Bank Slope (H:V):	0.6:1		
	Right Bank Height:	1.0 m	Type:	Concrete
	Right Bank Slope (H:V):	1:1	Diameter:	900mm
	Low Flow Channel Width:	3.0 m	Stability Issue:	
	Low Flow Channel Depth:	0.4 m

Comment: 900 mm diameter culvert with concrete headwall built underneath a private driveway. Inlet is obstructed with vegetative debris.

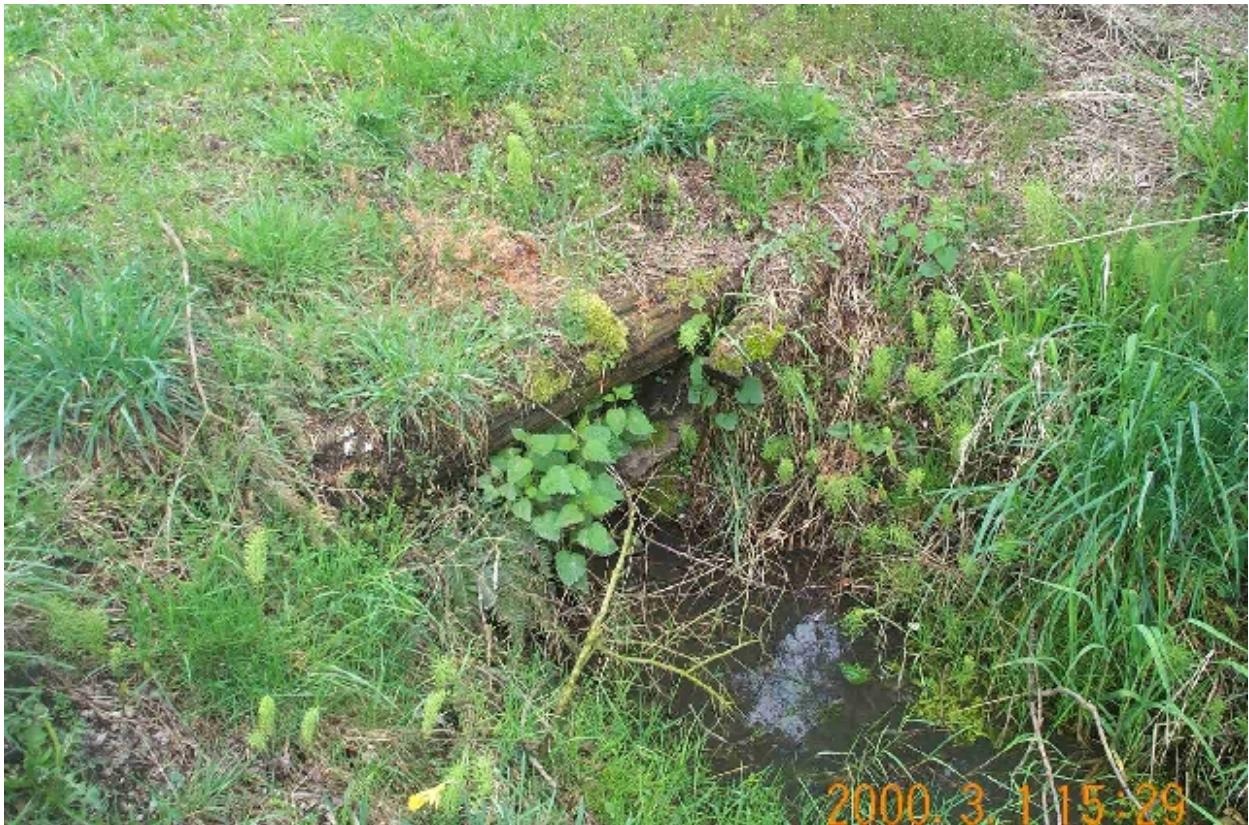
Photos P1000177.jpg

Comment: Wooden vehicle bridge providing access to a private property. The bridge is 2 m wide and 3 m long and is approximately 600 mm above the channel invert.

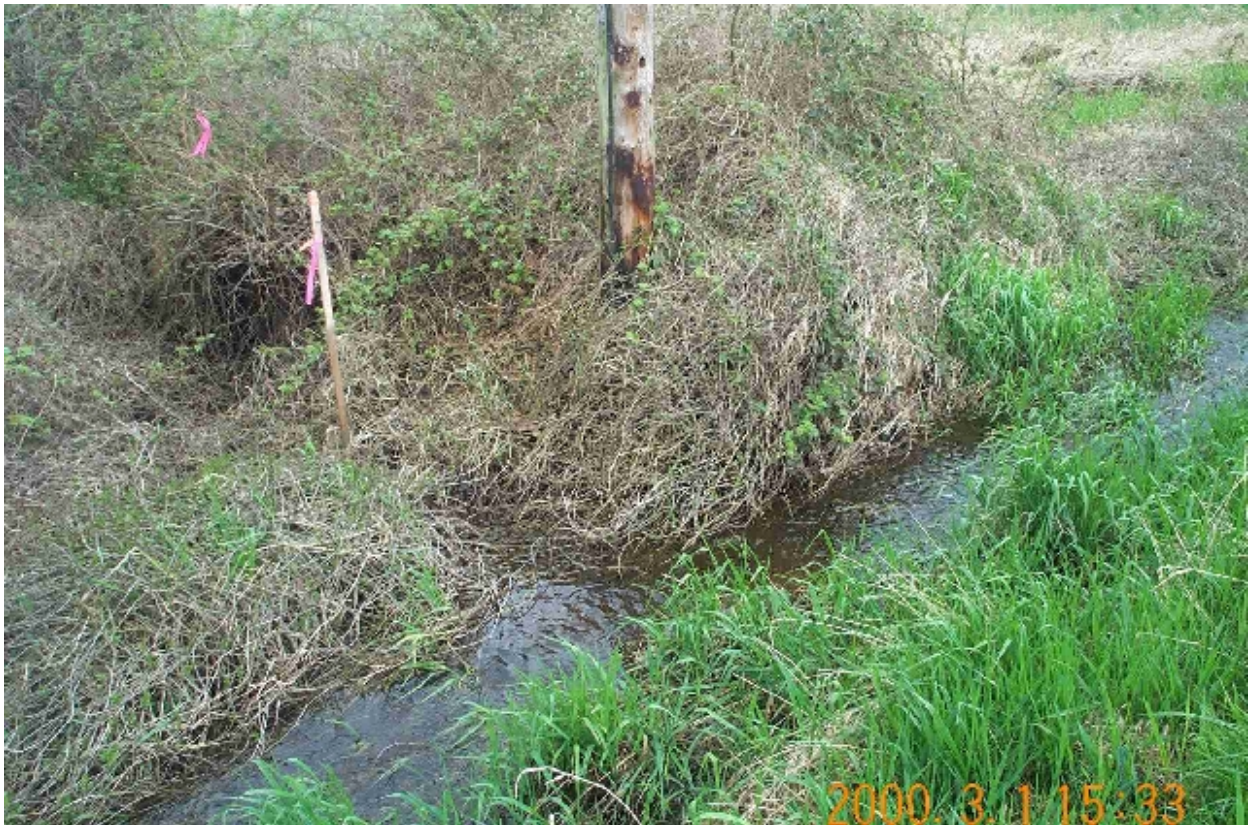
Photos P1000178.jpg

Comment: Confluence with ditch draining field to the east. Channel banks are well vegetated.

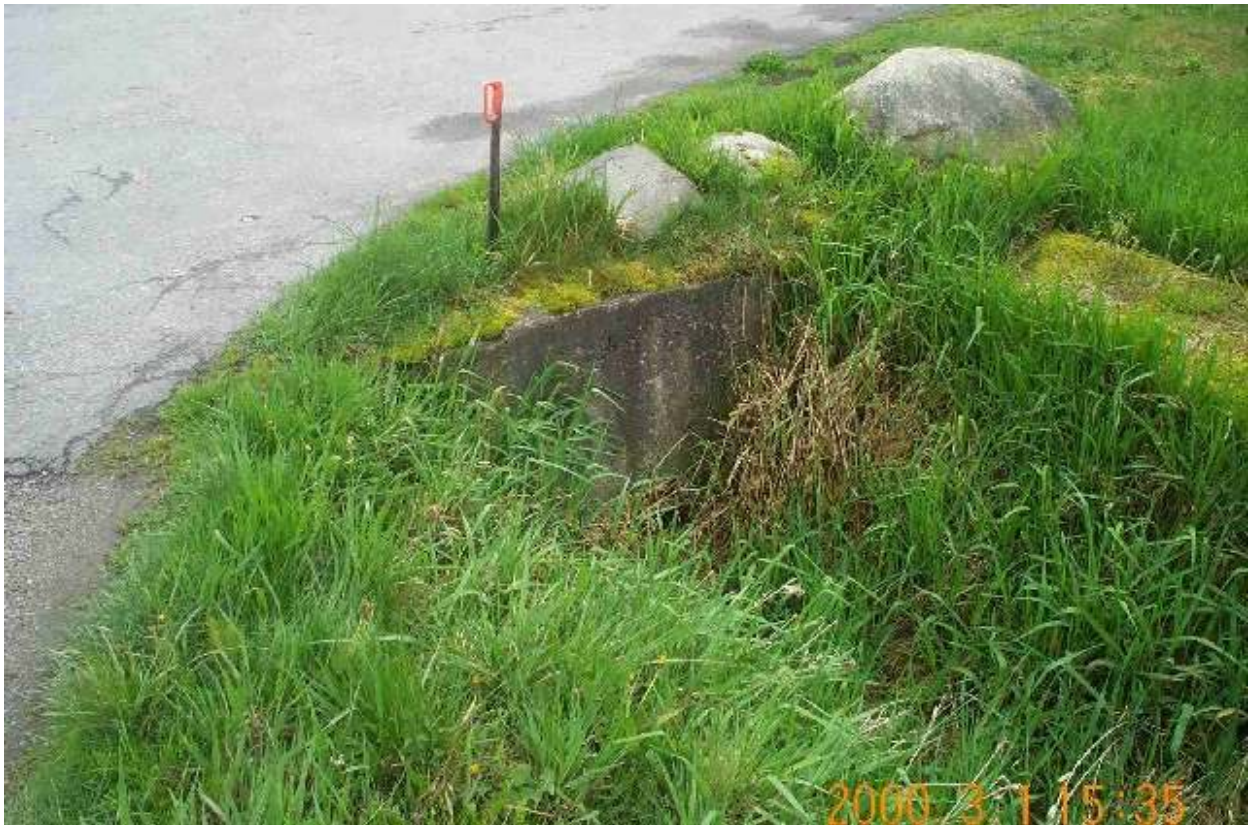
Photos P1000179.jpg

Comment: 450 mm diameter culvert with concrete headwall built underneath a private driveway.
