City of Surrey

Erickson Creek Integrated Stormwater Management Plan

September 2010

**Re: ERICKSON CREEK INTEGRATED STORMWATER MANAGEMENT PLAN
FINAL REPORT**

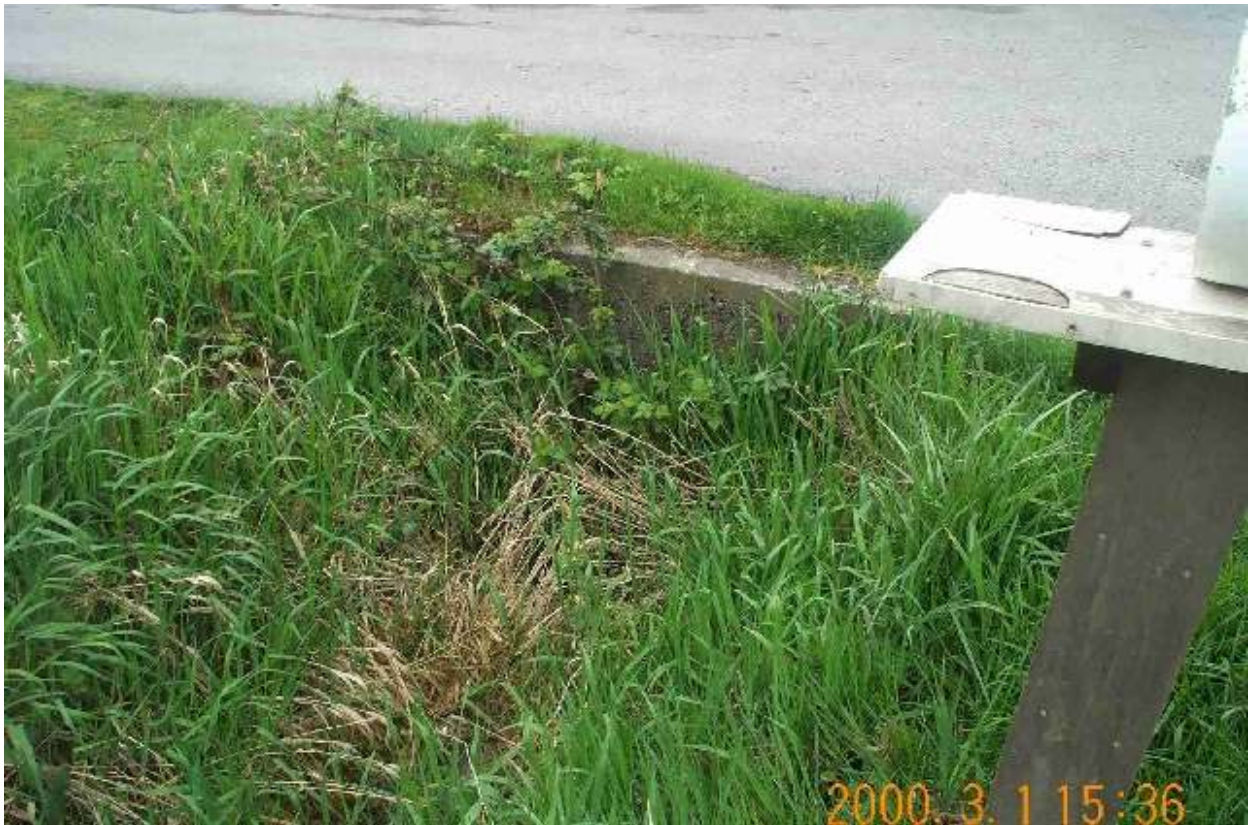
Photos P1000180.jpg

Comment: 450 mm diameter culvert with concrete headwall built underneath a private driveway.

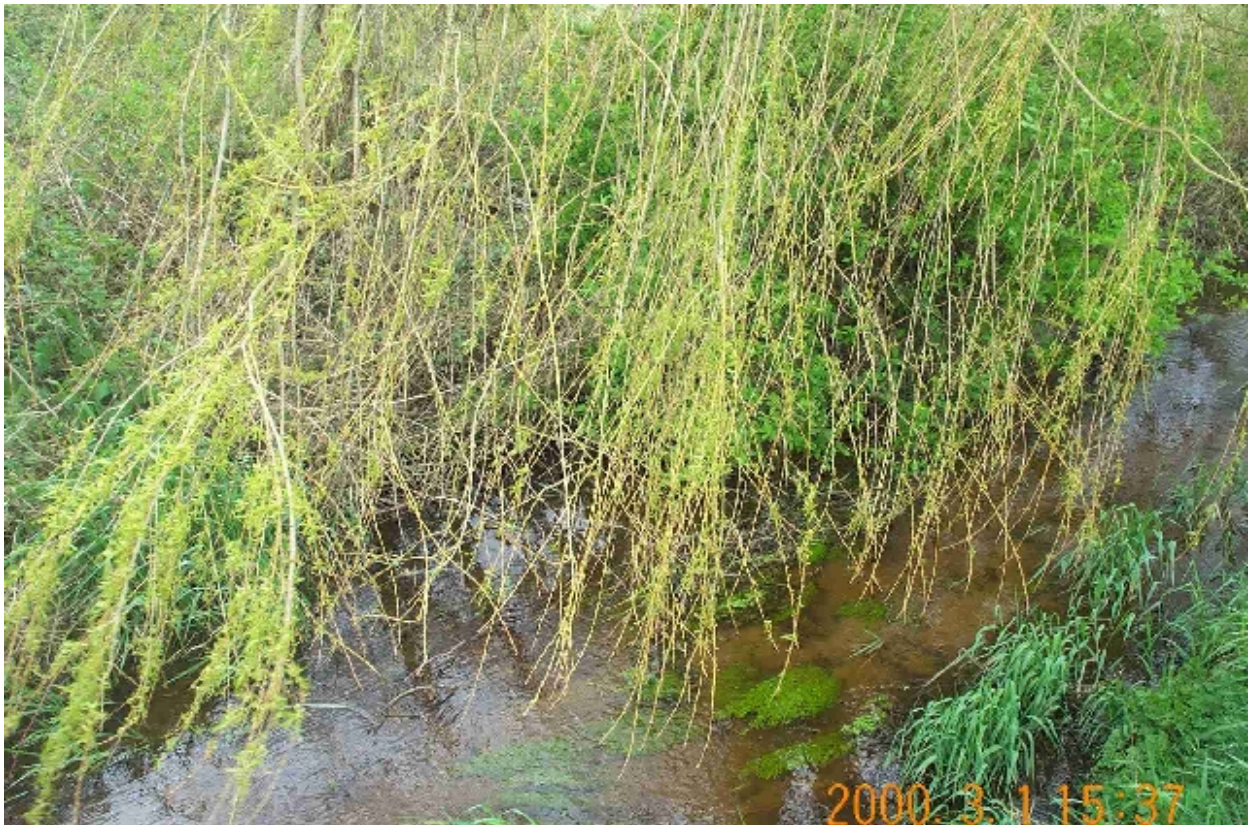
Photos P1000181.jpg

Comment: Confluence with ditch draining field to the east. Channel banks are well vegetated.

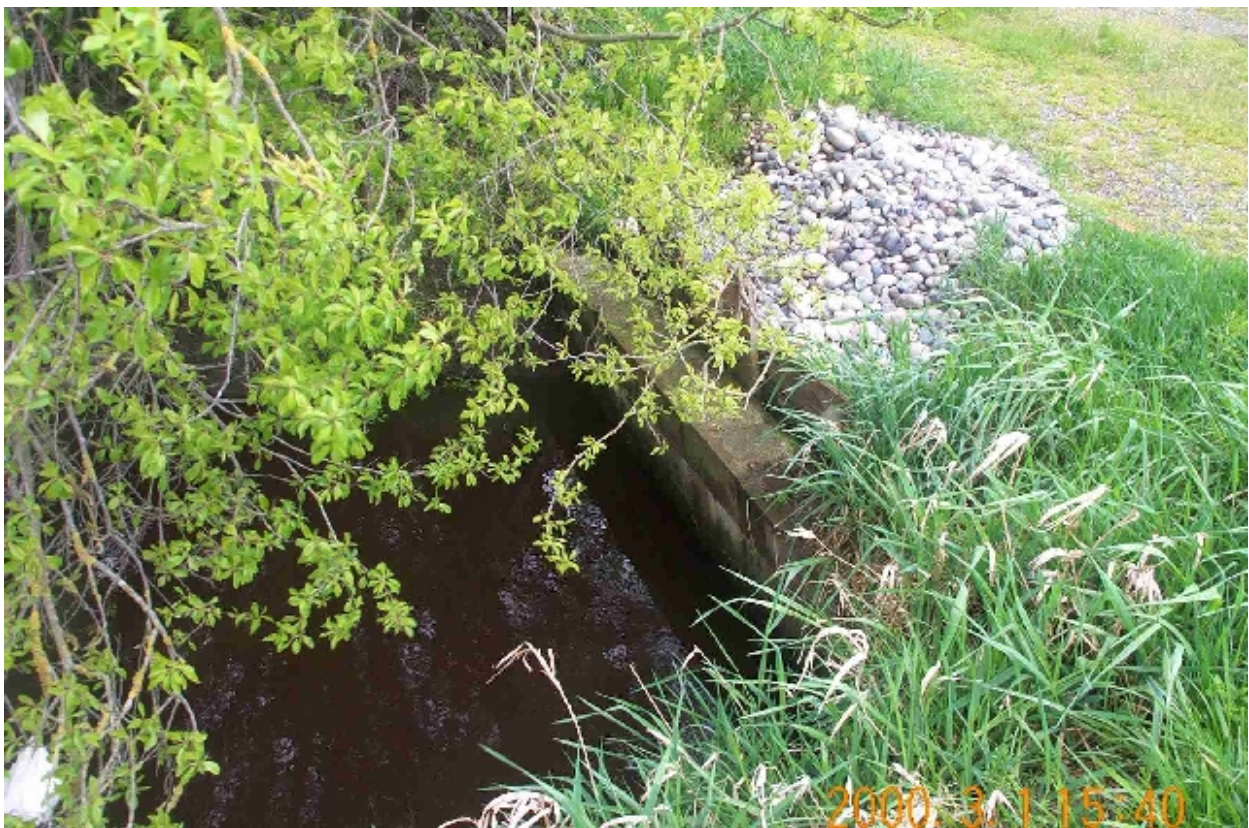
Photos P1000182.jpg

Channel Dimensions:	Left Bank Height:	2.5 m	Site Feature:	Culvert Outlet
	Left Bank Slope (H:V):	0.6:1		
	Right Bank Height:	2.0 m	Type:	Concrete
	Right Bank Slope (H:V):	0.6:1	Diameter:	900mm
	Low Flow Channel Width:	3.0 m	Stability Issue:	
	Low Flow Channel Depth:	1.0 m

Comment: 900 mm diameter culvert with cinder block headwall built underneath a private driveway. Outlet is submerged and headwall is bulging outwards and backfilled with gravel.

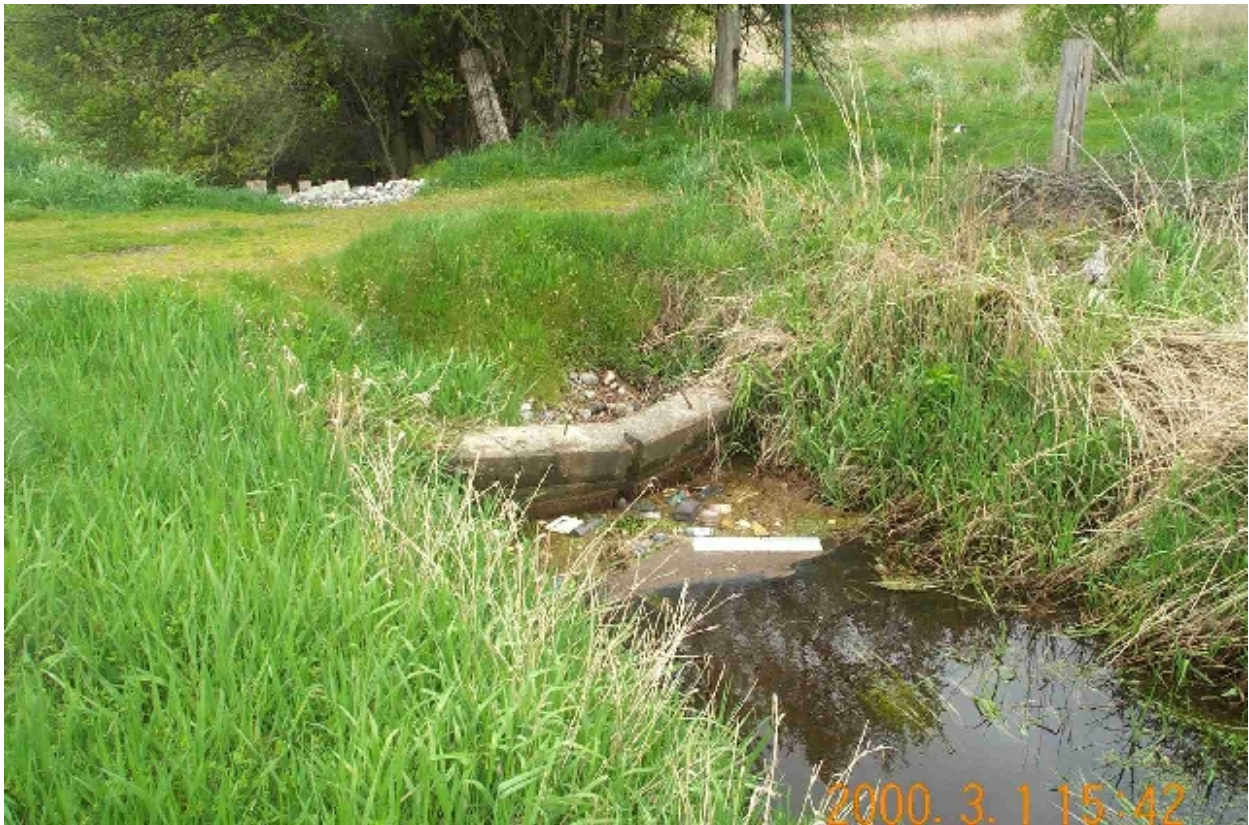
Photos P1000183.jpg

Channel Dimensions:	Left Bank Height:	2.5 m	Site Feature:	Culvert Inlet
	Left Bank Slope (H:V):	0.7:1		
	Right Bank Height:	2.0 m	Type:	Concrete
	Right Bank Slope (H:V):	0.7:1	Diameter:	900mm
	Low Flow Channel Width:	2.0 m	Stability Issue:	
	Low Flow Channel Depth:	1.0 m

Comment: 900 mm diameter culvert with cinder block headwall built underneath a private driveway. Outlet is submerged and headwall is bulging outwards.

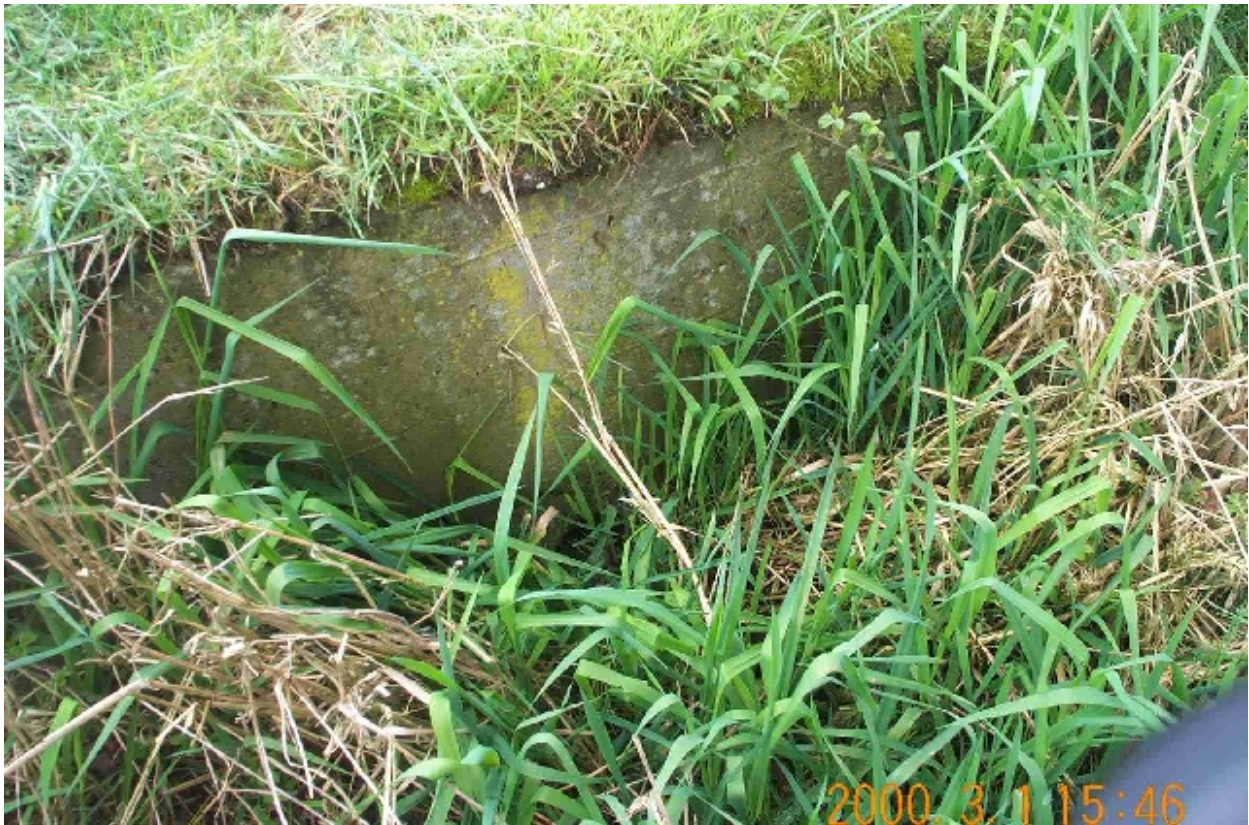
Photos P1000185.jpg

Comment: 300 mm diameter culvert with concrete headwall built underneath a private driveway. Outlet is obstructed by light vegetation

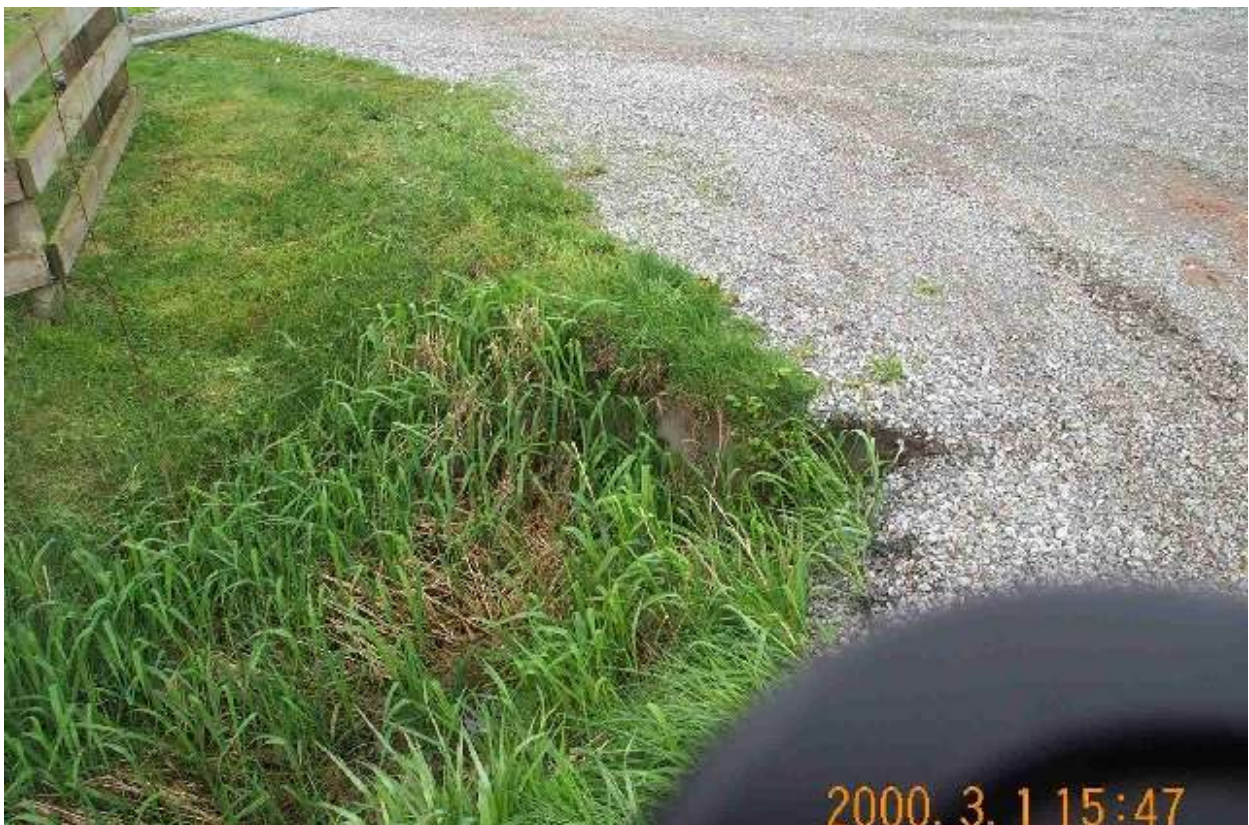
Photos P1000186.jpg

Comment: 300 mm diameter culvert with concrete headwall built underneath a private driveway. Inlet is obstructed by light vegetation

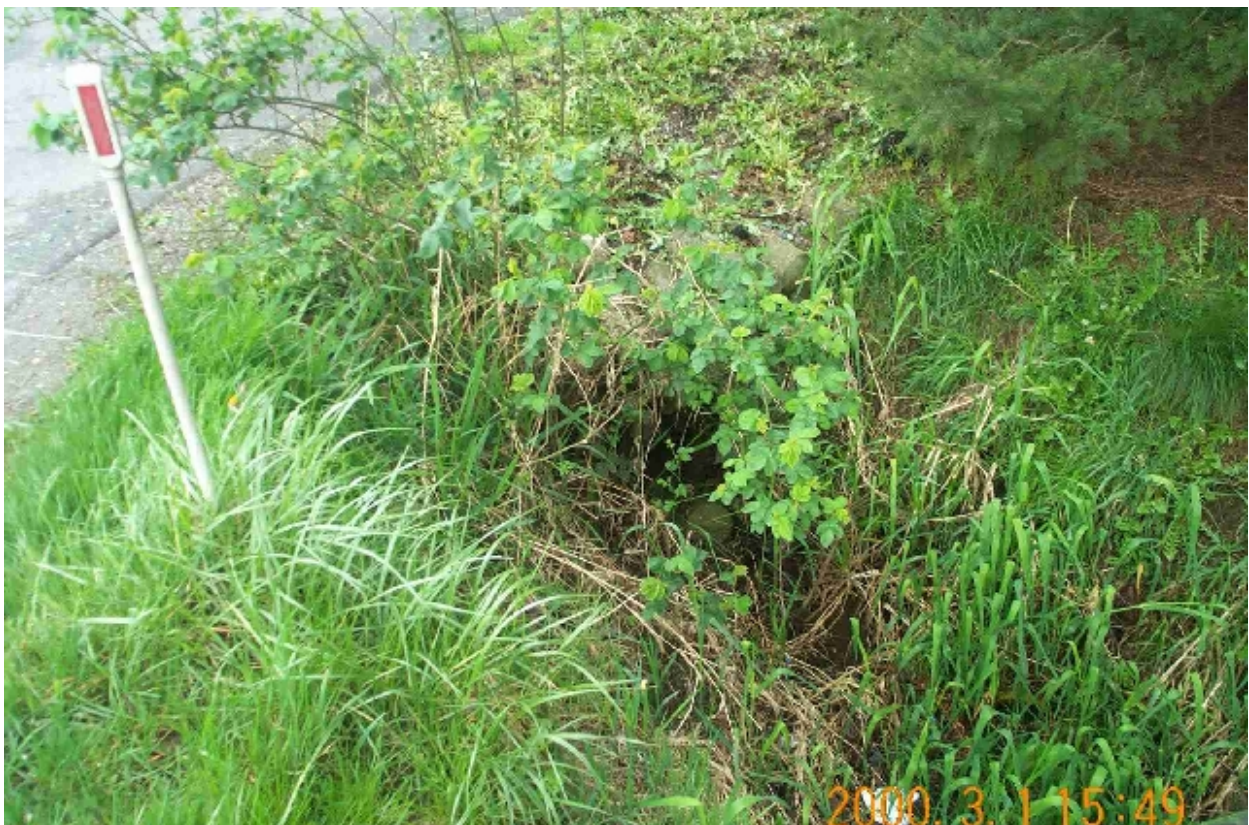
Photos P1000187.jpg

Comment: 300 mm diameter culvert with concrete cylinder headwall built underneath a private driveway.

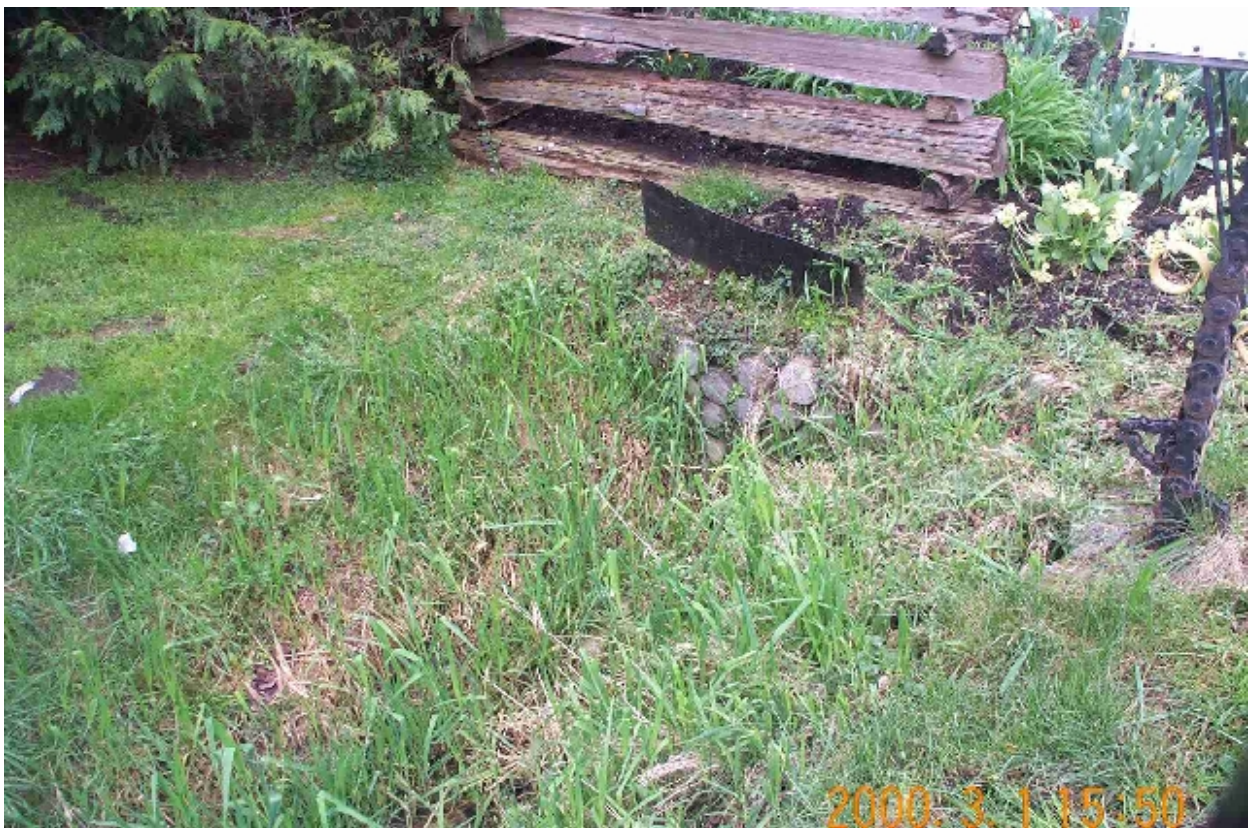
Photos P1000188.jpg

Comment: 300 mm diameter culvert with concrete cylinder headwall built underneath a private driveway.

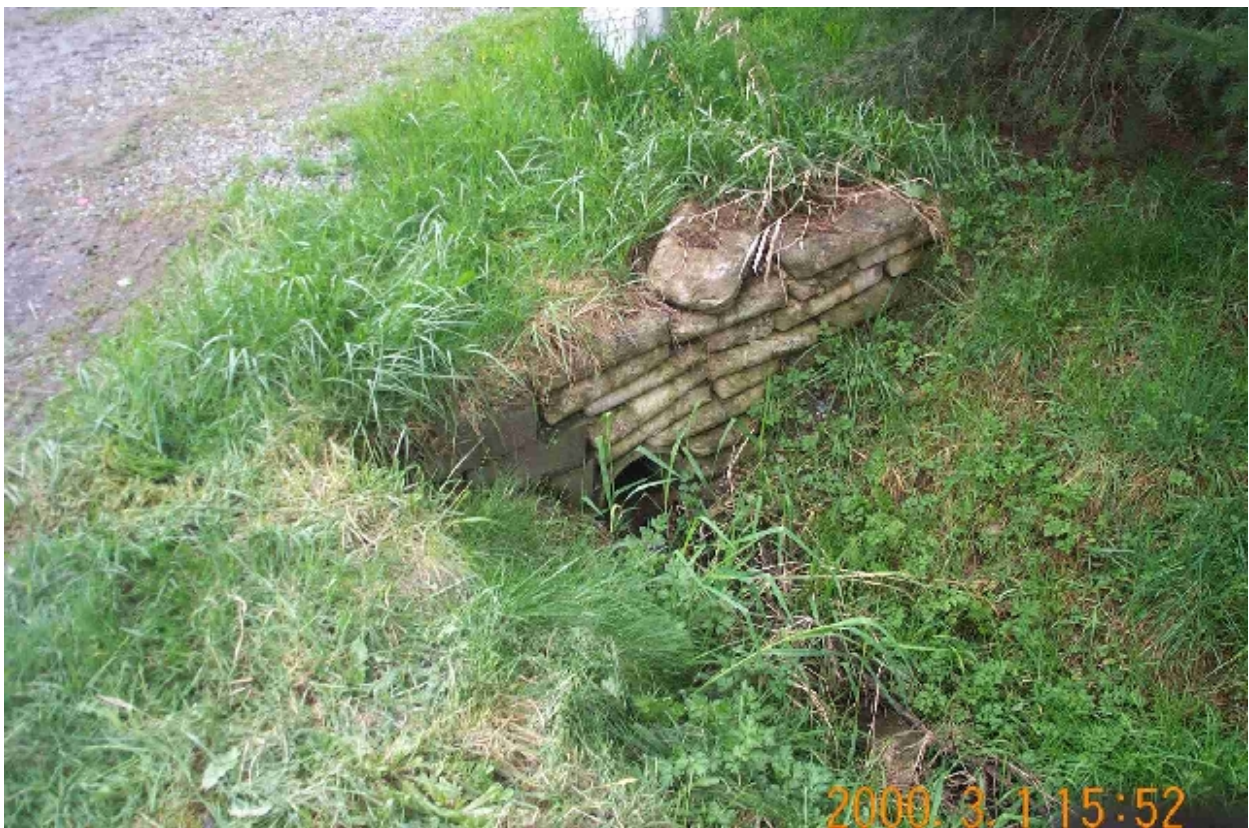
Photos P1000189.jpg

Comment: 300 mm diameter culvert with cinder block headwall built underneath a private driveway. Upper part of headwall has been replaced with concrete sandbags.

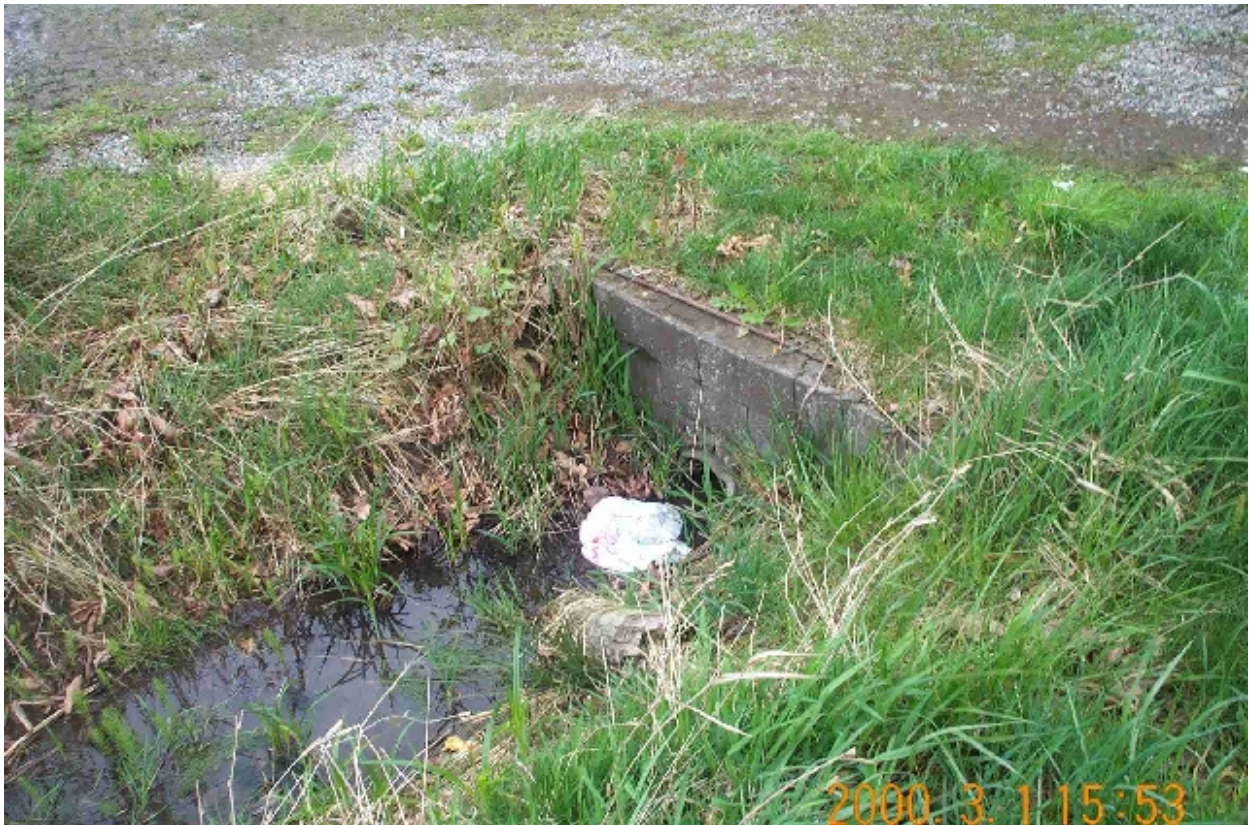
Photos P1000190.jpg

Comment: 300 mm diameter culvert with cinder block headwall built underneath a private driveway. Inlet is obstructed by debris.

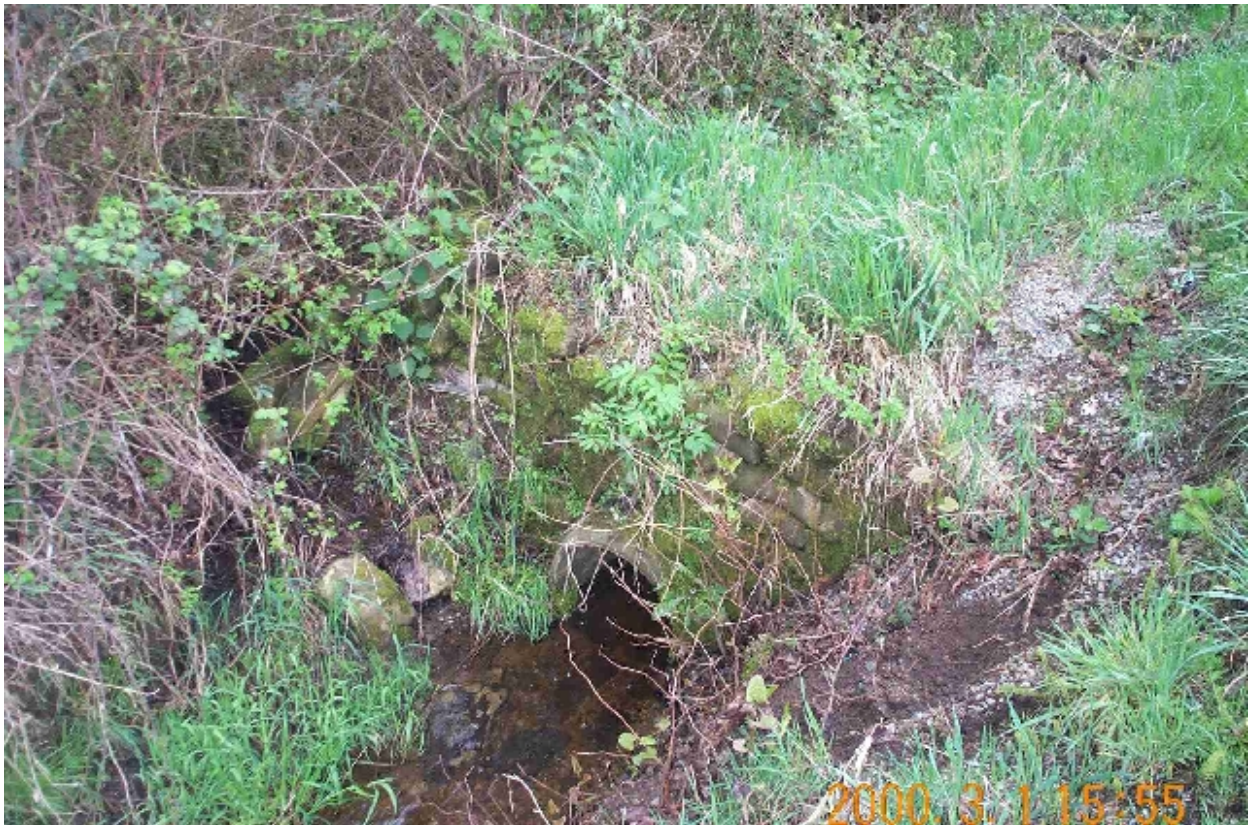
Photos P1000191.jpg

Comment: 750 mm diameter culvert with concrete sandbag headwall and confluence with ditch from the east.

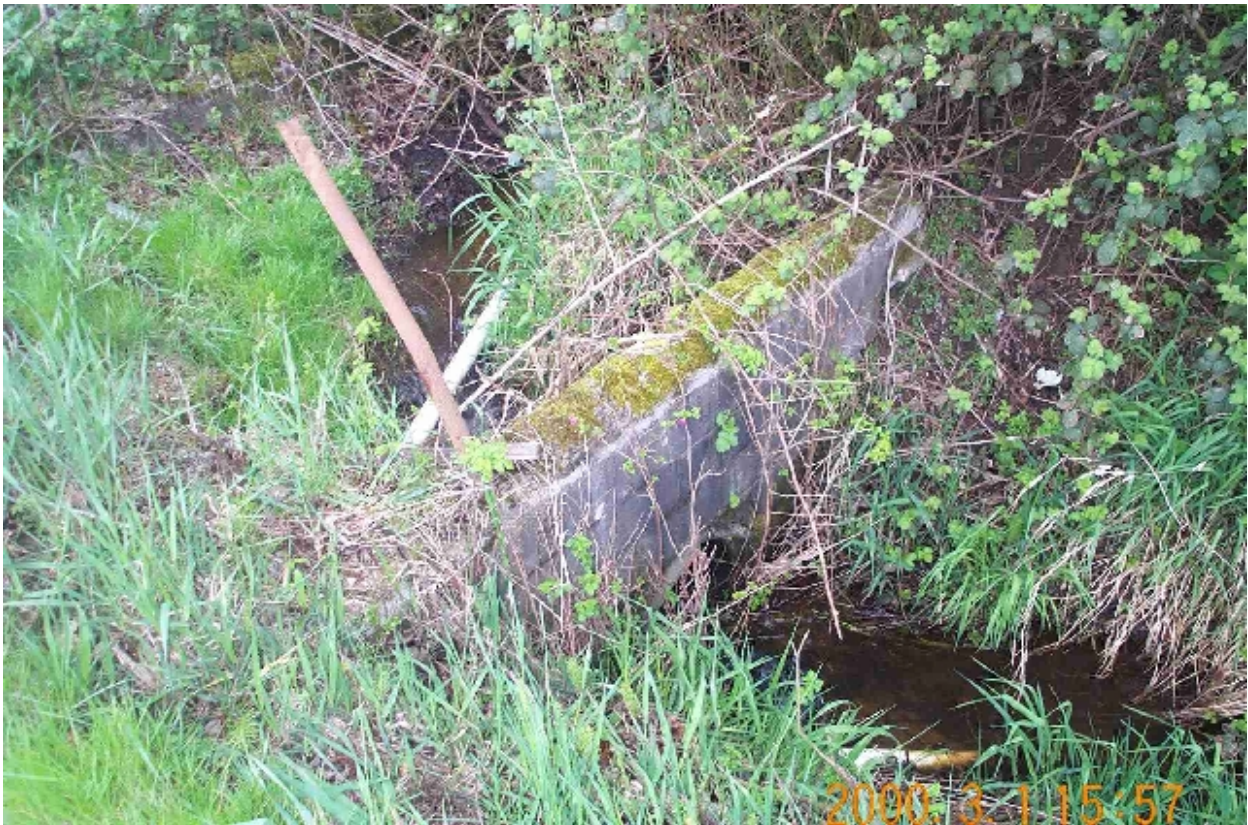
Photos P1000192.jpg

Comment: 750 mm diameter culvert with cinder block headwall and confluence with ditch from the east. Concrete is damaged behind headwall and flow from east is bypassing inlet.

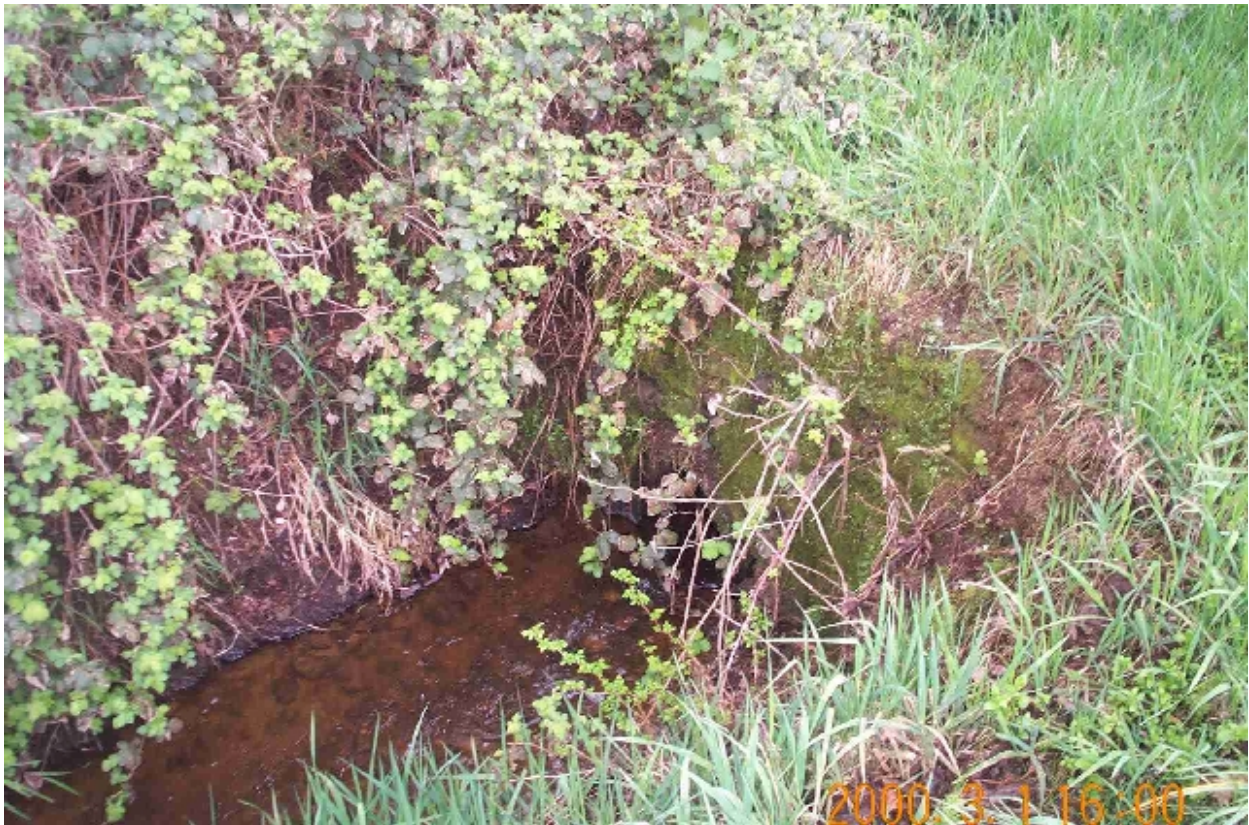
Photos P1000193.jpg

Comment: 600 mm diameter culvert with concrete sandbag headwall.

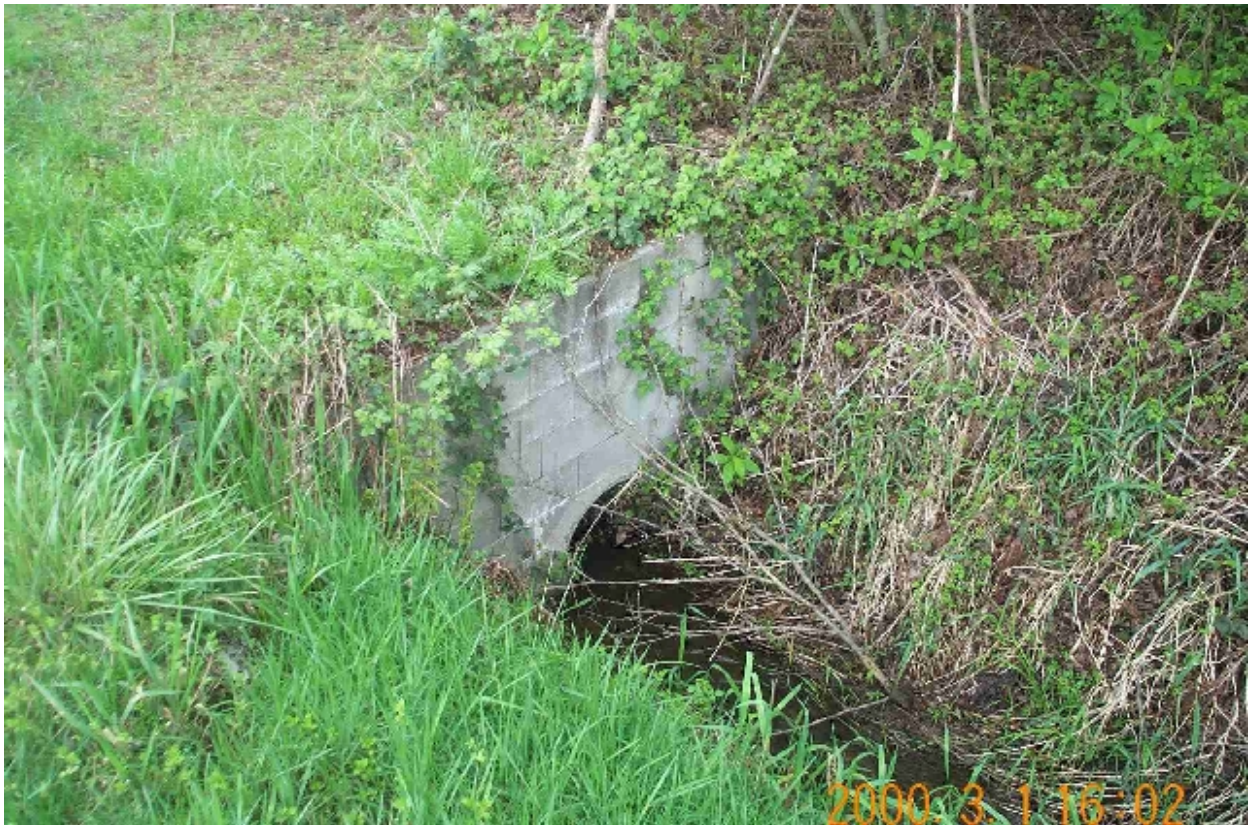
Photos P1000194.jpg

Comment: 600 mm diameter culvert with cinder block headwall.

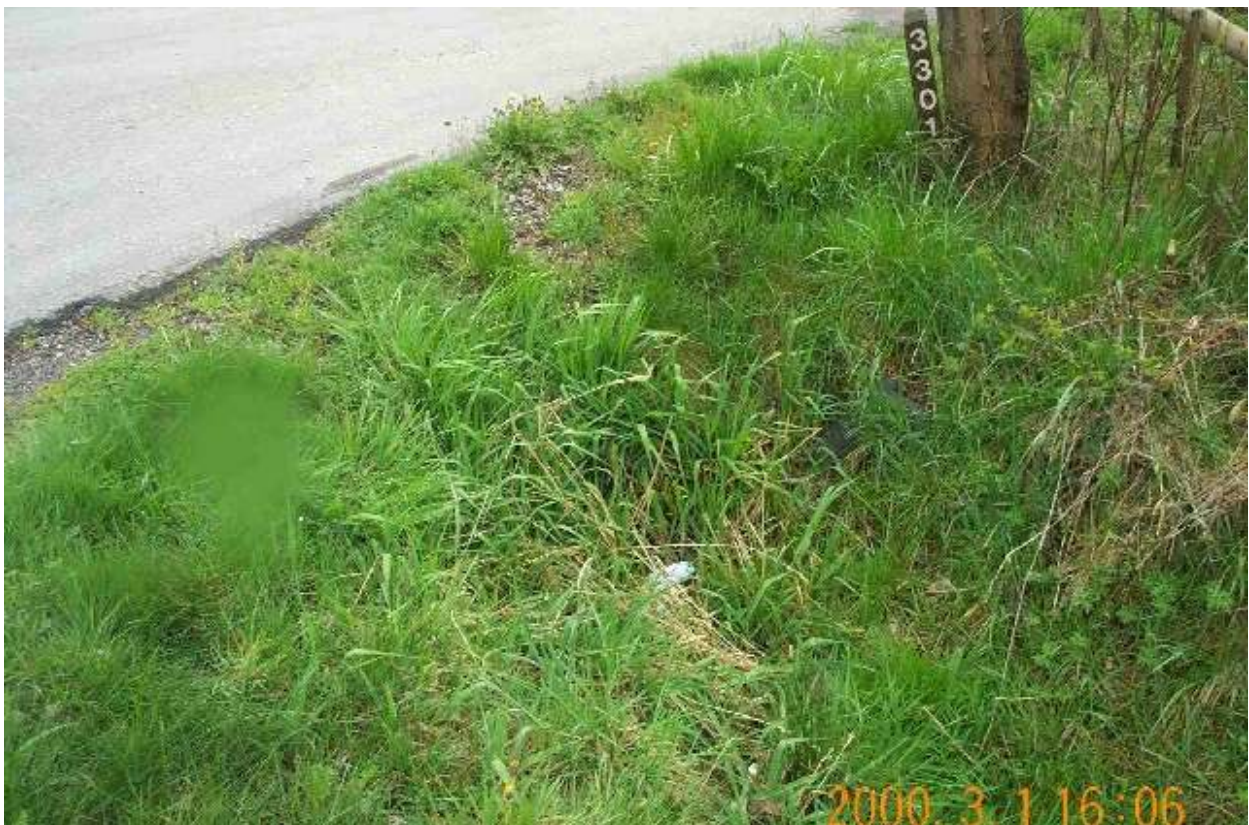
Photos P1000196.jpg

Comment: 300 mm diameter culvert with no headwall. Outlet is obstructed by light vegetation.

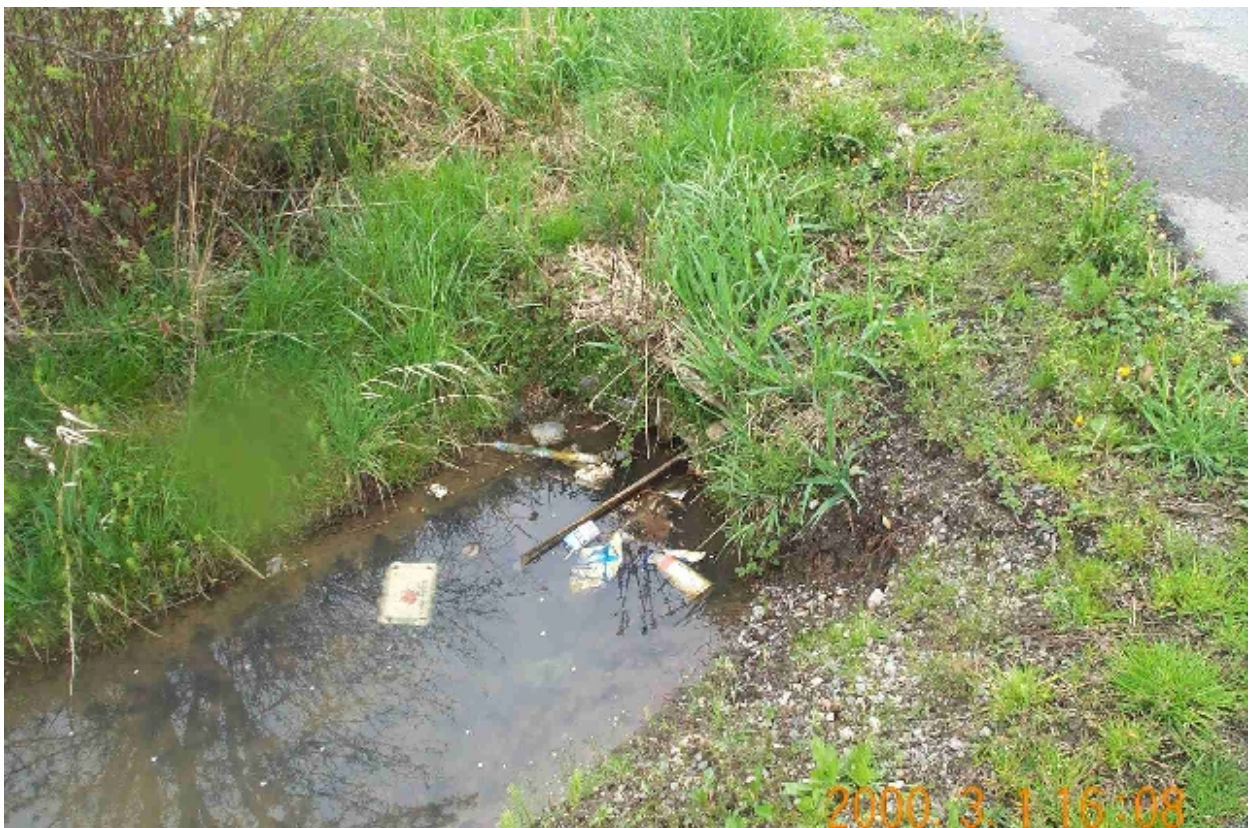
Photos P1000198.jpg

Comment: 300 mm diameter culvert with no headwall. Inlet is obstructed by small debris.

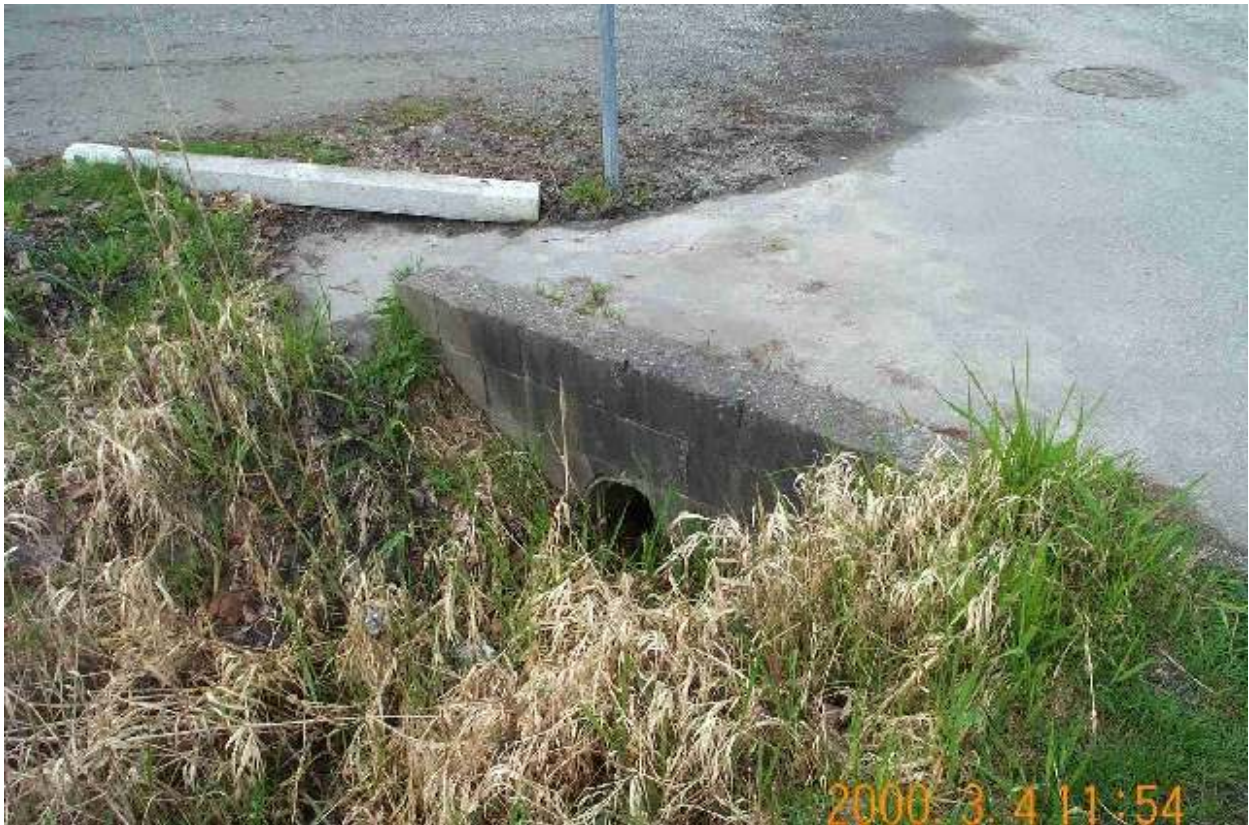
Photos P1000203.jpg

Comment: 300 mm diameter culvert with cinder block headwall. Culvert connects to same manhole as 28E-020.

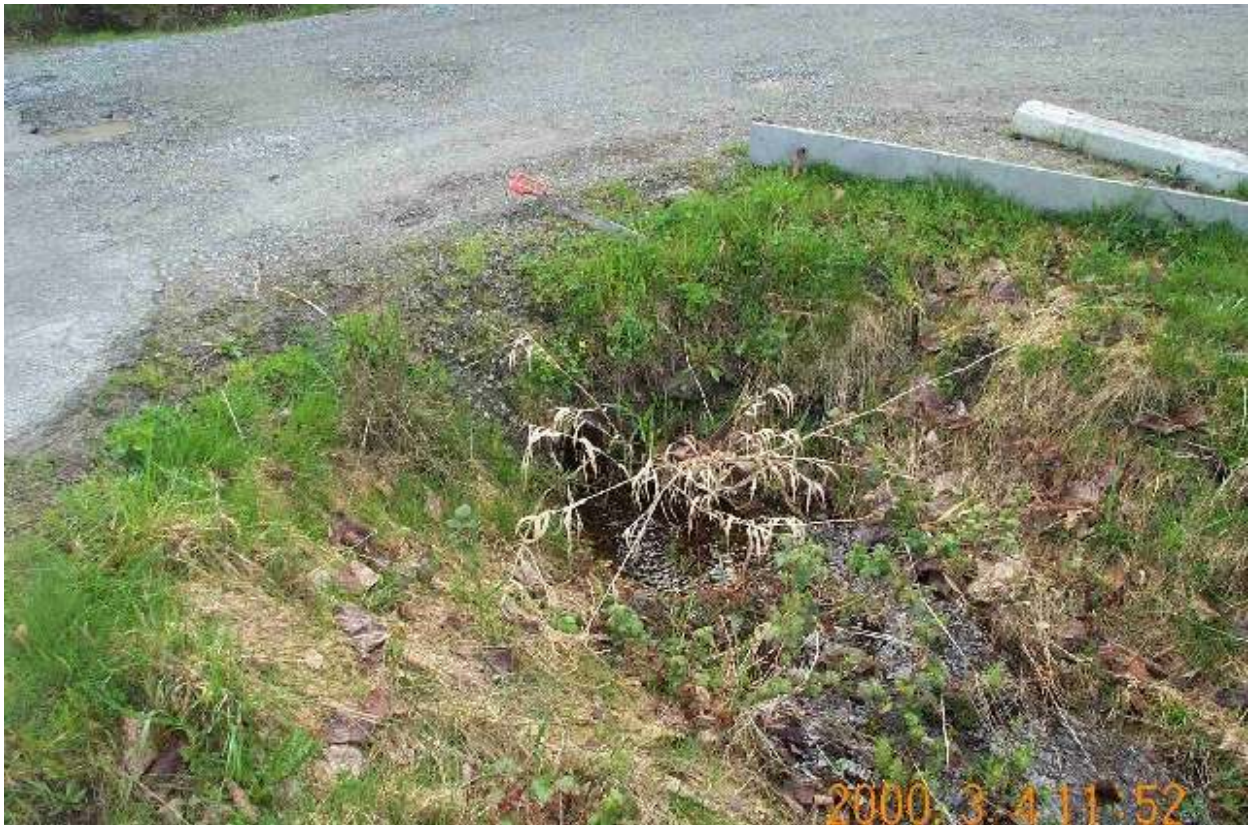
Photos P1000202.jpg

Comment: 300 mm diameter culvert with cinder block headwall.

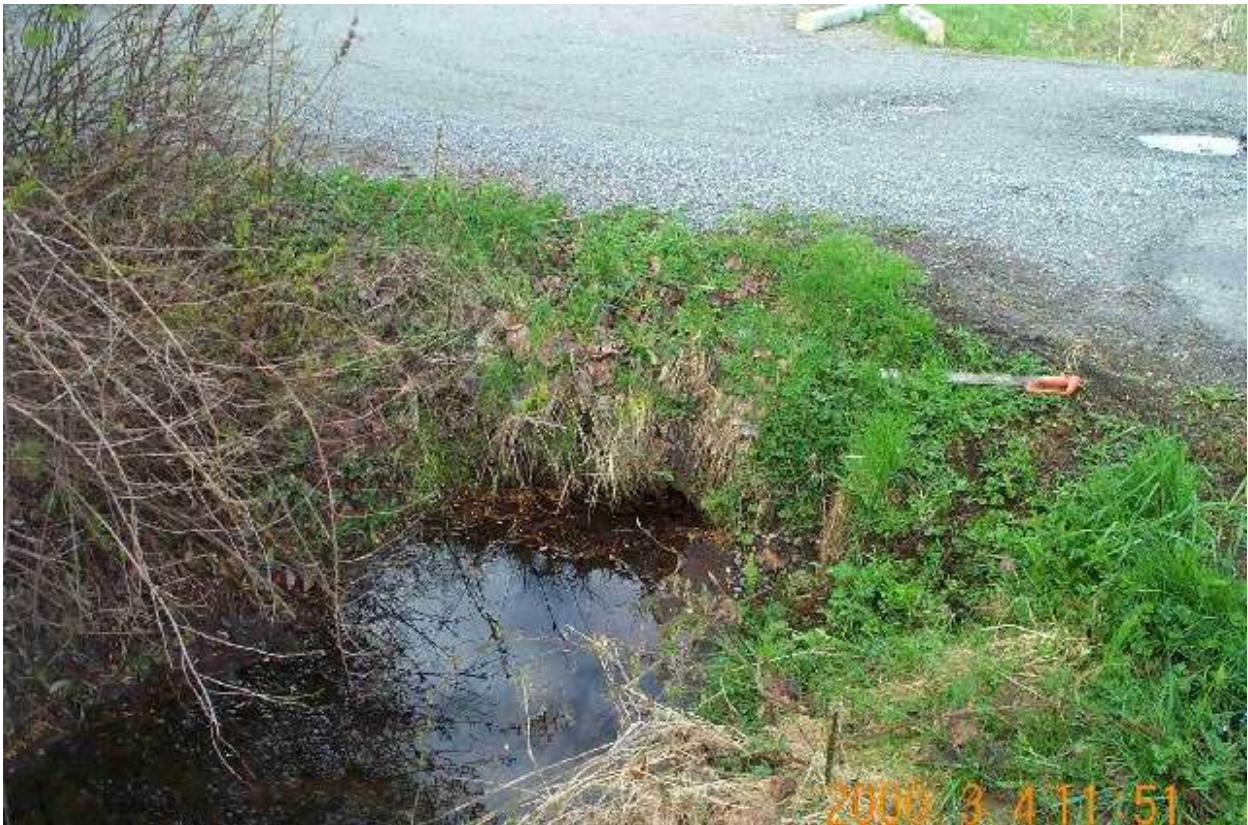
Photos P1000201.jpg

Comment: 300 mm diameter culvert with no headwall built underneath a private driveway.

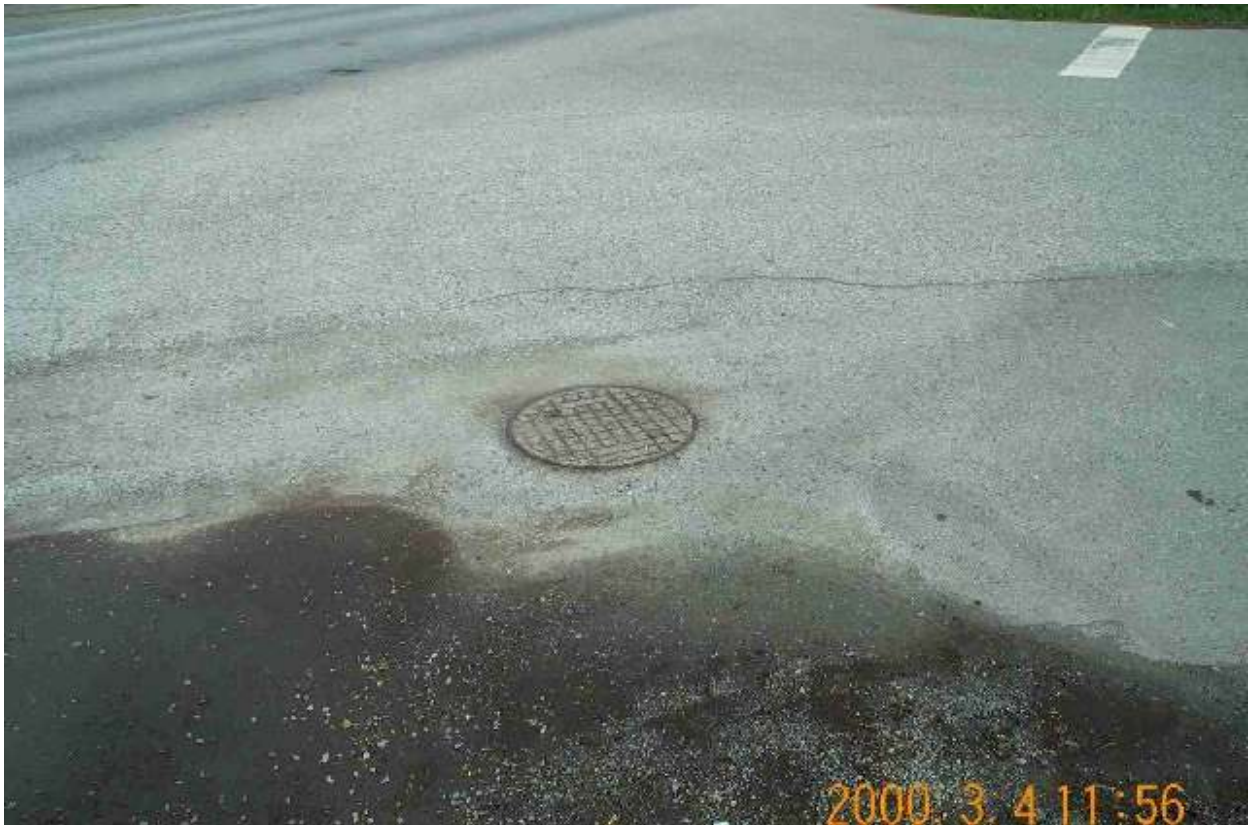
Photos P1000204.jpg

Comment: 300 mm diameter culvert outlet is at a manhole located at the south east corner of the intesection between 28th Avenue and 184th Street.

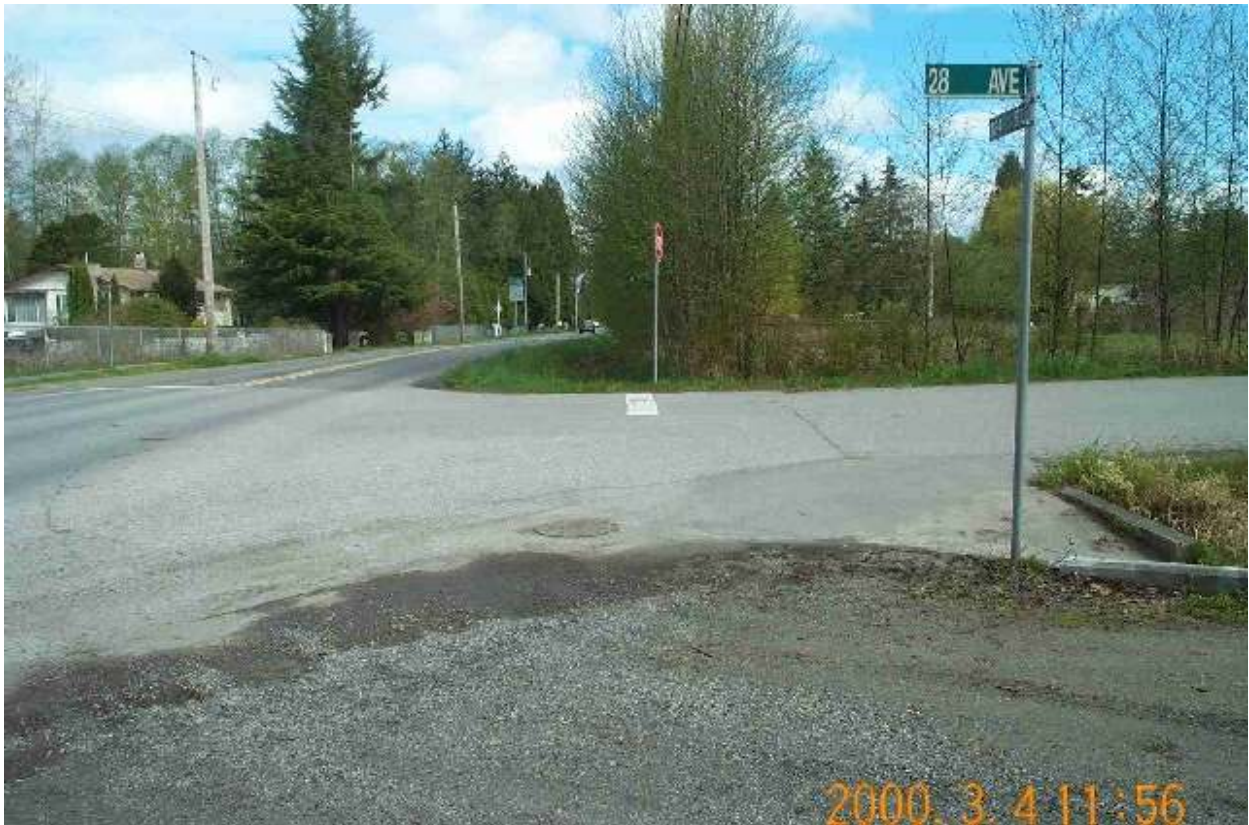
Photos P1000205.jpg

Comment: 300 mm diameter culvert with no headwall built underneath a driveway access to a school parking lot.
