City of Surrey

Erickson Creek Integrated Stormwater Management Plan

September 2010

**Re: ERICKSON CREEK INTEGRATED STORMWATER MANAGEMENT PLAN
FINAL REPORT**

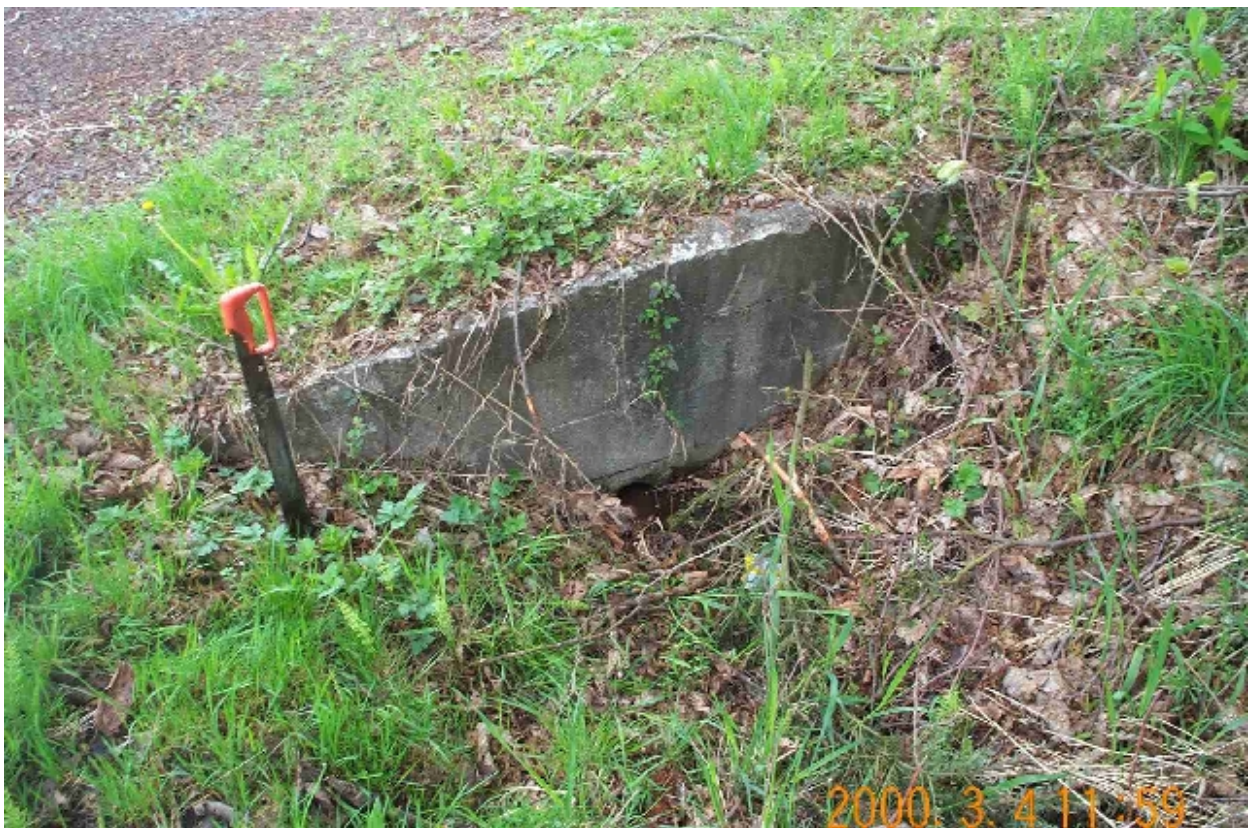
Photos P1000206.jpg

Comment: 300 mm diameter culvert with cinder block headwall built underneath a driveway access to a school parking lot.

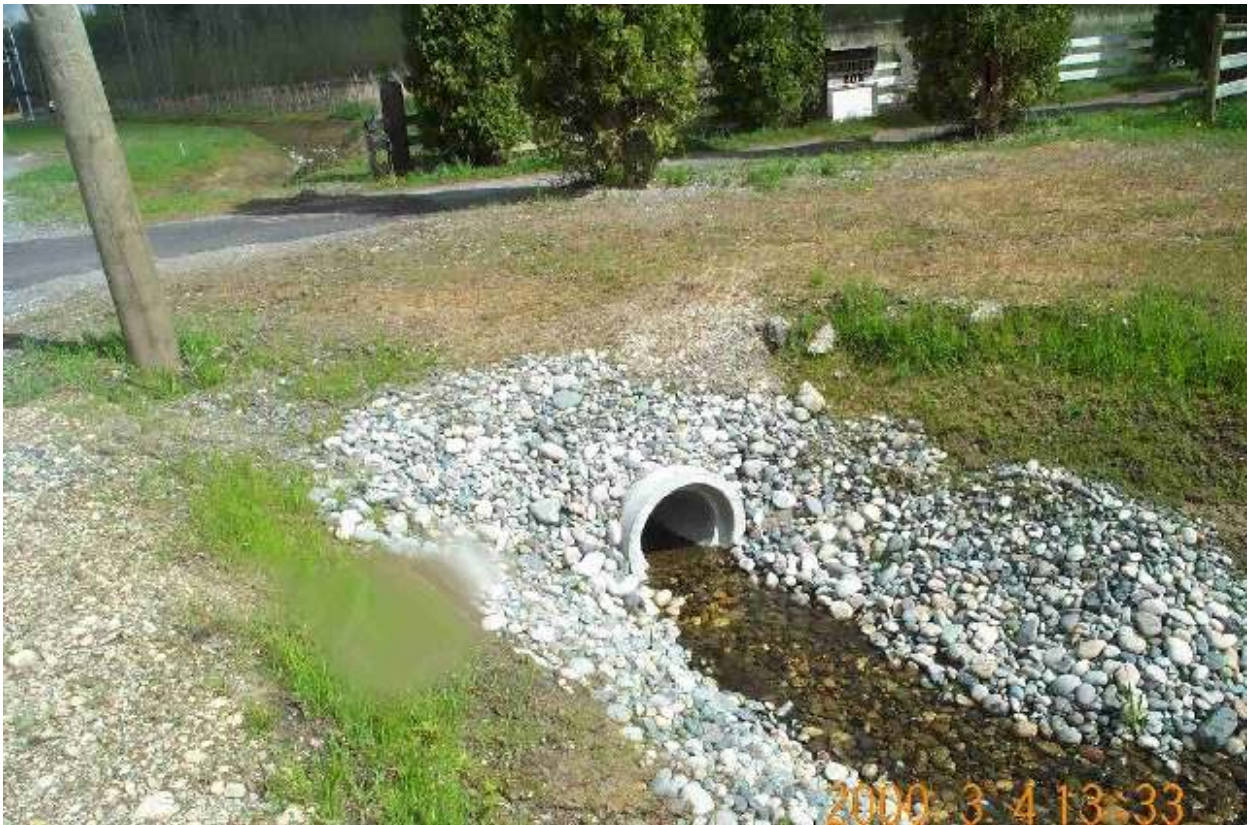
Figure 5-7

Existing and Post-Development Hydrographs for Discharge Location
GHD20

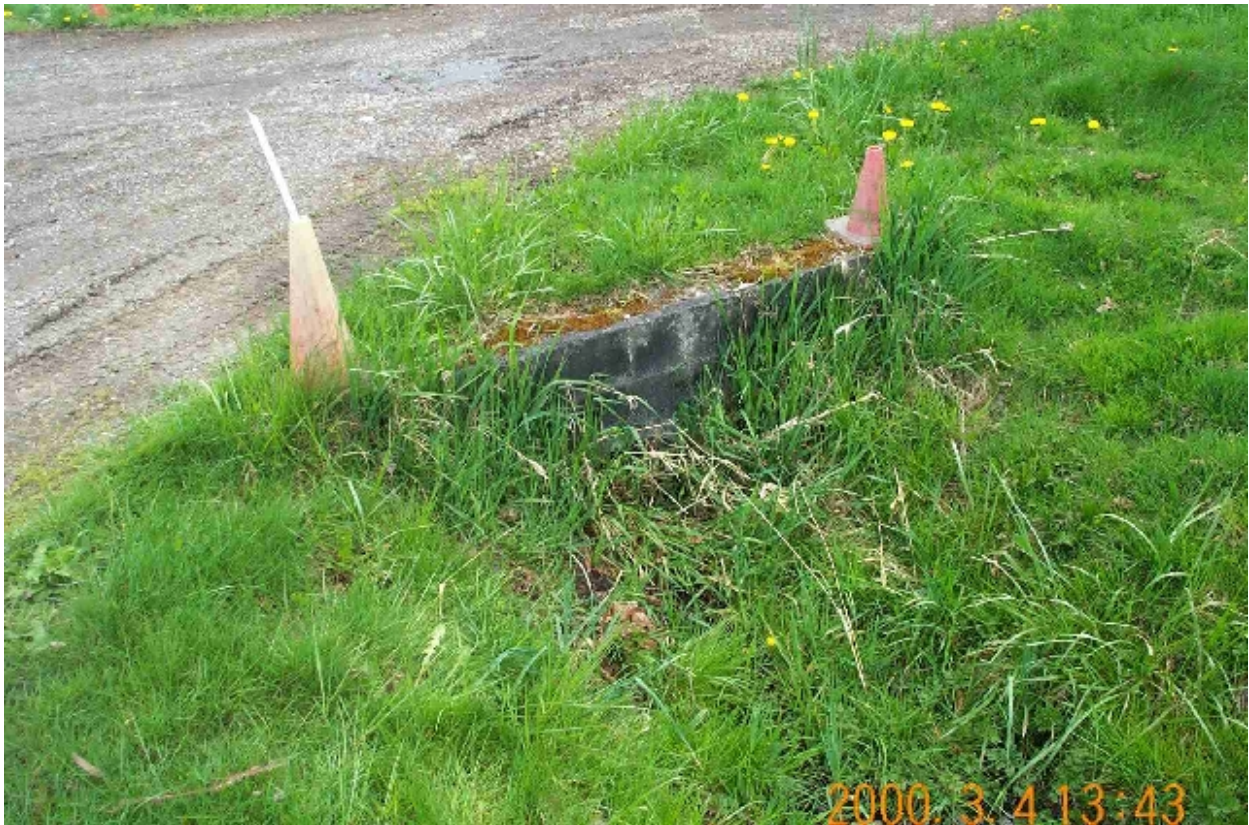
6.2 CAMPBELL HEIGHTS CONVENTIONAL BMPS

In the Campbell Heights area the intent is to maximize infiltration of stormwater into the underlying permeable soils. However, the WBM conceptual analysis indicates that approximately 15% of the annual rainfall volume could become direct runoff.

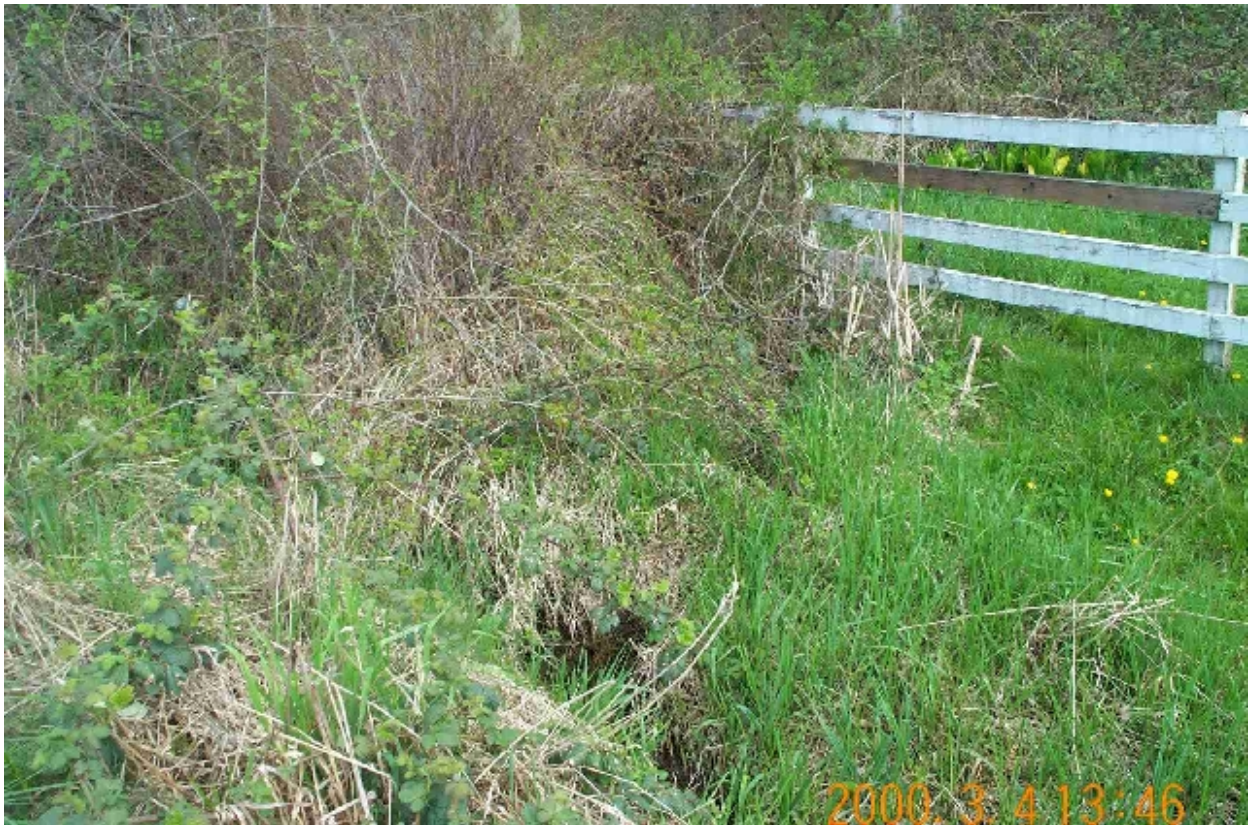
As only 15% of the long term rainfall volume is able to infiltrate, as compared to 56% dispersed by interception and evapotranspiration, it is apparent that the existing vegetative cover is particularly important for the current hydrologic state of the watershed. By extension, significant removal of the remaining vegetation will result in a substantial increase in runoff that is unlikely to be successfully mitigated by promotion of infiltration, given that the soil conditions do not appear conducive to receiving increased water volumes.

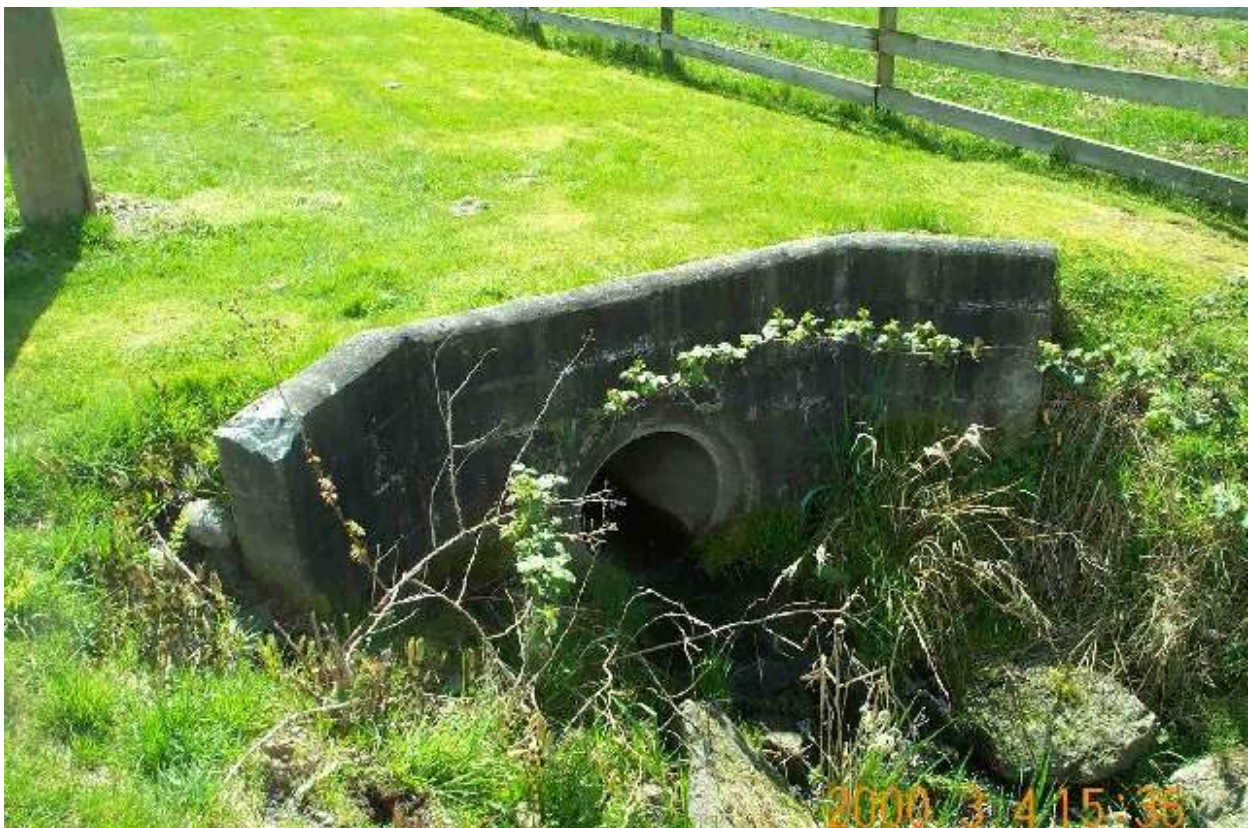
**Table 6-1
LID Scenario 1 Assumed Surface Conditions and LID measures in Grandview Heights Urban Residential Developments**

Area	Surface Sub-Area			% Routed	LID Measure	Area
Forest Buffer	10%	1000 m ²	Forest	100%	1000 m ²	None Required		
Road/Street	15%	1500 m ²	Paving	70%	1050 m ²	100%	Infiltration Swale	225 m ²
			Grass	30%	450 m ²			
Urban Residential	75%	7500 m ²	Roof	45%	3375 m ²	100%	Infiltration Facility ¹	750 m ²
			Paving	15%	1125 m ²	67%		
								33%
			Lawn/Landscaping	40%	3000 m ²	40%	Absorbent Landscaping	1200 m ²

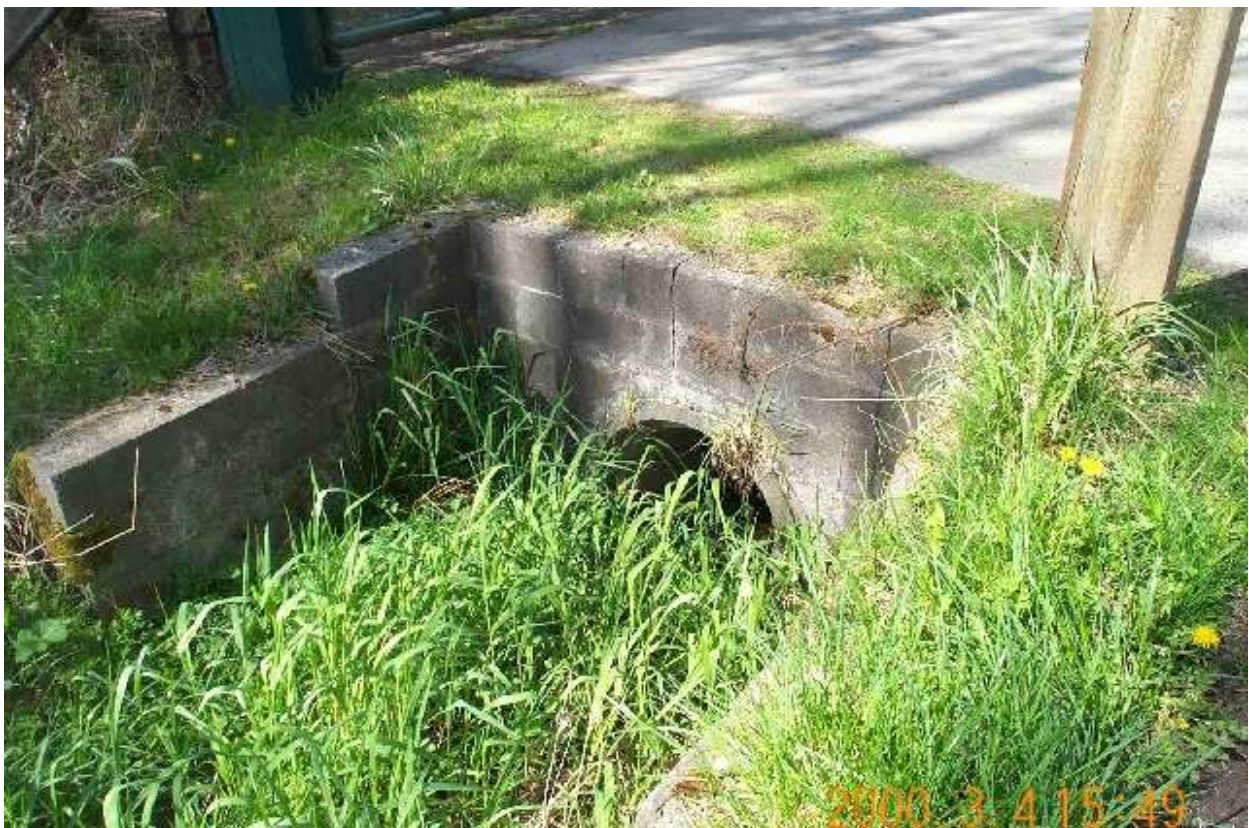
Stormwater detention facilities are unlikely to achieve the long term flow attenuation benefits that groundwater recharge provides. In particular, storage of runoff as groundwater to provide dry season base flow to the creek system will not be provided by any reasonably sized detention storage facility. Given the high runoff volumes that we expect, providing sufficient detention storage to provide flow attenuation over a period of days to ensure ARDSA criteria are met in the lowlands would be challenging. Conventional detention storage attenuates runoff over a relatively short period of time, typically 24 hours to 48 hours. ARDSA requires that flooding durations be limited to five days during the winter. For upland storage to effectively address lowland flooding conditions as defined by ARDSA, would require much slower release rates, and consequently larger storage volumes.

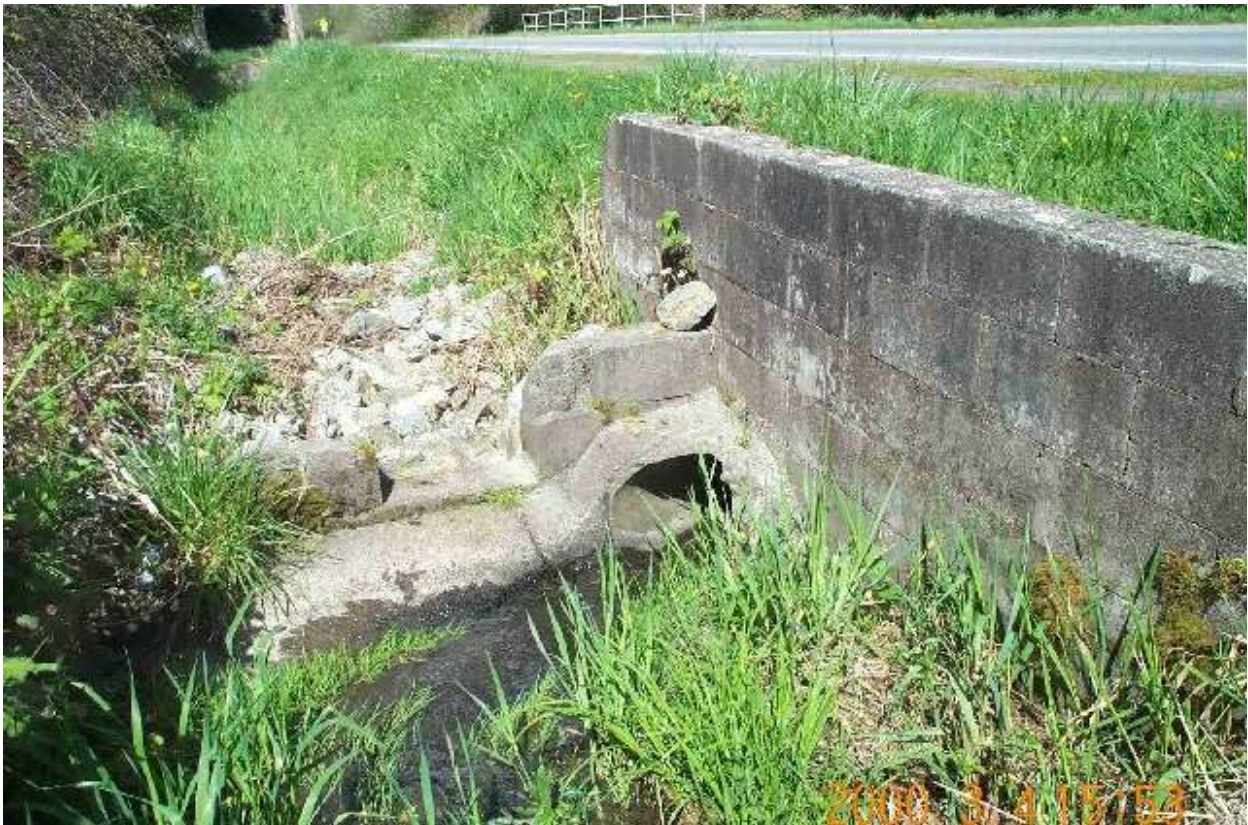
Photos P1000243.jpg

Comment: 450 mm diameter culvert with cinder block headwall built underneath 184th Street. A notched weir has been built north of the inlet and is armored with rip rap.

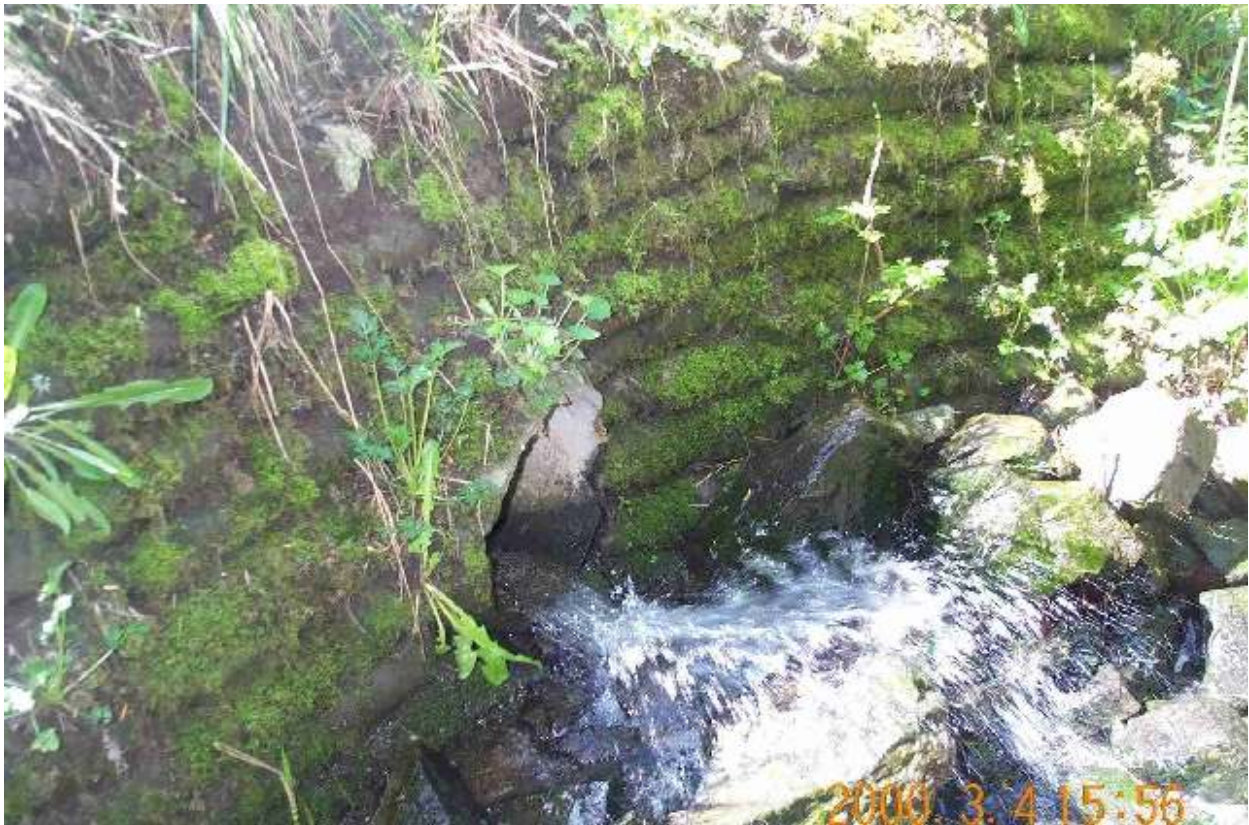
Photos P1000244.jpg

Comment: 450 mm diameter culvert with concrete sandbag headwall built underneath 184th Street. Confluence with south east 184th Street ditch and Erickson Creek.

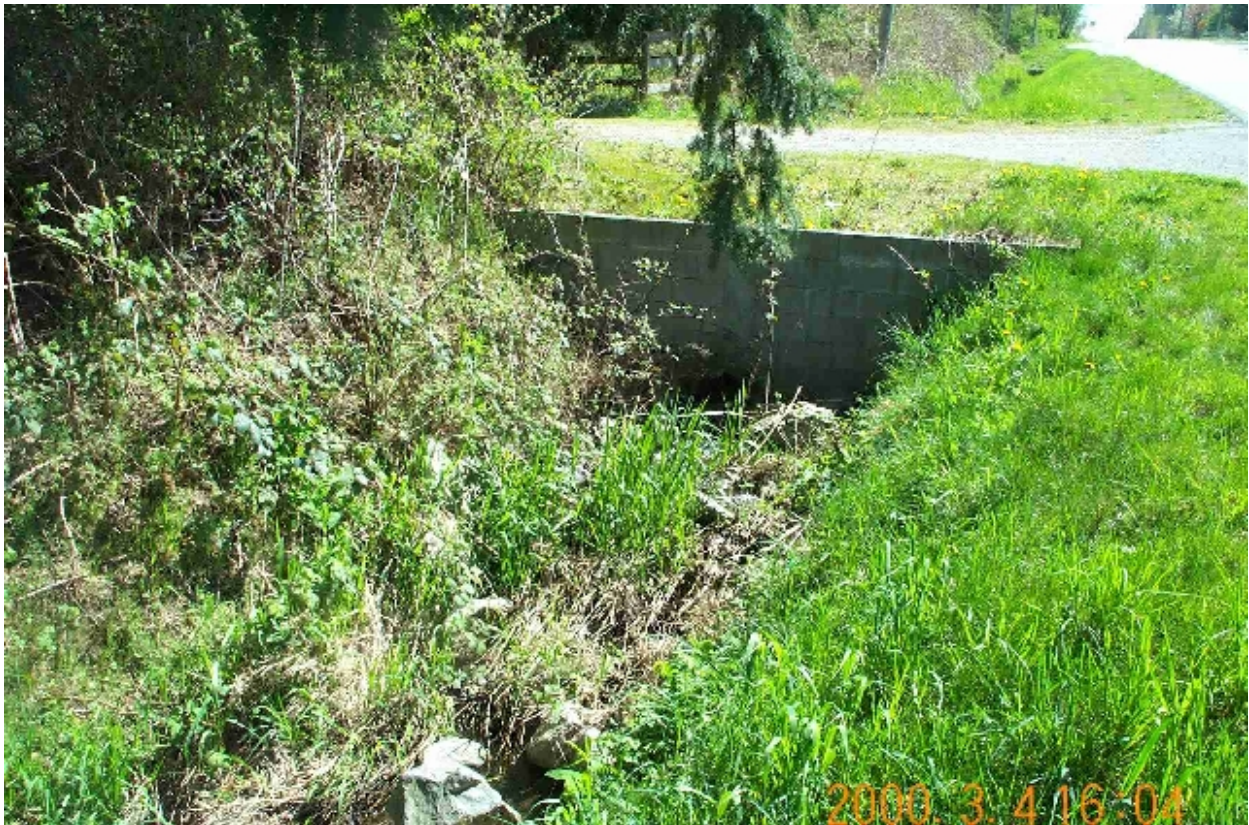
Photos P1000246.jpg

Comment: 450 mm diameter culvert with cinder block headwall underneath a private driveway.

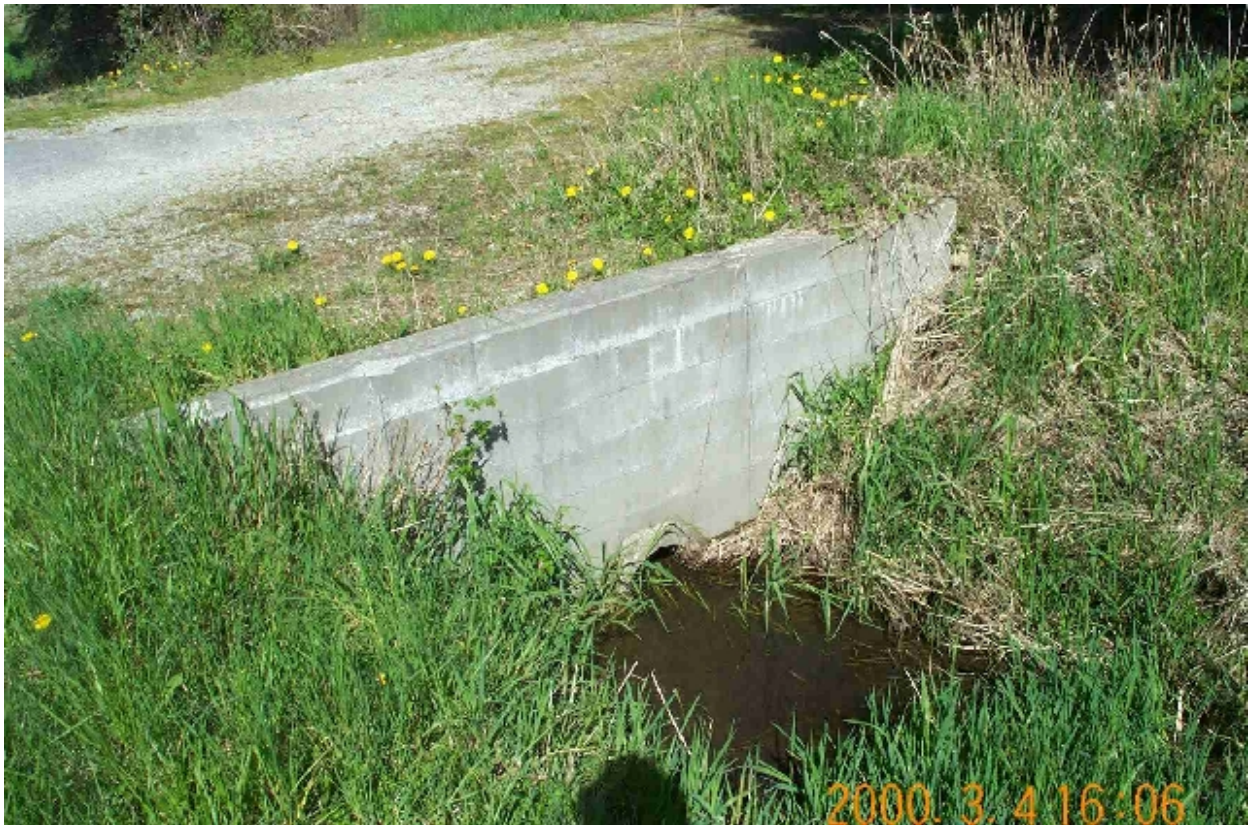
Photos P1000247.jpg

Comment: 450 mm diameter culvert with cinder block headwall underneath a private driveway.

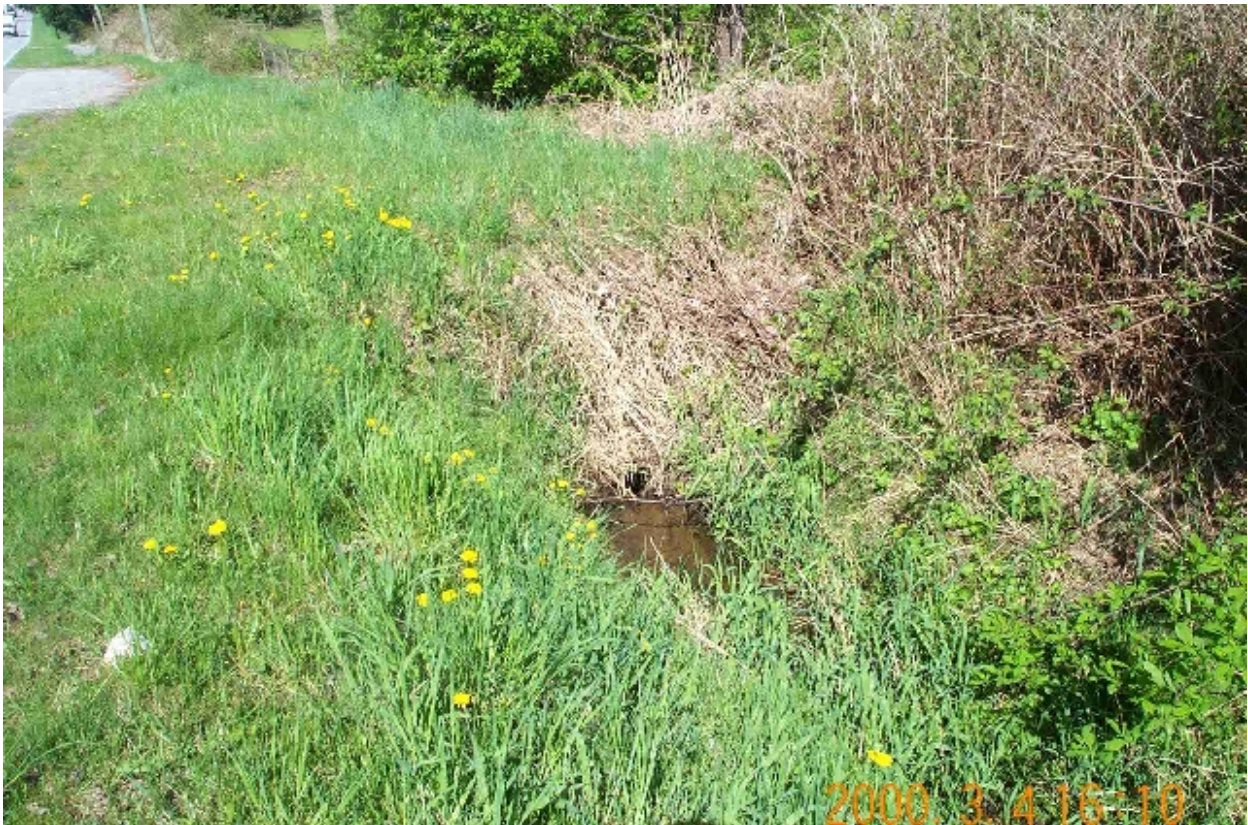
Photos P1000249.jpg

Comment: 600 mm diameter culvert with cinder block headwall underneath a private driveway.

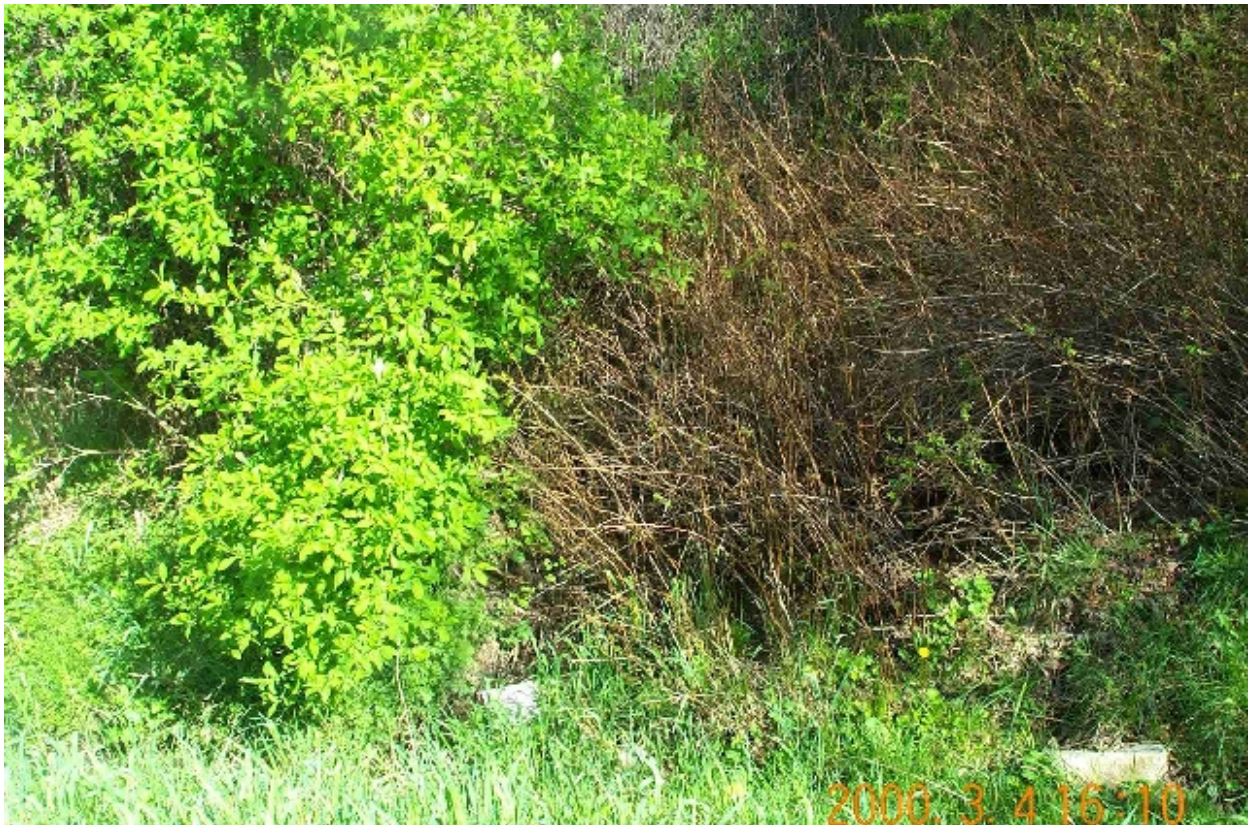
Photos P1000250.jpg

Comment: 600 mm diameter culvert with cinder block headwall underneath a private driveway. Confluence with a small ditch to the east.

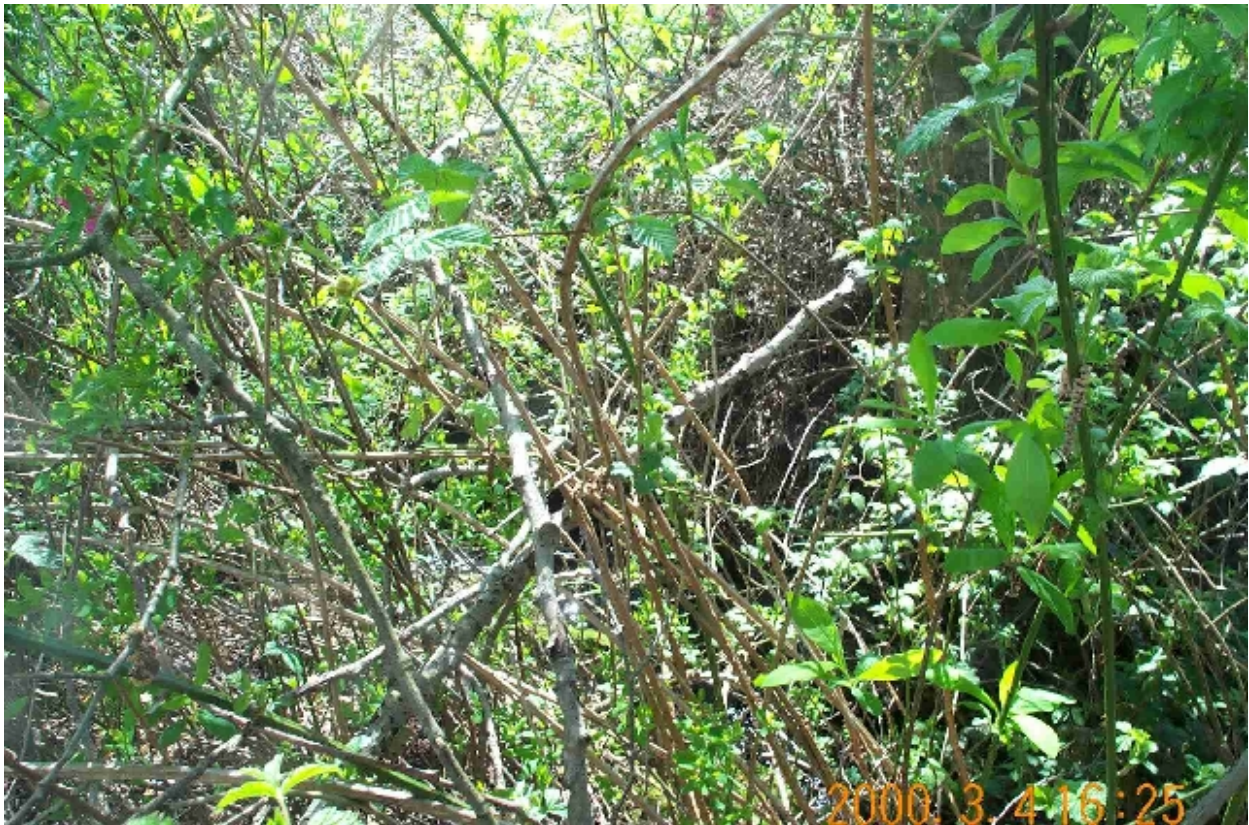
Photos P1000251.jpg

Comment: Cross-section downstream of 184th Street crossing. Channel banks are well vegetated.

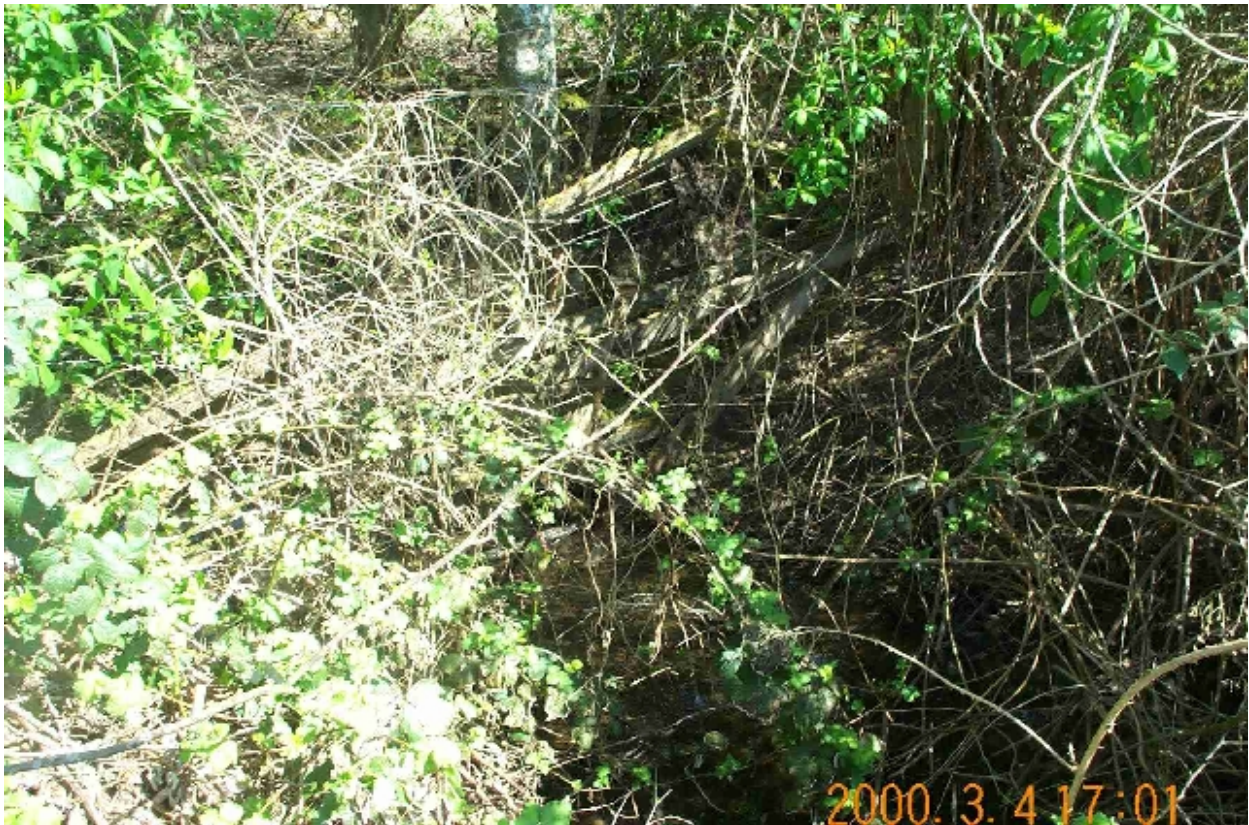
Photos P1000256.jpg

Comment: Confluence with farm ditch draining field to the west.

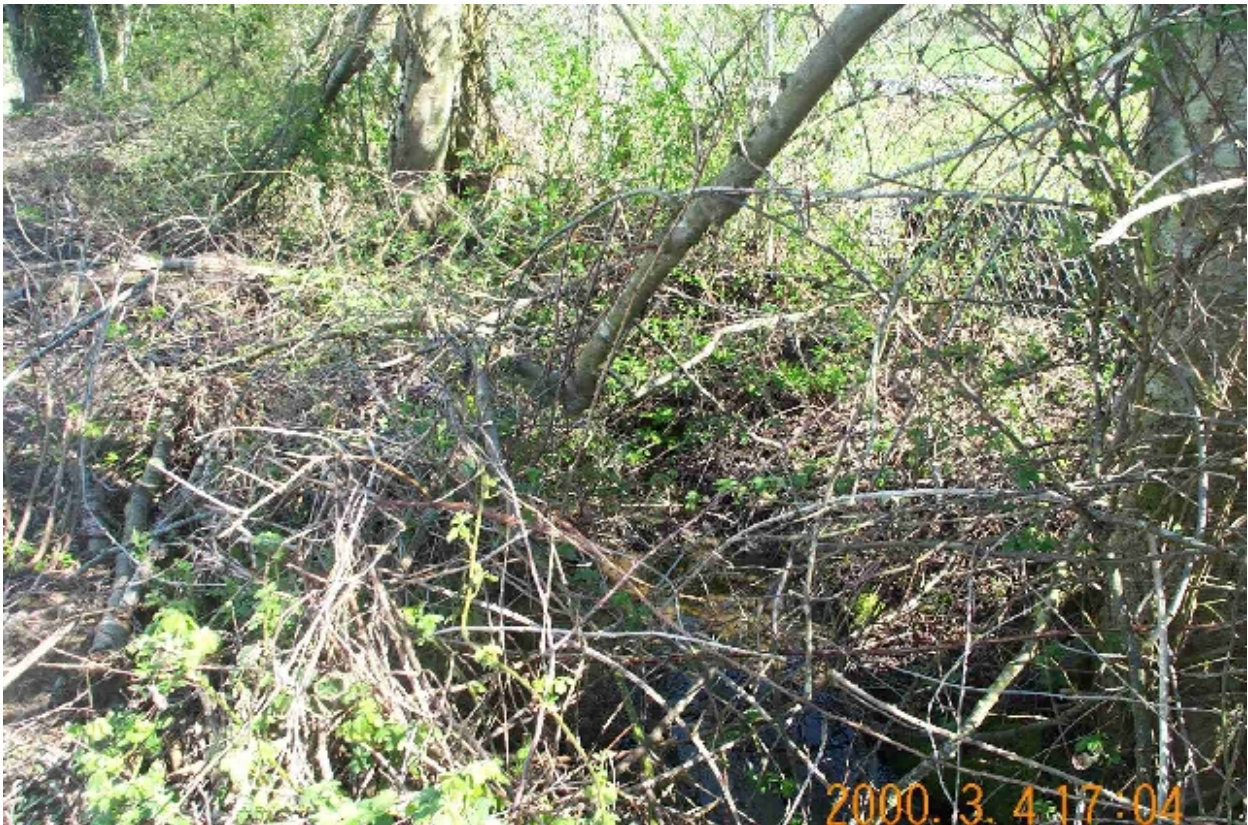
Photos P1000257.jpg

Comment: Confluence with small creek draining from the north.

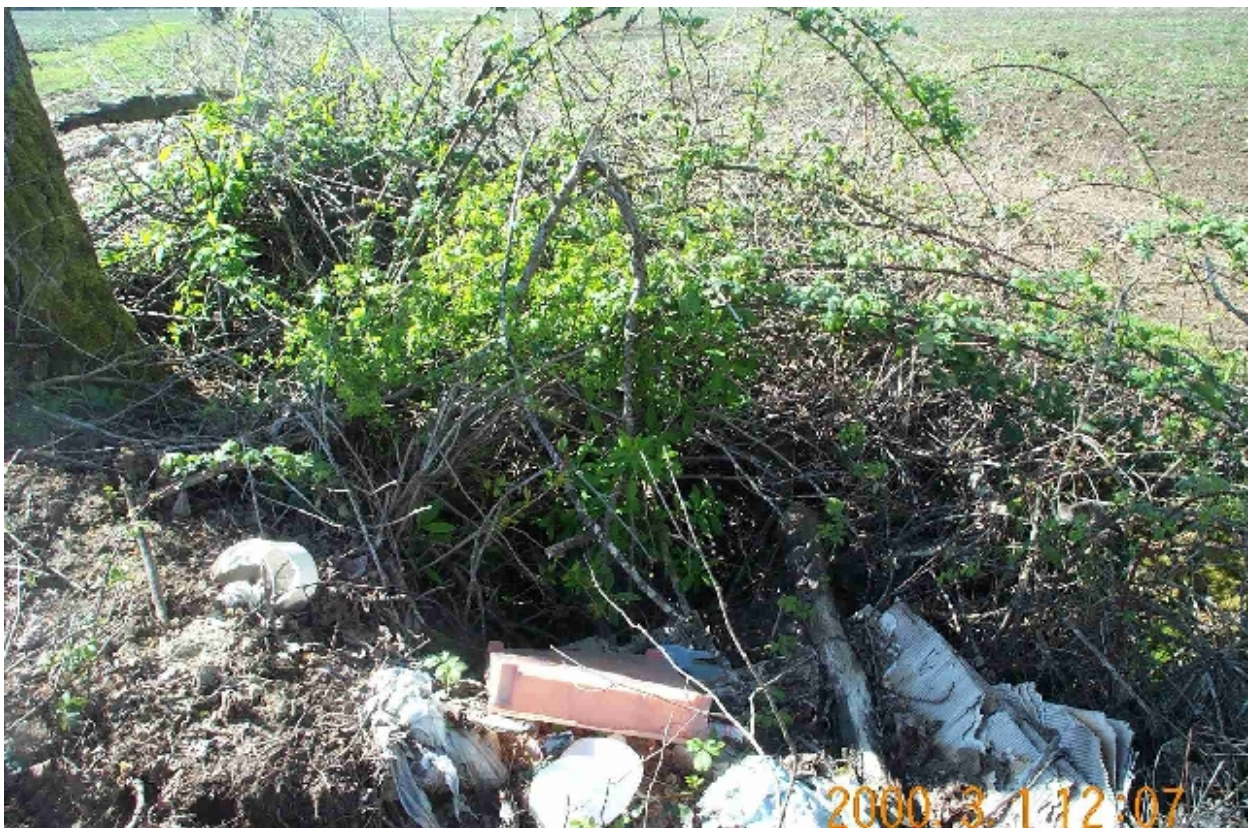
Photos P1000259.jpg

Comment: Well defined side channel in farm field. Channel banks are well vegetated.

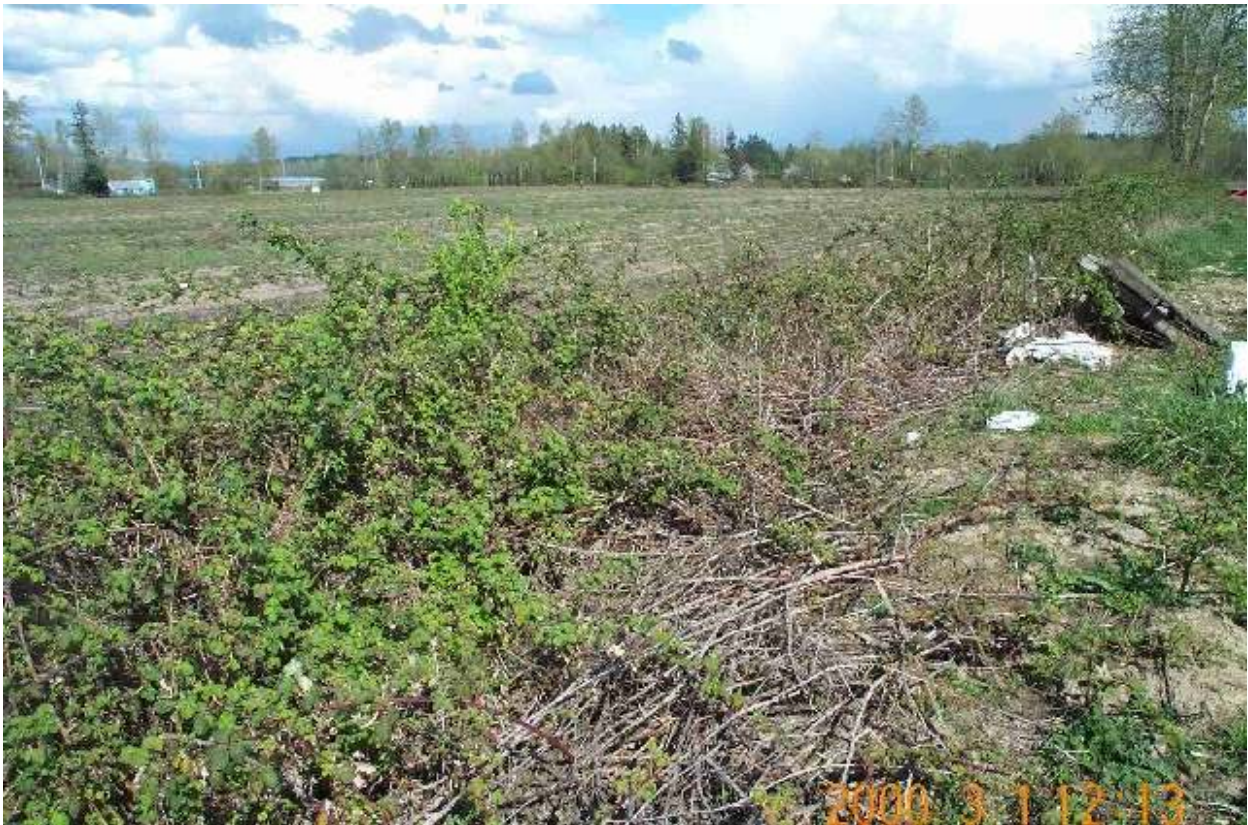
Photos P1000260.jpg

Comment: Well defined side channel in farm field. Channel banks are well vegetated.

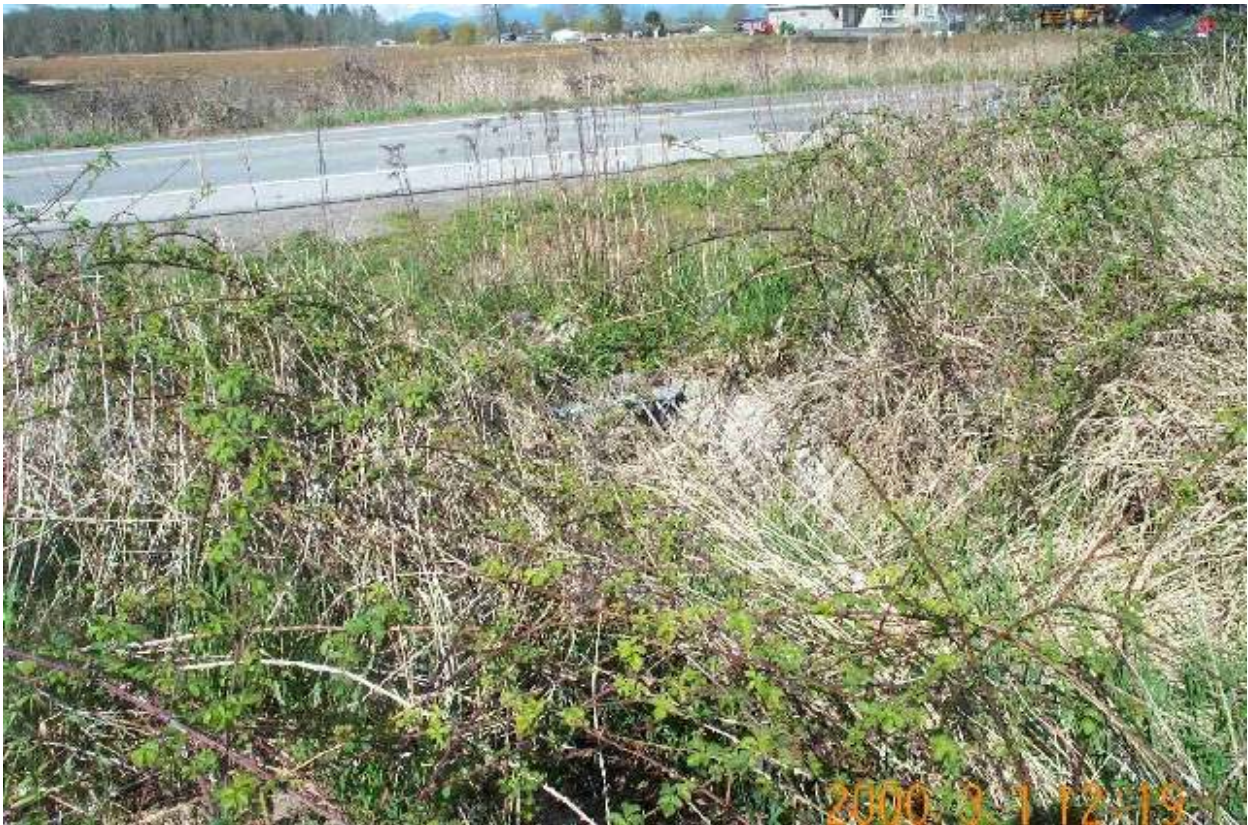
Photos P1000262.jpg

Comment: 600 mm diameter culvert with concrete headwall and wingwalls and trash rack. Built underneath 32nd Avenue.

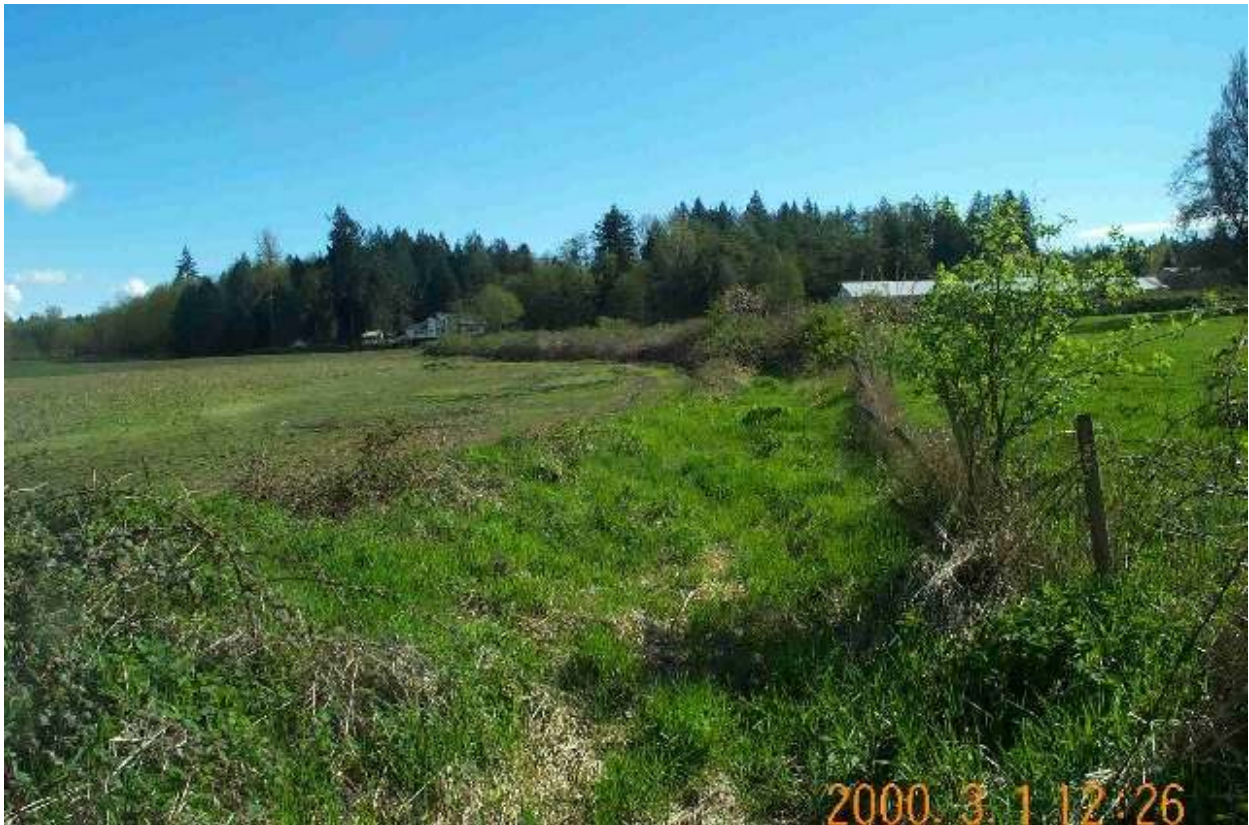
Photos P1000264.jpg

Comment: 600 mm diameter culvert with concrete headwall and wingwalls with trashrack built underneath 32nd Avenue.

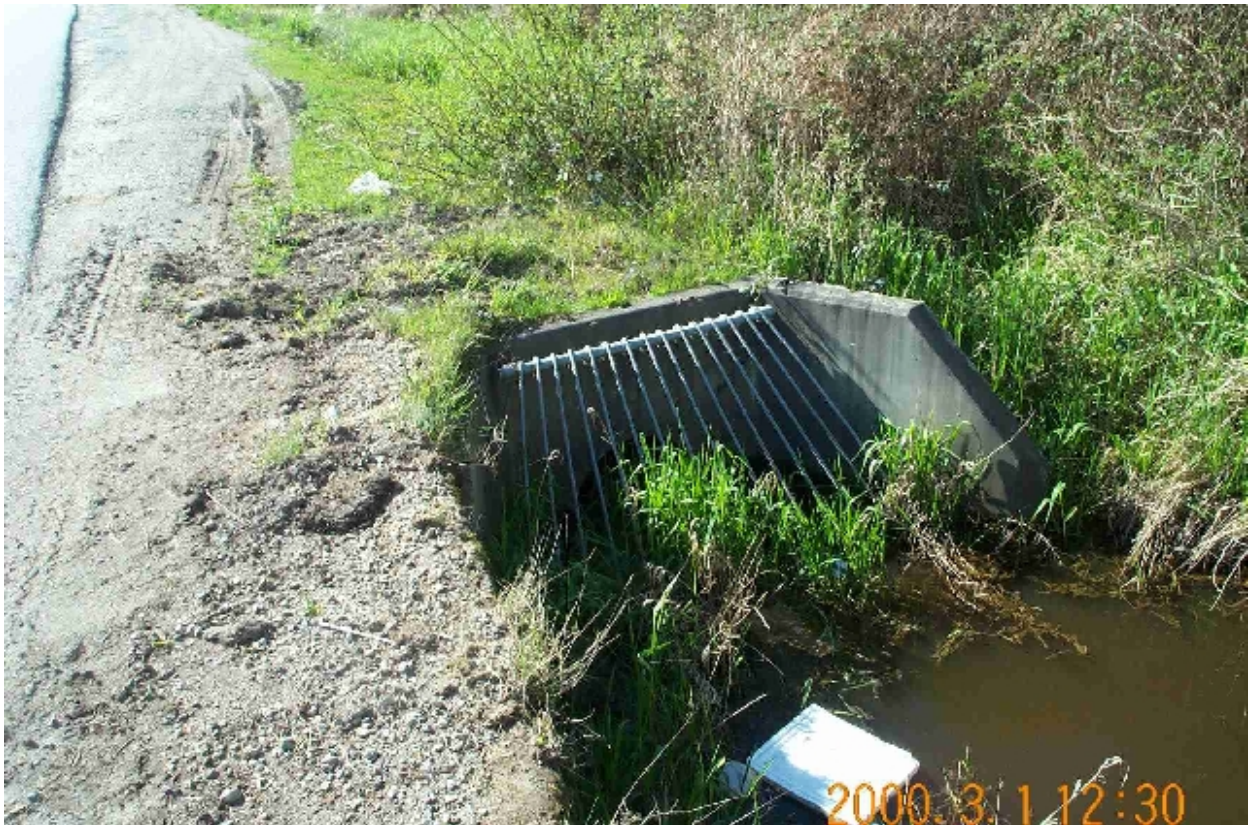
Photos P1000265.jpg

Comment: 600 mm diameter culvert with concrete headwall and wingwalls with trashrack built underneath 32nd Avenue.

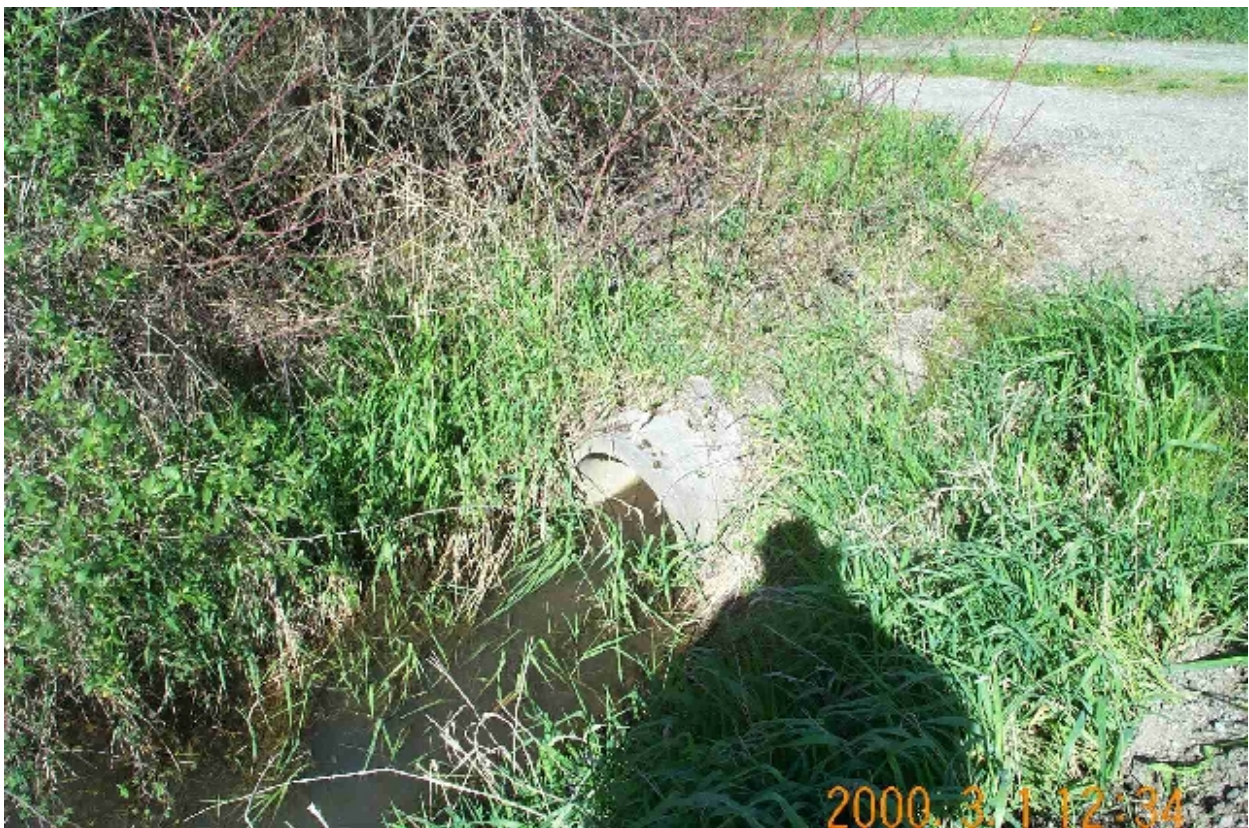
Photos P1000266.jpg

Comment: 600 mm diameter culvert built underneath a private driveway.
