City of Surrey

Erickson Creek Integrated Stormwater Management Plan

September 2010

**Re: ERICKSON CREEK INTEGRATED STORMWATER MANAGEMENT PLAN
FINAL REPORT**

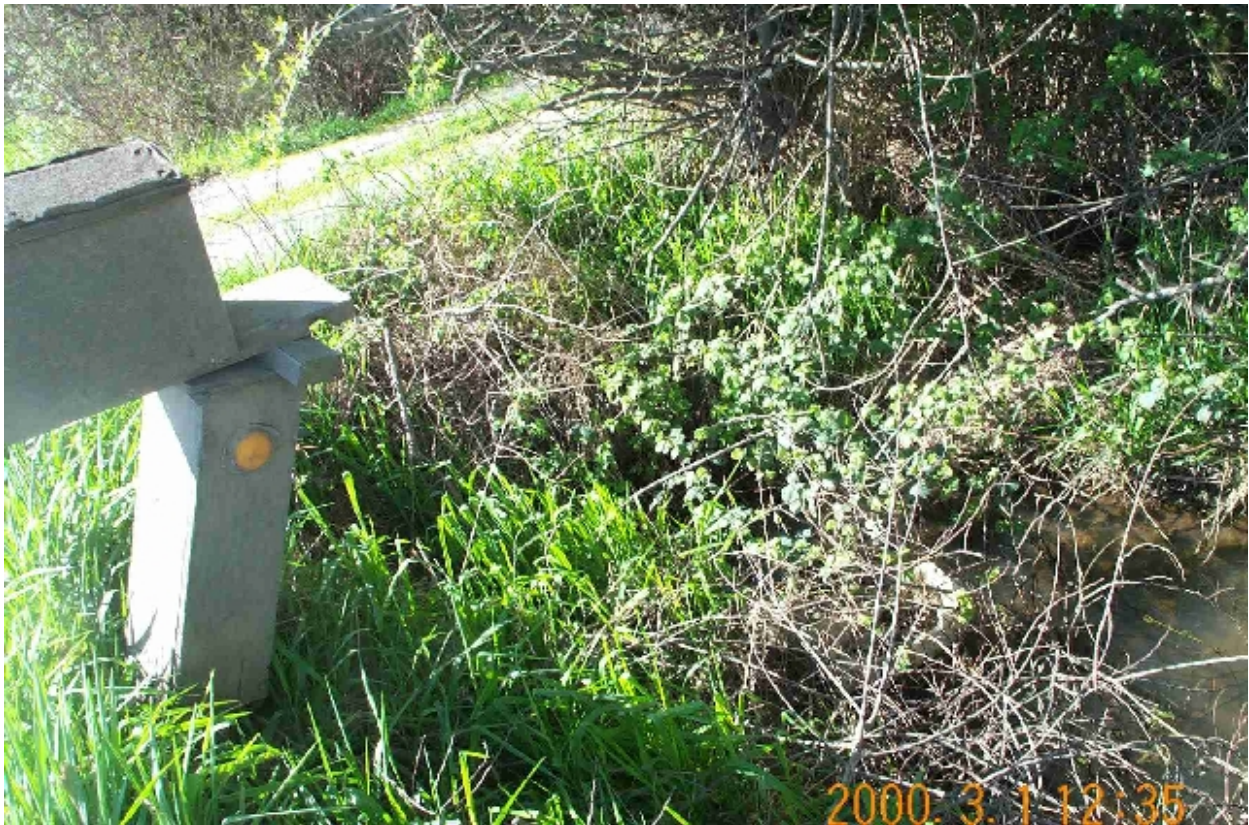
Photos P1000267.jpg

Comment: 600 mm diameter culvert built underneath a private driveway. Inlet slightly obstructed by vegetation.

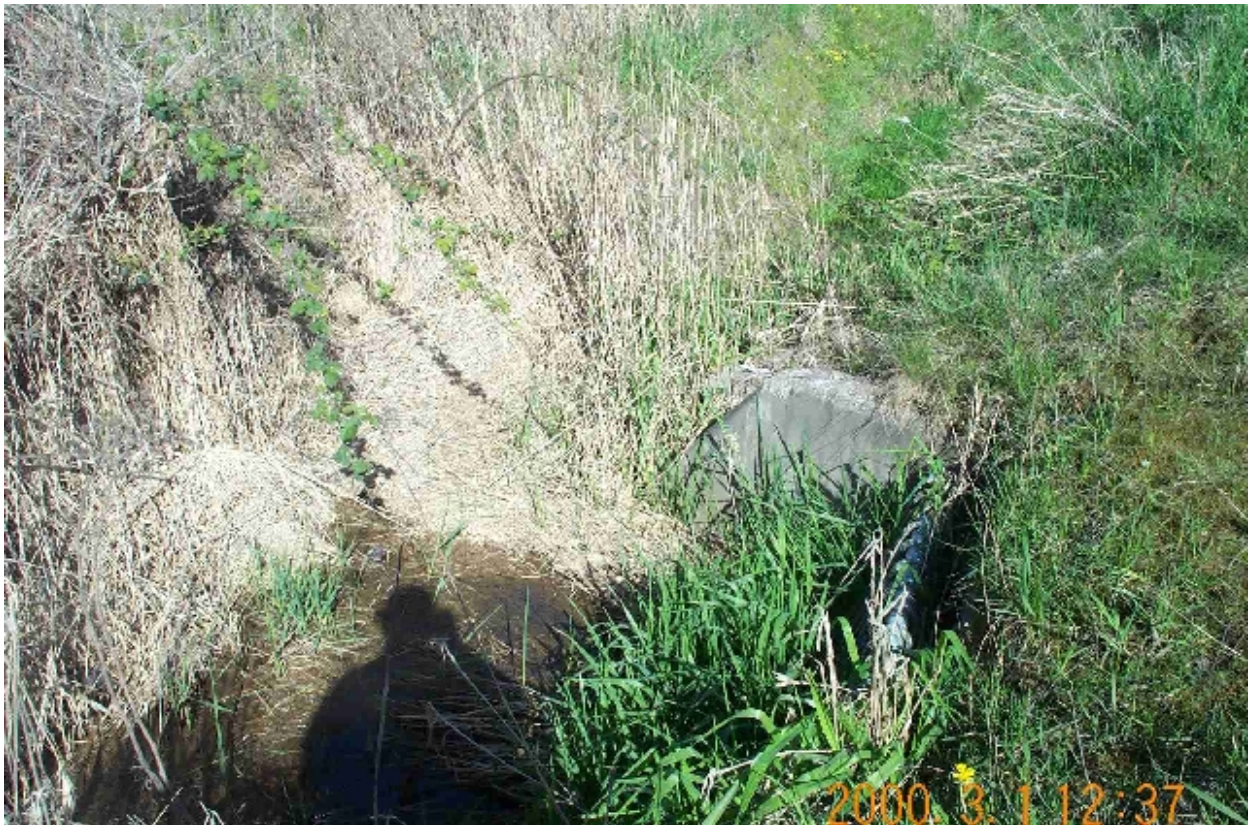
Photos P1000268.jpg

Comment: 600 mm diameter culvert with concrete headwall and wingwalls and trash rack. Built underneath 32nd Avenue and is a confluence with the north side 32nd Avenue ditch.

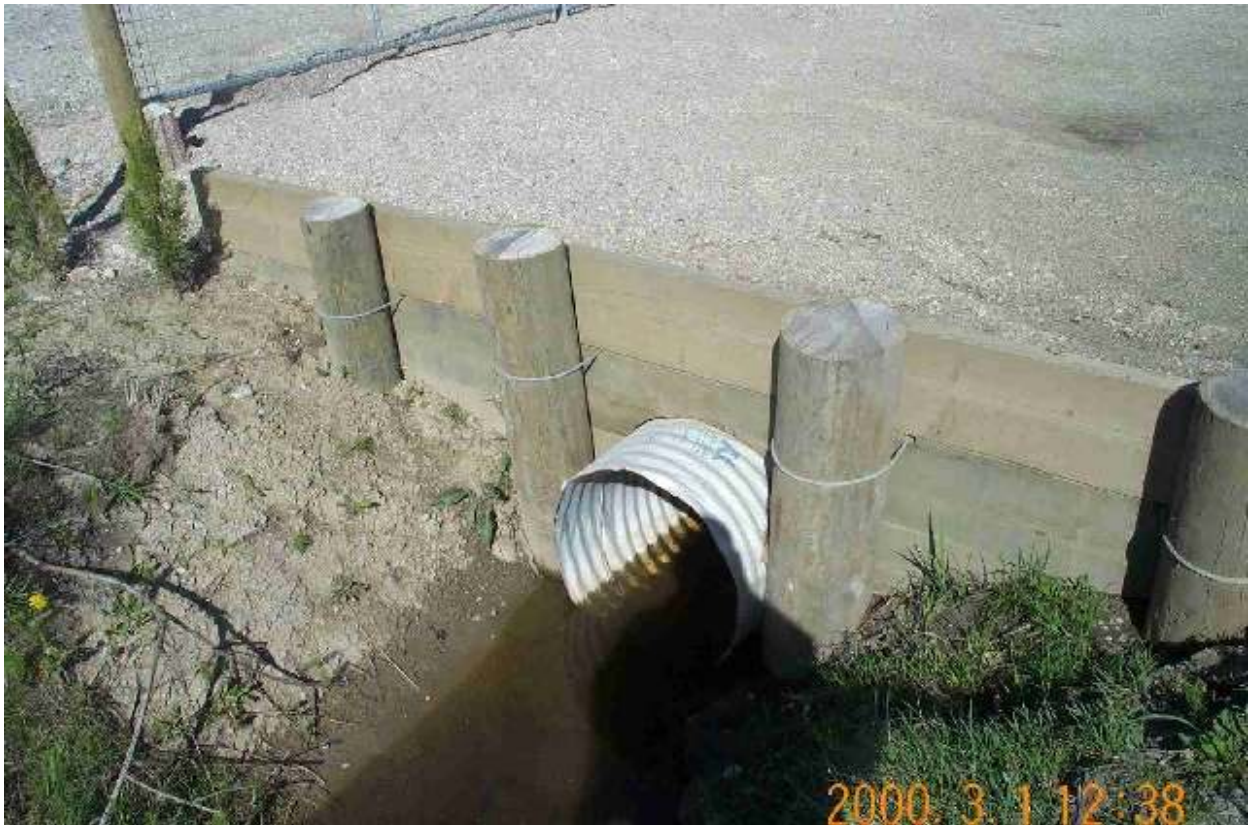
Photos P1000269.jpg

Comment: 600 mm diameter culvert with timber headwall built underneath a private driveway

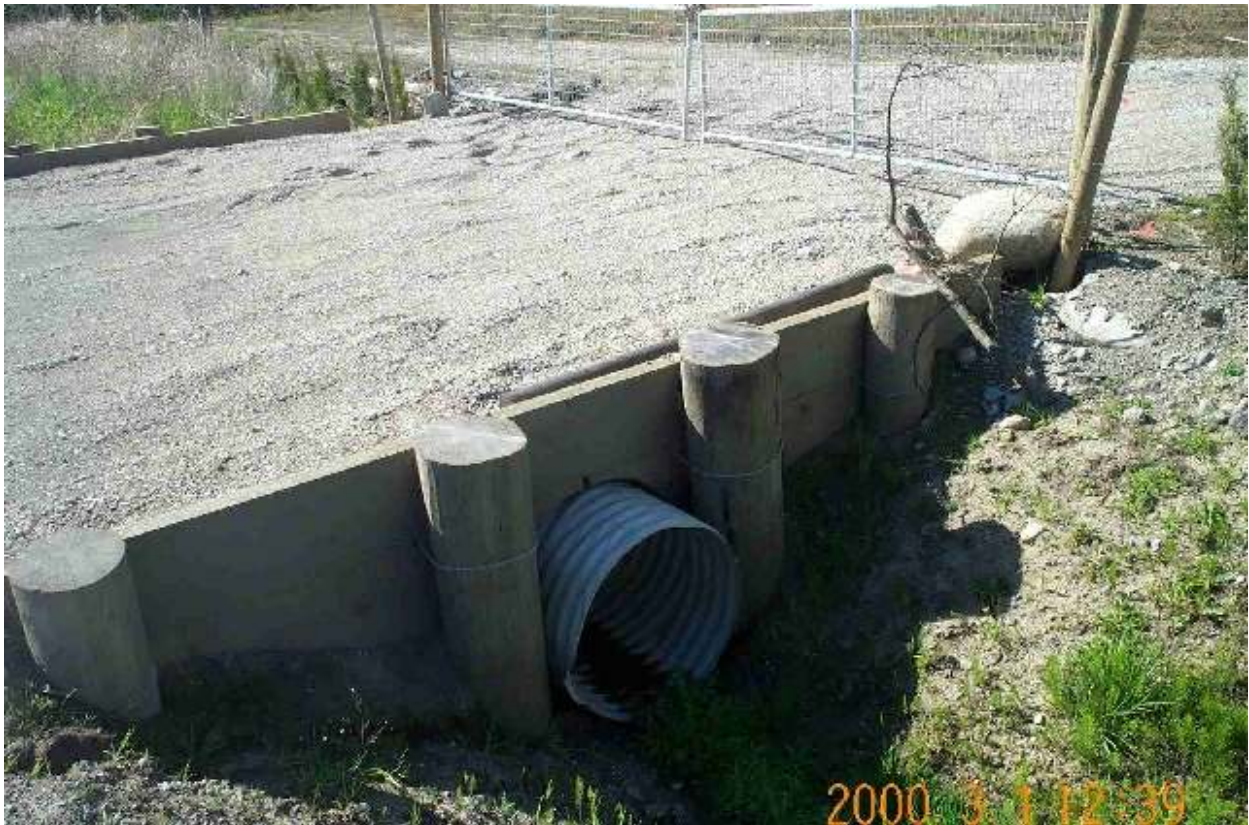
Photos P1000270.jpg

Comment: 600 mm diameter culvert with timber headwall built underneath a private driveway

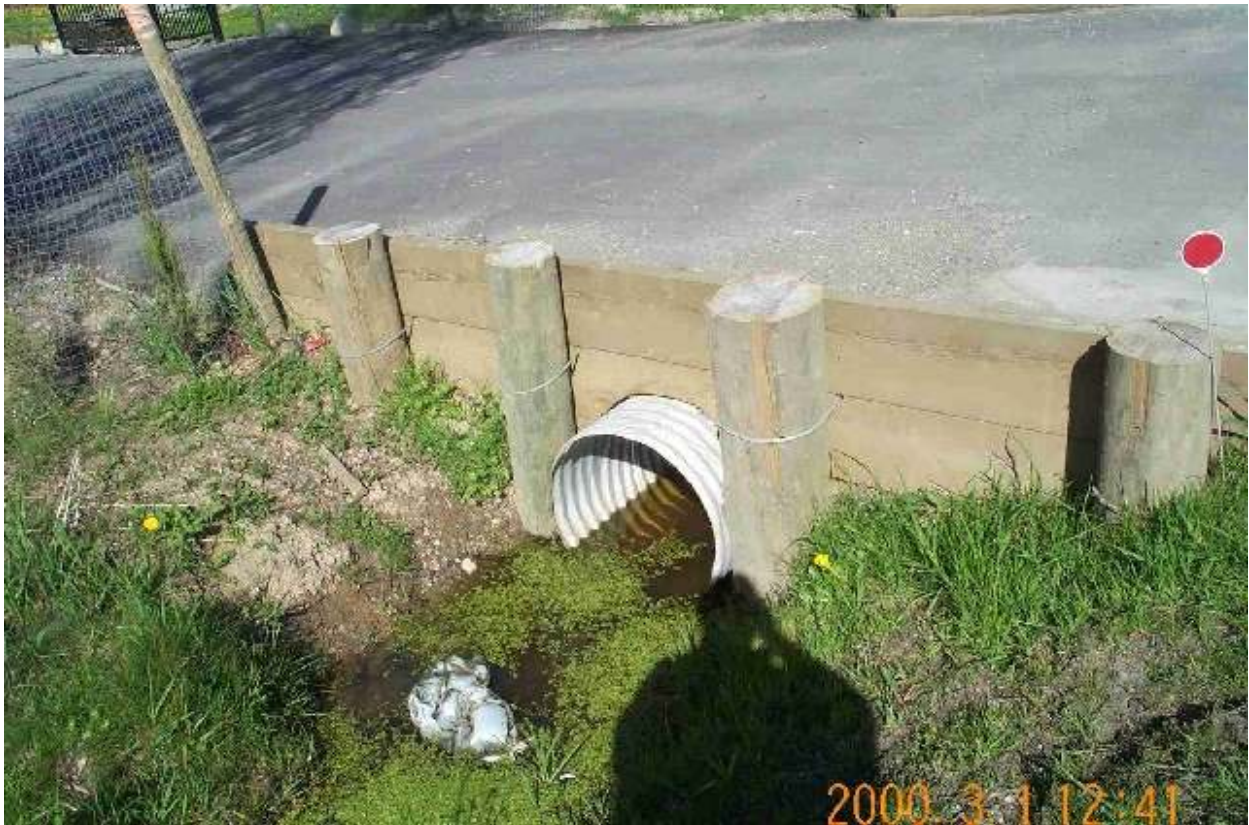
Photos P1000271.jpg

Comment: 600 mm diameter culvert built underneath a private driveway.

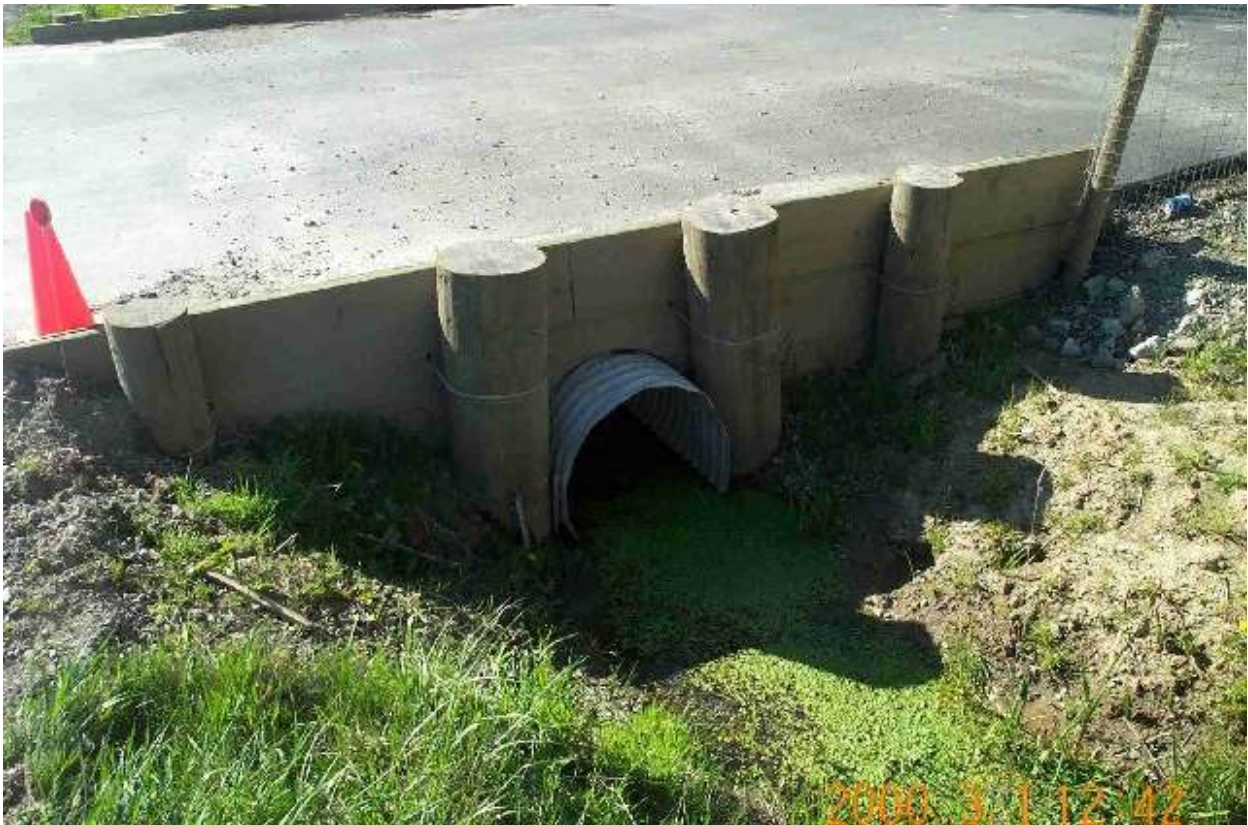
Photos P1000272.jpg

Comment: 600 mm diameter culvert built underneath a private driveway.

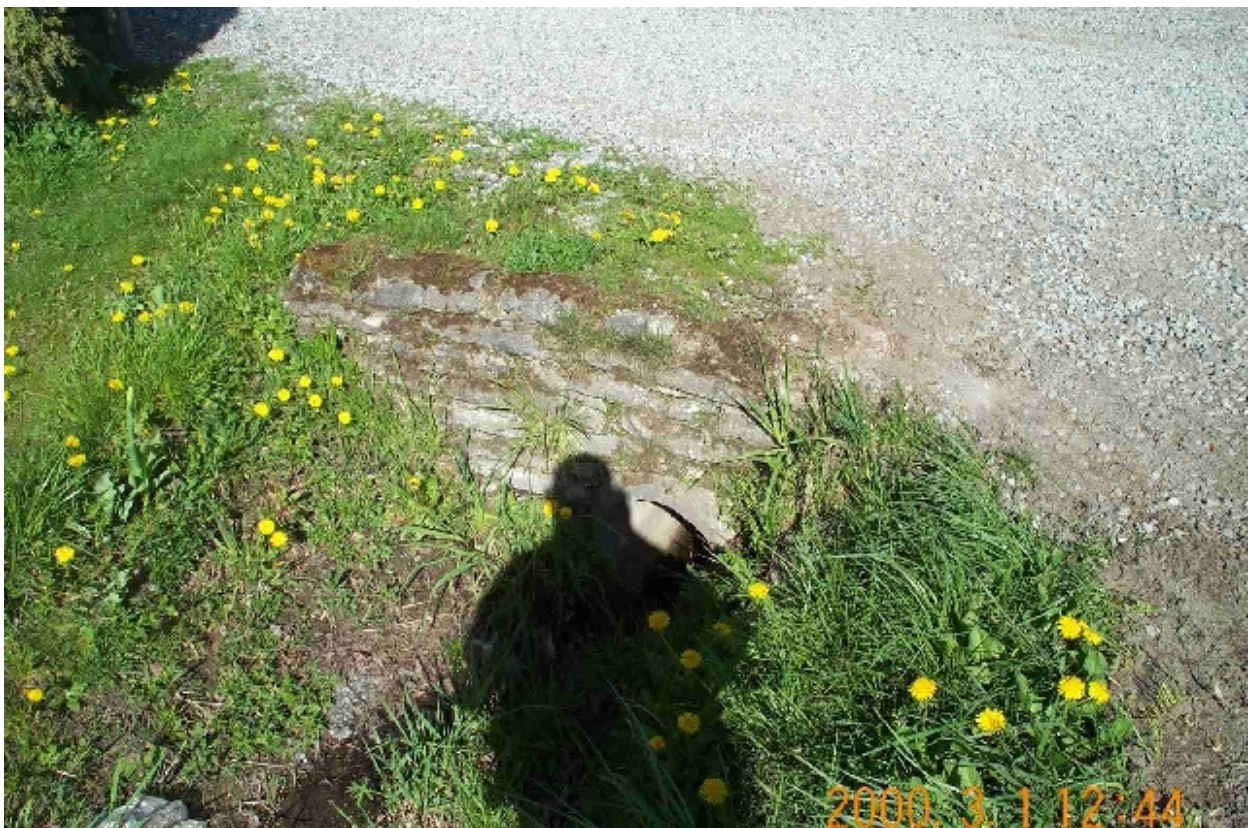
Photos P1000273.jpg

Comment: 450 mm diameter culvert with concrete sandbag headwall.

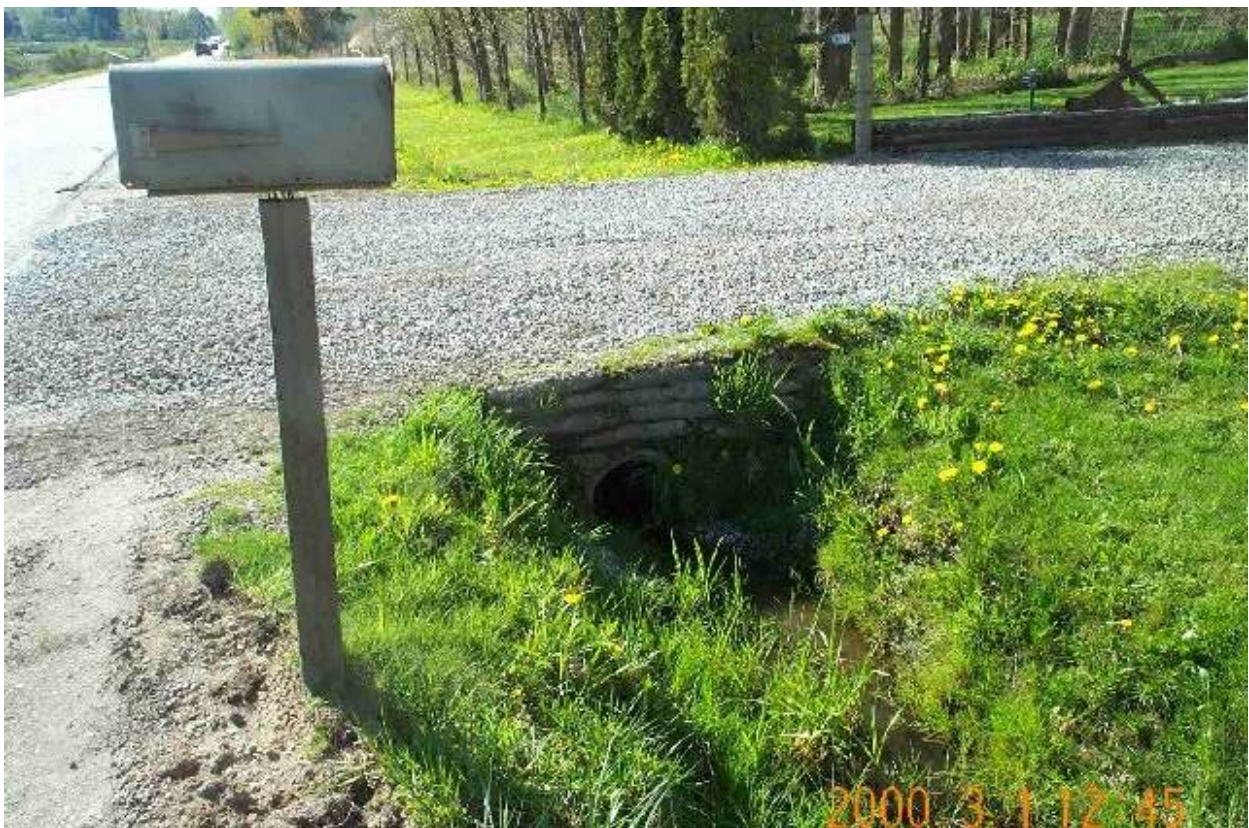
Photos P1000274.jpg

Comment: 450 mm diameter culvert with concrete sandbag headwall.

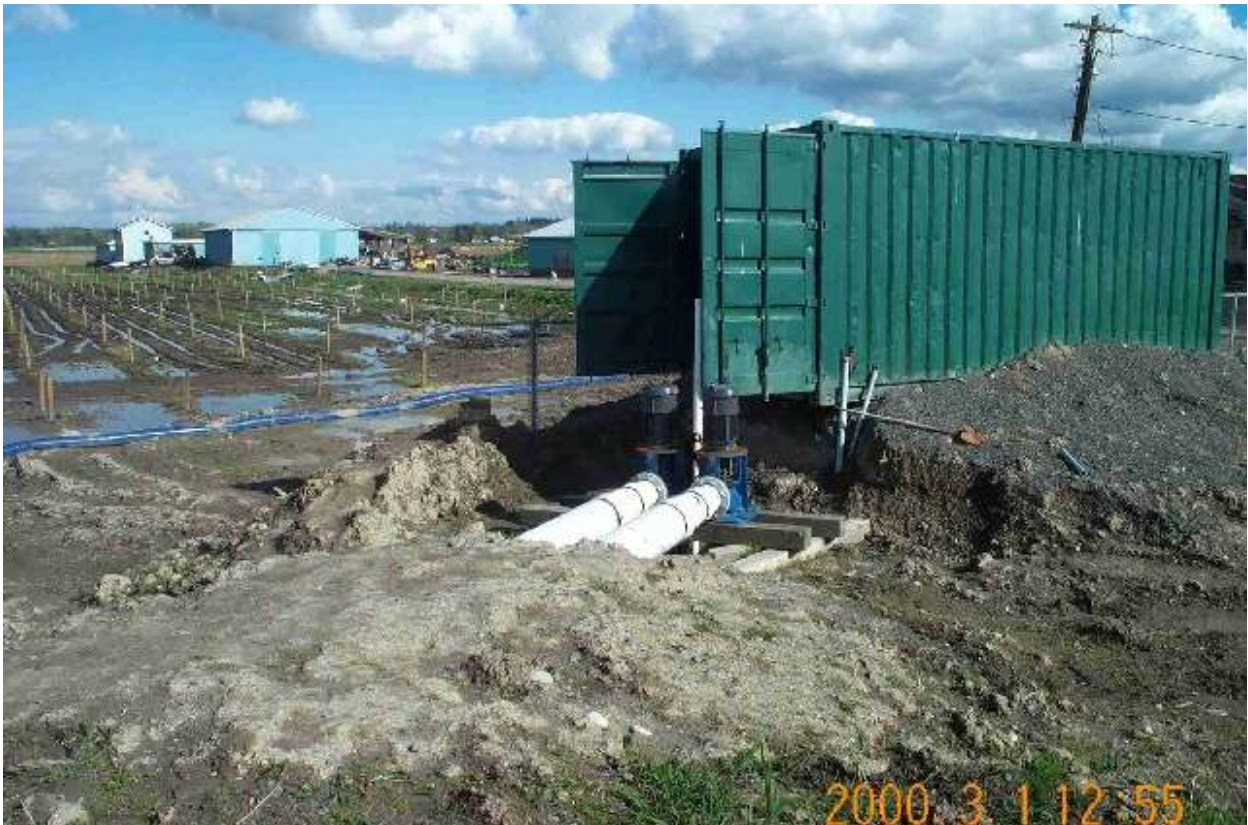
Photos P1000276.jpg

Comment: Private pump station that services an agricultural field. Outflow is directed to the Nicomekl River.

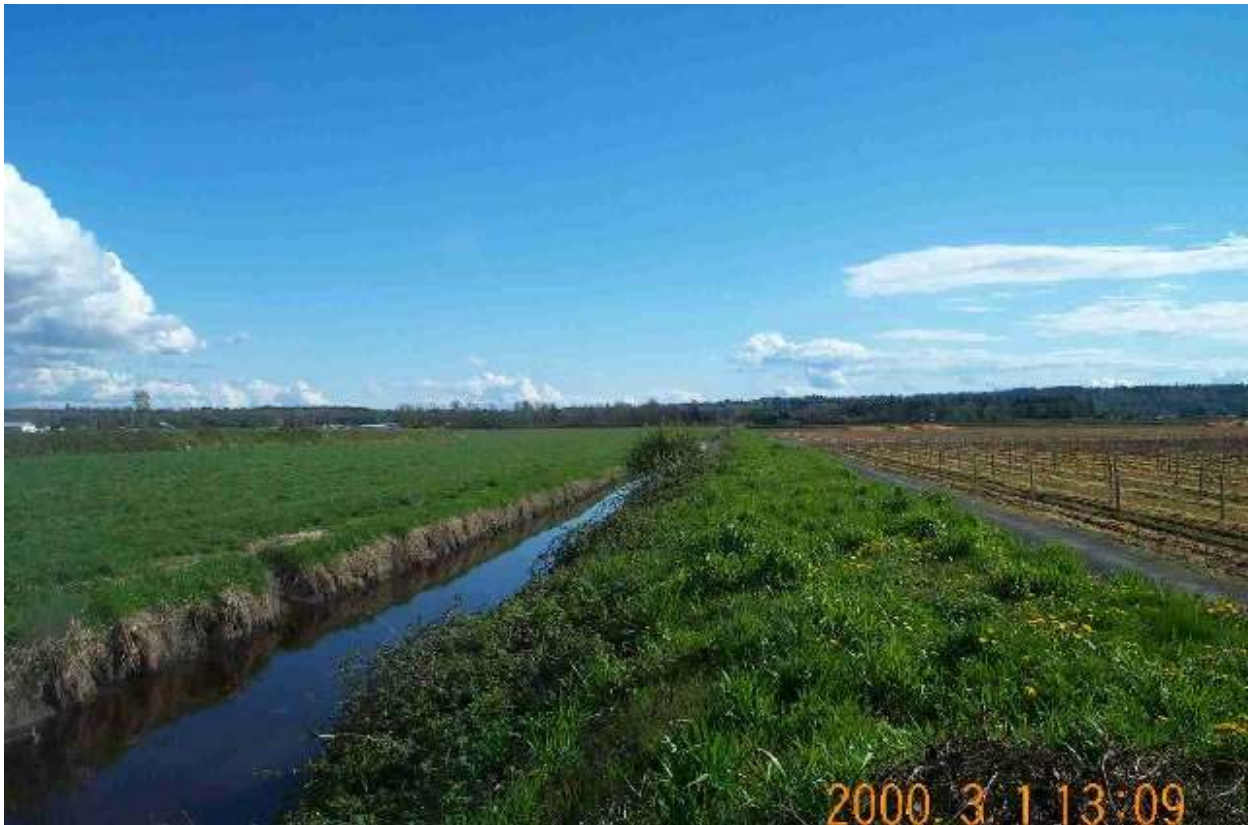
Photos P1000280.jpg

Comment: Pump station at Nicomekl River.

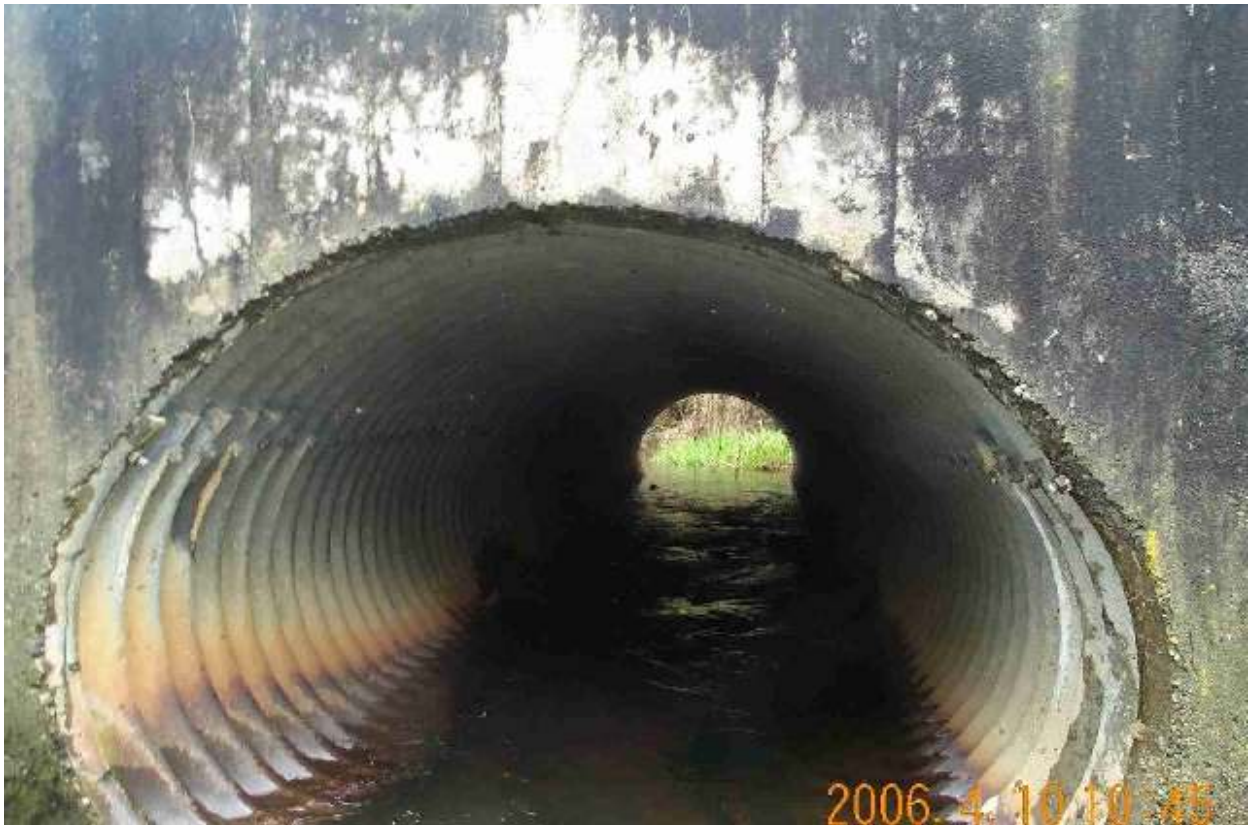
Photos P1009998.jpg

Comment: Twin 1500 mm diameter culverts with concrete headwall and concrete sandbag wingwalls built underneath 32nd Avenue.

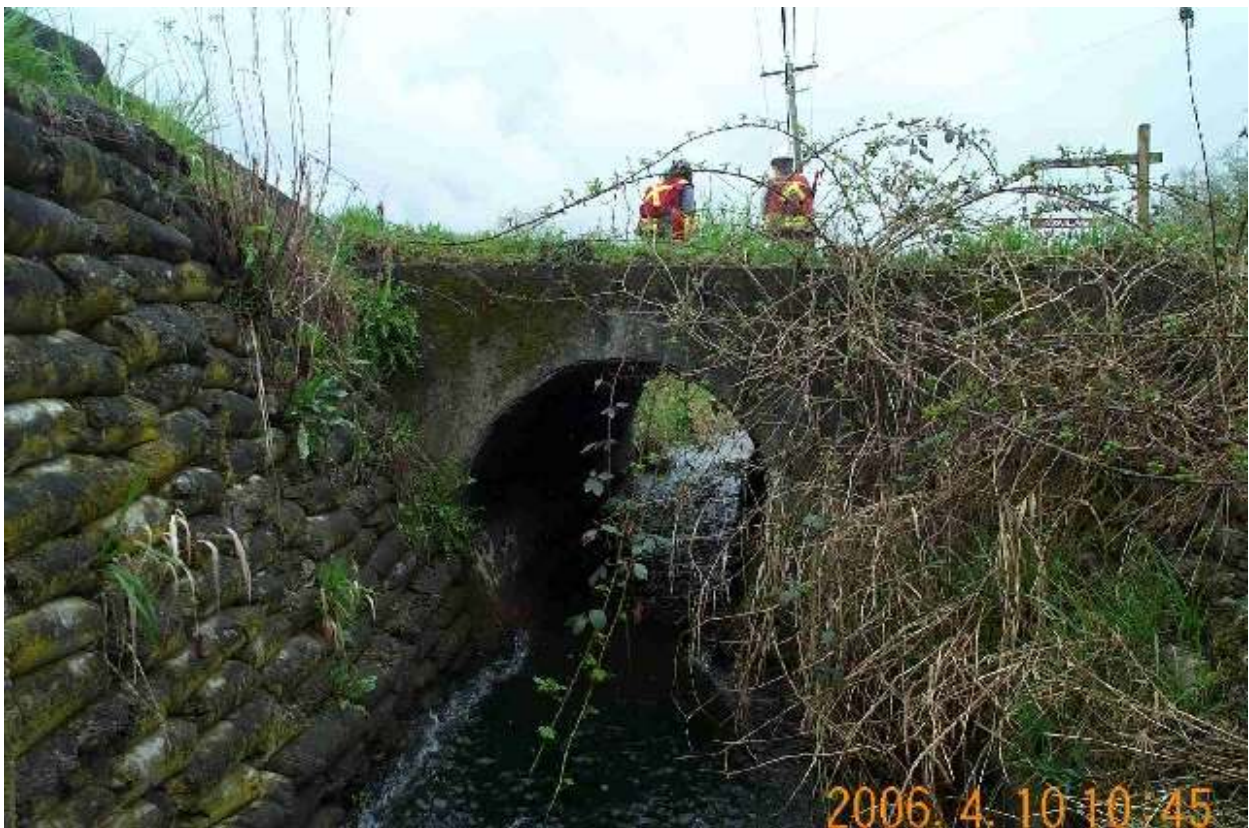
Photos P1010001.jpg

Comment: 1200 mm culvert with concrete headwall built underneath a private driveway to a dog kennel.

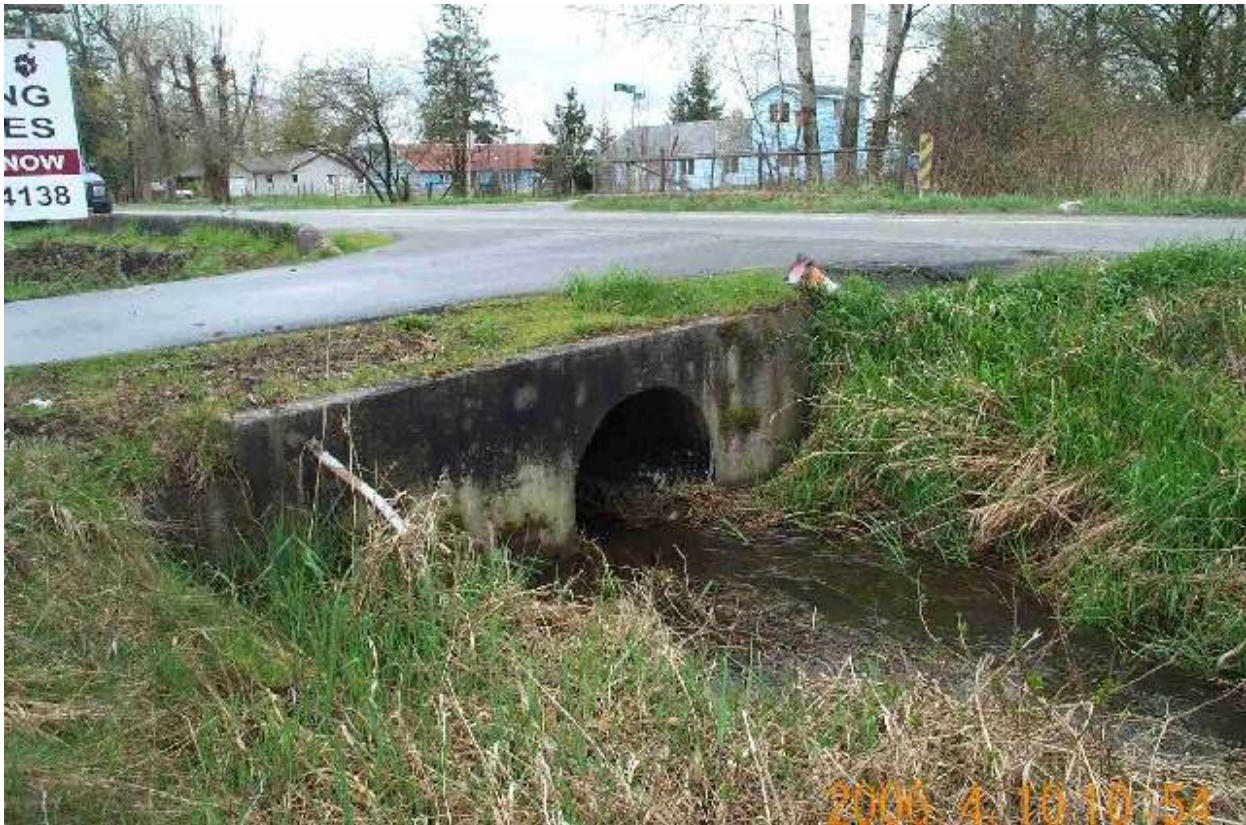
Photos P1010004.jpg

Comment: 1200 mm diameter culvert with concrete headwall built underneath a private driveway to a dog kennel.

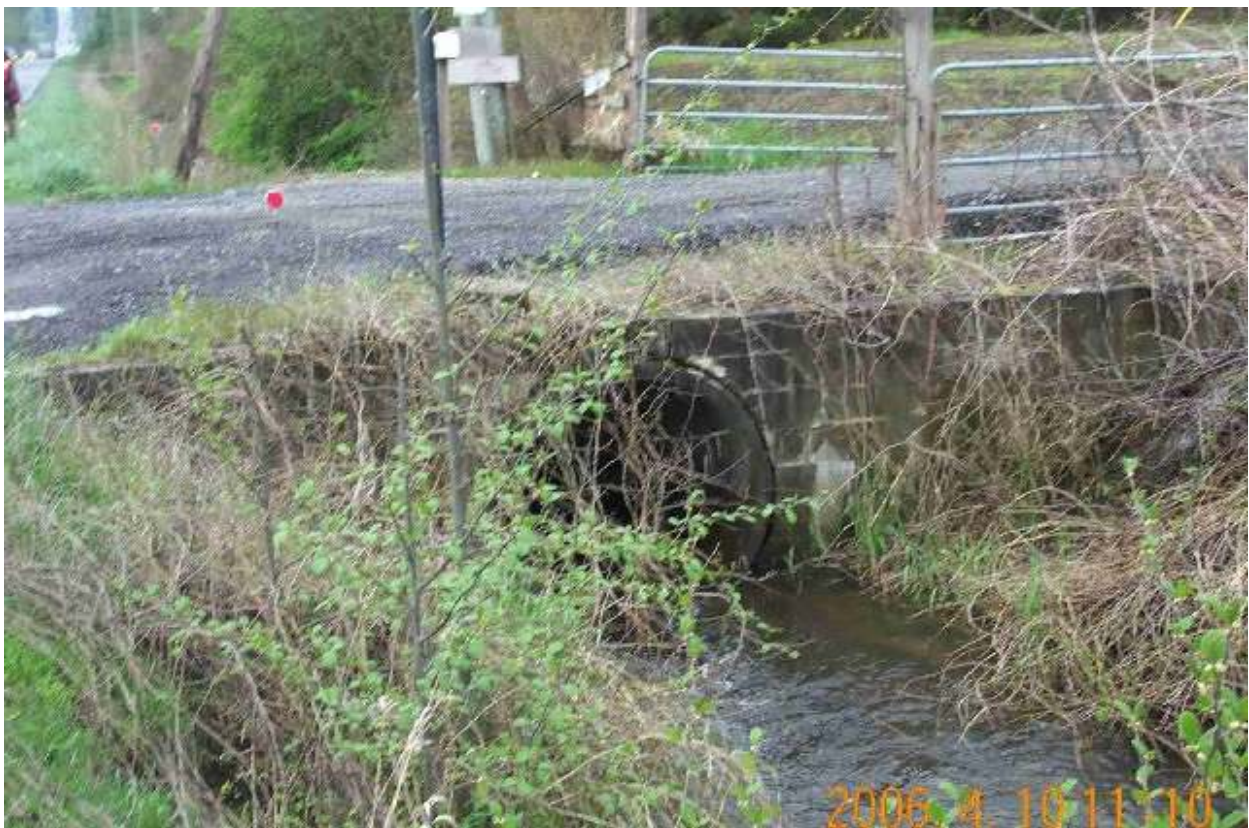
Photos P1010006.jpg

Comment: 1300 mm diameter culvert with cinder block headwall built underneath a private driveway.

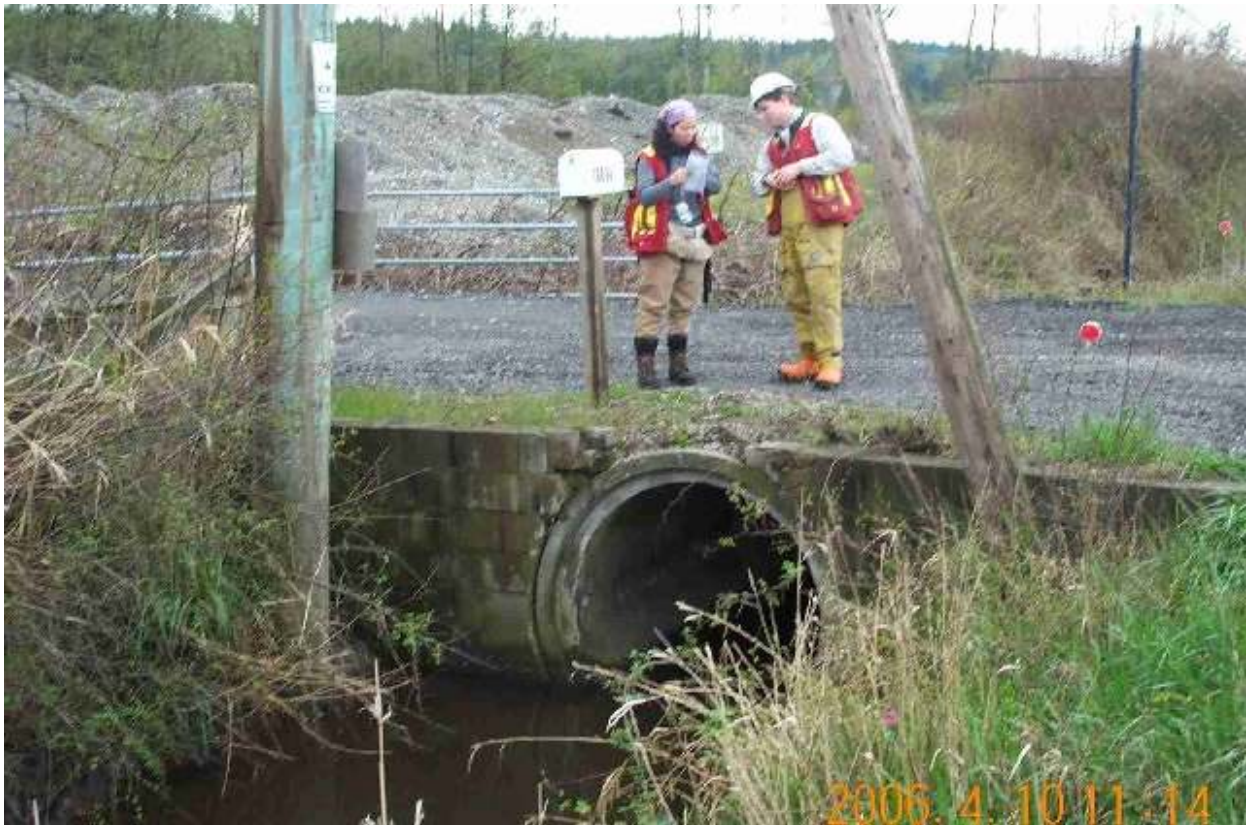
Photos P1010007.jpg

Comment: 1300 mm diameter culvert with cinder block headwall built underneath a private driveway.

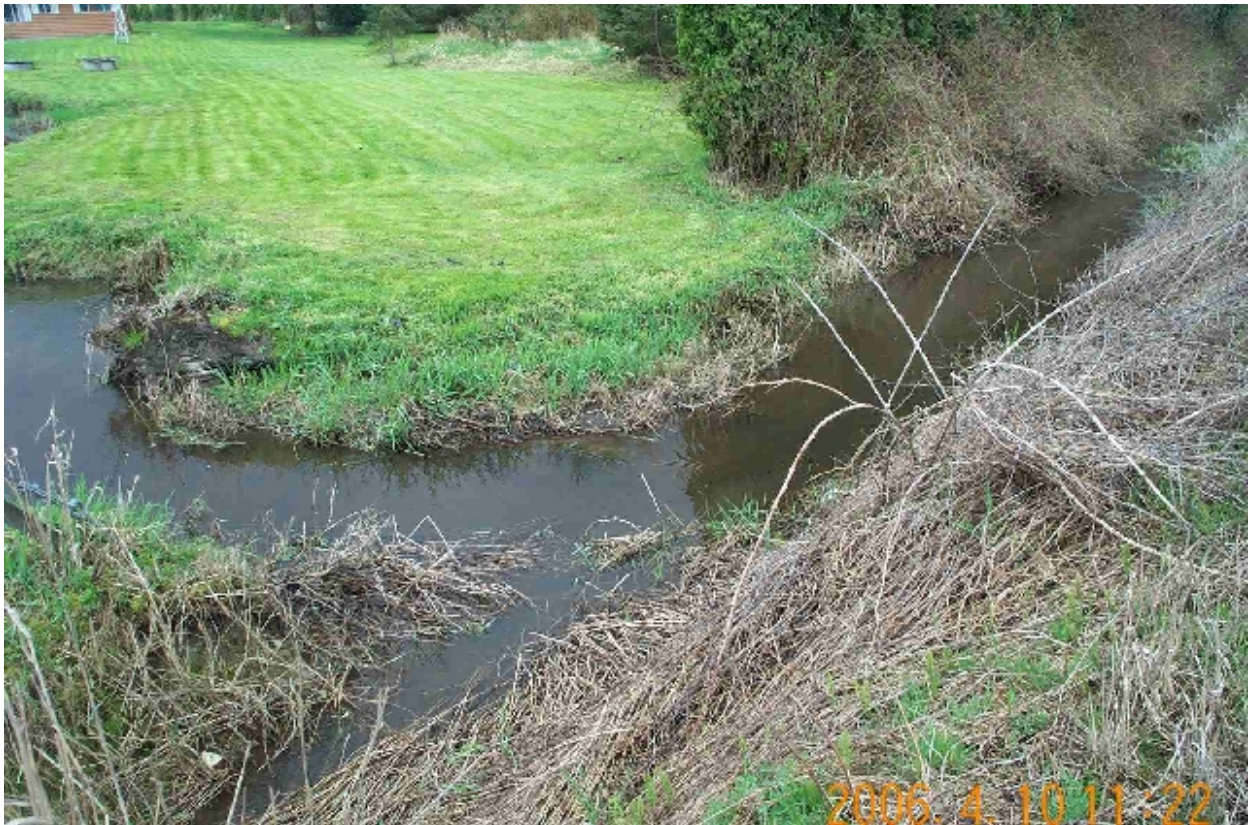
Photos P1010009.jpg

Comment: Confluence with south side 32nd Avenue ditch. Channel banks composed of grass.

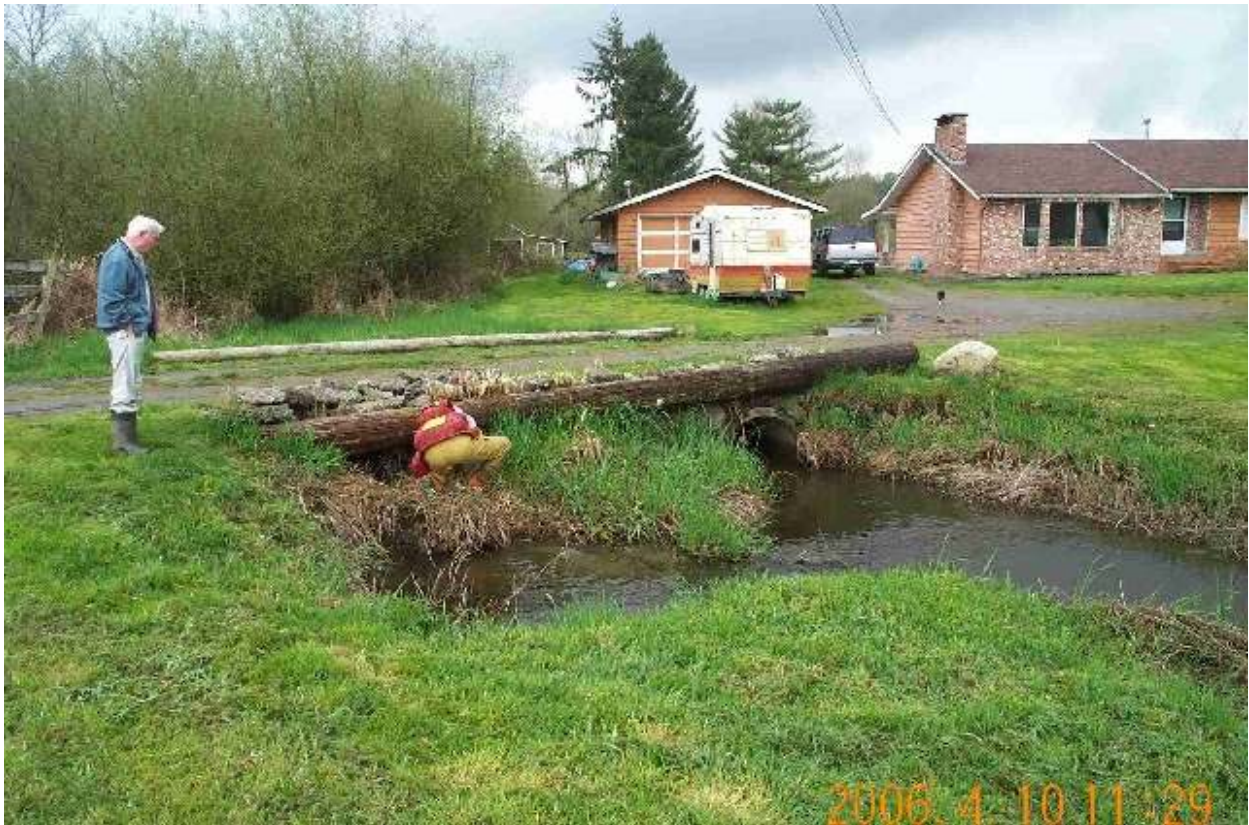
Photos P1010011.jpg

Comment: One 1000 mm diameter driveway culvert on private property with a 600 mm high flow concrete culvert.

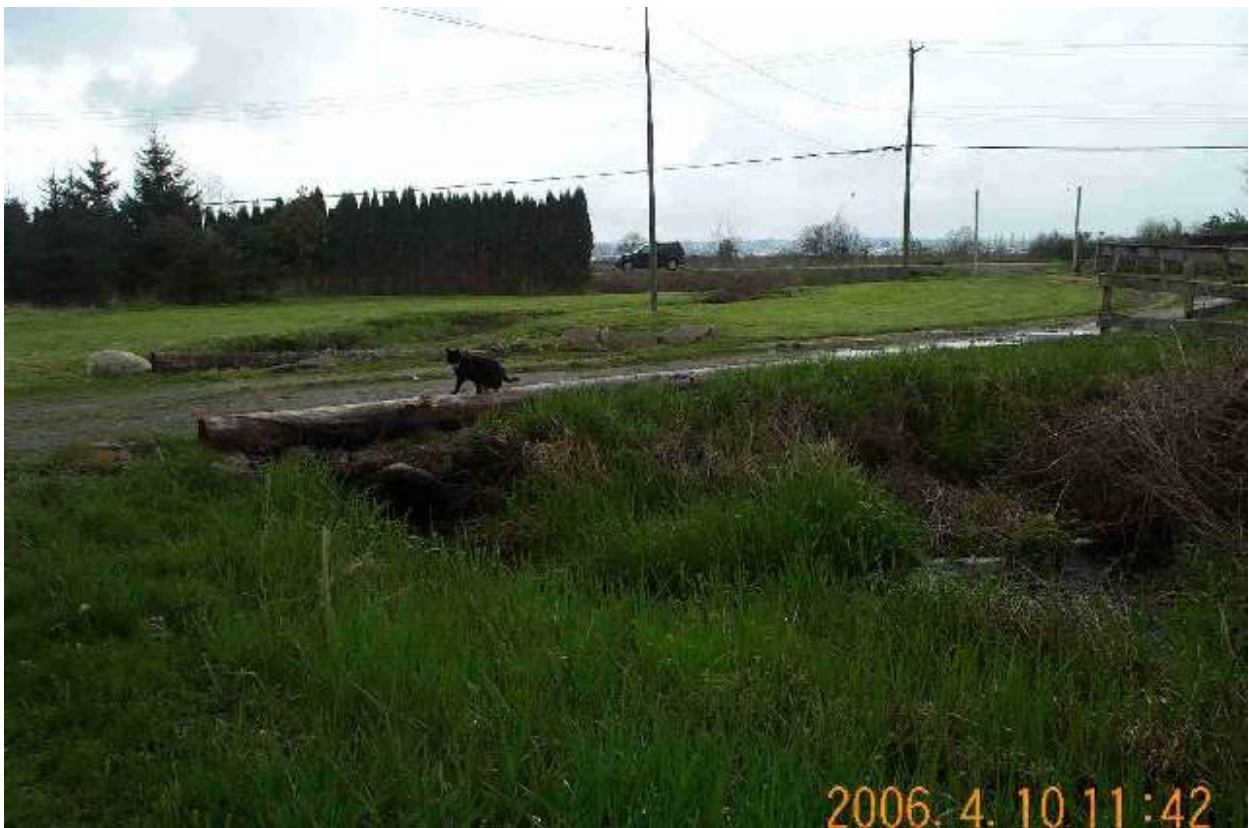
Photos P1010012.jpg

Comment: One 1000 mm diameter driveway culvert on private property with a 600 mm high flow concrete culvert.

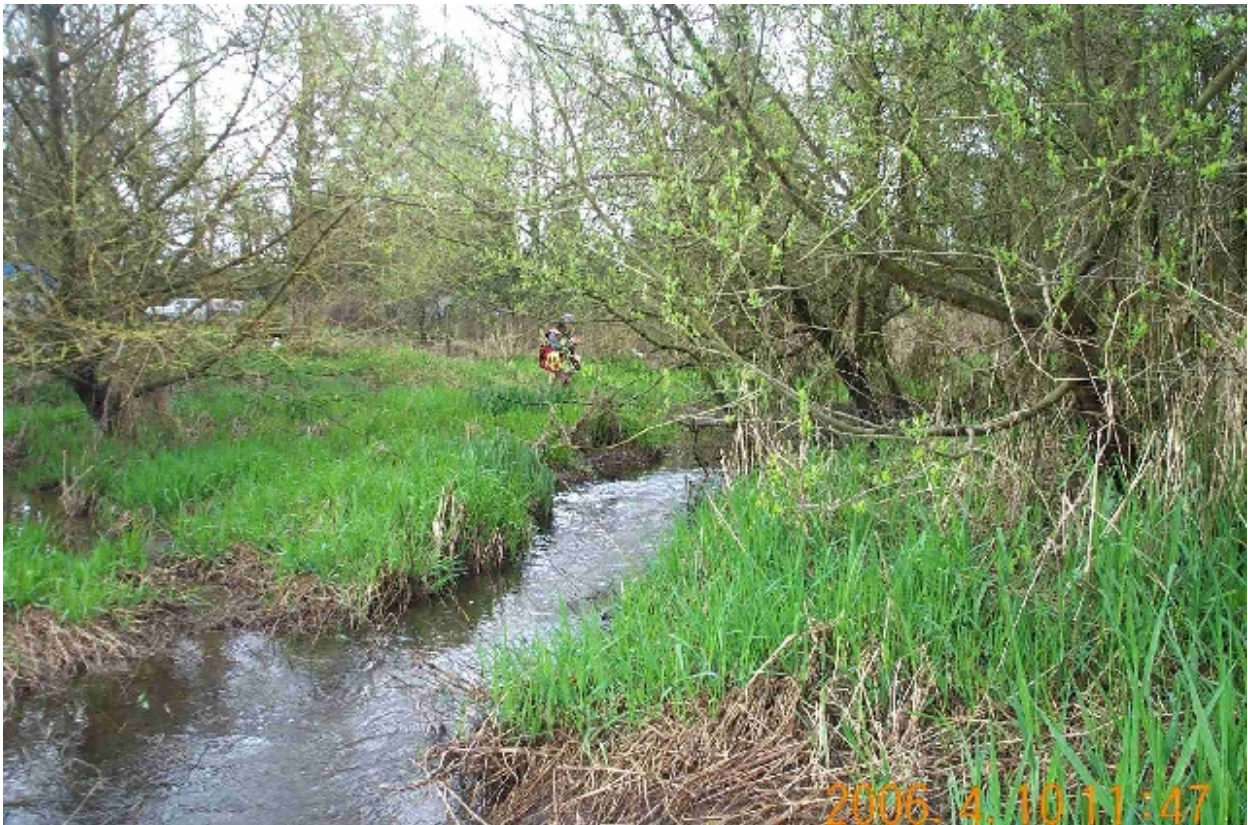
Photos P1010013.jpg

Comment: Confluence with Laura Brook with channel banks composed of grass.

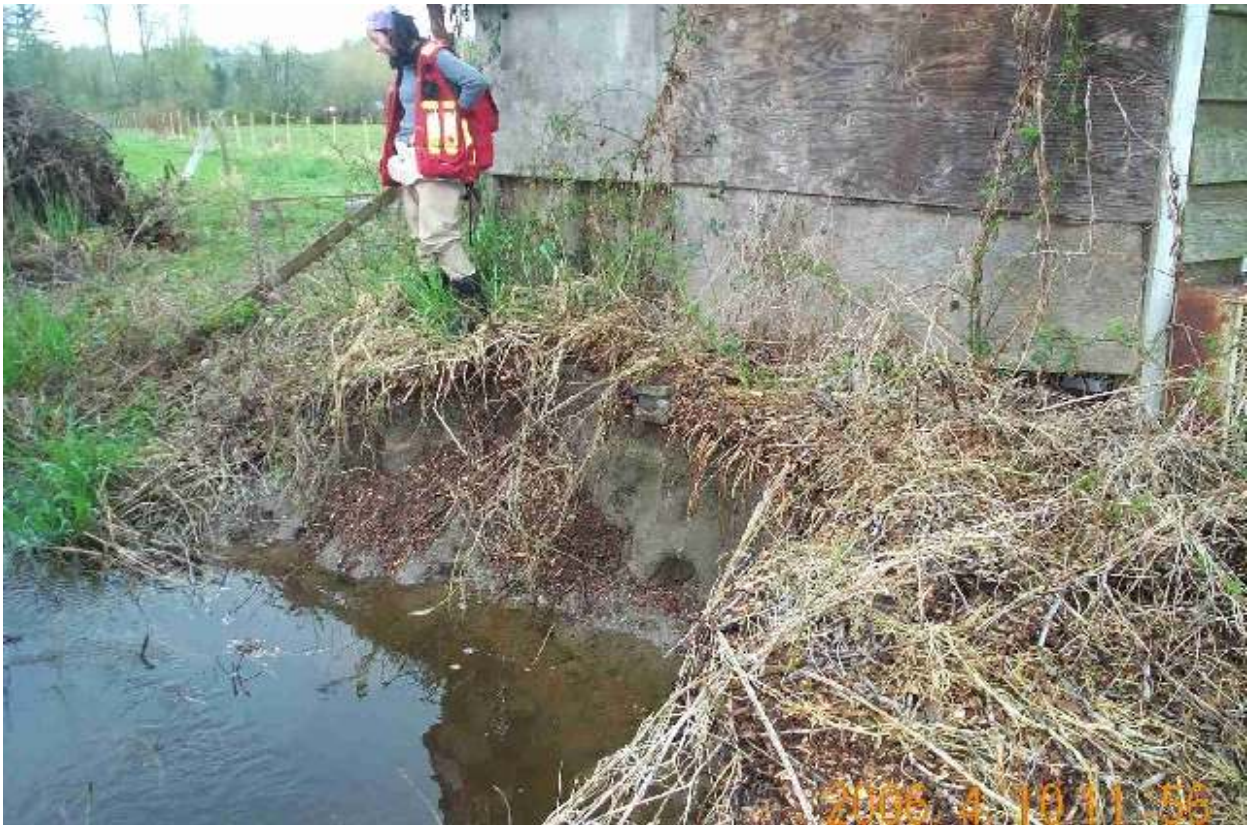
Photos P1010015.jpg

Comment: Erosion area undercuts slope adjacent to work shed. Erosion area is approximately 5 m long and 2 m high.

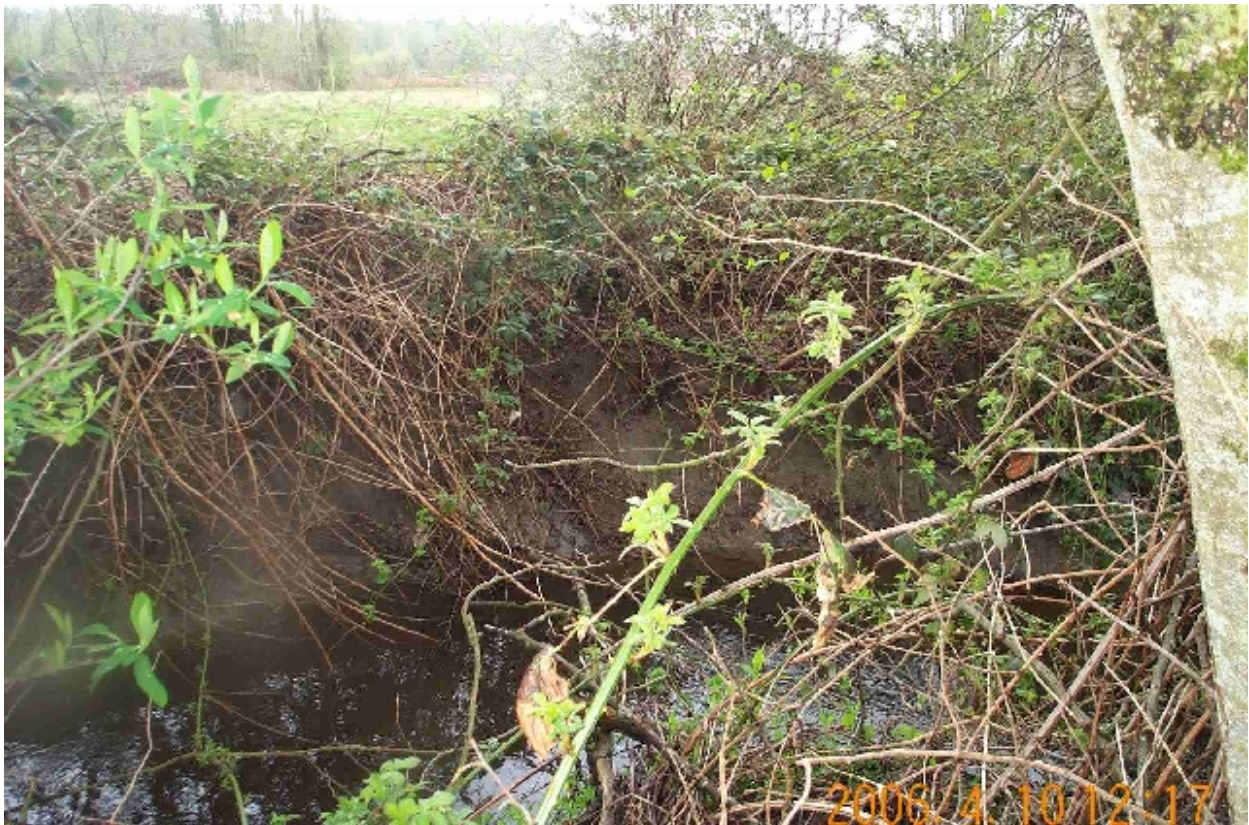
Photos P1010017.jpg

Comment: Erosion areas on both sides of the channel. Erosion area is approximately 10 m long and 2 m high.

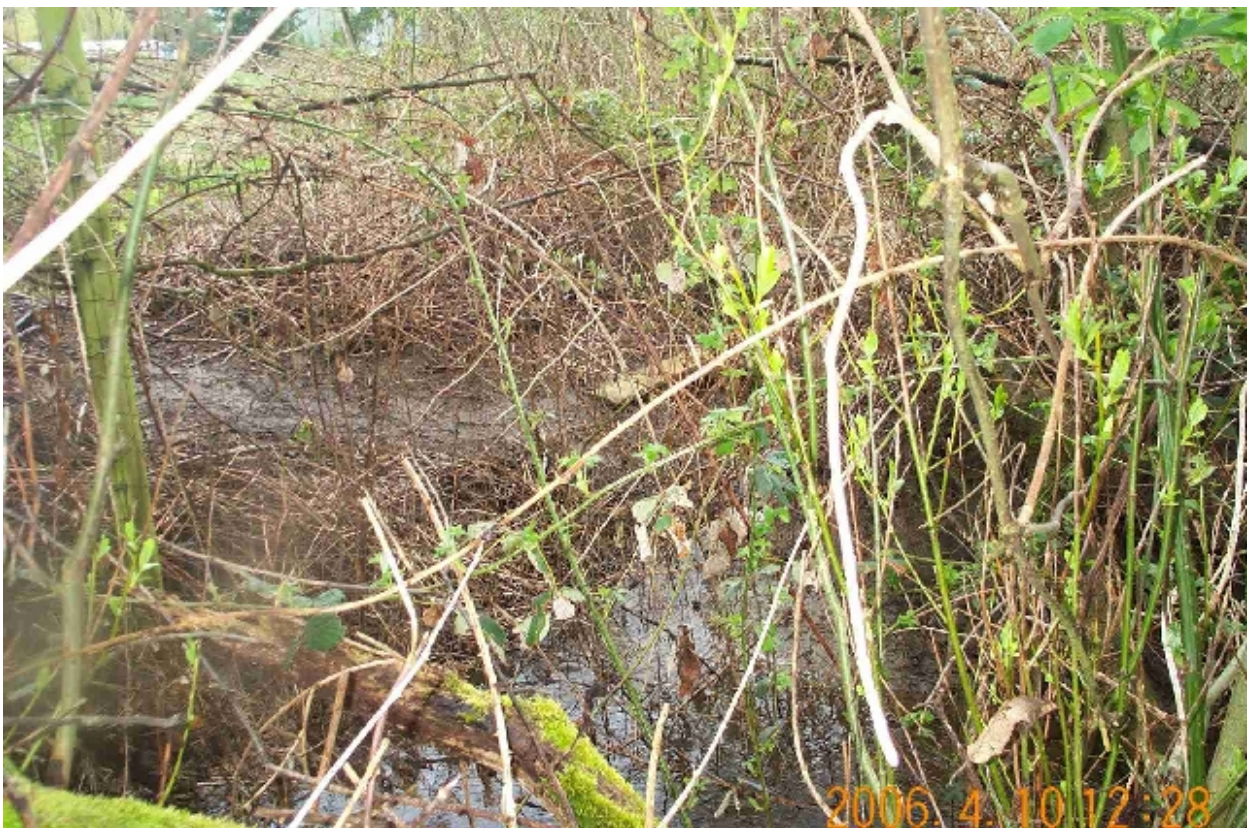
Photos P1010018.jpg

Comment: Confluence with Tributary 2.
