City of Surrey

Erickson Creek Integrated Stormwater Management Plan

September 2010

**Re: ERICKSON CREEK INTEGRATED STORMWATER MANAGEMENT PLAN
FINAL REPORT**

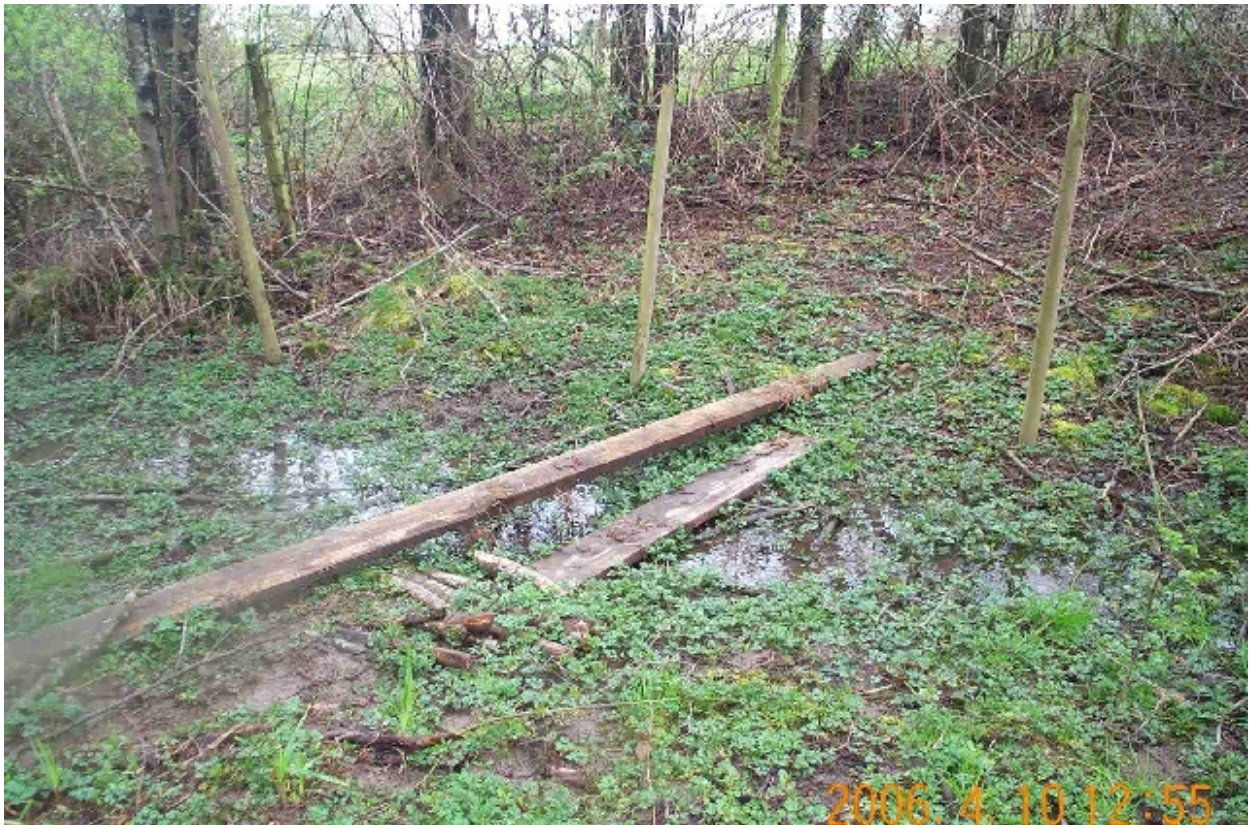
Photos P1010019.jpg

Comment: Undefined side channel upstream of 300 mm concrete culvert.

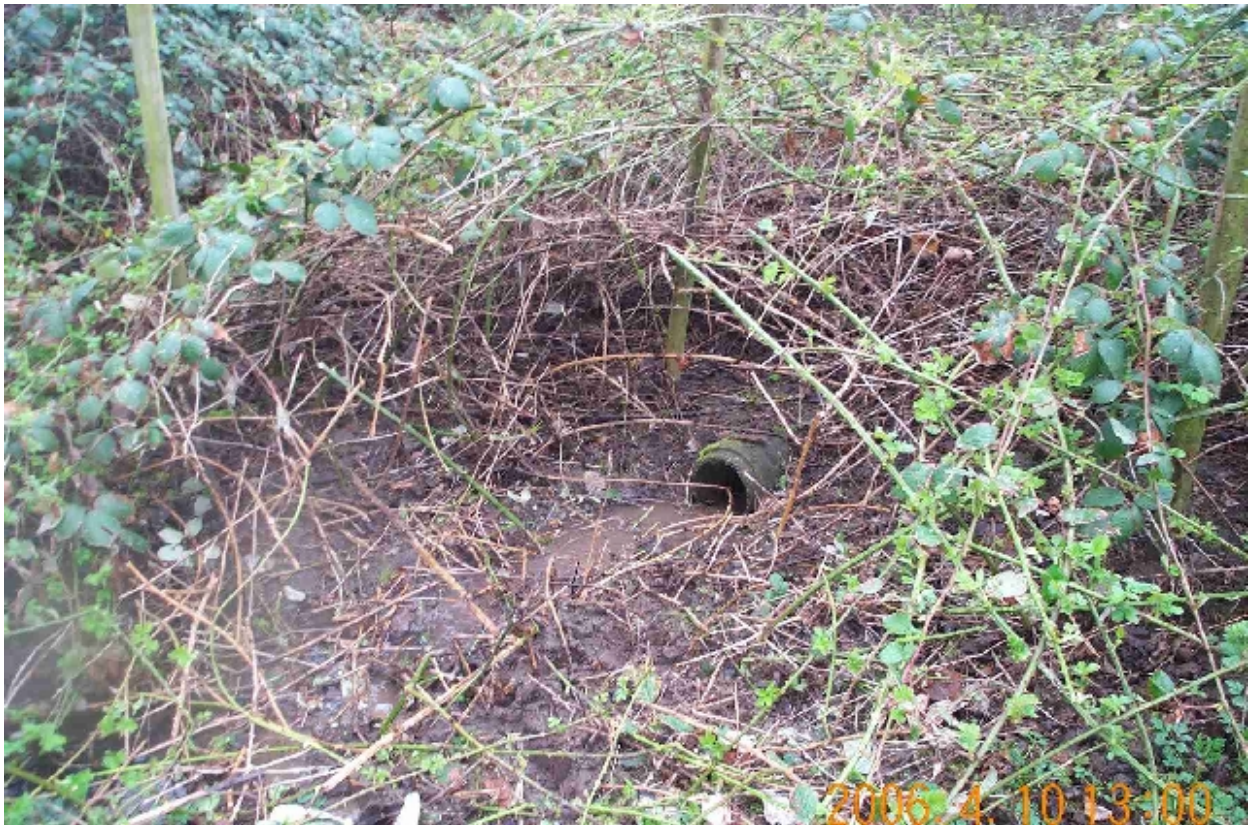
Photos P1010020.jpg

Comment: 200 mm diameter culvert with no headwall. Inlet is overgrown.

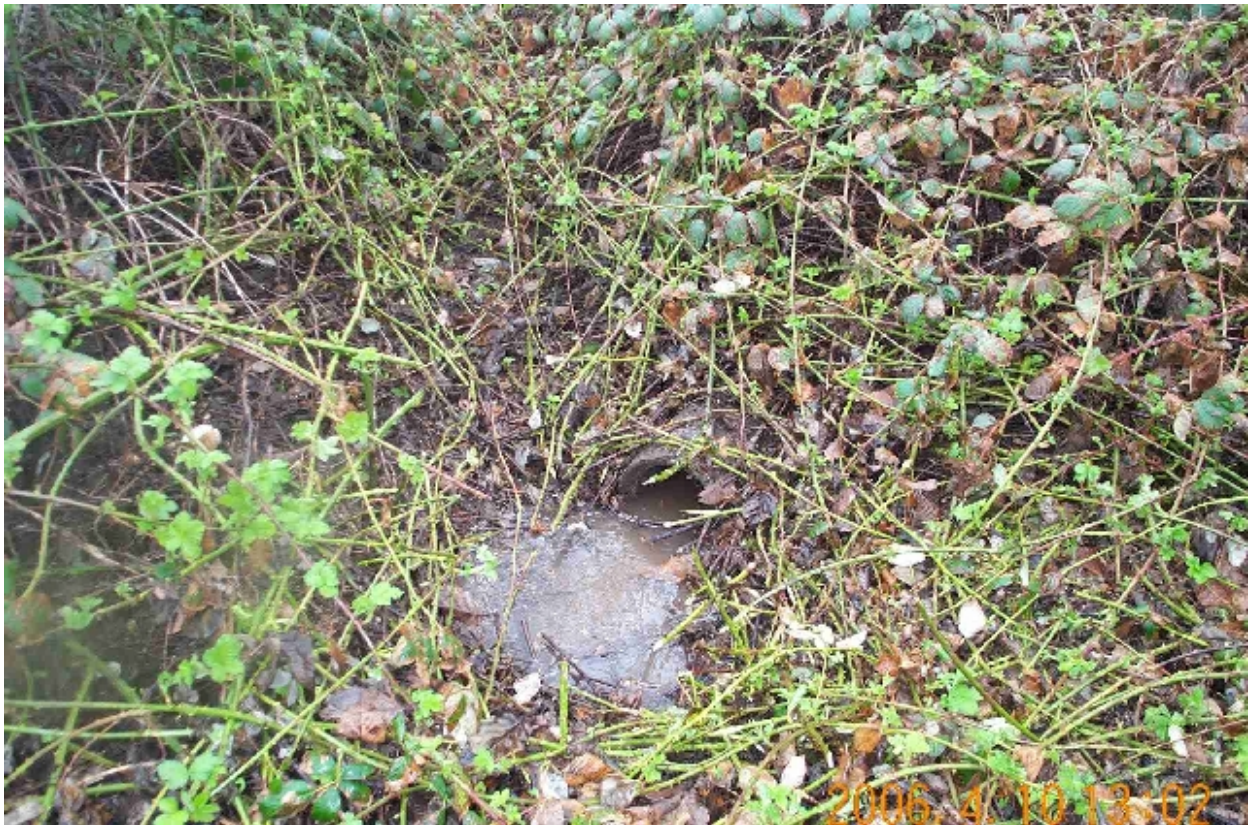
Photos P1010021.jpg

Comment: 200 mm diameter culvert with no headwall. Outlet is overgrown.

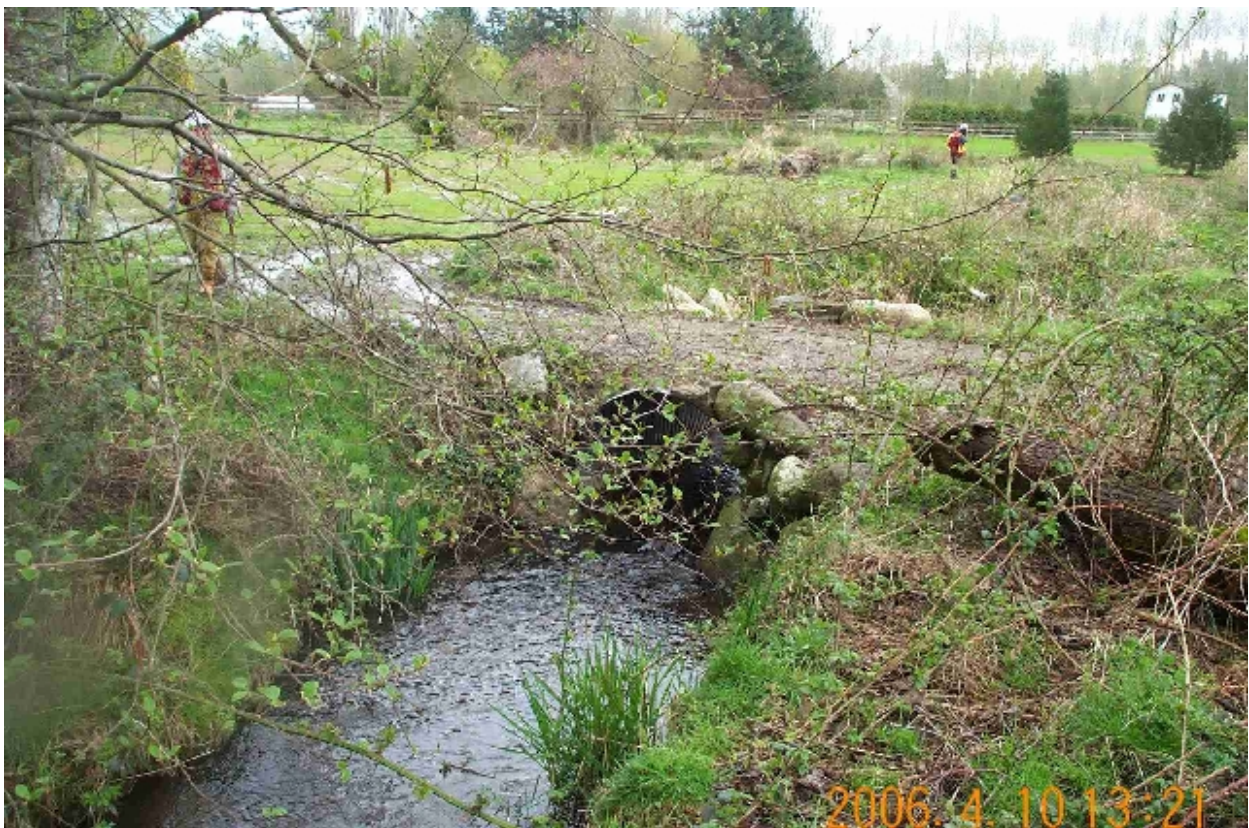
Photos P1010023.jpg

Comment: 1200 mm diameter culvert built underneath a vehicle access (less than 300 mm of cover) on private property. Outlet is armored with 300 mm diameter rip rap. There is visual evidence of the creek overtopping the culvert.

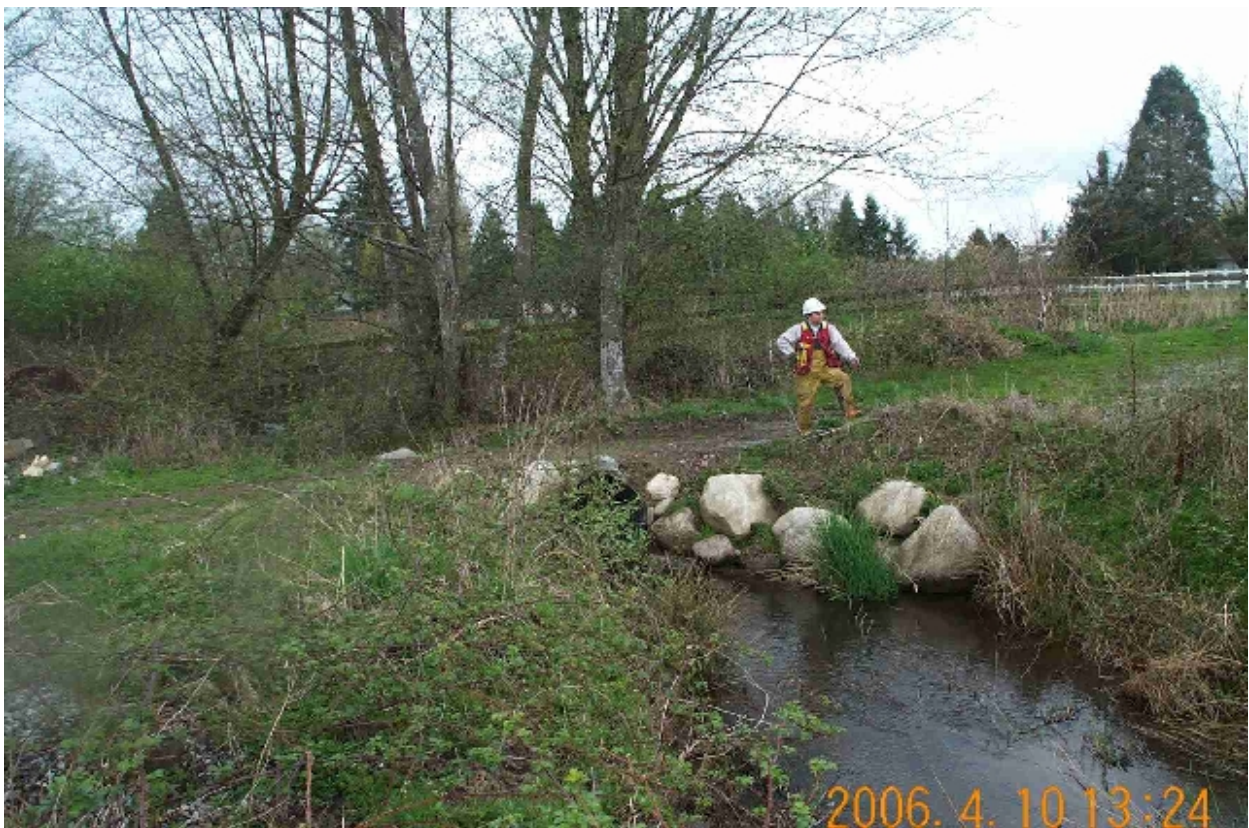
Photos P1010024.jpg

Comment: 1200 mm culvert built underneath a vehicle access (less than 300 mm of cover) on private property. Outlet is armored with 300 mm diameter rip rap.

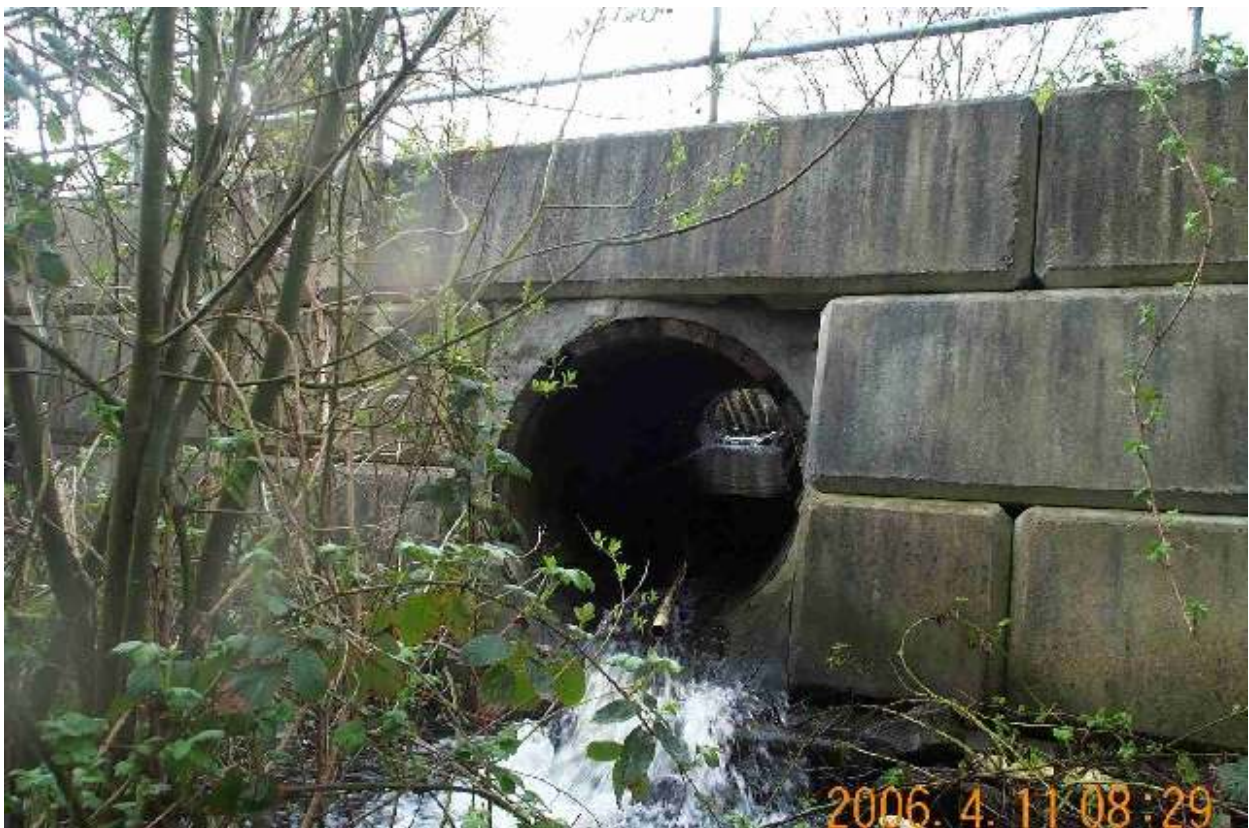
Photos P1010047.jpg

Comment: 1500 mm diameter culvert built underneath 29A Avenue with a concrete lock block retaining wall.

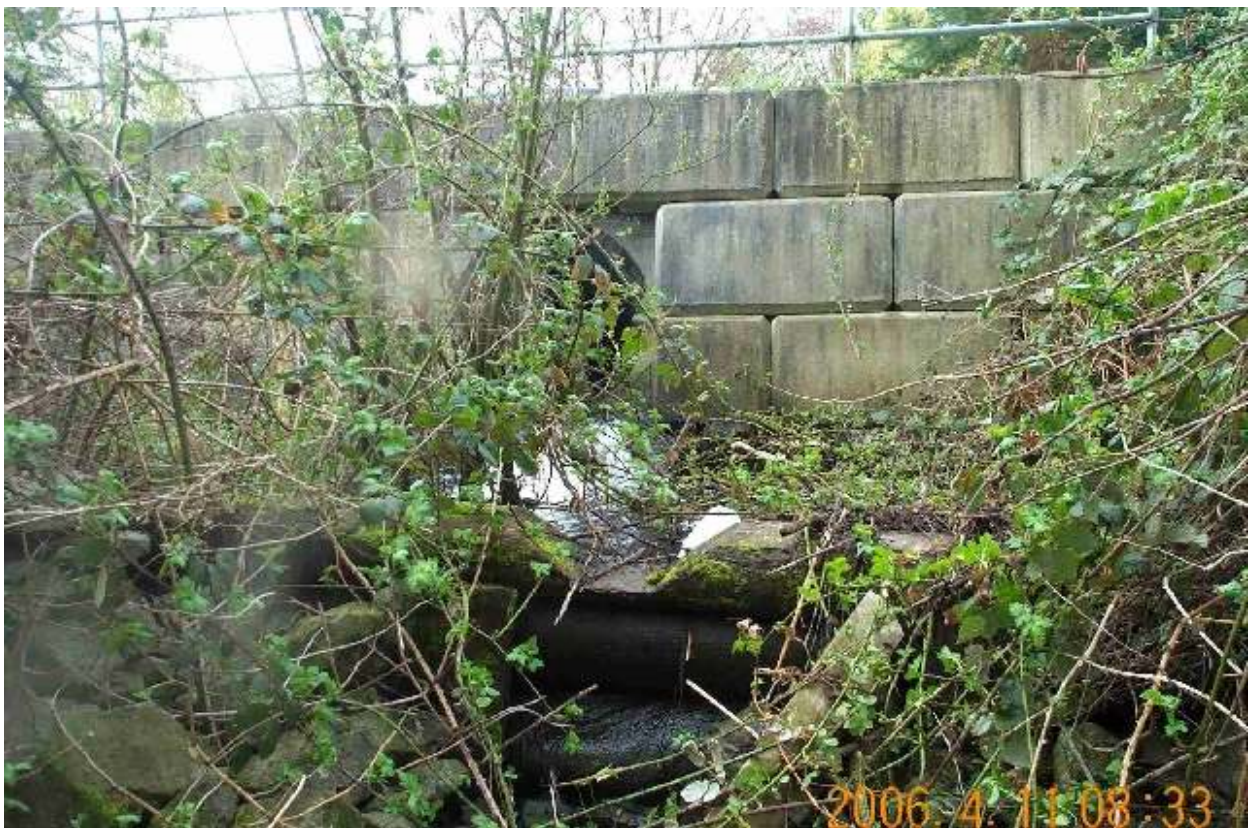
Photos P1010048.jpg

Comment: V-Notch weir built downstream of 29A Avenue. Rip rap has been installed downstream of the weir.

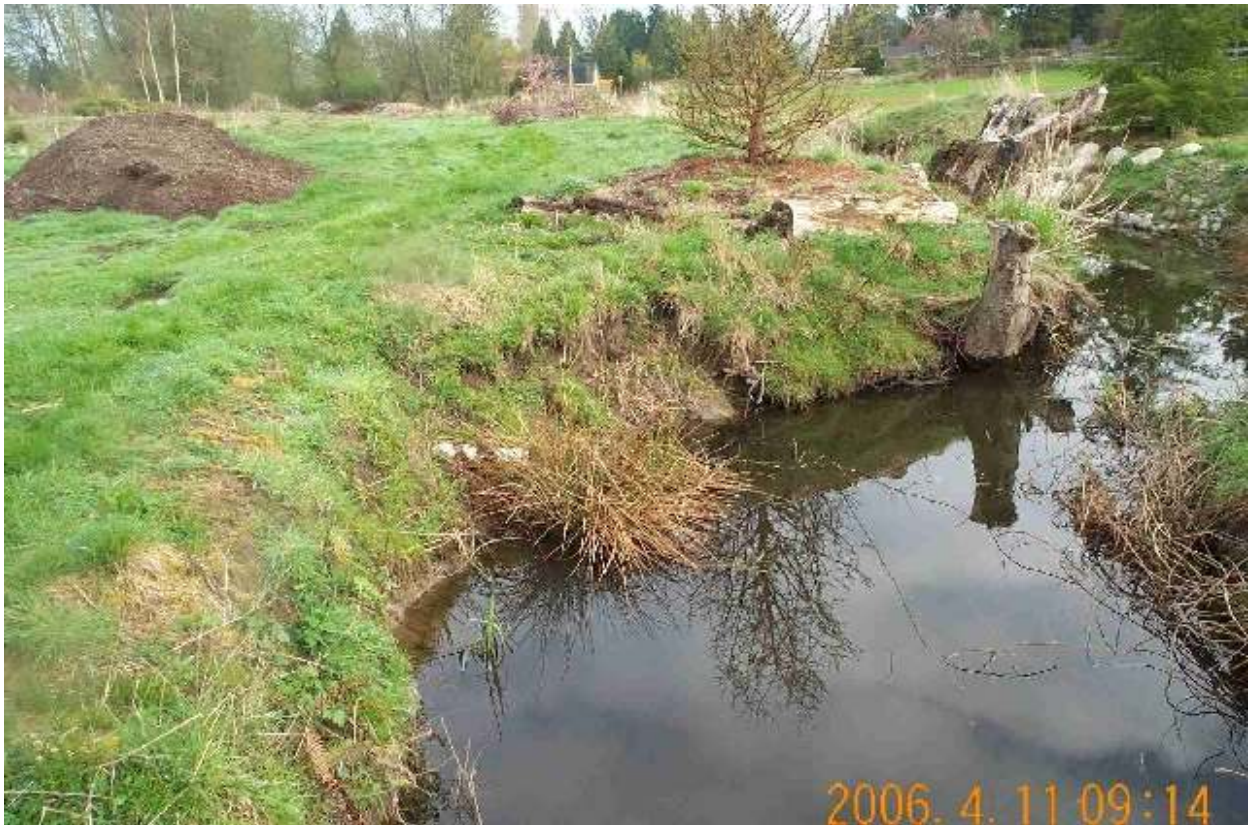
Photos P1010053.jpg

Comment: Erosion on both sides of the channel, grass has started to grow back. Erosion area approximately 5 m long and 1.5 m high.

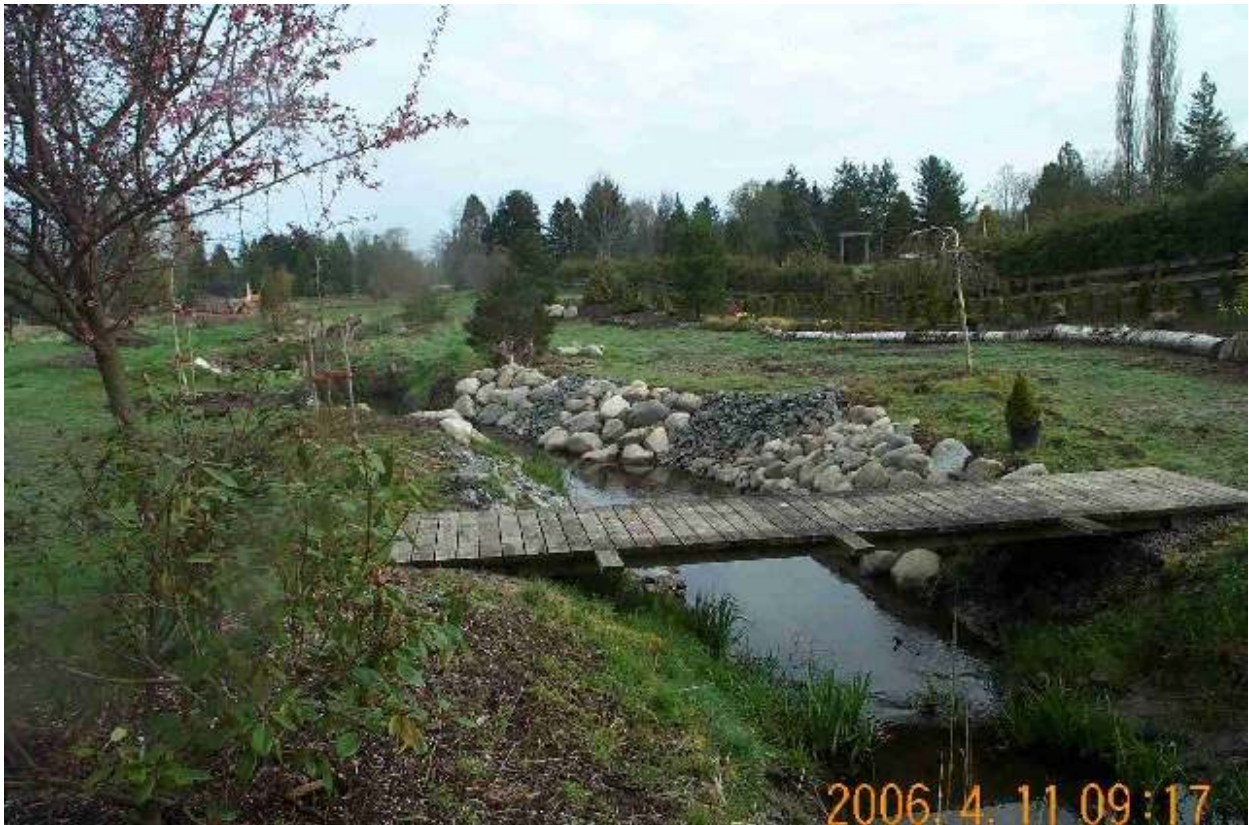
Photos P1010054.jpg

Comment: Vehicle bridge built on private property at the crest of the creek. Owner has installed rip rap downstream of bridge.

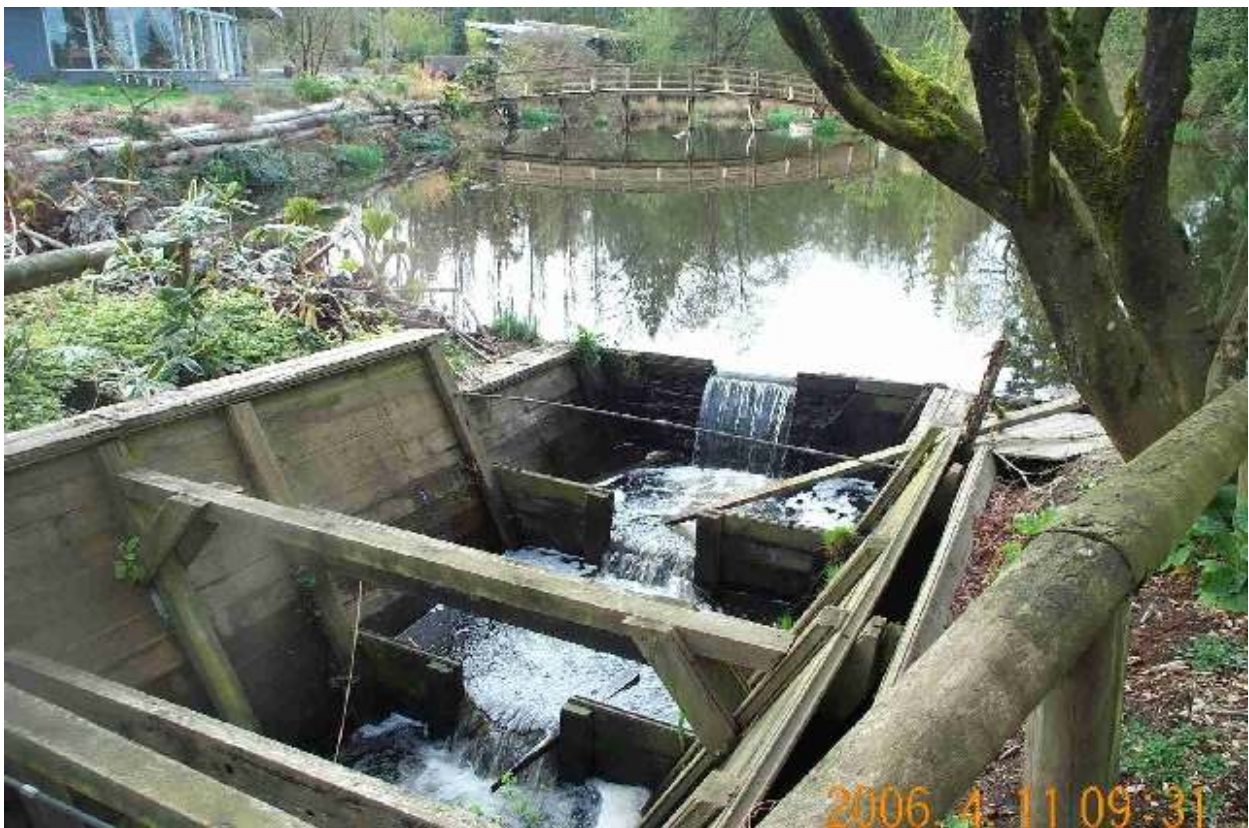
Photos P1010058.jpg

Comment: Fish ladder drains an ornamental pond built on private property. A notched weir at the top of the fish ladder may have been replaced.

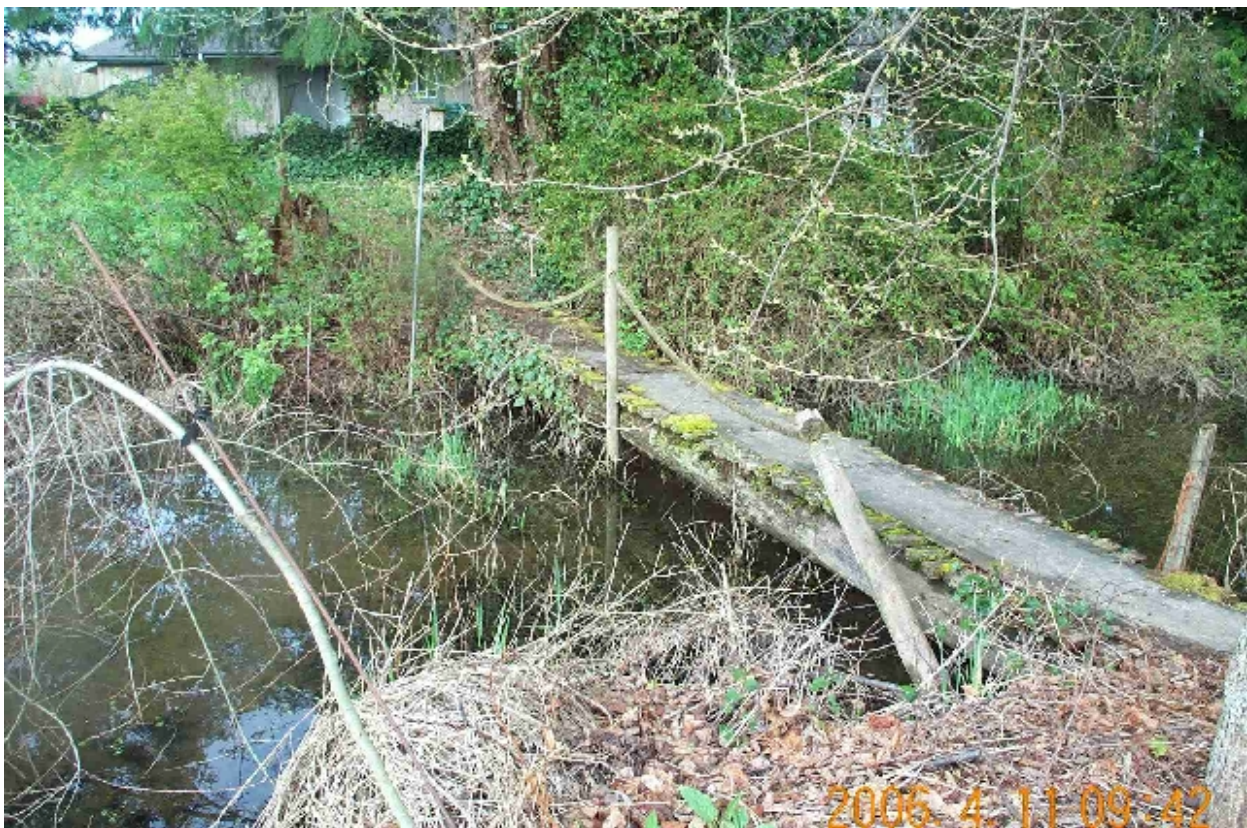
Photos P1010059.jpg

Comment: Two pedestrian bridges meet join an island in the middle of an ornamental pond to either side of the pond. West bridge is approximately 0.2 m above the surveyed water level. East bridge is approximately 1.5 above the surveyed water level and is built on a

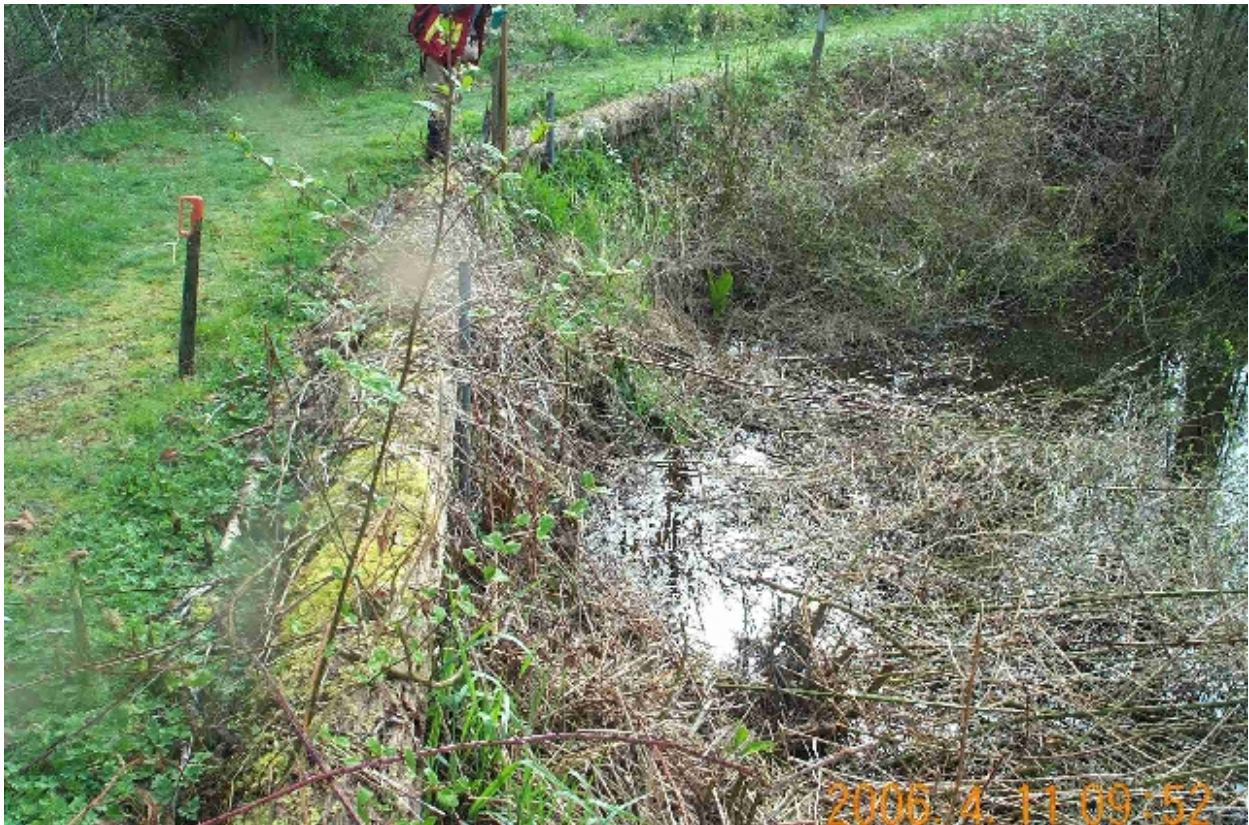
Photos P1010061.jpg

Comment: 750 mm diameter culvert with a log and concrete headwall and trash rack. The culvert drains a large pond.

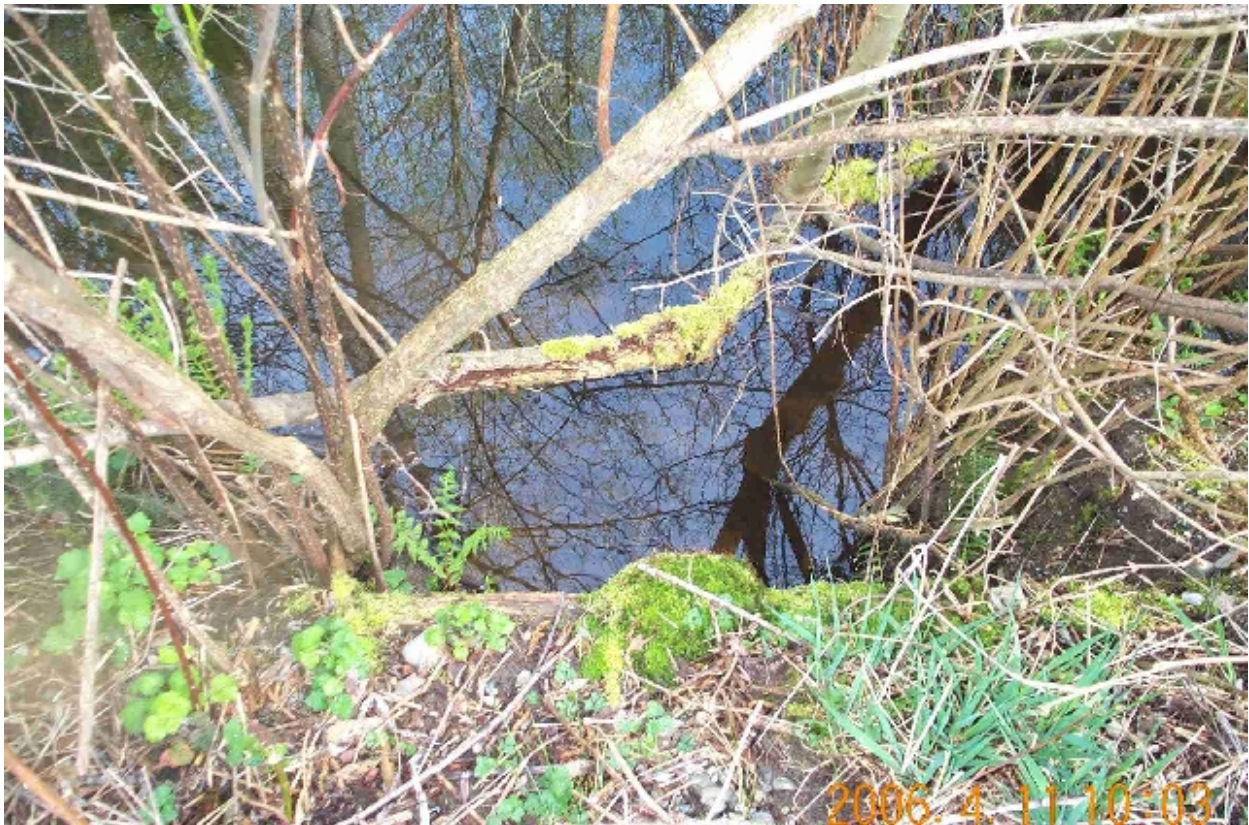
Photos P1010064.jpg

Comment: 750 mm diameter culvert with a log headwall. Outlet is clogged by vegetation.

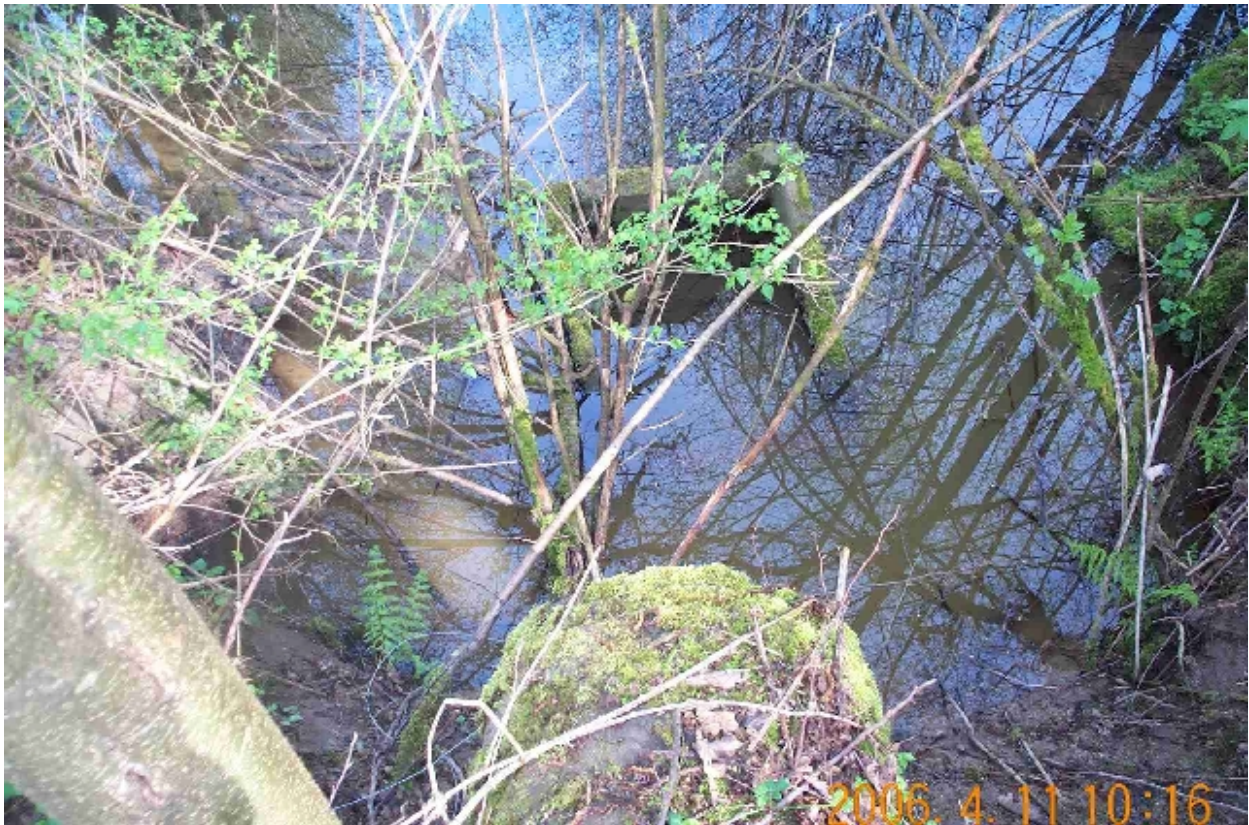
Photos P1010067.jpg

Comment: 750 mm diameter high flow culvert discharges into a pond.
Adjacent to 600 mm diameter low flow concrete culvert.

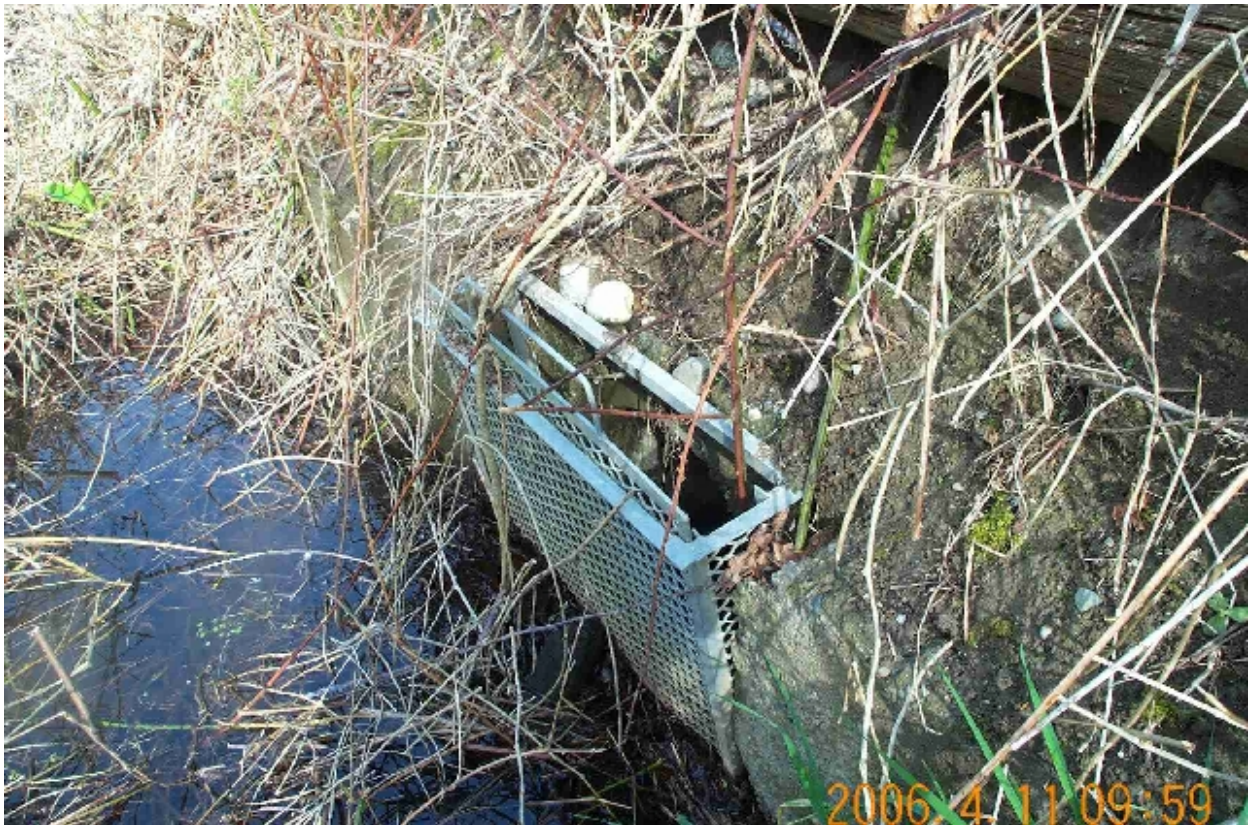
Photos P1010063.jpg

Comment: 750 mm diameter high flow culvert discharges into a pond. Could not locate outlet 600 mm diameter low flow concrete culvert.

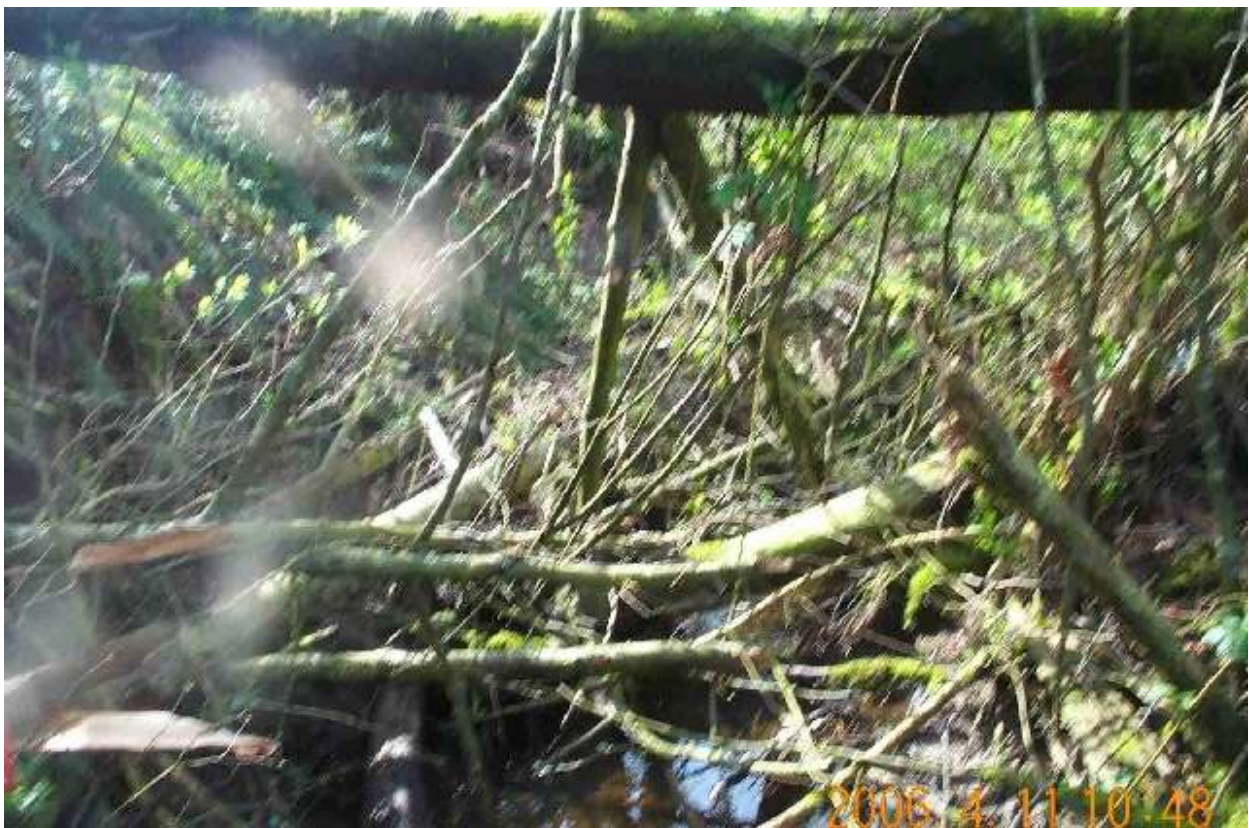
Photos P1010071.jpg

Comment: Log has fallen across creek channel. Branches have built up and clog the creek channel.

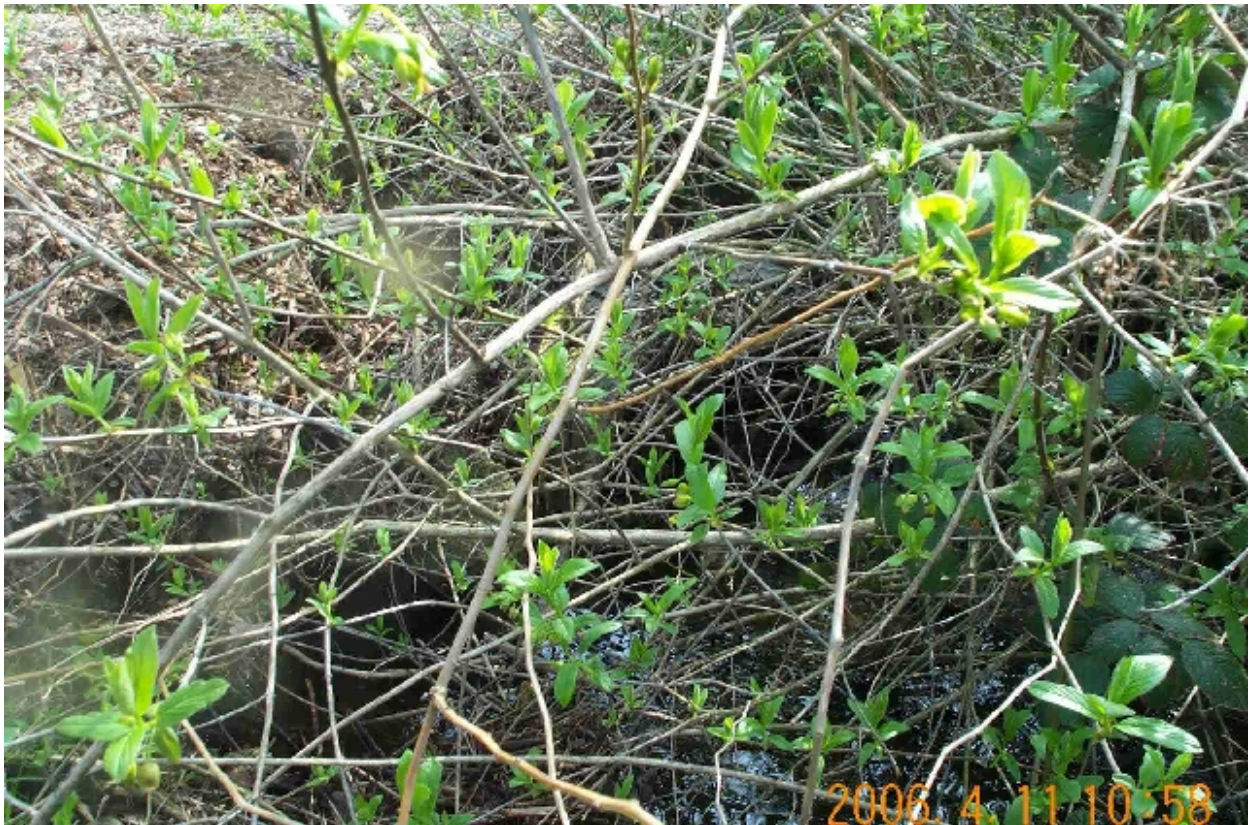
Photos P1010074.jpg

Comment: 900 mm diameter concrete culvert built underneath a vehicle access road.

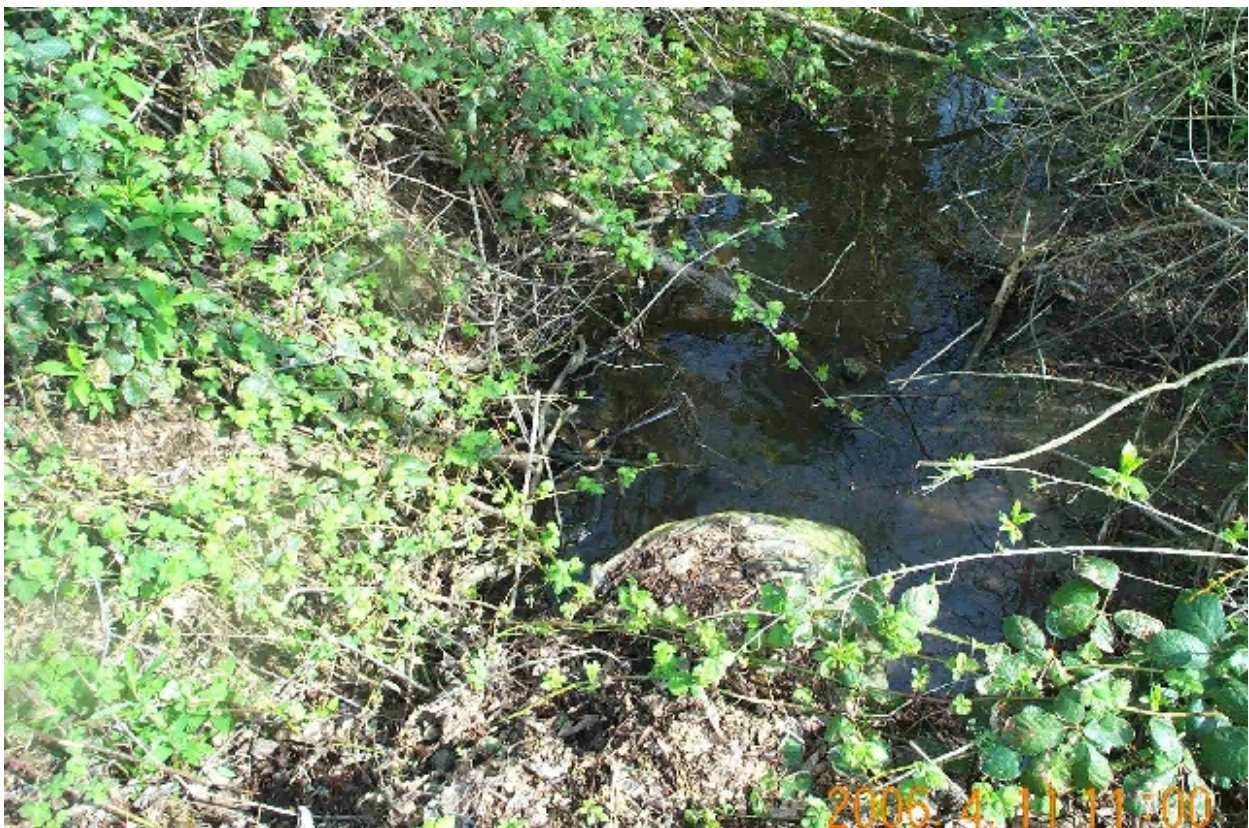
Photos P1010075.jpg

Comment: CSP outlet connected to a 900 mm diameter concrete culvert built underneath a vehicle access road.

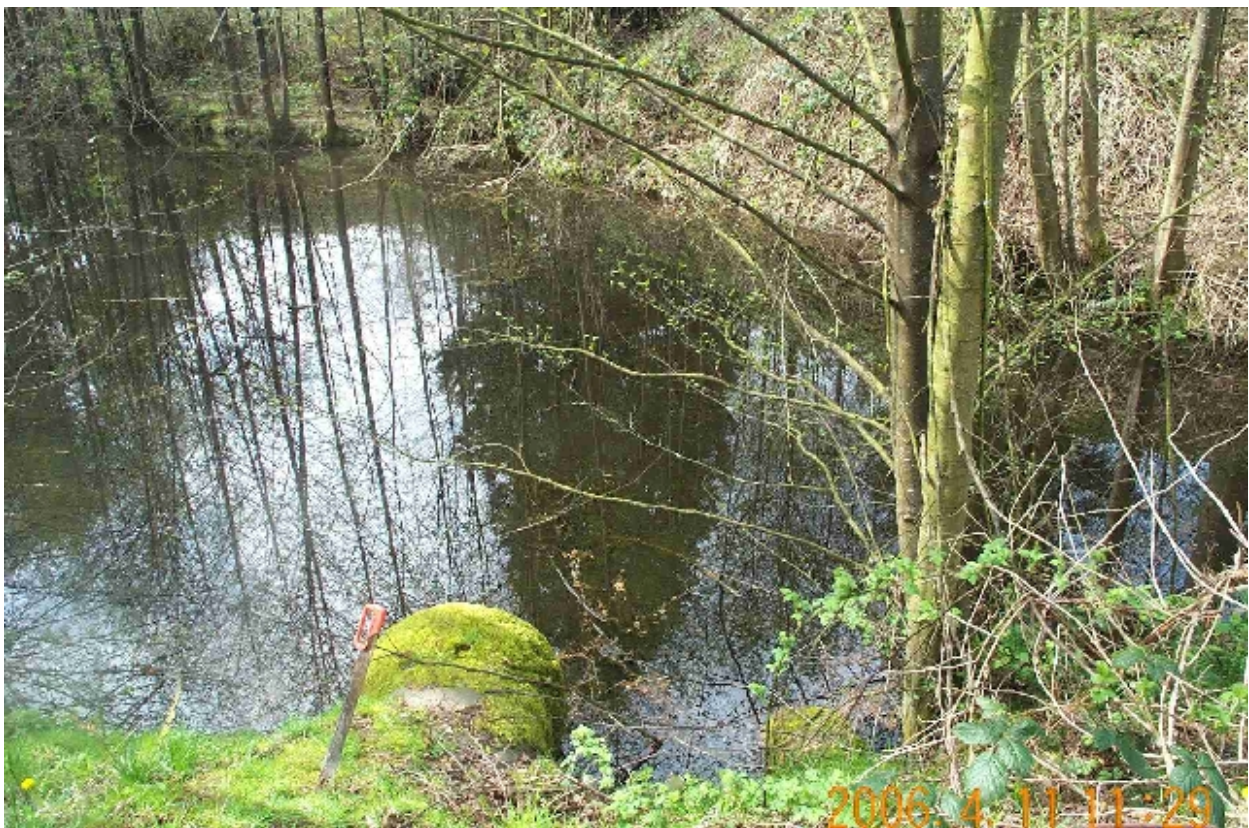
Photos P1010078.jpg

Comment: 300 mm diameter culvert adjacent to a 750 mm diameter high flow culvert draining pond.

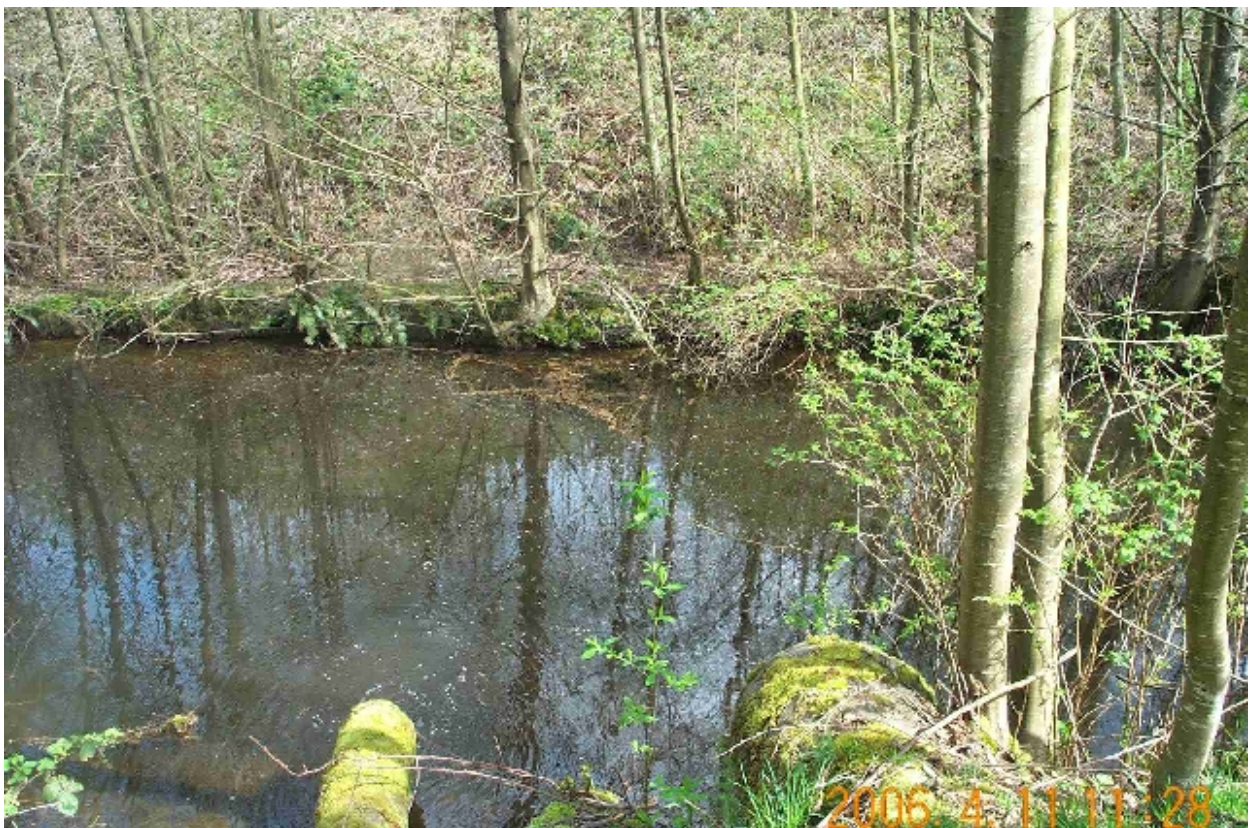
Photos P1010077.jpg

Comment: 300 mm diameter culvert adjacent to a 750 mm diameter high flow culvert draining into pond.

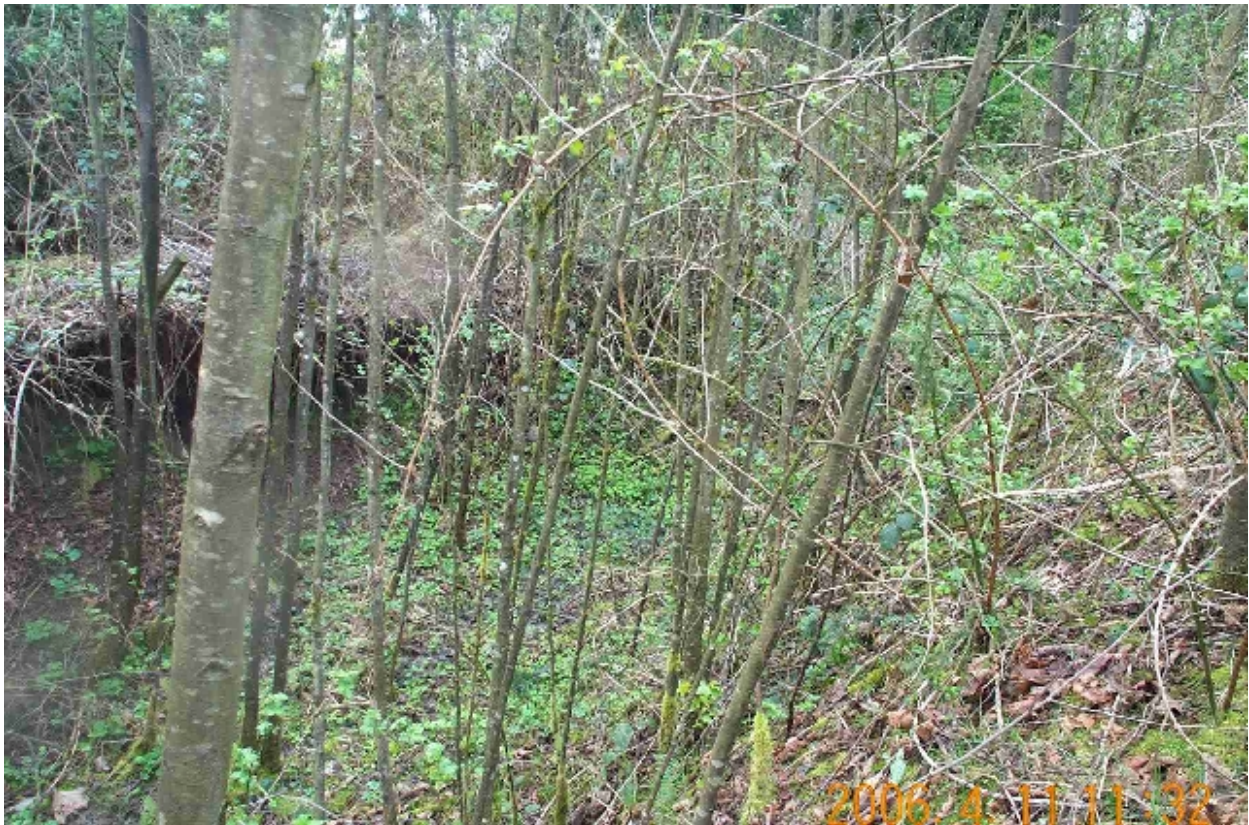
Photos P1010079.jpg

Comment: Cross-section of Breaks Creek upstream of confluence some erosion evident on east bank.
