City of Surrey

Erickson Creek Integrated Stormwater Management Plan

September 2010

**Re: ERICKSON CREEK INTEGRATED STORMWATER MANAGEMENT PLAN
FINAL REPORT**

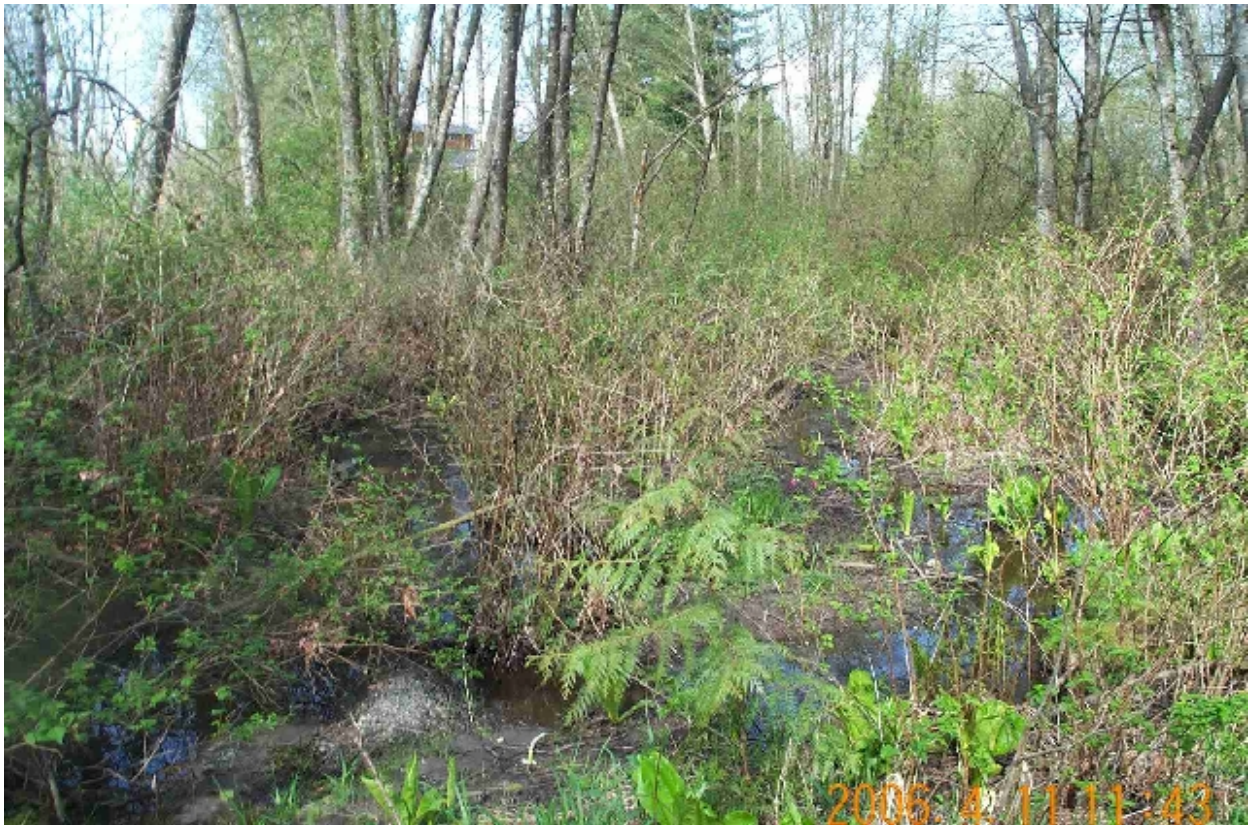
Photos P1010080.jpg

Comment: Confluence with Breaks Creek. Channel is not well defined and possibly meanders.

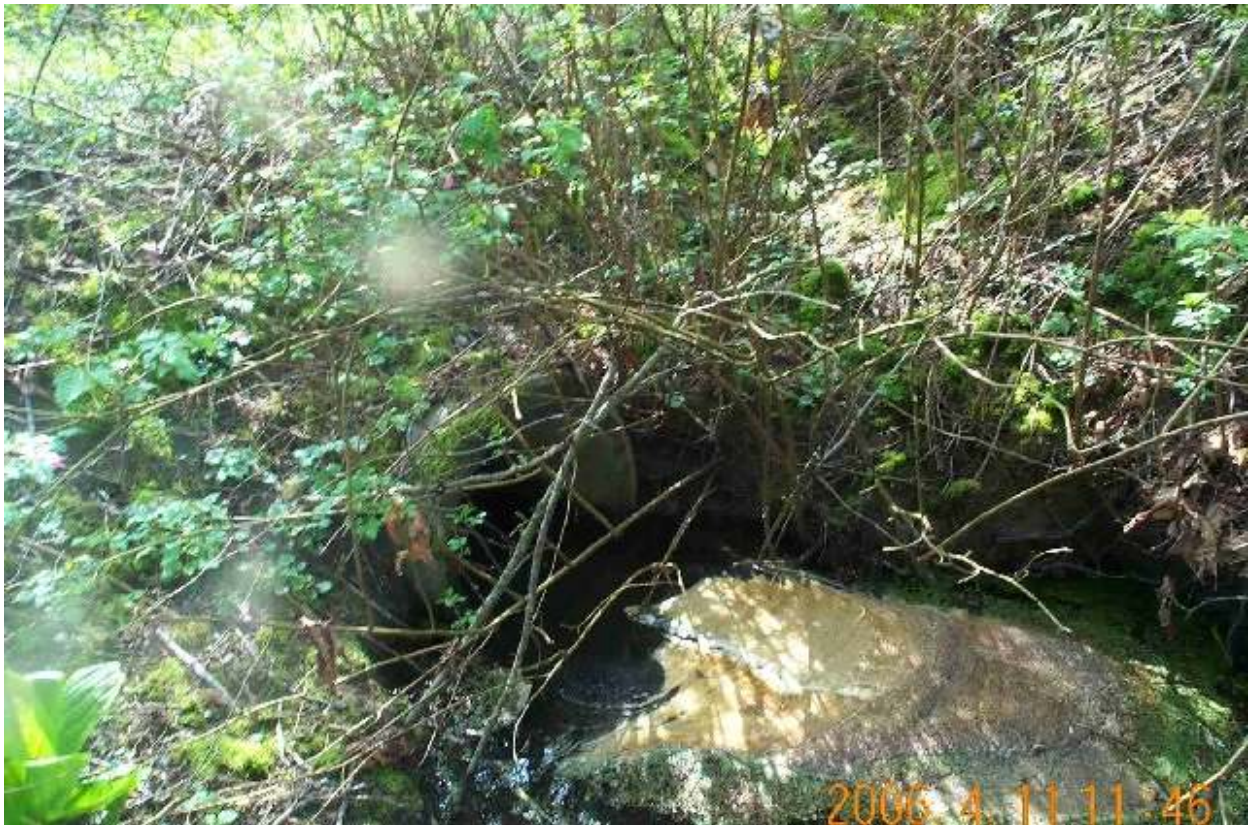
Photos P1010081.jpg

Comment: 900 mm culvert built underneath private driveway that drains an ornamental pond.

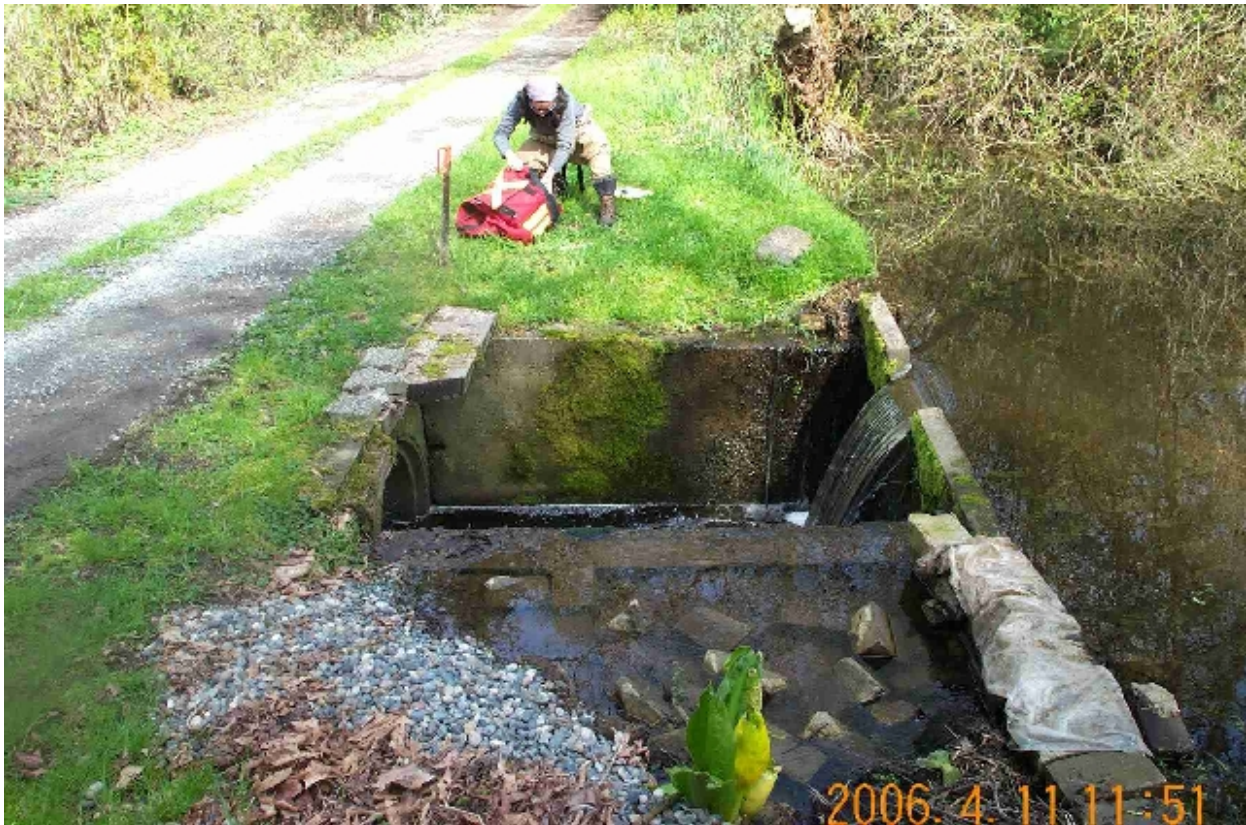
Photos P1010082.jpg

Comment: 900 mm culvert built underneath private driveway that drains an ornamental pond. Flow is controlled by a notched weir and a 300 mm high flow culvert.

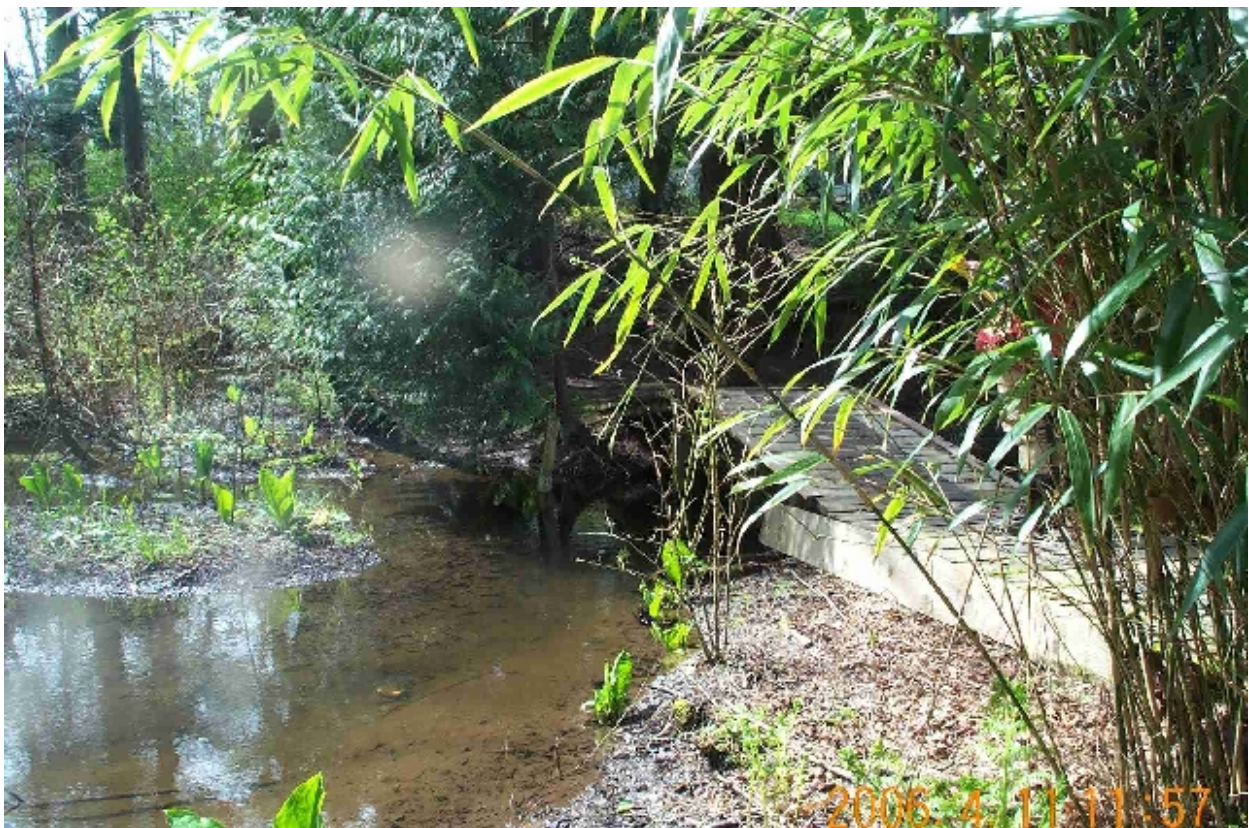
Photos P1010084.jpg

Comment: Pedestrian bridge that spans across an ornamental pond. The bottom side of the bridge is approximately 600 mm above the surveyed water surface level

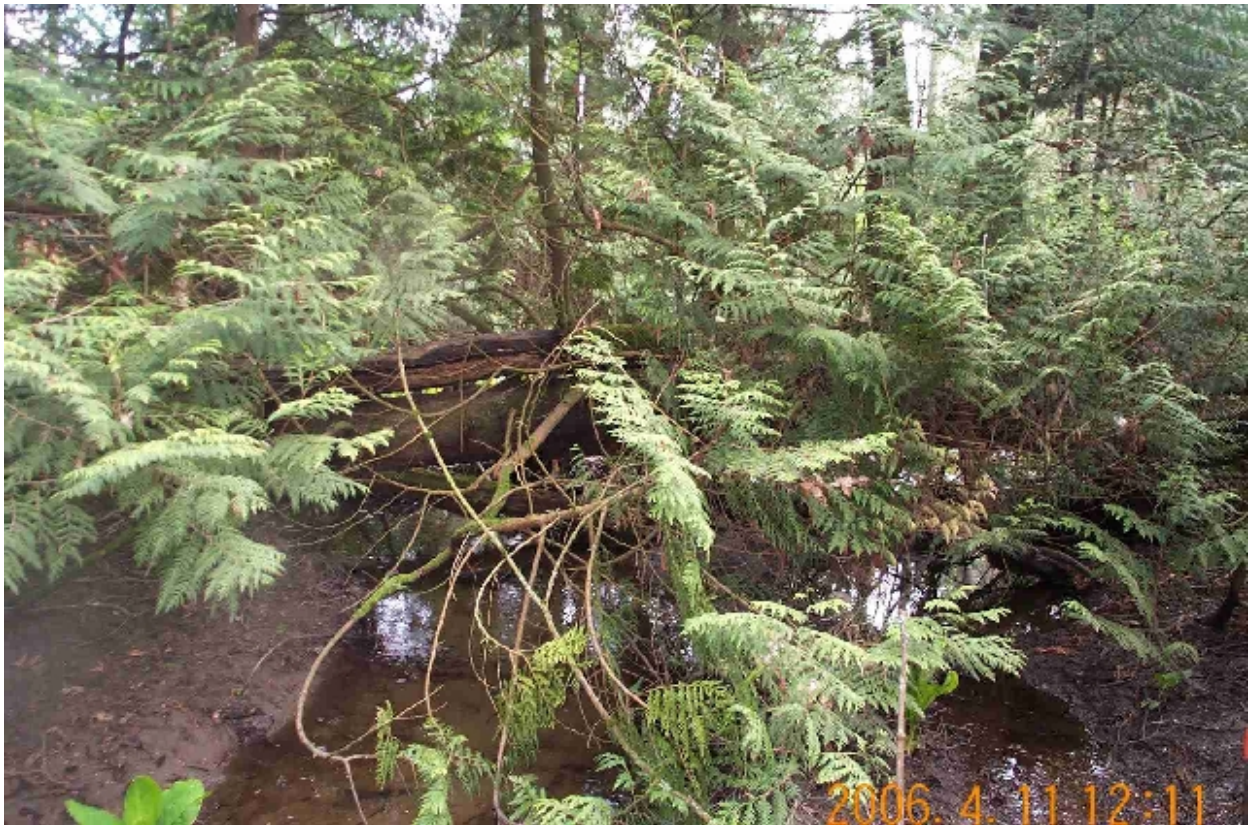
Photos P1010086.jpg

Comment: A tree has fallen across the creek channel.

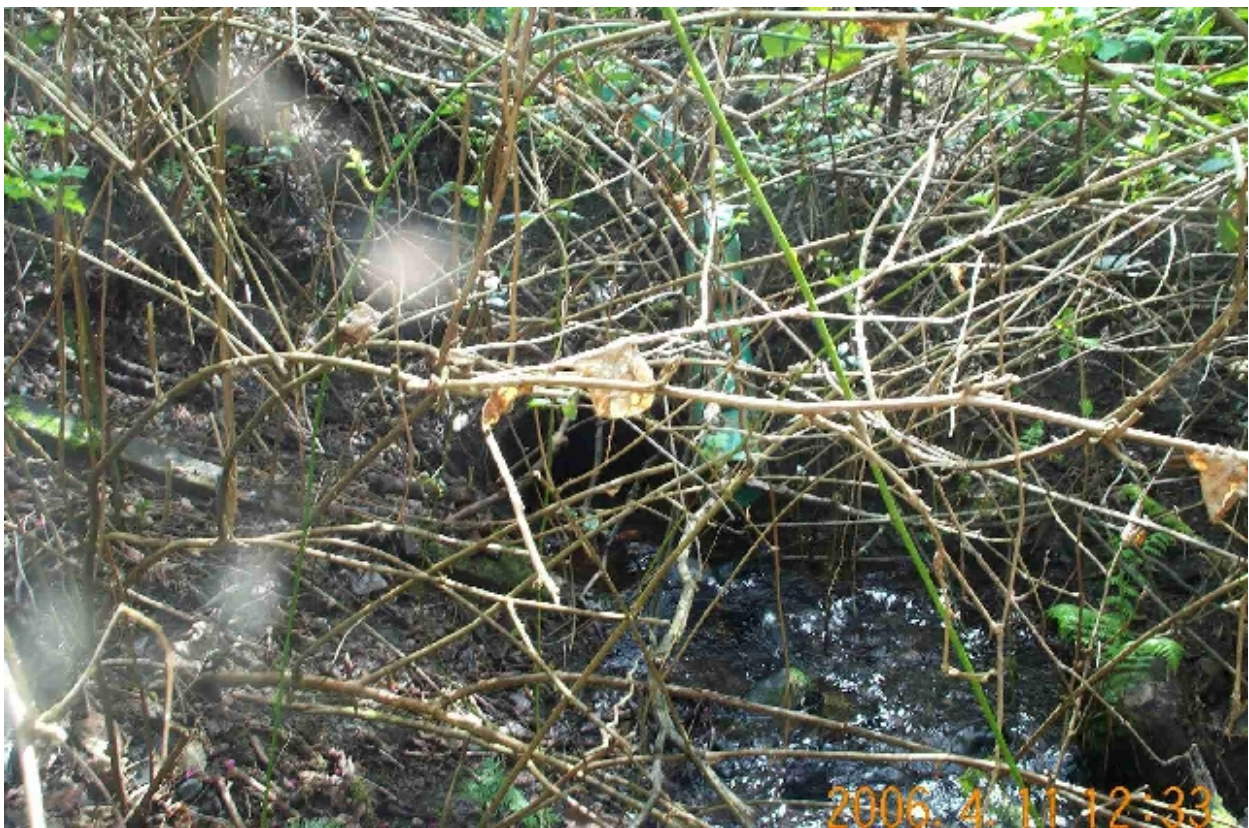
Photos P1010088.jpg

Comment: 600 mm diameter culvert with no headwall built underneath 184th Street.

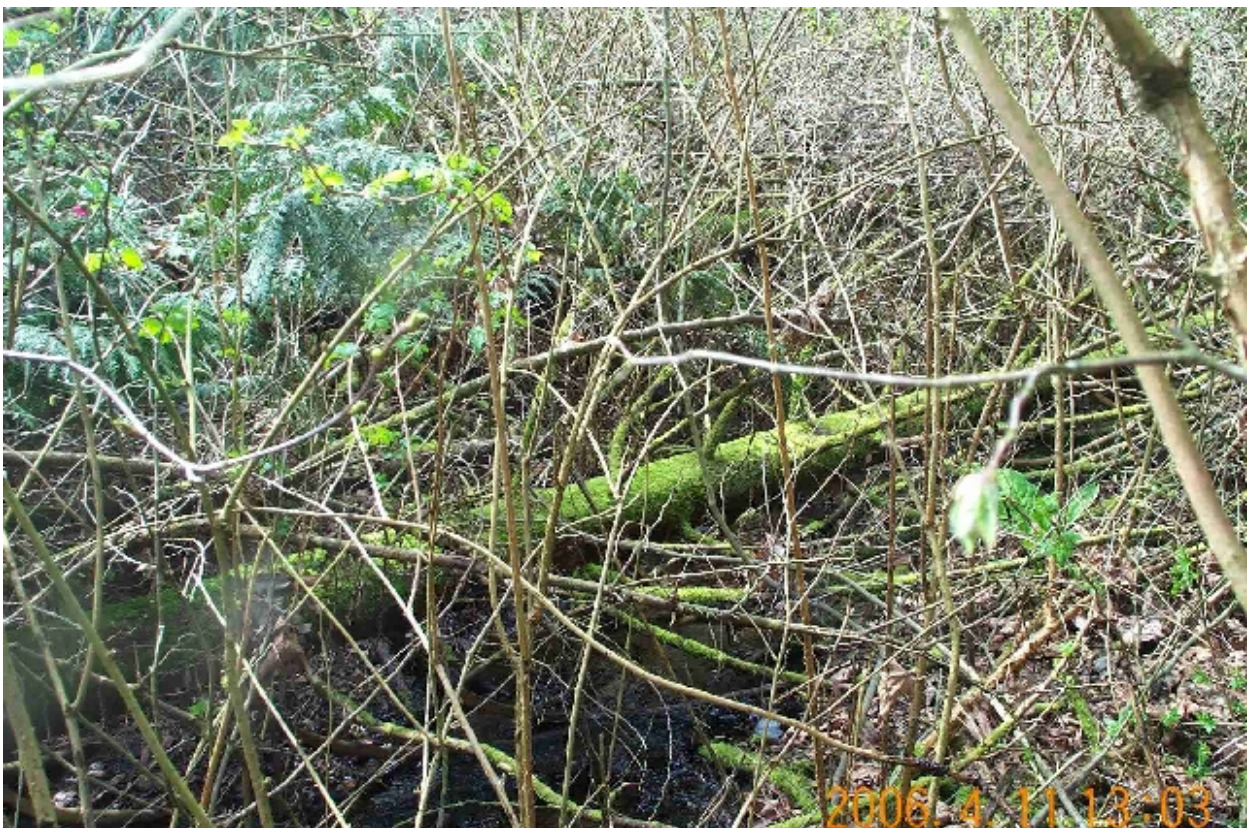
Photos P1010089.jpg

Comment: Confluence with Dall Brook. Channel is not well defined and possibly meanders.

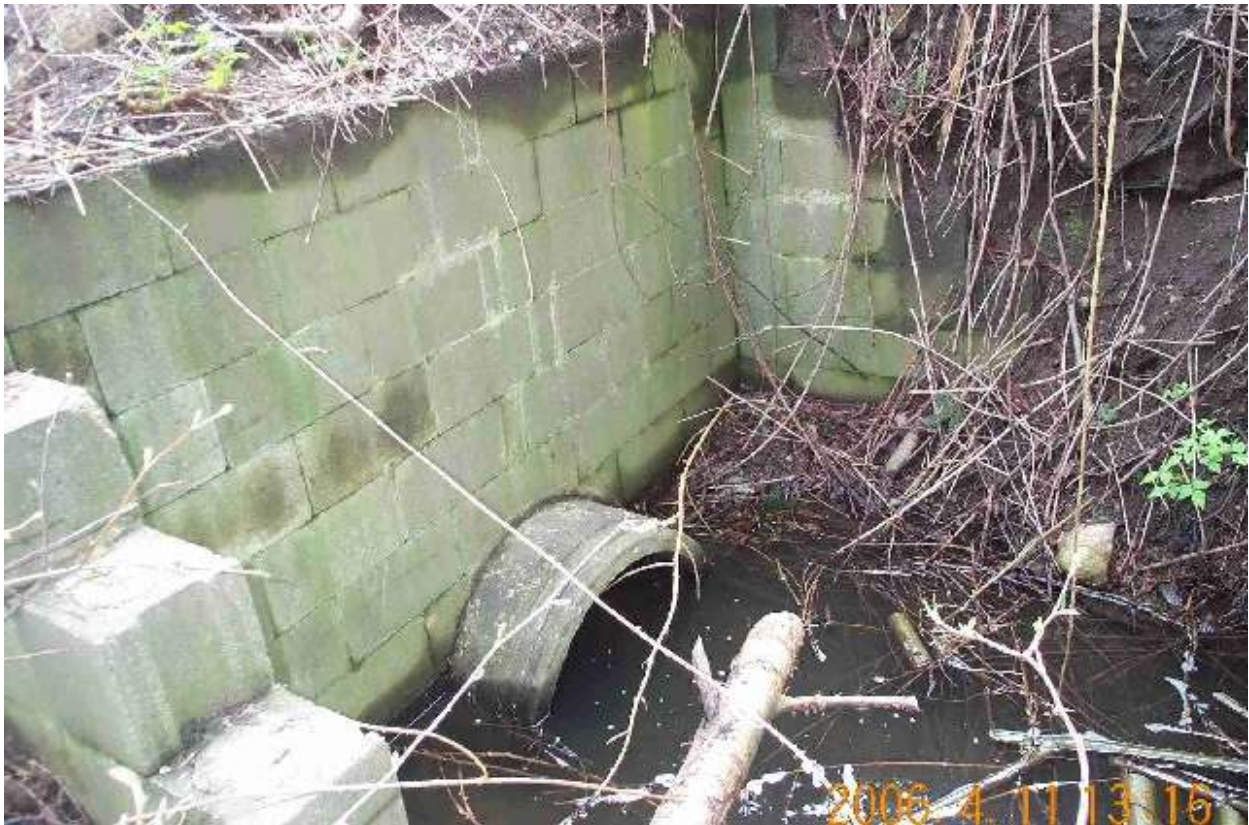
Photos P1010090.jpg

Comment: 900 mm diameter culvert built underneath 184th Street with cinder block headwall and wingwalls.

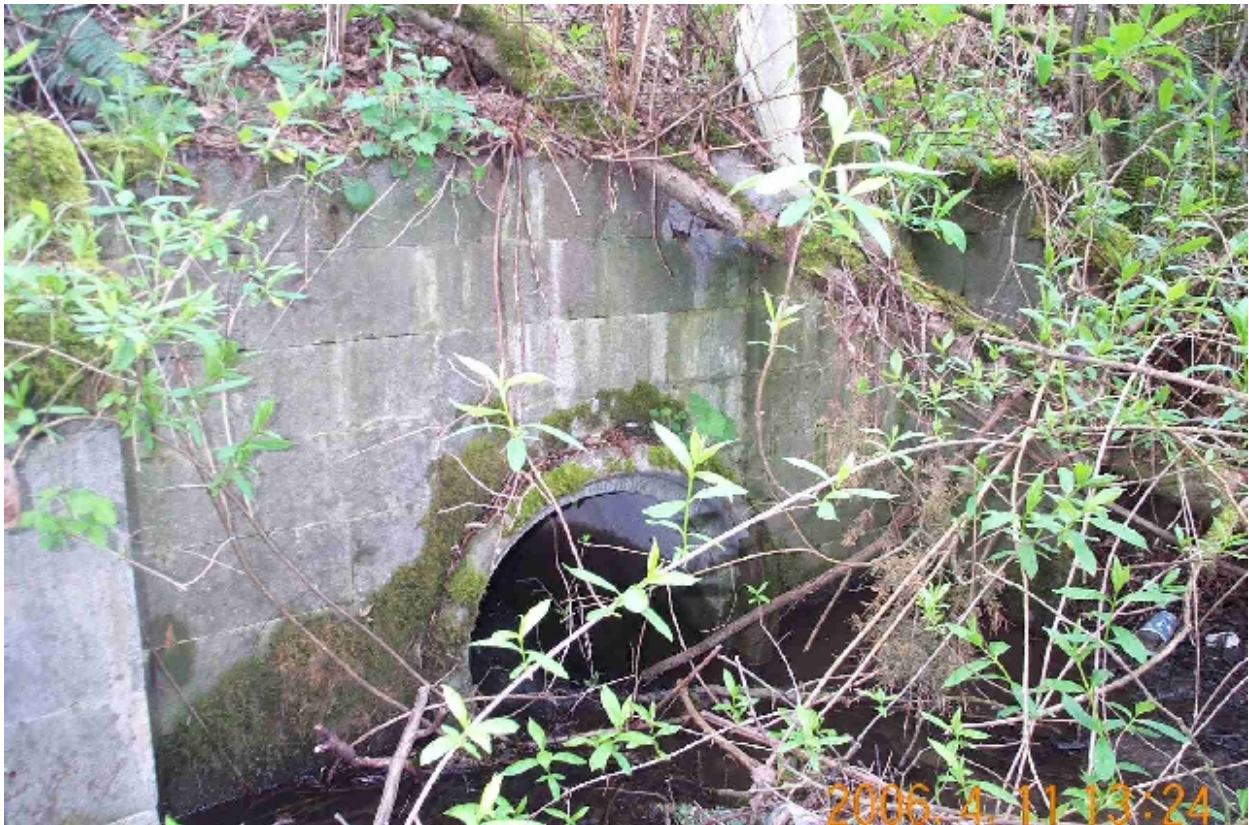
Photos P1010091.jpg

Comment: 900 mm diameter culvert built underneath 184th Street with cinder block headwall and wingwalls.

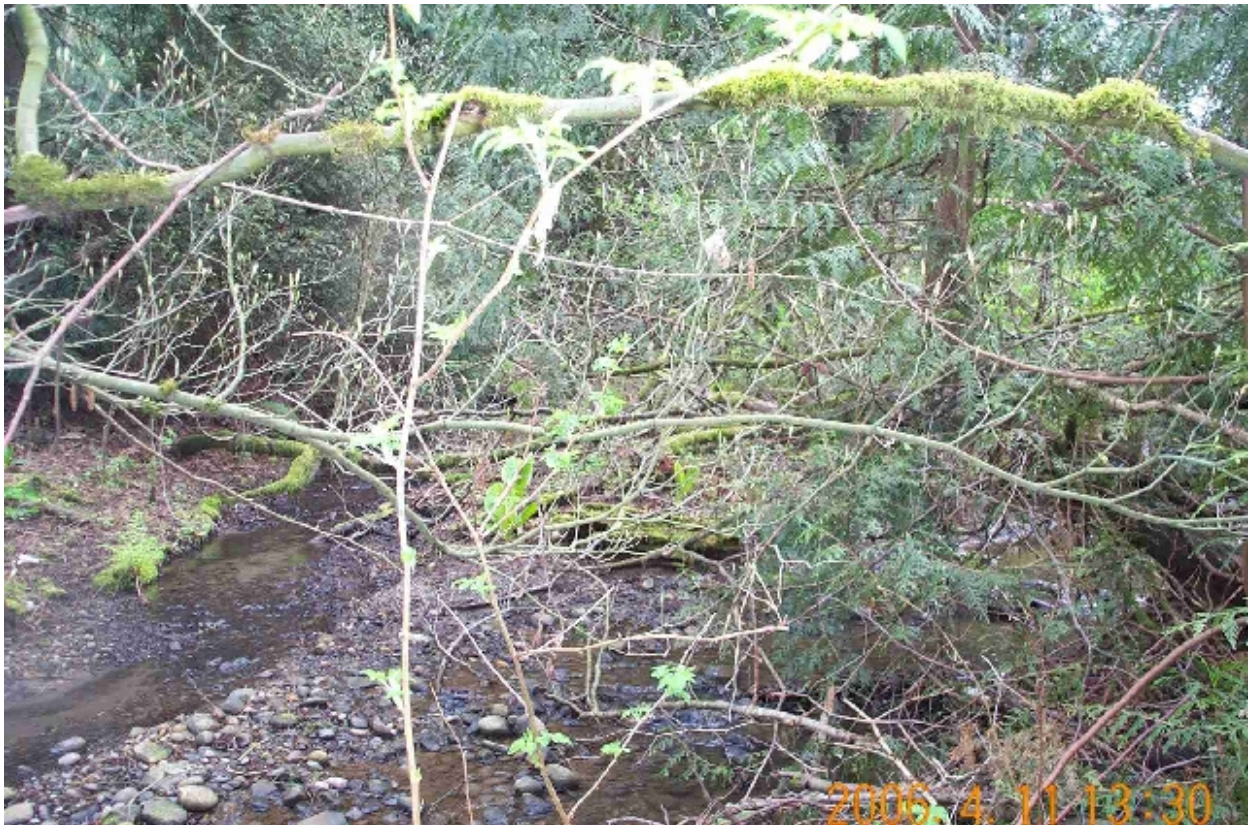
Photos P1010092.jpg

Comment: Fallen logs and other wood debris present in creek channel.

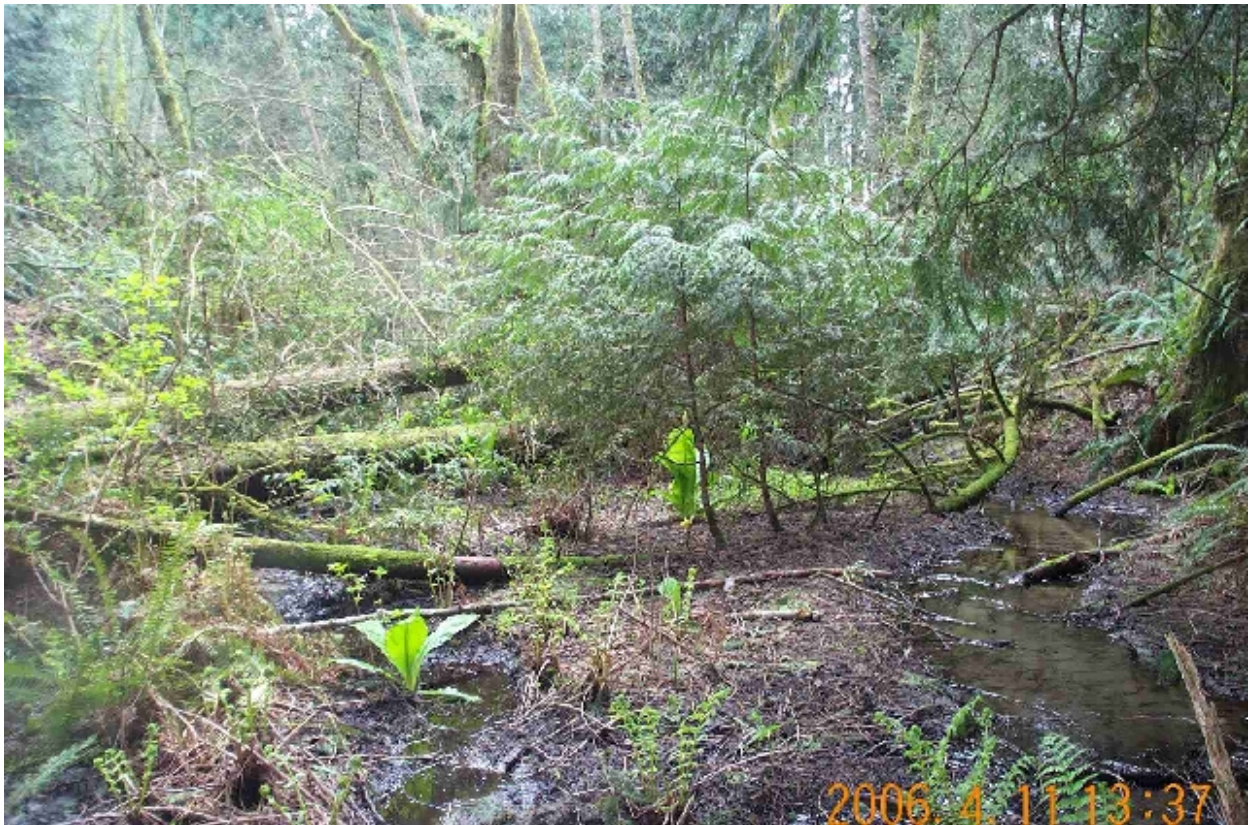
Photos P1010093.jpg

Comment: Fallen logs and other wood debris present in creek channel.

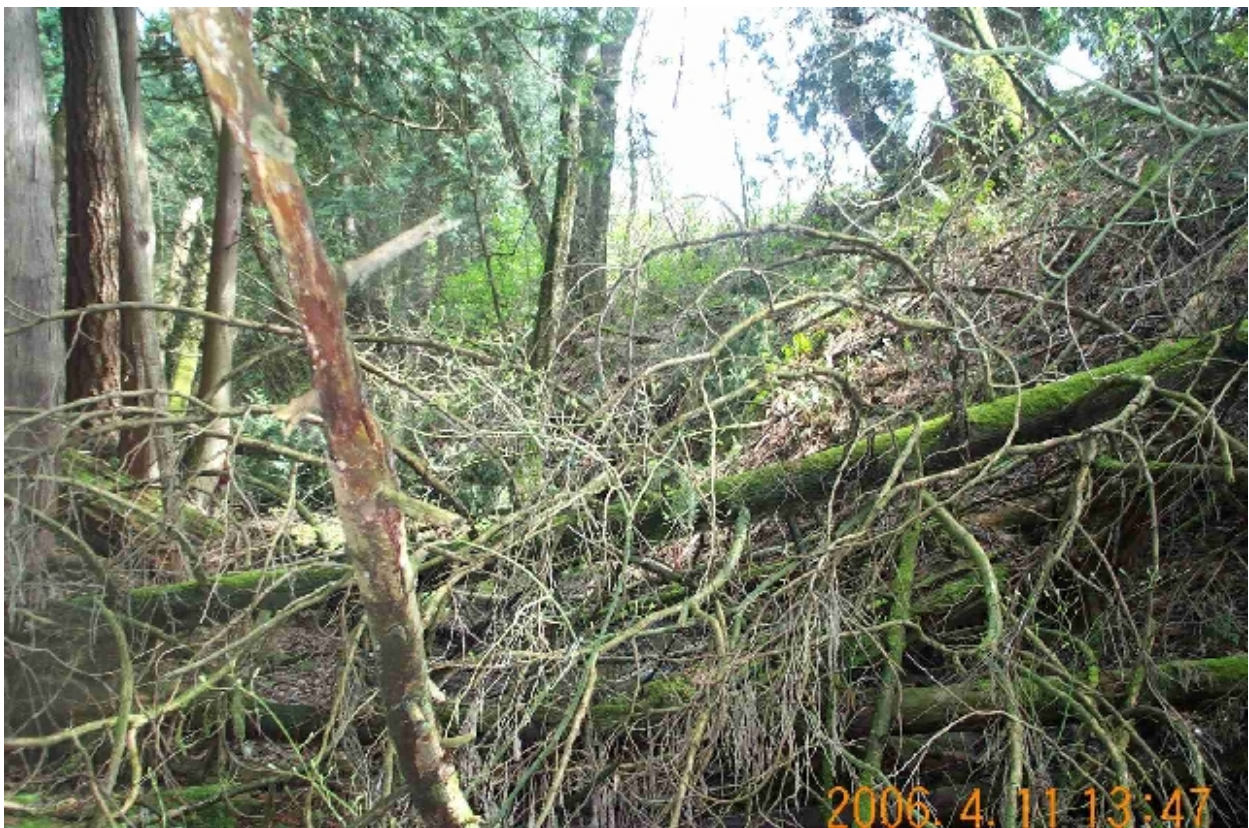
Photos P1010094.jpg

Comment: Fallen logs and other wood debris present in creek channel.

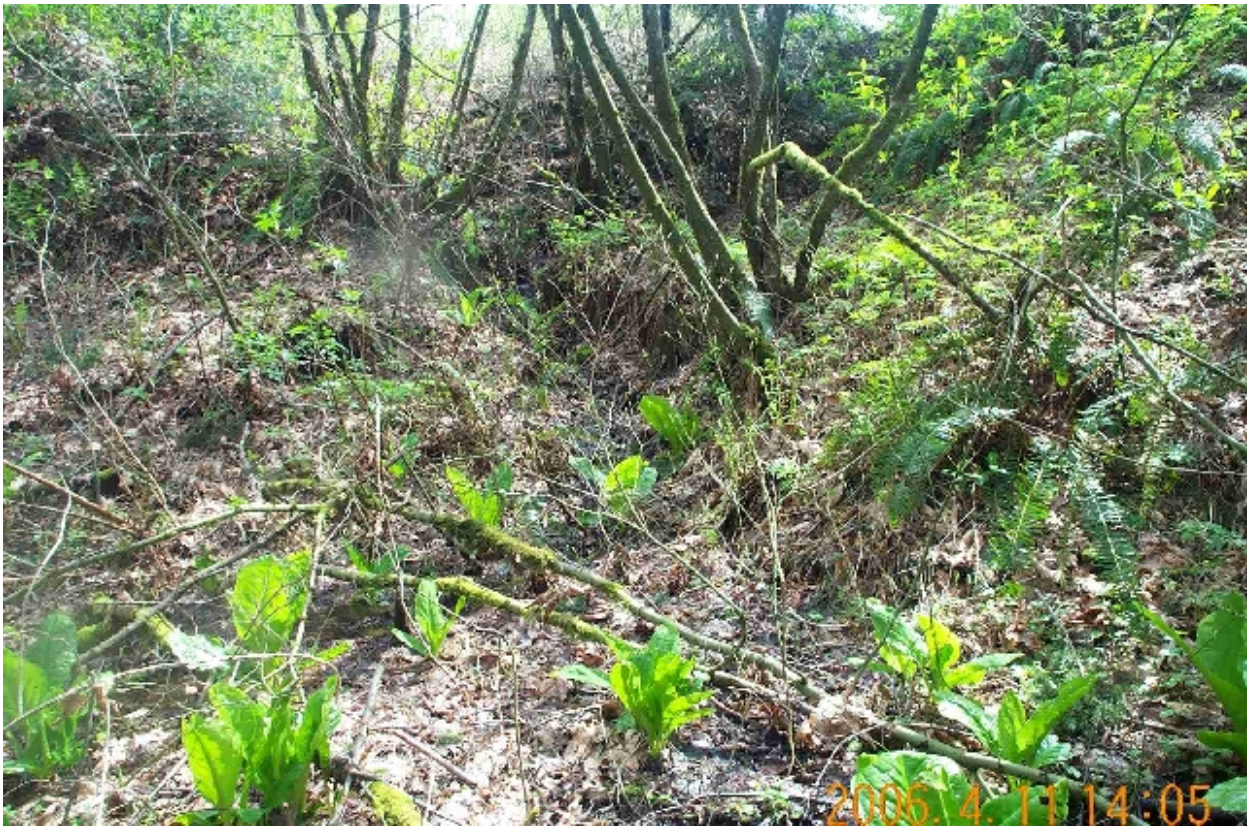
Photos P1010096.jpg

Comment: Confluence with unidentified channel to the east.

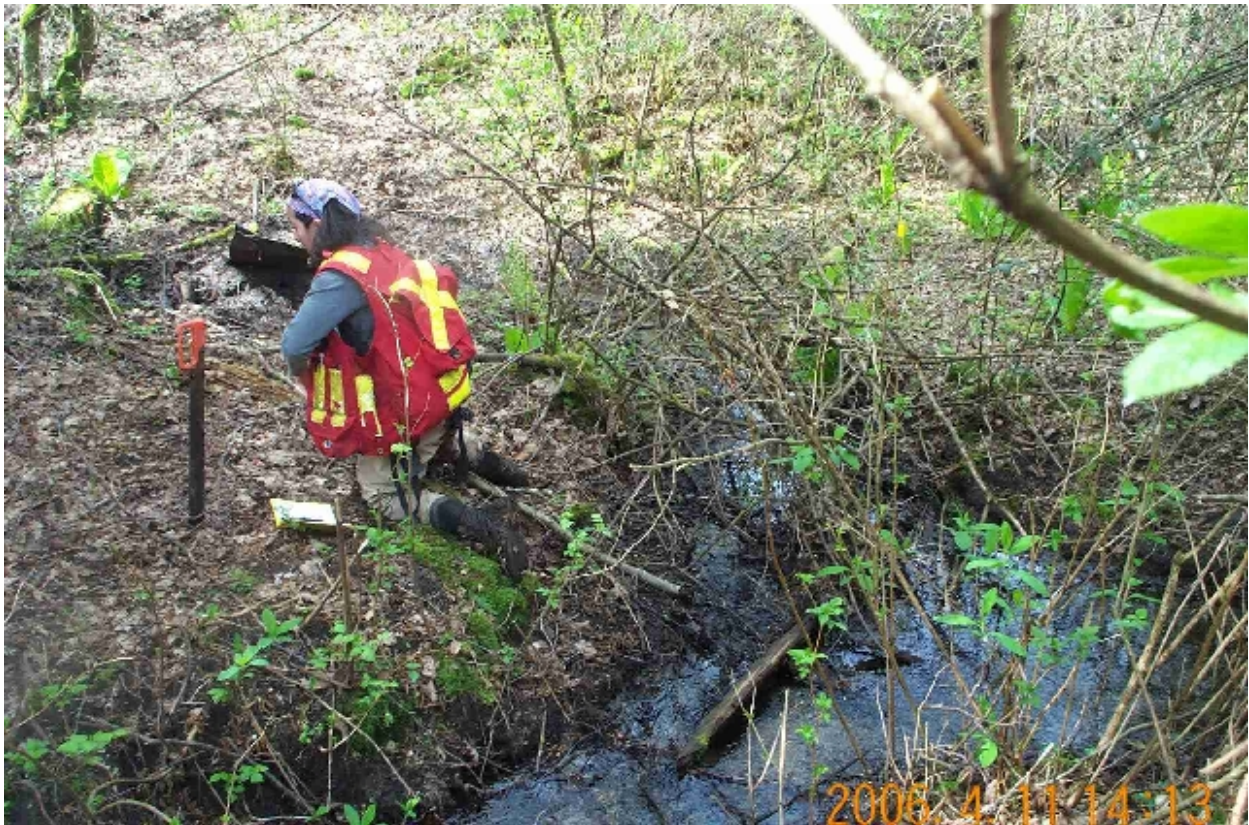
Photos P1010097.jpg

Comment: Confluence with unidentified channel to the west.

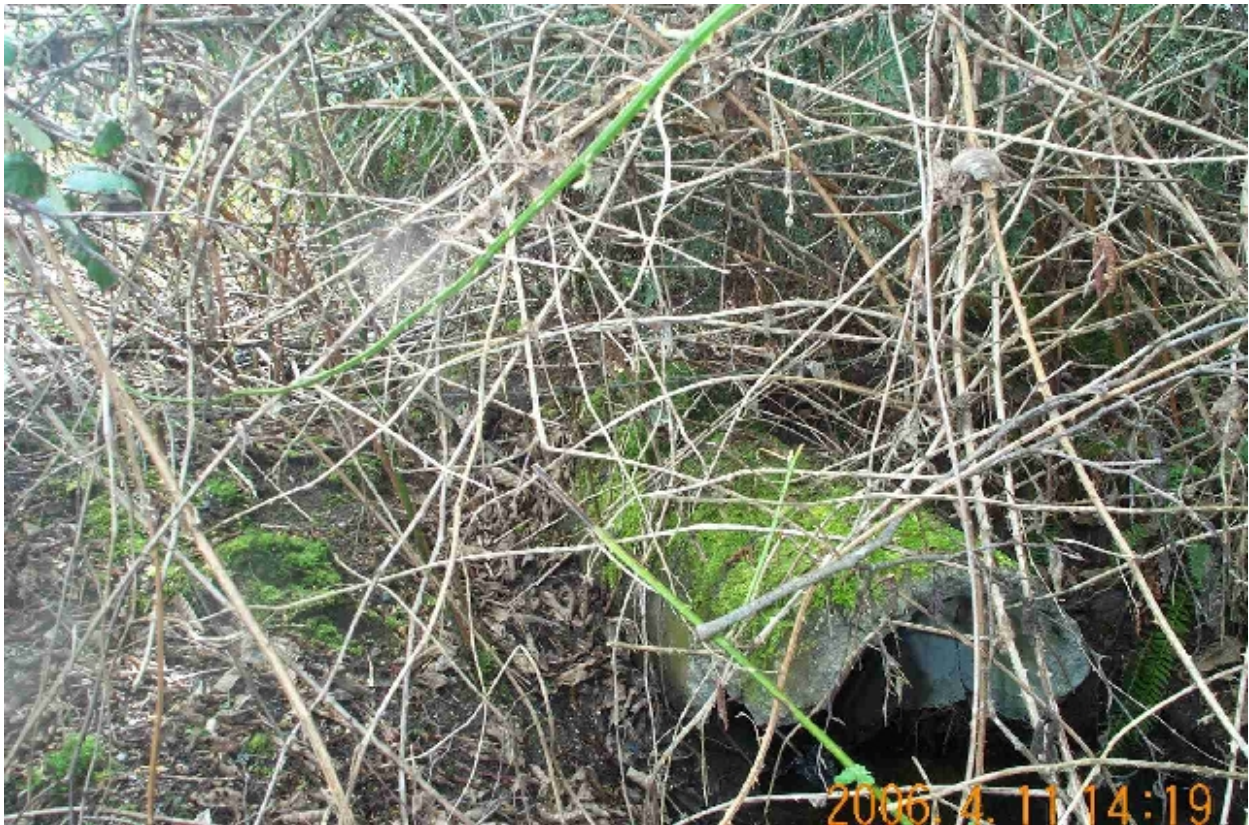
Photos P1010098.jpg

Comment: A broken and plugged 600 mm diameter culvert has created a weir in the creek channel.

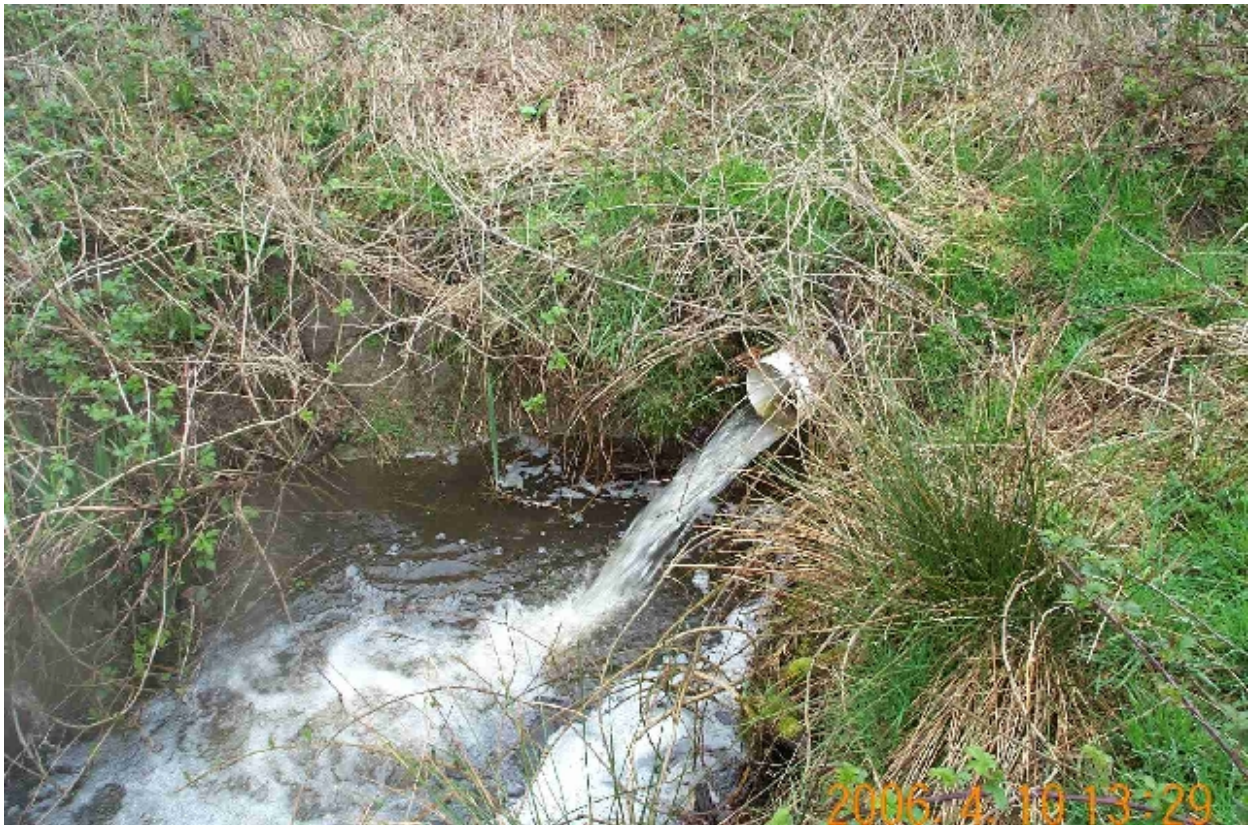
Photos P1010025.jpg

Comment: 200 mm diameter culvert that drains an ornamental pond on private property. Water velocity seems high and an erosion area has formed around the culvert outlet. The culvert outlet is located at the confluence of Vandrish Brook and Erickson Creek.

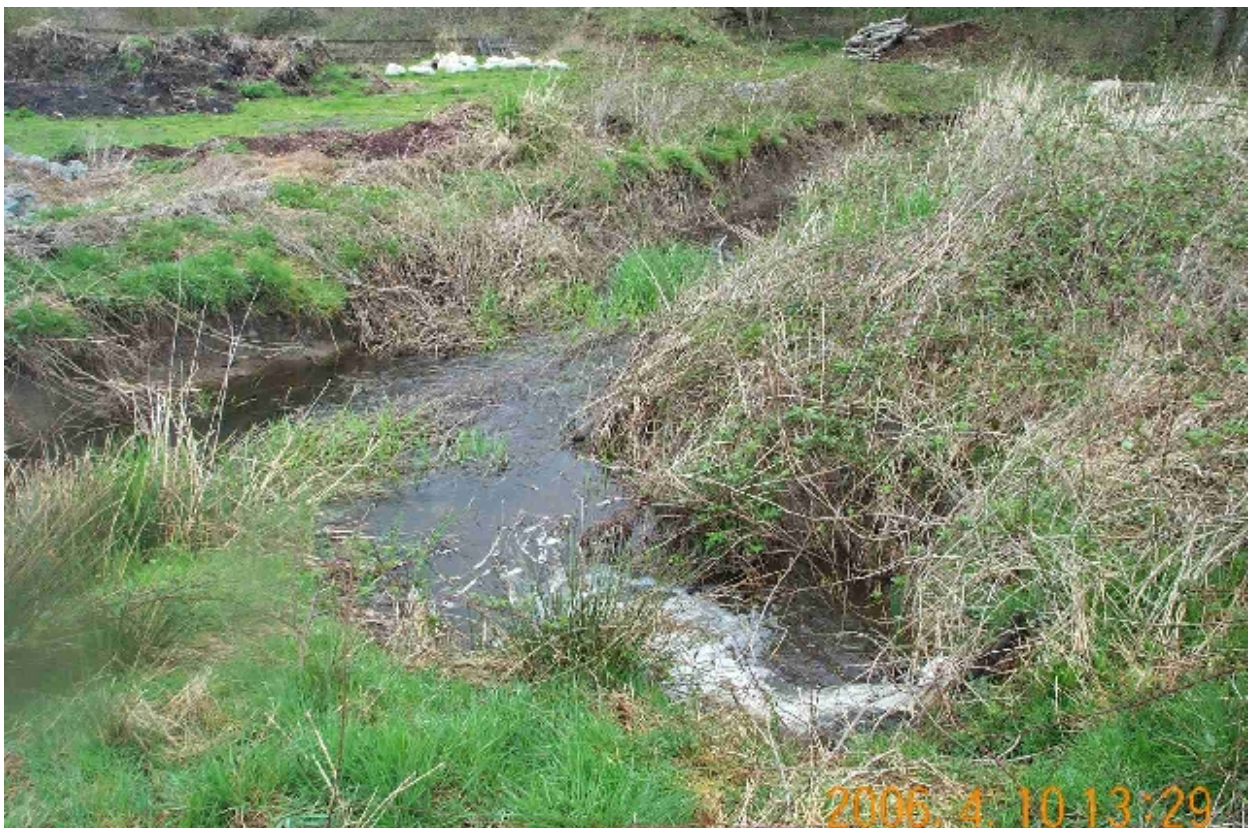
Photos P1010026.jpg

Comment: 200 mm diameter culvert that drains an ornamental pond on private property. The inlet is clogged by small floating debris.

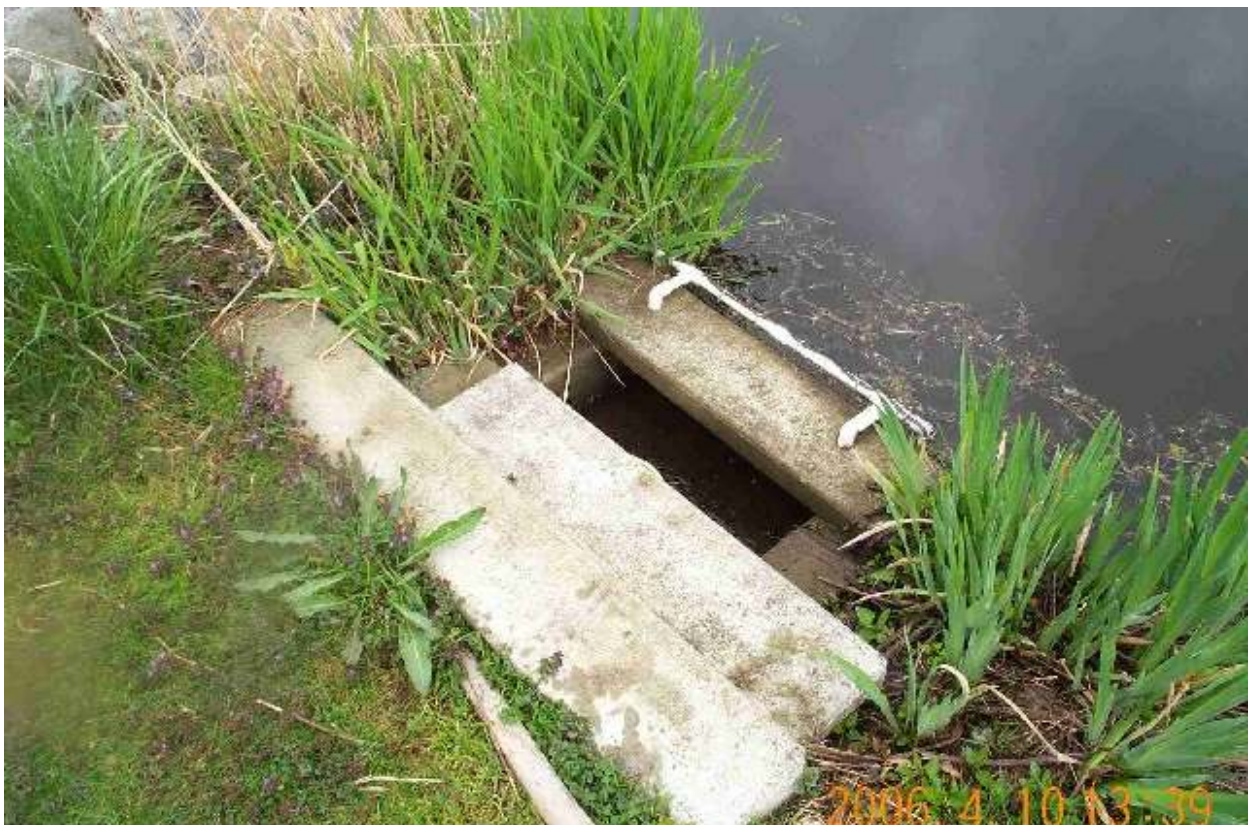
Photos P1010029.jpg

Comment: 200 mm diameter culvert that drains an ornamental pond into another ornamental pond. The inlet is controlled by a concrete weir with a mesh gate.

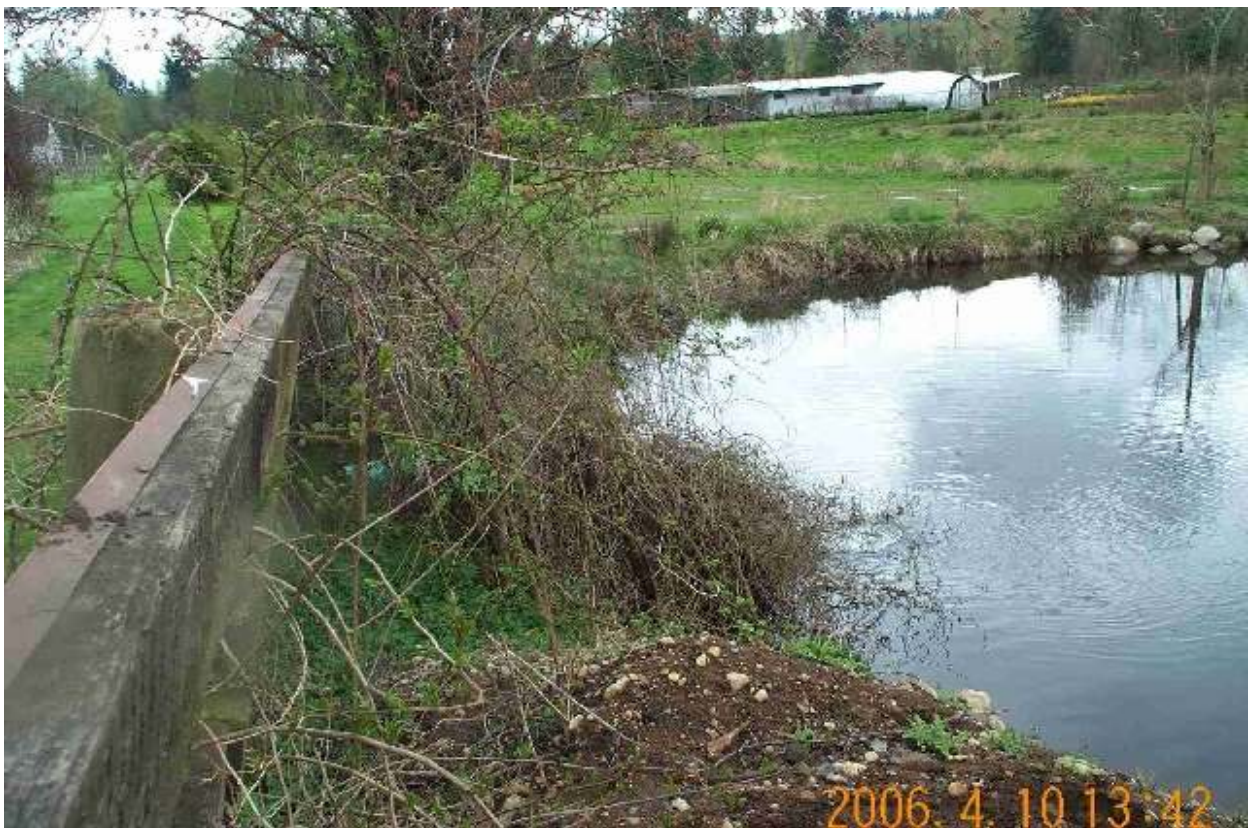
Photos P1010030.jpg

Comment: 200 mm diameter culvert that drains an ornamental pond into another ornamental pond. There is a 45 degree angle in the culvert.

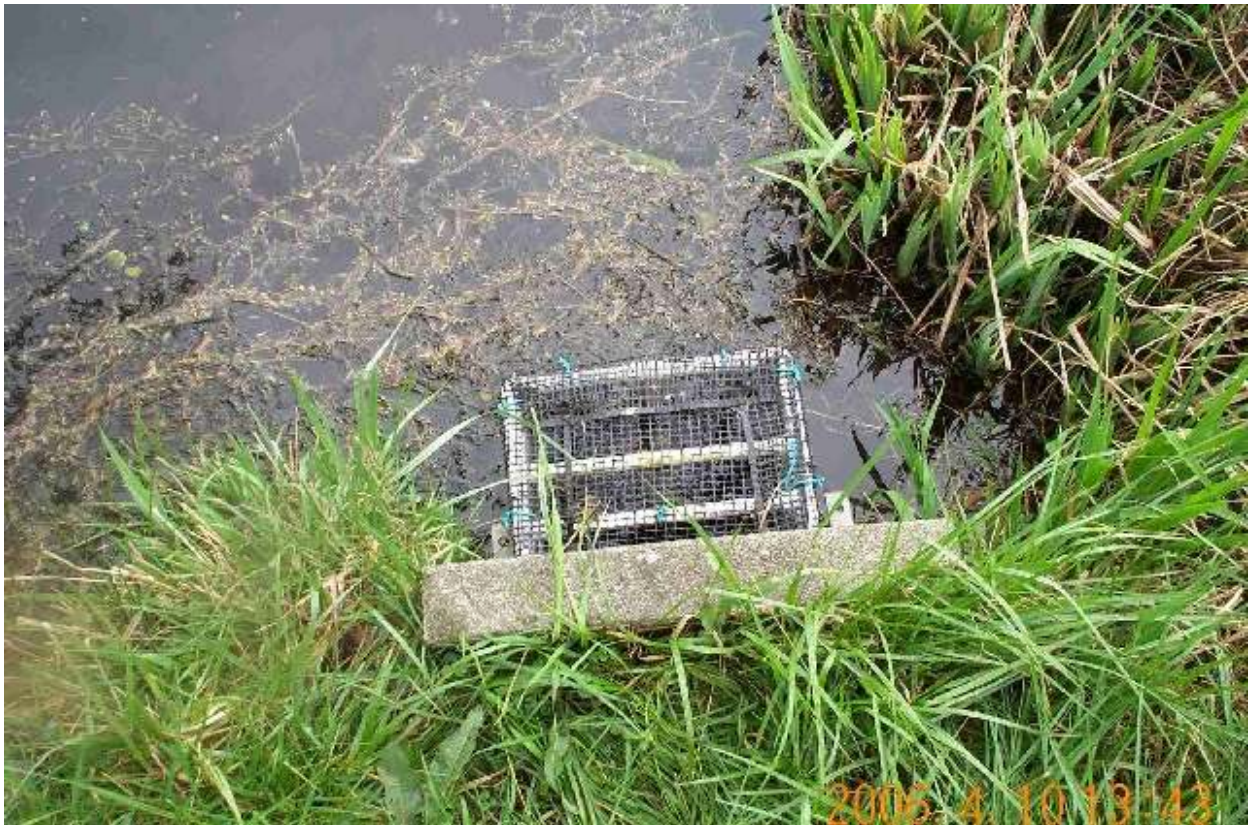
Photos P1010031.jpg

Comment: 150 mm diameter culvert and a 300 mm diameter high flow culvert draining an ornamental pond into side channel. Inlet is controlled and surrounded by a wire mesh.

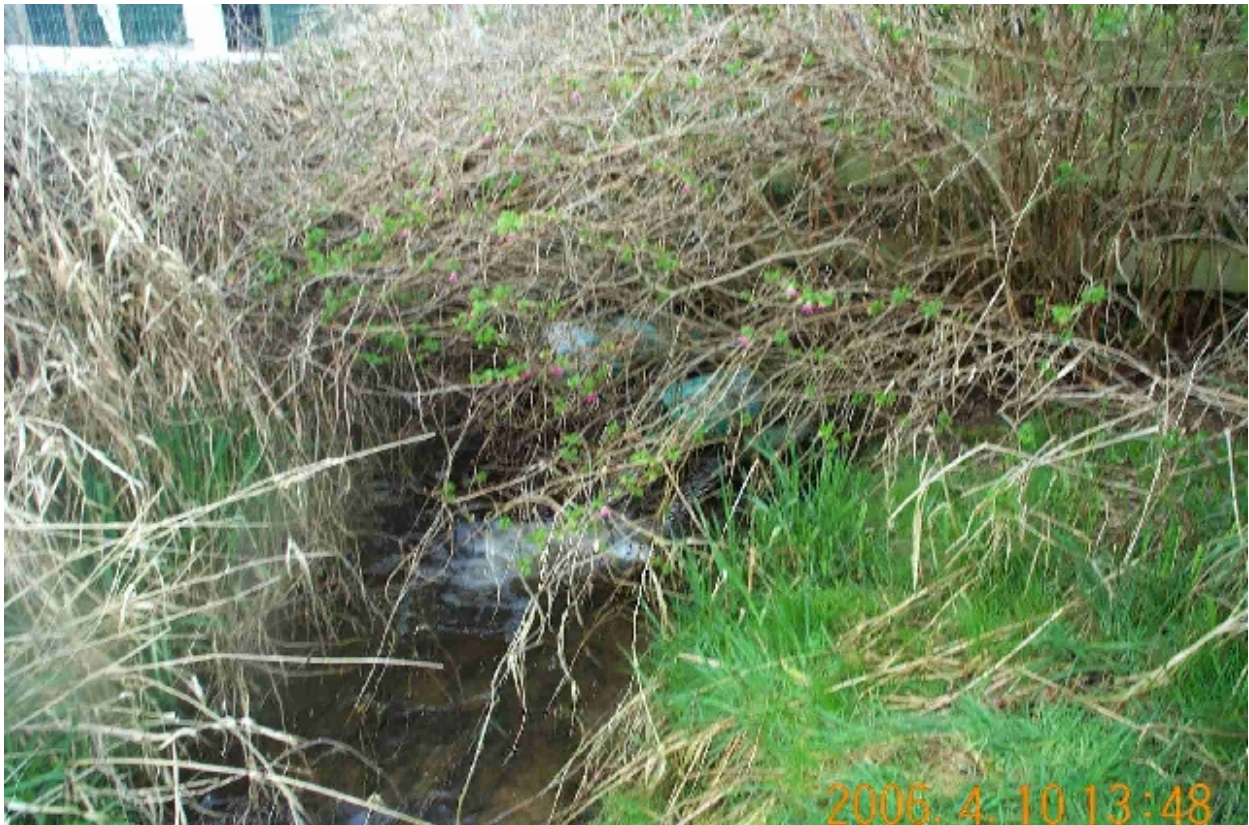
Photos P1010033.jpg

Comment: 150 mm diameter culvert and a 300 mm diameter high flow culvert draining an ornamental pond into side channel.
