City of Surrey

Erickson Creek Integrated Stormwater Management Plan

September 2010

**Re: ERICKSON CREEK INTEGRATED STORMWATER MANAGEMENT PLAN
FINAL REPORT**

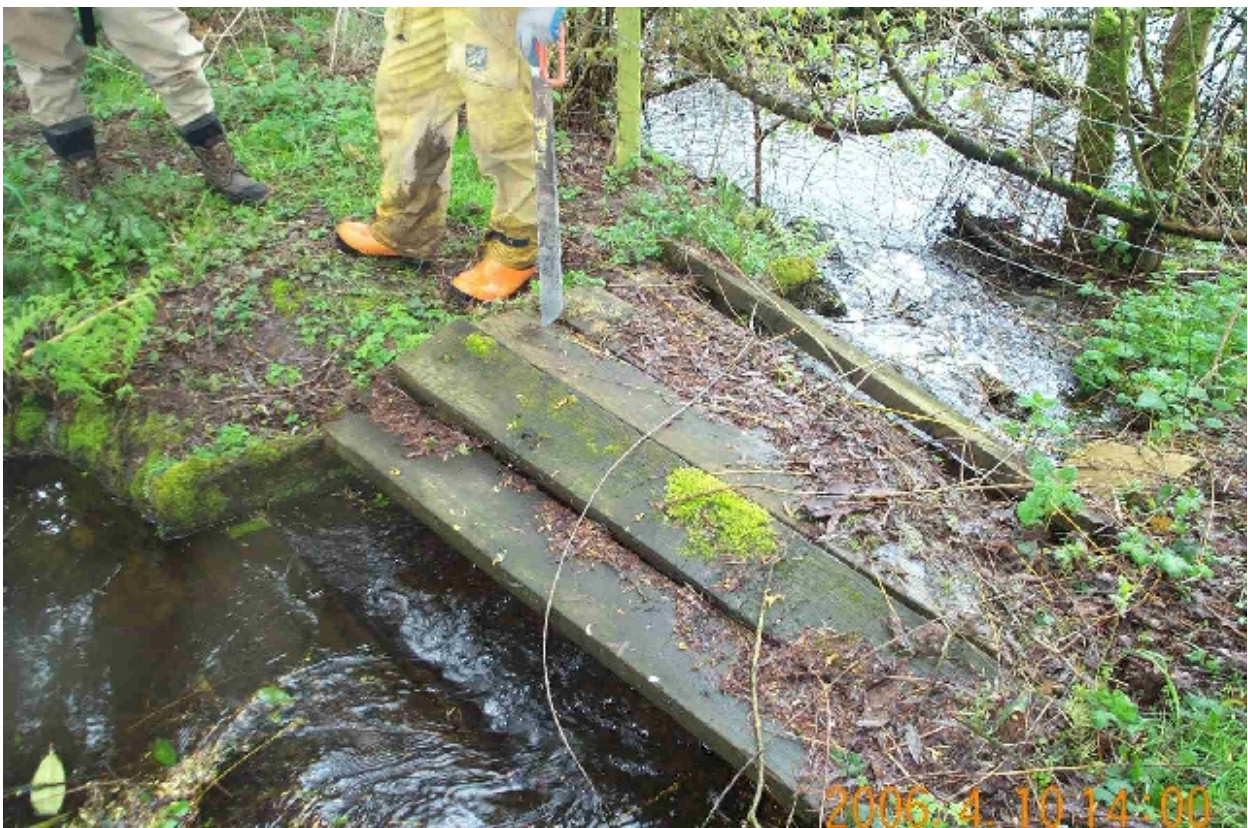
Photos P1010034.jpg

Comment: Pedestrian bridge built on concrete vertical walls at downstream end of ornamental pond. Bridge is approximately 200 mm above the surveyed water level.

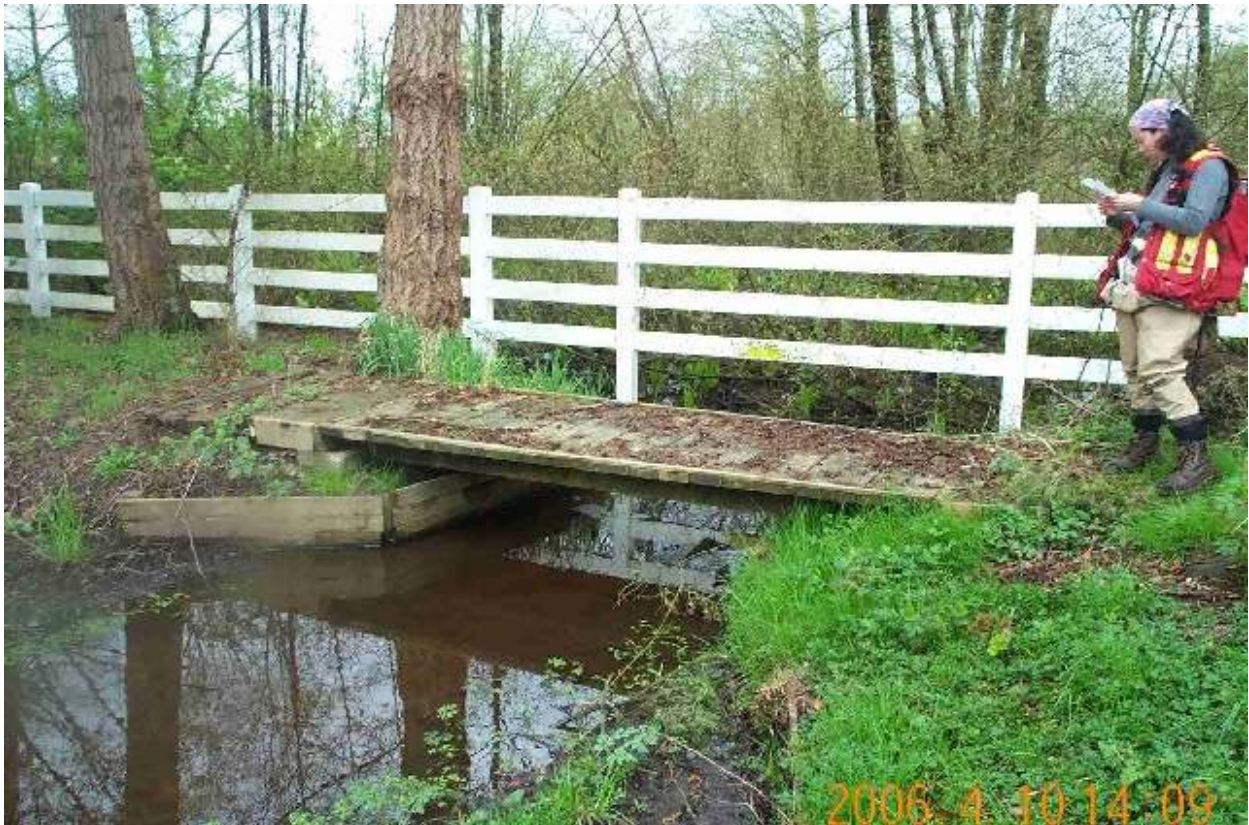
Photos P1010035.jpg

Comment: Vehicle Bridge spans narrow point between two ornamental ponds. Flow is channelized between wood abutment walls. Bridge is approximately 400 mm above the surveyed water level.

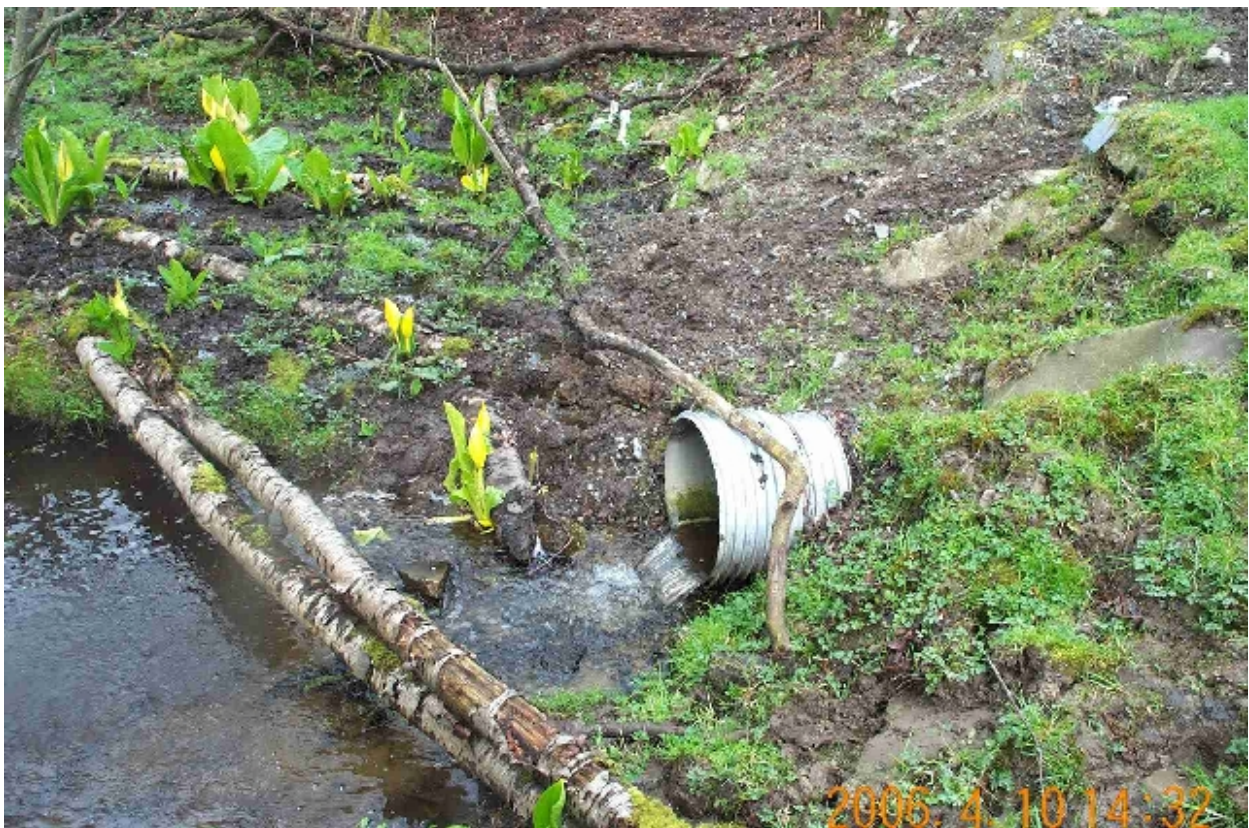
Photos P1010038.jpg

Comment: 450 mm diameter culvert built underneath possible vehicle access road.

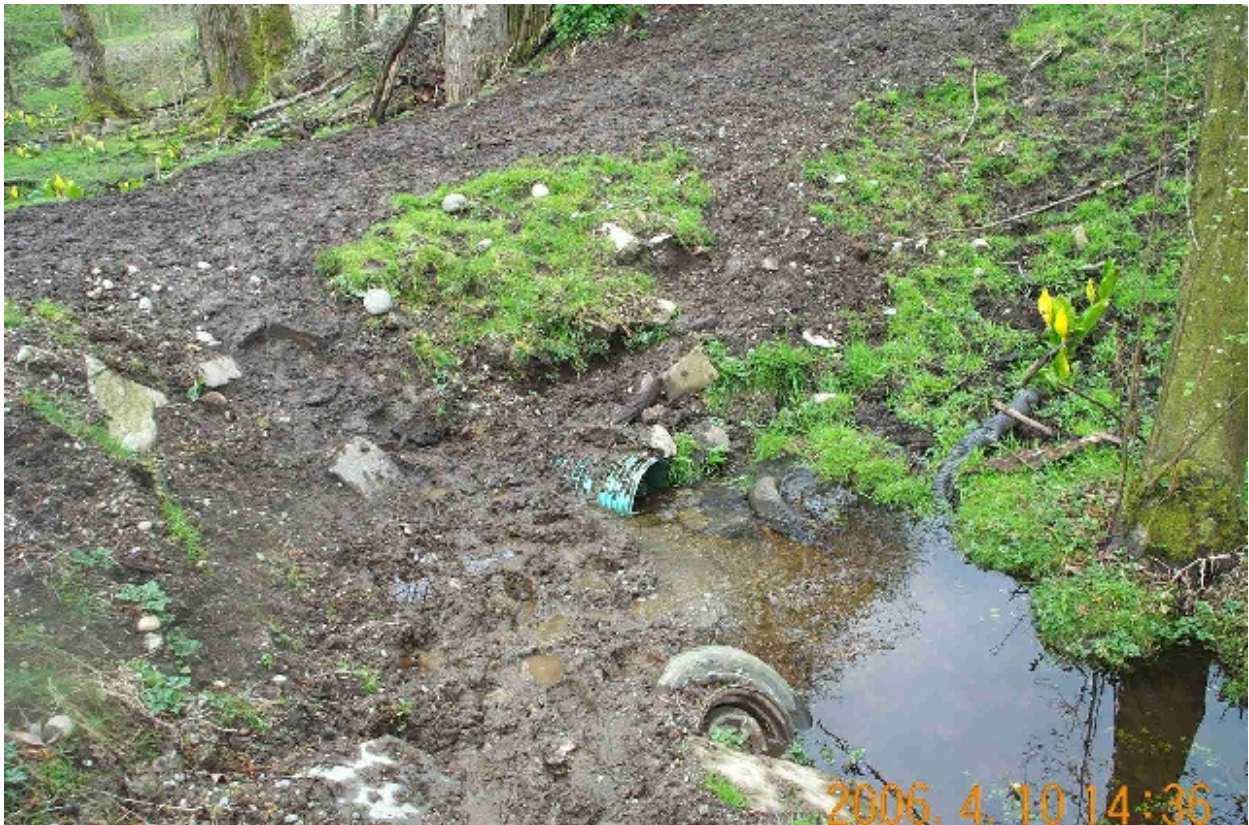
Photos P1010039.jpg

Comment: 450 mm diameter culvert built underneath possible vehicle access road.

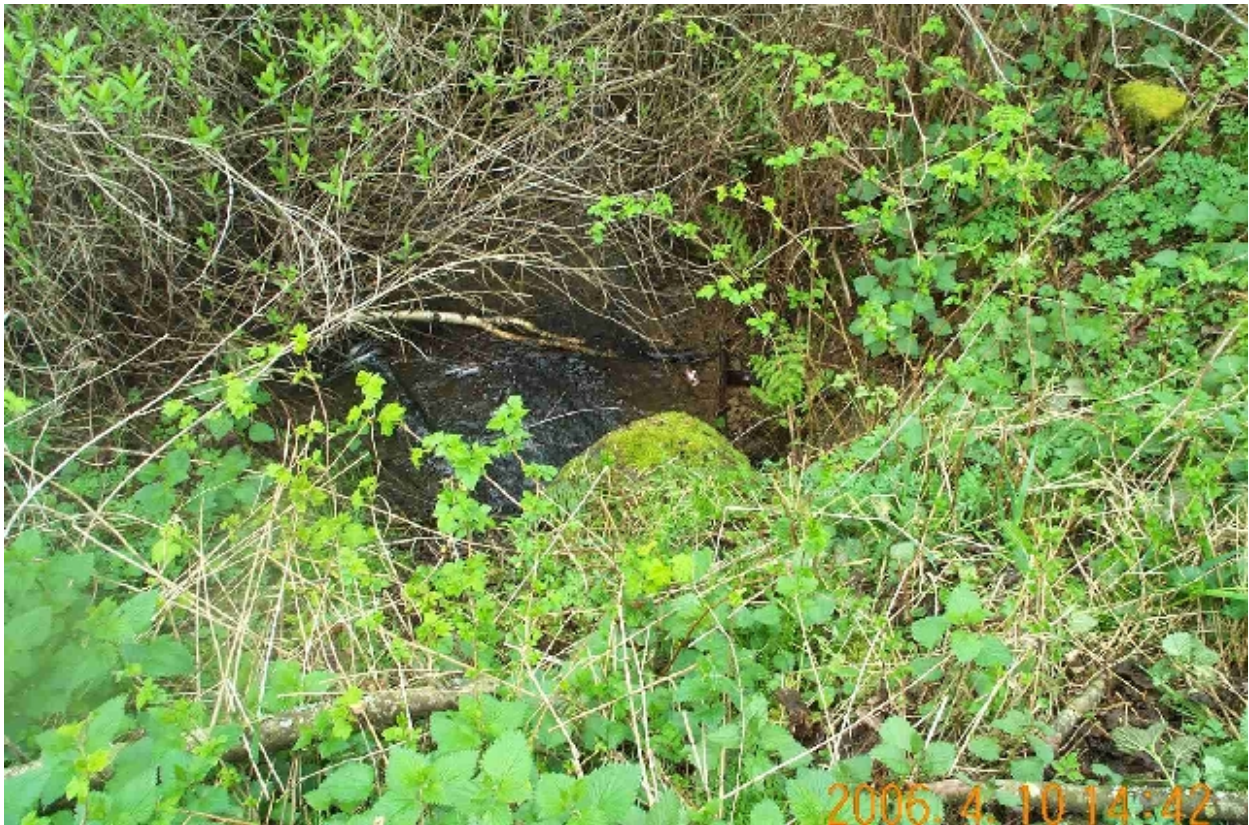
Photos P1010040.jpg

Comment: 600 mm diameter culvert built underneath 29A Avenue with minimal erosion around outlet.

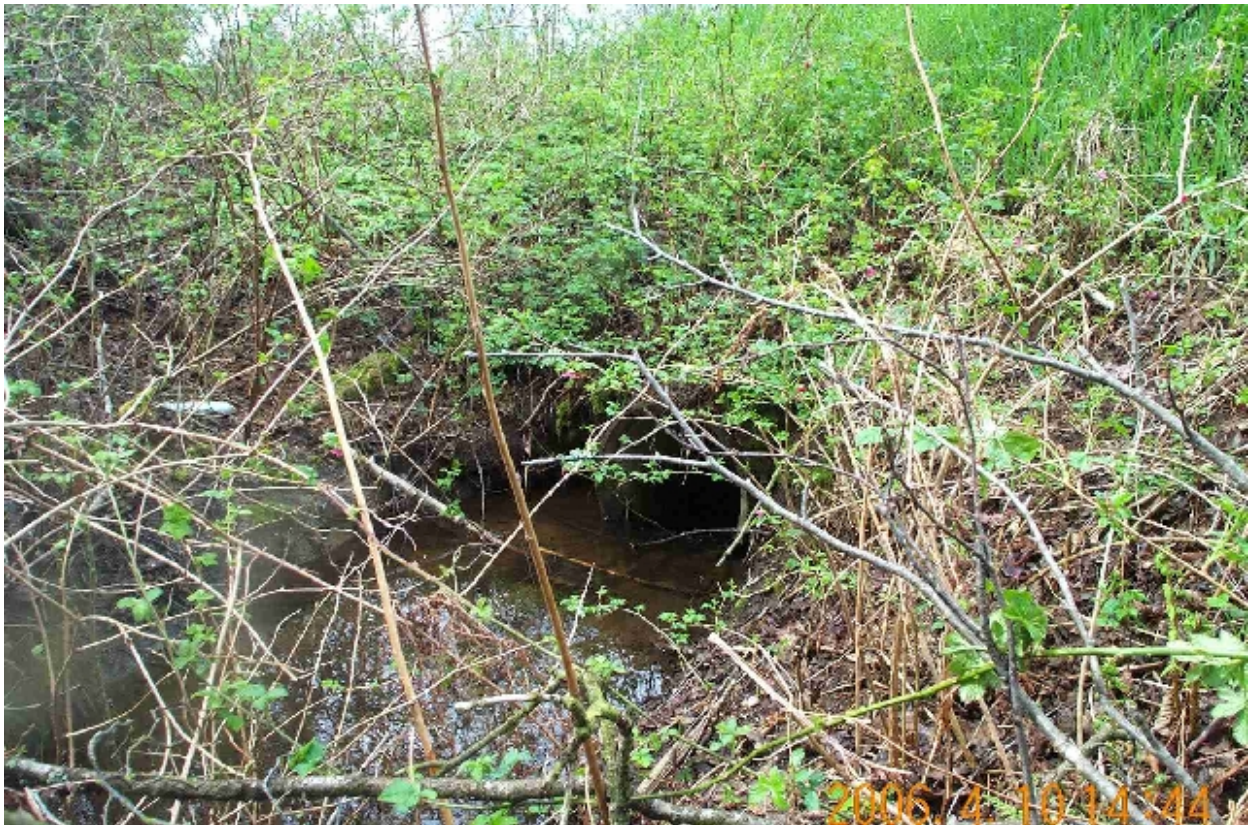
Photos P1010041.jpg

Comment: 600 mm diameter culvert built underneath 29A Avenue with minimal erosion around inlet.

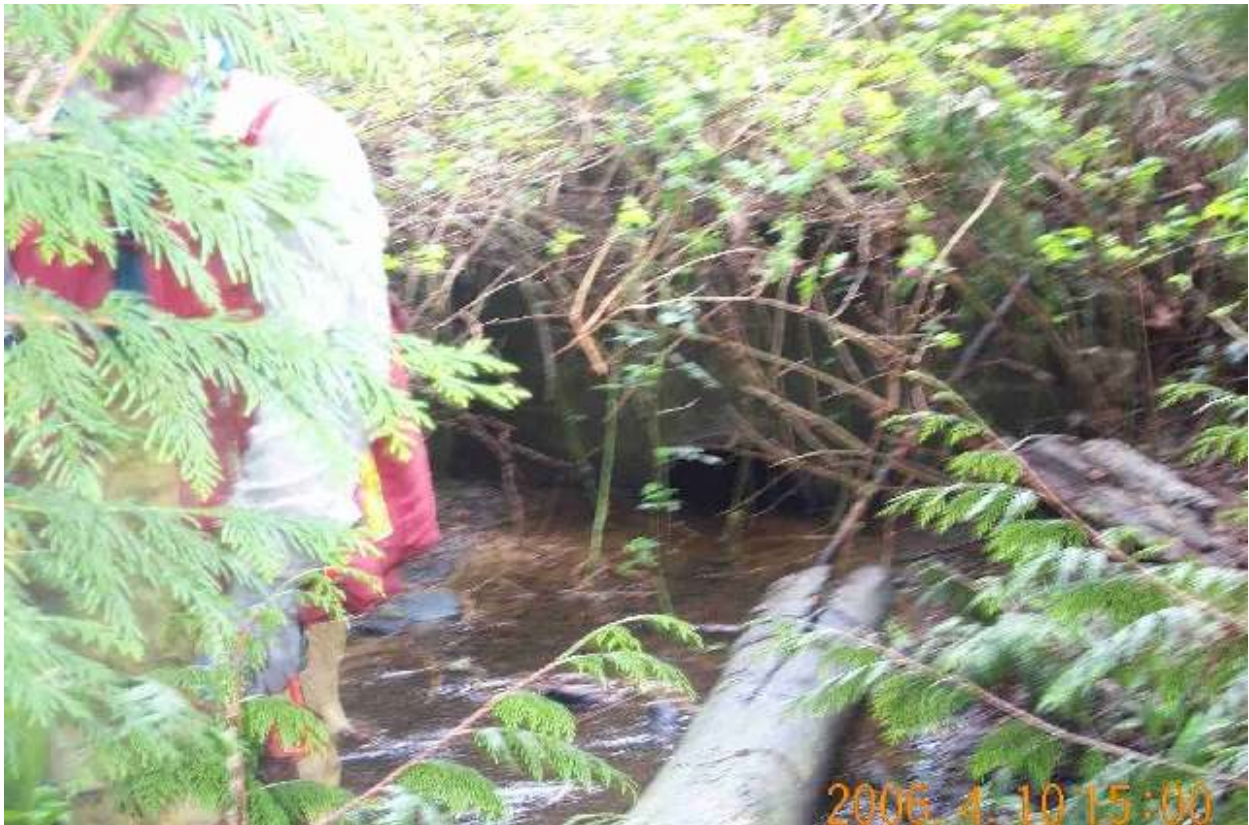
Photos P1010042.jpg

Comment: 600 mm diameter culvert build underneath 184th Street with concrete headwall. Possible sediment issue as the culvert invert is below channel bottom.

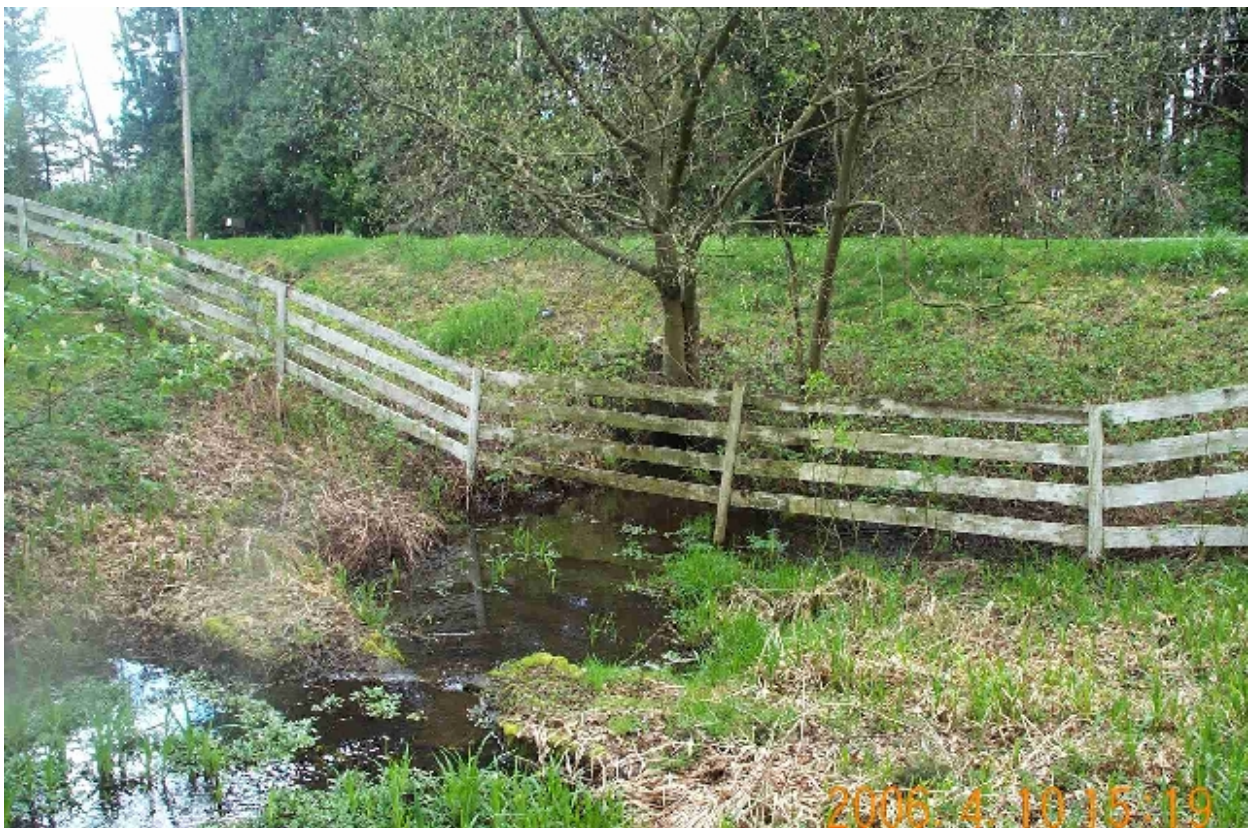
Photos P1010043.jpg

Comment: 600 mm diameter culvert build underneath 184th Street and a confluence with the 184th Street east ditch.
