SUBJECT: **Heritage Revitalization Agreement Application No. 7918-0037-00 for
1881 Town Hall and Old Anniedale School located at 17710 – 56A Avenue**

conservation plan

3 CONDITION ASSESSMENT

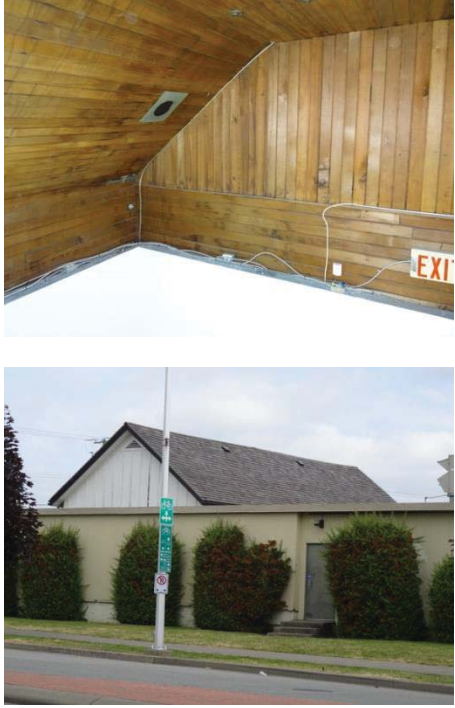
3.1.14	Structure: Roof	Access to the attic was not available, but the recent structural and roof rehabilitation appears to have been very successful in rectifying any discontinuities in the ridge line.

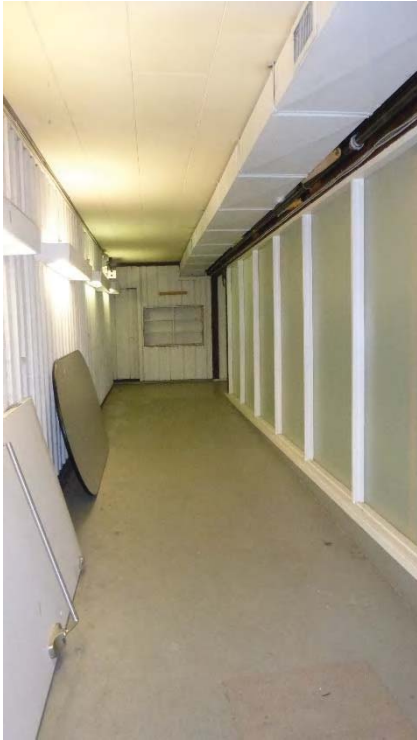
South

once the structure is loaded onto lowboy. The entire south side frontage of the current building has to be removed to accommodate the move, including the raised concrete slab and wall foundation.

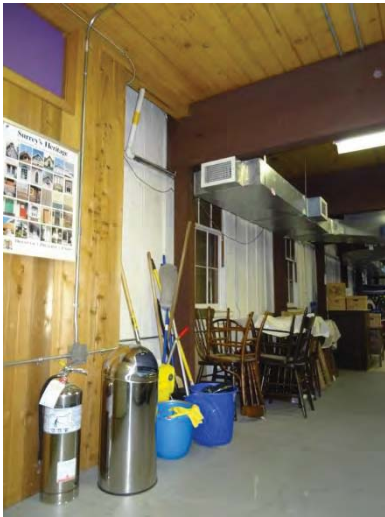
West

The north, west and east structures will have to be removed for minimum of four (4) feet measured from the perimeter walls of the Townhall. This would include removal of the foundation, concrete slabs and adjustments to roof supporting structural elements – gluelam beams and supporting columns.

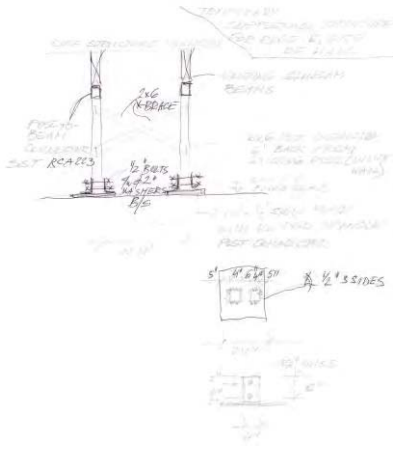
The 6x24 beams will have to be cut back 4 ft. and supported by temporary 6x6 columns allowing for some 24" cantilever as per the following sketch.

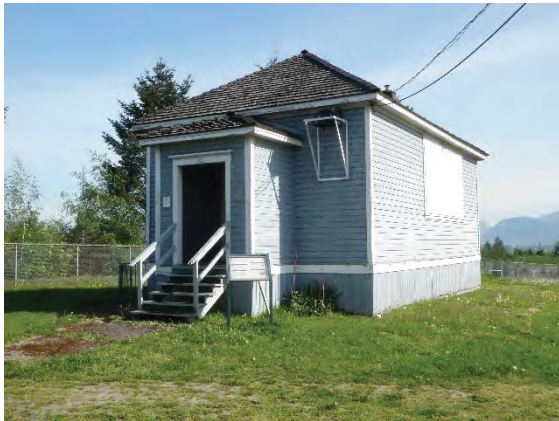
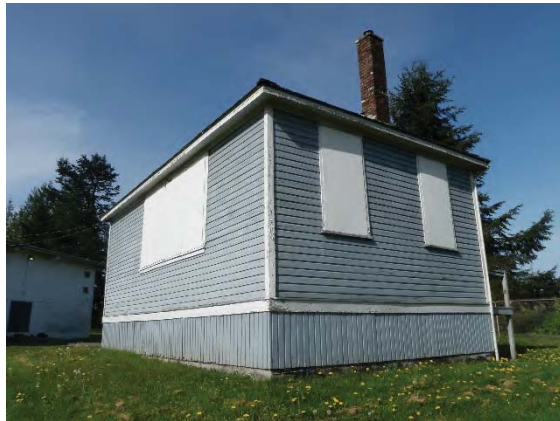
Old Anniedale School is in good condition overall. It was moved to the present location some 40 years ago. Some structural components of the building were improved at the time.

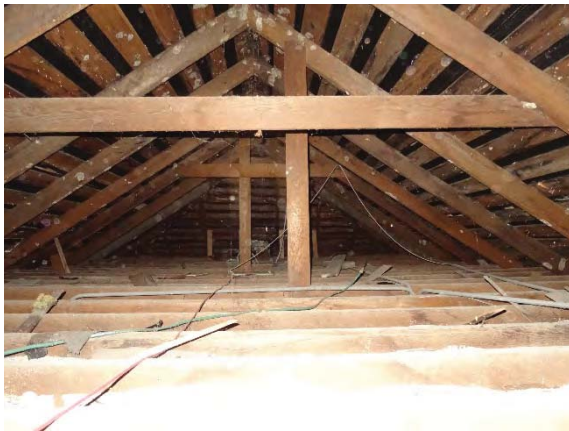
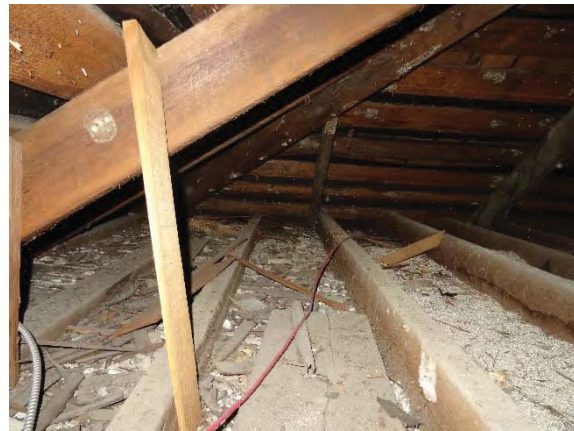
The hip roof structure has 2x6 rough cut rafters at approximately 3'-0" o.c. The rafters extend about a foot past the wall top plate to form the outer roof perimeter including fascia, soffit and gutters. The rafters must be "birdmouthed" and possibly toe nailed to the top plate as they do not match the ceiling joists which are 16" o.c. The common rafter sets have collar ties every 4th set and wind braces at one of the common rafter sets inbetween the colar tie sets. It is generally very well constructed roof though somewhat evading current roof standards. The roof structure complies with current load standards though in order to comply with the 2012 Building Code the rafters would have to be connected to wall plate by ties. As the rafters butt-end at the hip line, installing a steel strap connector would stiffen the roof structure.

One possible connector type that could be installed to tie the roof to the walls.

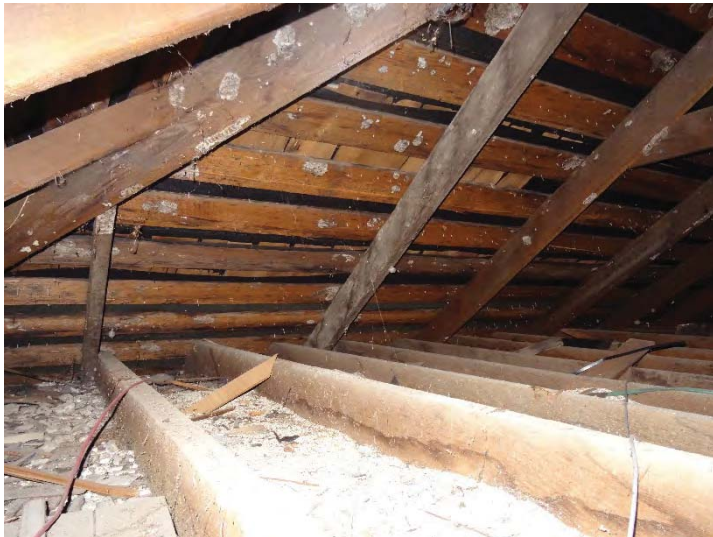
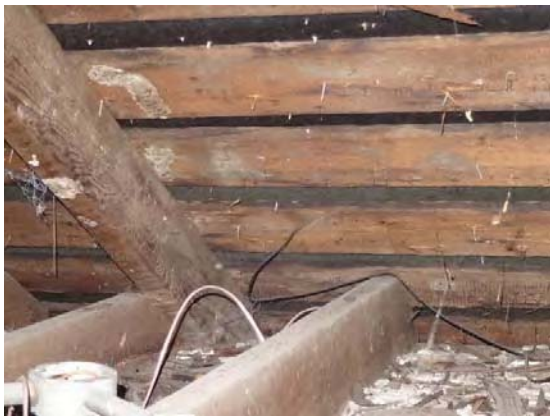
The rafters support horizontal battens but at some roof areas the battens are doubled by perpendicular installed boards, the boards as well as the batten lathe are of varied width as the following photo documents.

One rare occurrence of rafter coinciding with ceiling joist.

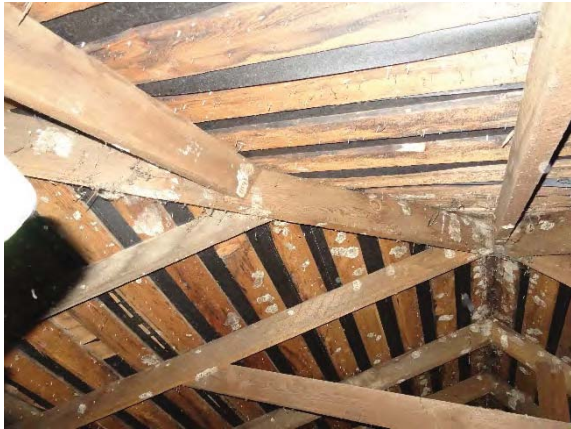
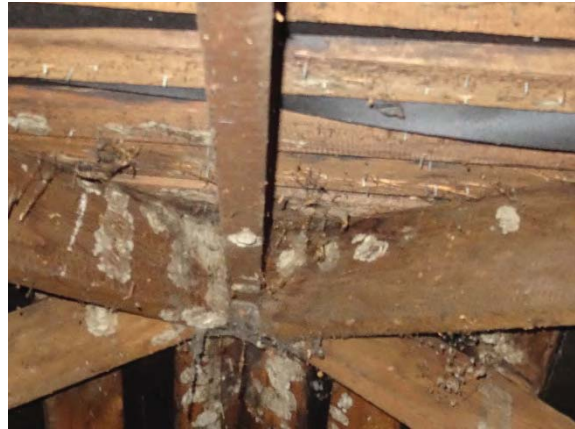
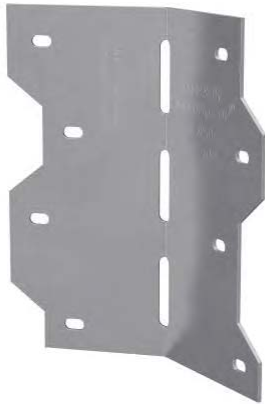
The two hip joints of the common rafters and hip rafters are a masterpiece of carpentry with no evidence of nails, strictly relying on compression. However, as winds and seismic events apply to the structure horizontally and uplift forces, it would be desirable to use steel connectors for the hip ridge joint and for the jacks attached to hip rafters.

SST – LS 18 field adjustable angle connector.
